Historic Building Record and Archaeological
Watching Brief
Craig of Stenton
Dunkeld
PERTH & KINROSS
DK09

**HISTORIC BUILDING RECORD &
WATCHING BRIEF
CRAIG OF STENTON
DUNKELD**

DK09

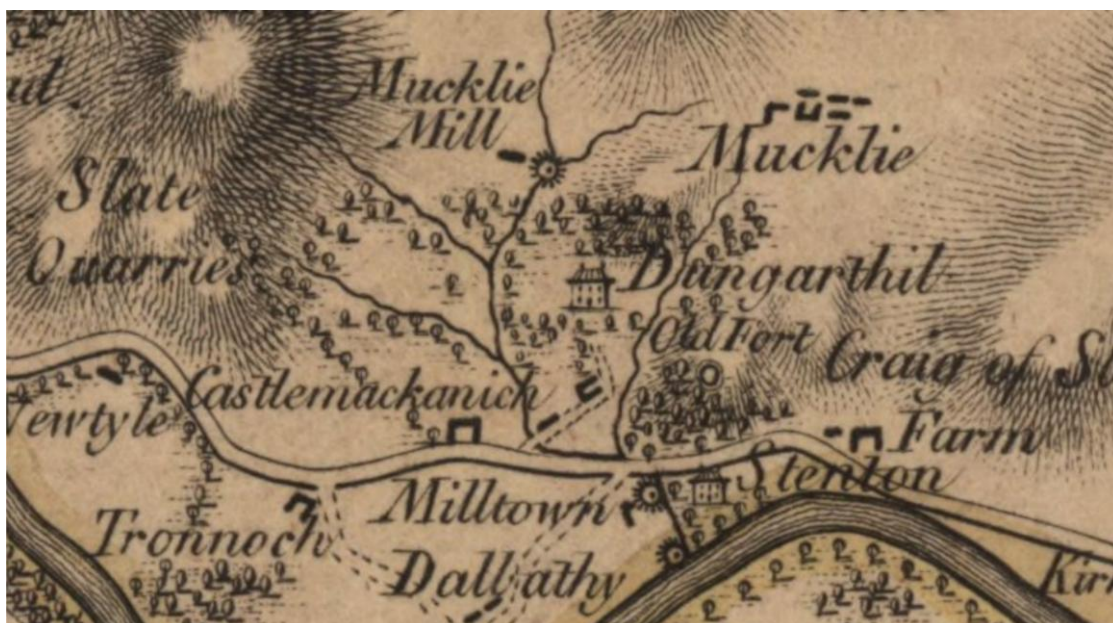
Stobie, 1783. A large house stands at Dungarthil (sic), with a steading to the S.

However, these seem rather too far from the fort to be the site itself and may represent buildings closer to the present road.

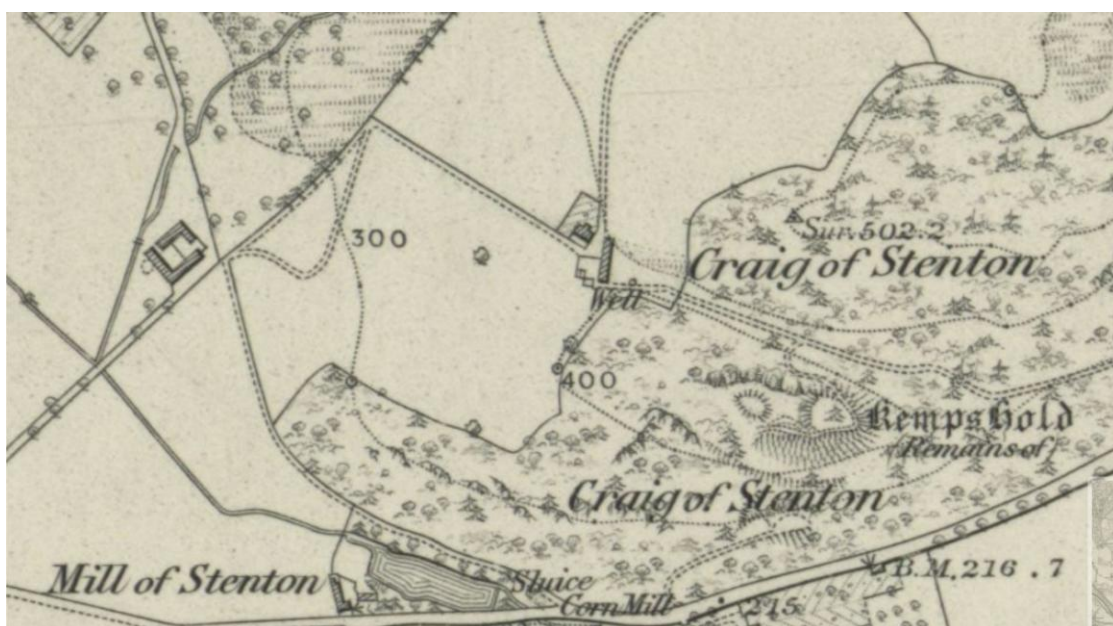
Ordnance Survey, surveyed 1864. The core of the cottage and the stone steading are present.

This shows a well to the E and an enclosure with small outbuilding to the W of the steading, on the footprint later occupied by the brick barn. A large steading to the W is probably that depicted by Stobie. The Second Edition (revised 1899) shows a larger building attached to the enclosure:

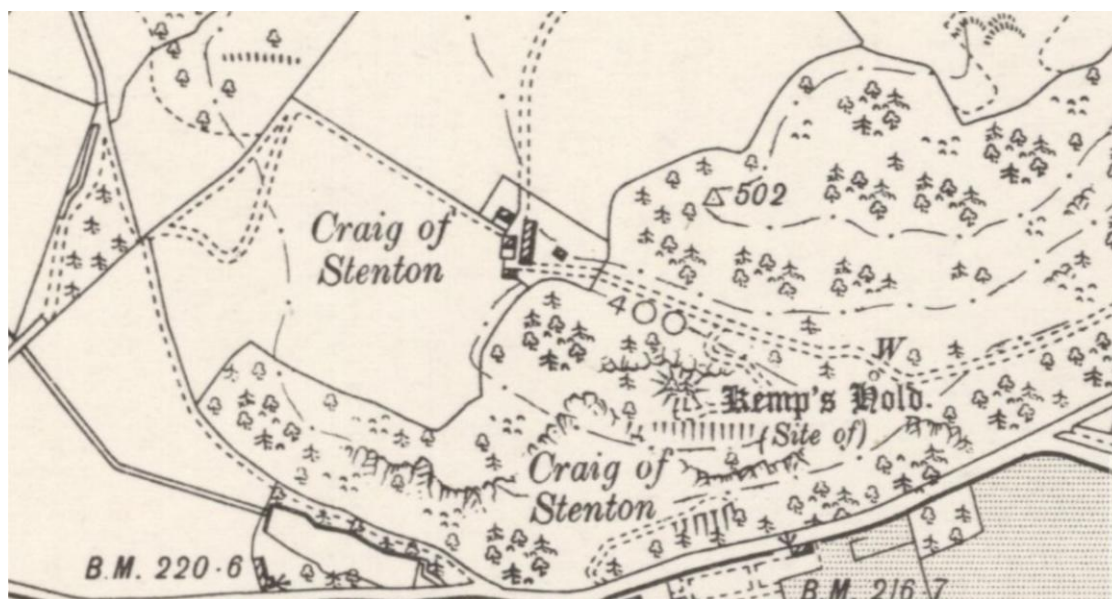
Ordnance Survey, revised 1899. The cottage appears simplified, the well enclosed in a substantial building and another outbuilding has appeared to the S
