Historic Building Recording  
Cramflat Farm  
Luncarty  
PERTH & KINROSS  
LJ03

**HISTORIC BUILDING RECORDING  
CRAMFLAT FARM  
PERTH & KINROSS**

**LJ03**

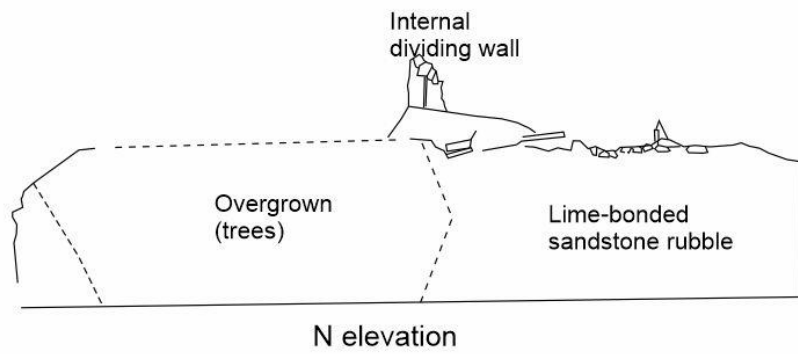
Illus 5 External elevations of outbuilding, building 3

NB- S elevation obscured by trees

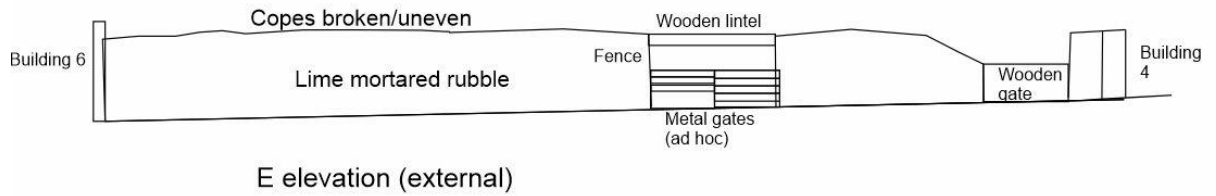
E elevation (external)

This was completely roofless and had been largely demolished (or had collapsed and then been partially cleared), apart from a rectangular, standing ruin in the NE corner and the N, E and S external walls. The N and S walls now formed part of buildings 4 and 6, while the E wall was effectively the E boundary of the farm. The interior was almost impenetrably overgrown, while most of the W side was covered by mounds of demolition rubble. Map evidence indicated a later 19<sup>th</sup> Century origin for this steading, which replaced an earlier version (see above). The surviving wall fabric was of lime-mortared stone rubble, with elements of brick in places. Within the ruin, entrances had been inserted in the N and S long walls, with a brick arch above a steel joist in the latter. The W ends of both long walls, were severely damaged.
