# AN ARCHAEOLOGICAL AND HISTORICAL SURVEY OF BLAIRADAM FOREST FIFE & PERTH AND KINROSS

Alder Archaeology Ltd was commissioned by Forestry Commission Scotland to carry out a desk-based assessment and walkover survey in Blairadam Forest, Fife. This work was carried out to enable the FCS to make informed and reasonable decisions on the future management of the cultural heritage within Blairadam Forest. The forest lies to the west of the M90 motorway, near Kelty, and measures roughly 12 square kilometres. Sites identified in the desk-based assessment were visited over several days between the 29th of August and the 28th of September 2009. The results of this survey found that many of the boundaries that once belonged to Blairadam estate can still be found hidden in the forest. The boundaries (comprising tree lined banks, ha-ha's and walls) belong to the designed landscape created by the Adam family over three generations between 1733 and 1834. It was possible in many areas to distinguish between three different phases of boundary alterations. The survey also found extensive mining remains along three different burns, some of which may date to the medieval period. The most extensive of

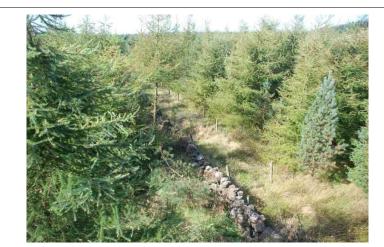
*Mitigation:* Avoid damage to the drystone walls of the square enclosure around the farmstead.

GIS info: Shapefile shows surviving wall round farmstead site

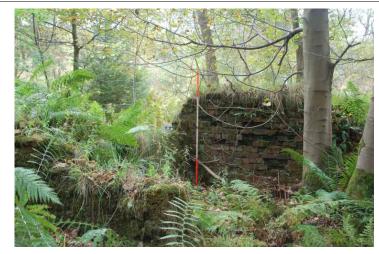
*Mitigation:* Avoid damage to buildings within 9.1. A detailed survey is recommended (possibly with public involvement). Interpretation panel also recommended.

GIS info: Shapefile shows extent of 9.1 and 9.2. Other features, points: 9.3 = hole/slot, 9.4 = hole and crushed mortar, 9.5 = shaft, 9.6 = brick buildings ruins, 9.7 = concrete plinths, 9.8 = concrete plinths, 9.9 = rubble from buildings, 9.10 = chimney.

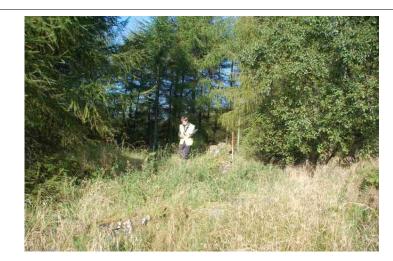
*Mitigation:* Larches have been grown very close to this structure and there is danger that they may cause it damage if blown down or felled. A recommendation is that the closest trees are controllably felled around this structure.

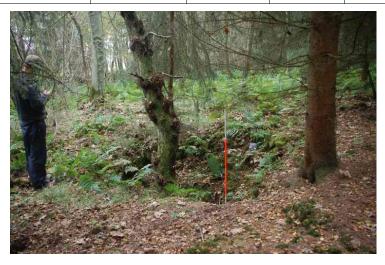
Mitigation: Avoid when carrying out forestry work.

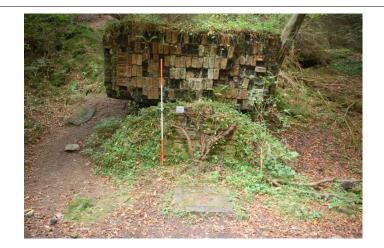
Walkover Description: The brick remains of a viaduct (bricks stamped Blairadam) over the Kelty burn. The locations of two brick piers were noted. The southern pier survives 2.4m high. The northern pier has been blown up but a surviving portion resting against the northern bank of the valley measures 3.9m long, 2.9m wide and 1.65m thick. Behind this piece of pier are further collapsed brick remains from the bridge. The distance between the southern pier and the collapsed northern pier is 16.5m. The curved brick remains of the top of the viaduct are visible on the north bank.

*Interpretation:* The remains of the viaduct over the Kelty burn serving Blairenbathie Colliery (9).

*Mitigation:* Avoid further alteration to brick remains. The remains are an important feature for the public in The Glen.

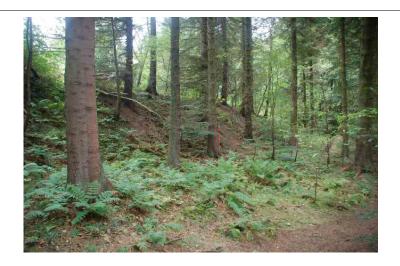
Walkover Description: Visible remains of a large reservoir can be seen in a grassy field on the south side of the Kelty burn (remains on the north bank not visited). The remains comprise a large oval depression 1.5m deep, 50m wide and 95m long. At the east end of the depression is the dam, a massive earth bank 3.7m high (downside) and 18m wide. The top of the dam is flat. The Kelty burn is currently eroding this structure at the northern end. At the south-eastern corner of the dam there is a stone lined channel leading from the reservoir to a double arched bridge. The bridge is 3.9m wide, 4.8m long, 2m high and has no parapets. The width of the arches are 2.3m and 2.1m, voussoirs 0.33m high. The bridge and the stone revetting of the channel are composed of well squared and pointed sandstone blocks cemented together. Under the bridge are the many pieces of worked sandstone, some of these may be from the original parapets. The central pillar of the bridge is chamfered at the NW end. About 5m along the stone lined channel NW of the bridge are the stone foundations of a 7m long, 0.5m wide wall which stick out into the channel at 90 degrees. On the bridge side of it (SE) there is a grassed over patch of rubble. At the end of the wall there is a 2.6m wide gap between it and a further area of rubble extending to the other side of the channel.

Mitigation: Avoid damaging the bridge and associated stonework when carrying out forestry operations. The dam and the bridge are impressive and could form an important part of a public trail.

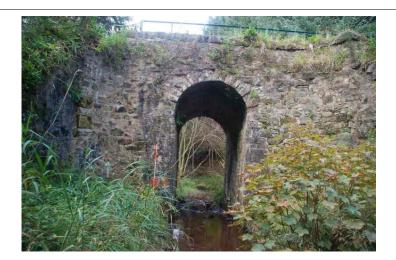
Walkover Description: A tall narrow arched bridge over Lochornie burn. Sides made of random rubble (repointed recently). The reveals and voussoirs are made of well squared pointed blocks of sandstone. The inside of the arch has been repaired using concrete. There is a slight lip to the parapet. Sides of bridge are gently curved. Arch 4.6m high and 1.5m wide. In total bridge is 4.6m long and 4.6m wide and distance from top of the arch to the top of the parapet is 1.7m.

*Interpretation:* A slightly modified original estate bridge in good condition. May have been built by Robert Adam. The concrete render dates to the construction of the reservoirs upstream and in fact the Lochornie burn has been edged in concrete just west of this bridge.

Mitigation: Avoid modification to this bridge.

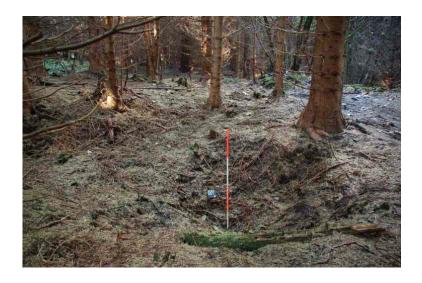
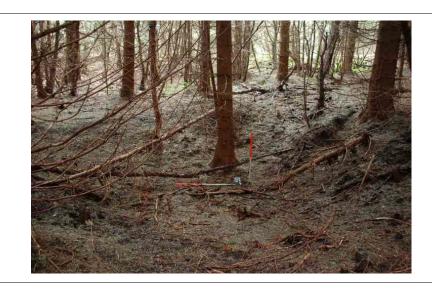
*Interpretation:* These depressions are a series of bell pits which probably followed a seam of coal running NE-SW. The seam was probably discovered in the sides of the Kelty burn

where it turns a loop some distance away to the NE. The Blairenbathie Colliery branch of the railway line was probably built over further pits which may have followed this seam to the NE.

*Mitigation:* The pits lie in a fairly dense area of conifers. Care should be taken not to disturb these features when thinning out trees.

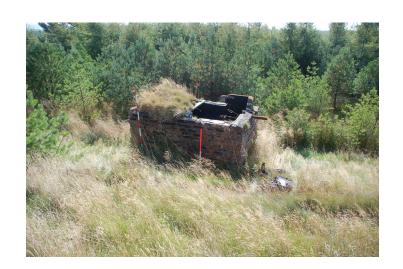
Walkover Description: A brick built rectangular structure (probably 1930s) 1.90m by 3m, 2m high. The internal walls are rendered in concrete and painted black, the internal chamber is full of water. Half of the roof was intact: a slab of slate covered in grass; the other half had fallen in and could be seen inside the structure. This half of the roof would have held a metal trapdoor (now fallen inside). There is a projecting (0.9m) rubble built stone ledge on the south side (0.65m high), presumably the foundations for this structure.

*Mitigation:* Avoid damaging the structure by any forestry work. This is the only surviving solid structure relating to King's Seat farmstead.

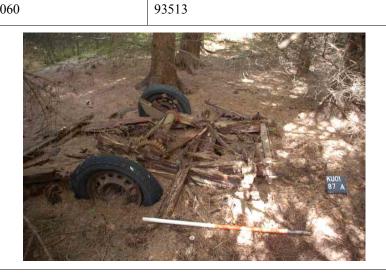
Walkover Description: A collapsed wooden and cast iron trailer. 2 inflatable tyres visible (medium sized). There is a winch attached to the trailer with steel cable wound round a drum. A series of pulleys and cogs visible. 'East Kilbride Patent 32488' visible on part of cast iron. Remains 3m long 1.7m wide.

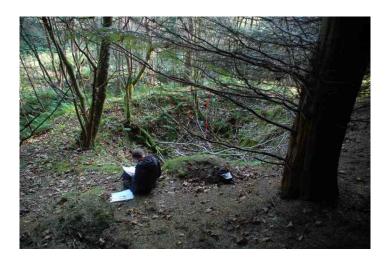
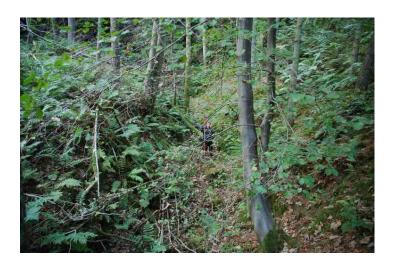
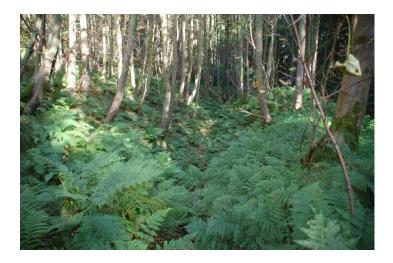
- An artificial ramp with a channel in the middle running from NT 12030 94840 north-west down to the Kelty burn. Feature lines up with the revetted stonework along railway line (59) and in the other direction with a hollow where the north bank of the Kelty burn has been cut away. Possibly an artificial watercourse or site of a conveyor running diagonally up the glen (135.2).

- A narrow (1-2m wide) rock cut gully running into the north side of the valley at roughly NT 11980 94910. It is 3-4m deep in places and the coal seams are visible on either side. The gully curves round to the north-west and ends in a large quarry which seems to be later phase of activity. This gully is difficult to date but it could be from the medieval period or perhaps slightly later. (135.3)

- Quarries next to the gully on the hillside. (135.4)
- Brickwork across Pierie's burn just before it joins the Lochornie burn (probably relates to the waterworks downstream).

Interpretation: The above features were all that could be noted in the time available but there are bound to be less obvious features, such as small early coal cuttings or small bell pits, that have been overlooked. Most of the remains that were noted seem to relate to a 19th century phase of coal mining and some quarrying (which probably both went hand in hand). It is likely that this phase of activity is superimposed on earlier, perhaps medieval phase of coal extraction.

Mitigation: There is little threat to these remains because they lie within The Glen, an area where little forestry work is planned to take place. However, it might be work carrying out a detailed survey of either side of the Kelty burn to further interpretation.
