**32 High Street
Saxmundham
Suffolk**

Report into the Architectural and Historic Significance of the Building

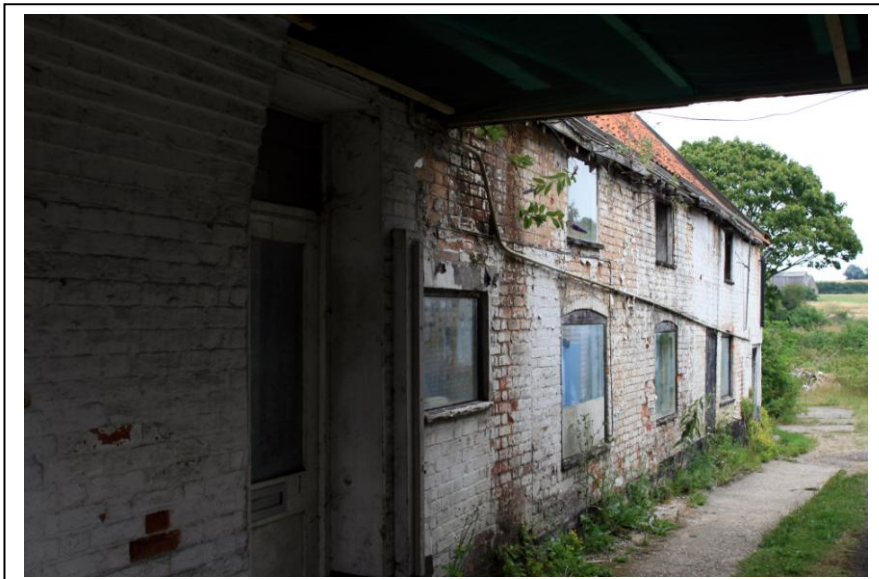
Fig. 2: South elevation towards the yard, looking east

1.2 The evidence of two but joins in the south elevation of the building tell us that each of the sections A, B and C were constructed at different times in the nineteenth century, or, more accurately, reconstructed as the needs of the business and domestic occupation changed. The implications of these joints will be considered under the section dealing with the description of the exterior.

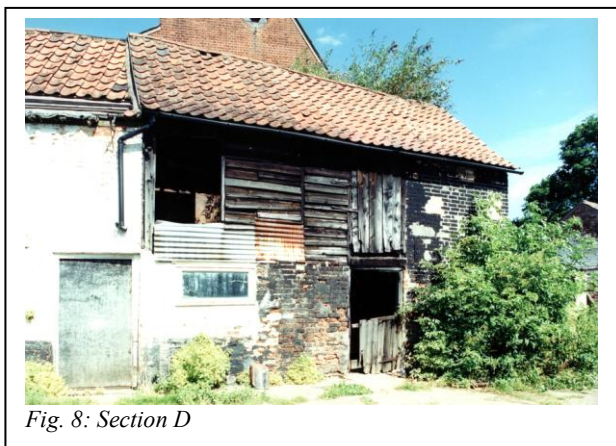
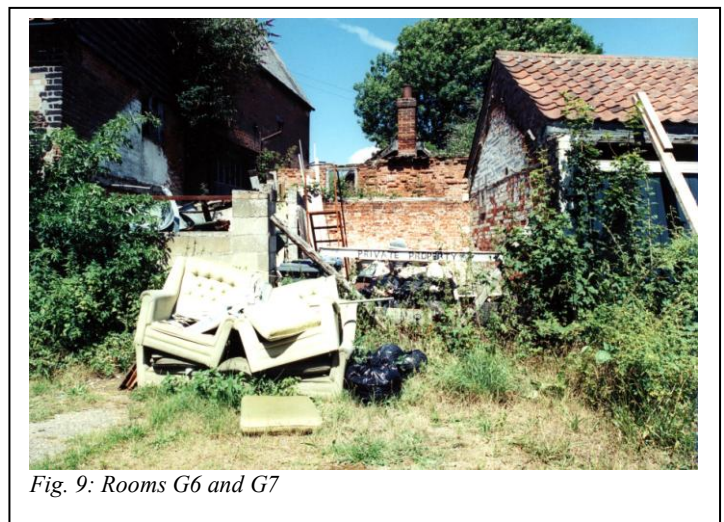
- 2.8 Section D, or room G5, is the animal shelter but it is an odd room in that the western third of it has been taken into room G4, probably about 1900 when a great deal of alteration took place to the building. There is a red brick ground floor with a plate-glass window of c. 1900 to the left and the lower leaf of a double stable door to the right. Above this is a plank door to the hay loft (for animal feed and bedding), and to the left of this door is a weatherboarded area reflecting a similar weatherboarded area in the north wall. Parts have been repaired with corrugated iron. The ground floor of the east gable end was until the 1970s open to the former storeroom and slaughterhouse to the east (G6 and G7), but this has been closed with blockwork on the inside and stretcher-bond brickwork to the outside. Over this is a two-light cross casement window, without glass, lighting the hay loft and over that is a weatherboarded gable head.

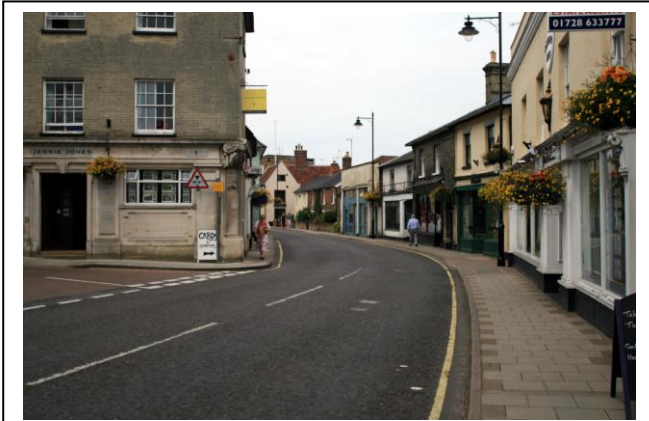
Fig. 15: High Street, looking north

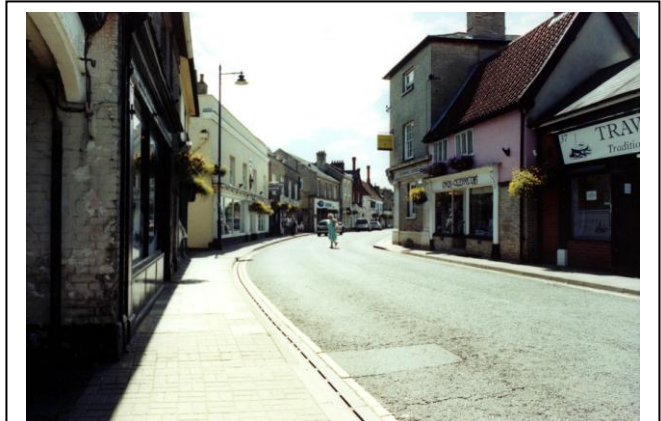
Fig. 16: High Street, looking south
