# Barn and adjacent buildings to the north-west of Golding's Farm, Sotterley, Suffolk

An Archaeological Record

January 2010

SCC HER ref: SOT012

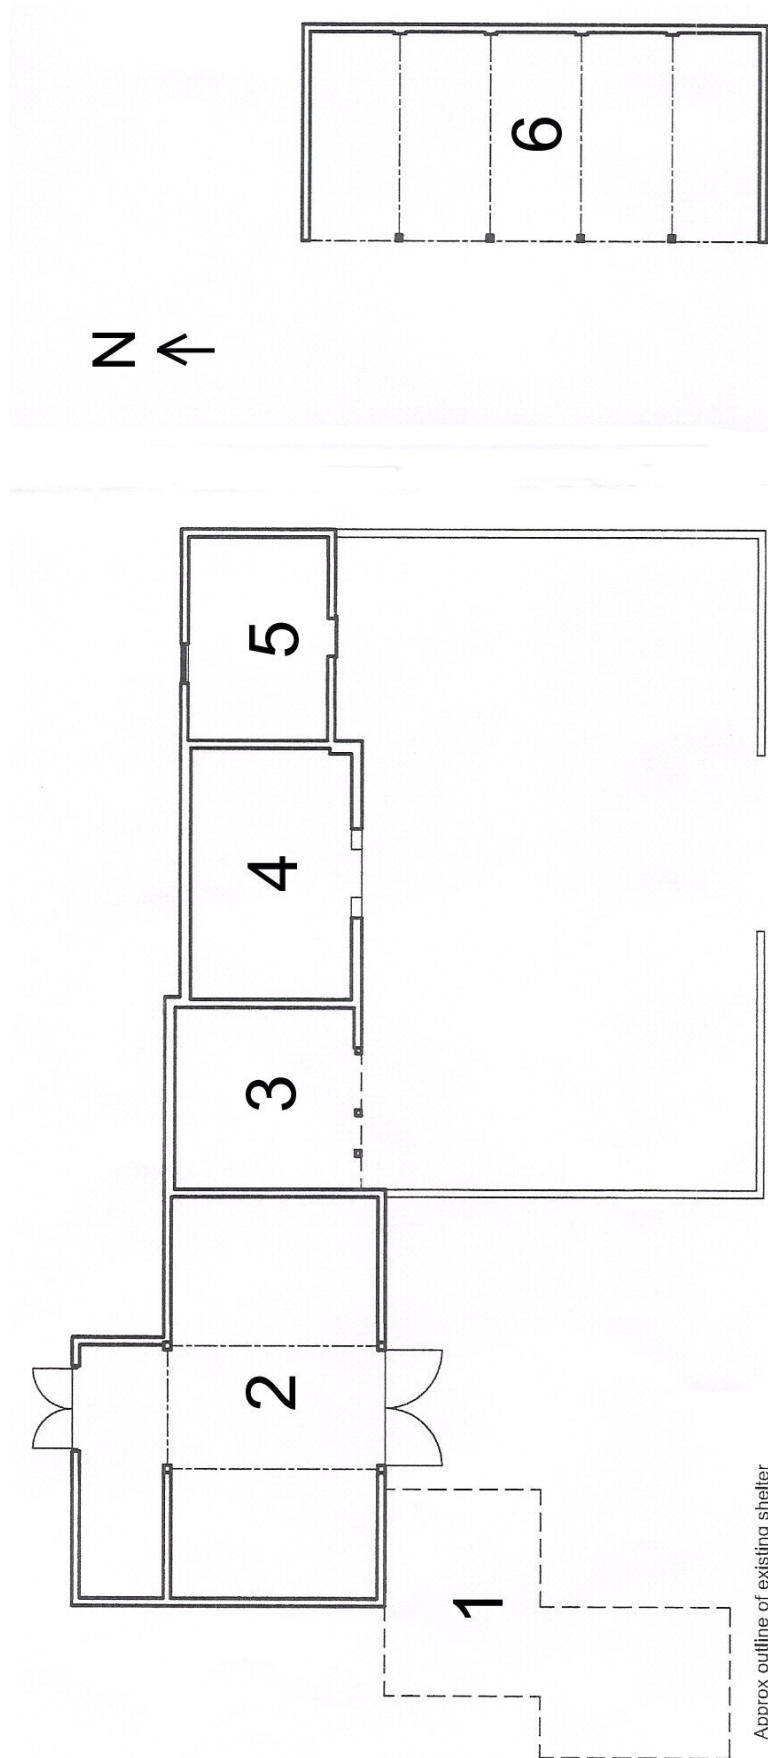
Fig 1: Block Plan of the site taken from the measured survey by Bidwells, October 2006. The Analysed Buildings have been numbered 1 to 6 to identify them in the report. Scale: approximately 1:200
