Corfe Hills Roman Road, Poole, Dorset

Archaeological Observations and Recording during Drain Repairs,
September 2014

Report No. 53422/3/1

Scheduled Monument No: 1018195

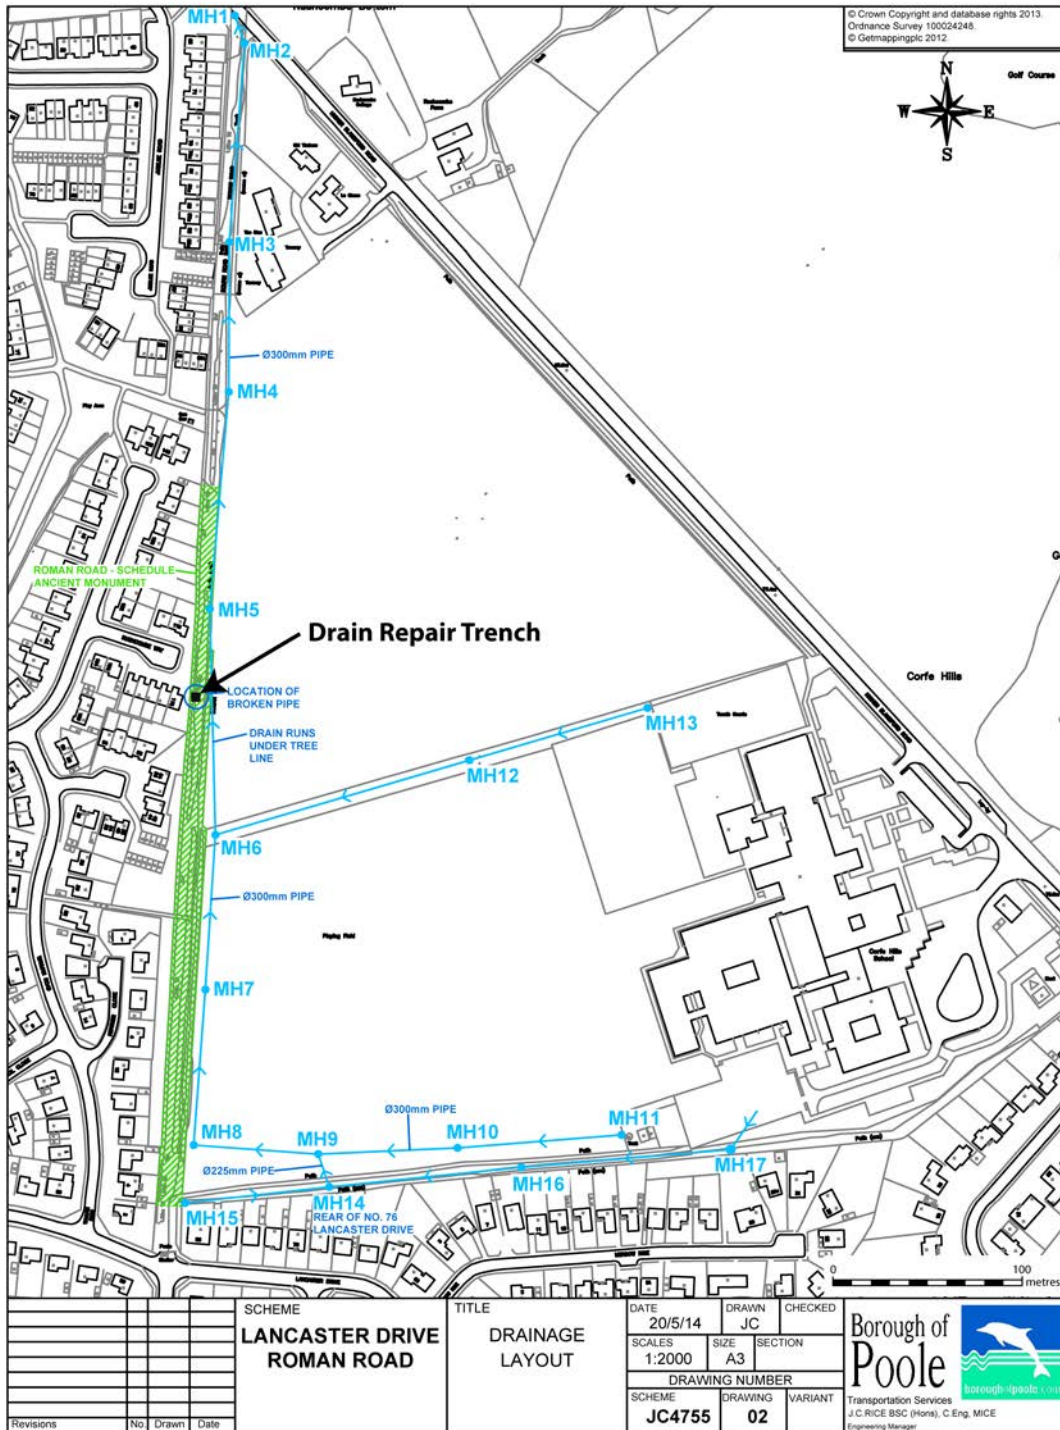
Figure 2: Location of drain repair trench. (Plan provided by Client).

The broken pipe lies on the east side of Bridleway No.1, which runs along the western edge of the Scheduled Roman road between Rushcombe Way and Lancaster Drive on the parish boundary between Poole and Corfe Mullen, at NGR SY 9930 9676 (Figures 1 and 2).
