# Church of St John the Baptist, Woodsford, Dorset

## Archaeological Observations and Recording of Works to Churchyard Wall

Report No. 53445/3/1

December 2016

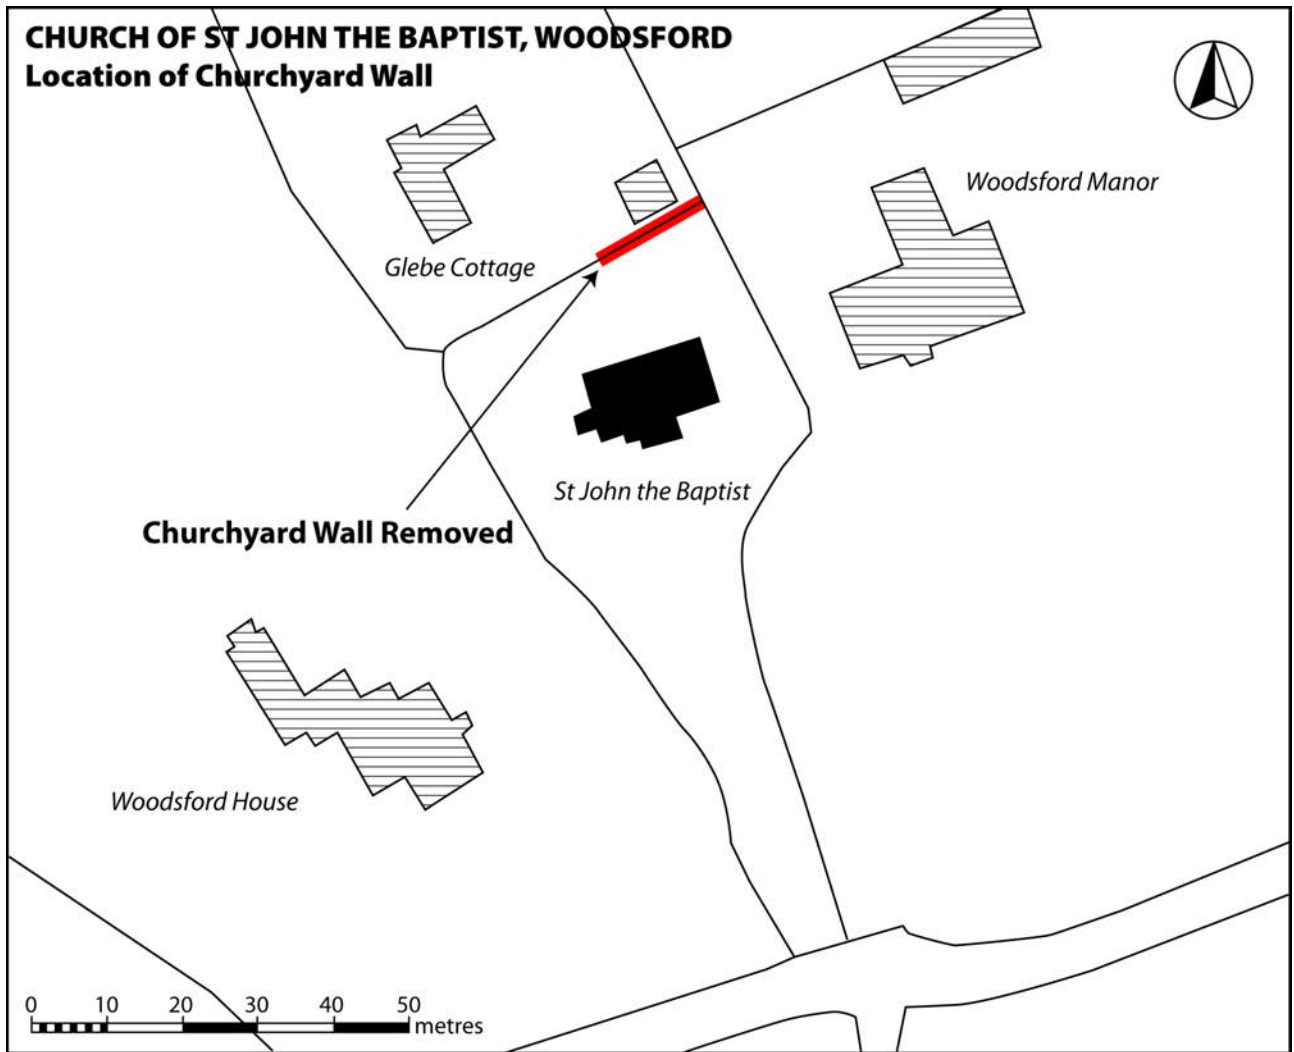
Figure 2: Location of dismantled length of Churchyard Wall.

The section of the churchyard boundary wall removed during this project was a 0.24 m wide Broadmayne brick wall laid in common bond with a chamfered brick coping and bonded with lime mortar. It was up to about 1.4 m high and was founded on a layer of large stone rubble up to 500mm across, just below ground level to the north of the churchyard. It was butted against the boundary wall with Woodsford Farm to the east and had a straight joint to the churchyard wall to the west.

The northern boundary wall of the churchyard was unsafe and a planning application (WD/D/15/000269) was submitted for dismantling and rebuilding part of this wall. Permission was granted on 21 May 2015. There was no specific archaeological condition attached to this permission. The rebuilding works proved too costly for the PCC and an alternative scheme for the dismantling the wall and the erection of a temporary wooden fence was submitted to the Local Planning Authority (Application No. WD/D/16/000753). Permission was granted on 17 August 2016. There was no specific archaeological condition attached to this permission.
