**BURNGATE PEARCE'S QUARRY, LANGTON MATRAVERS,
PURBECK, DORSET**

Assessment and Recording

Report No. 53246/5/1

June 2007

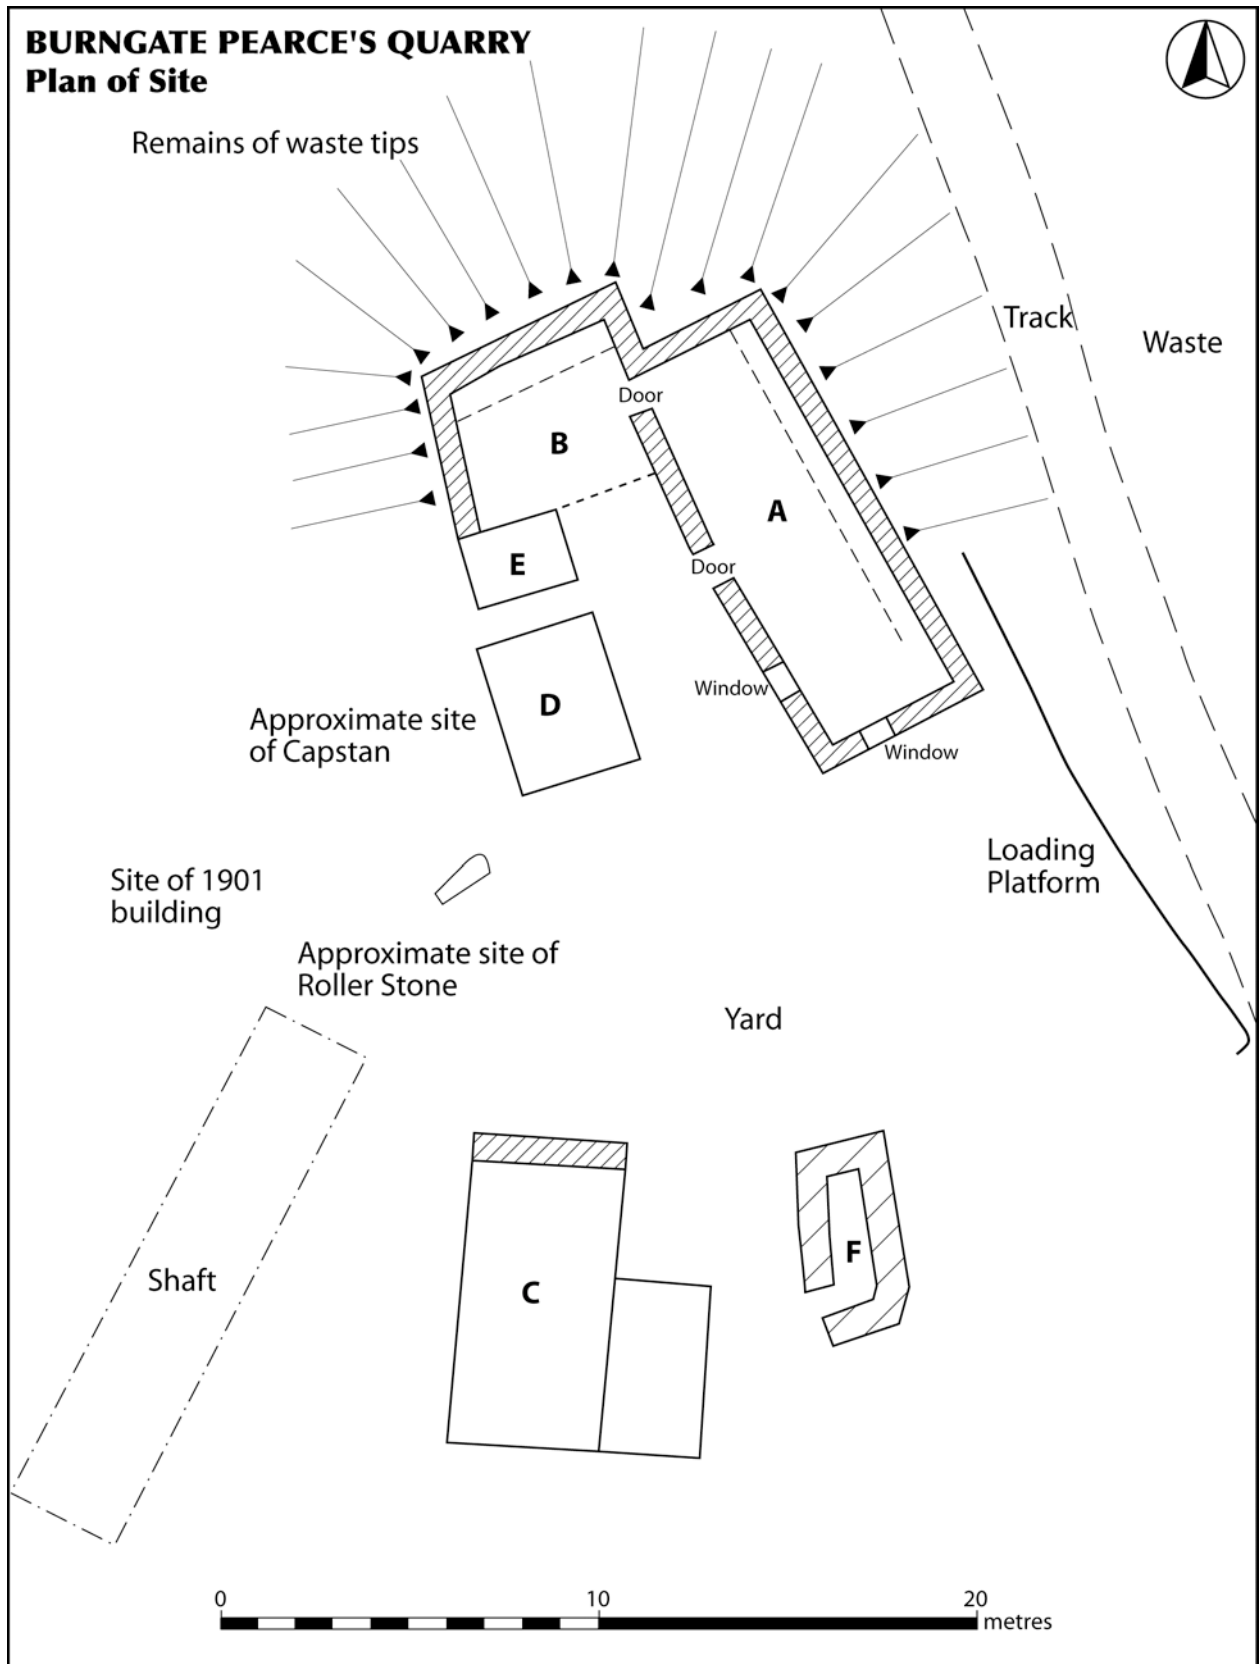
Figure 3: Plan showing location of principal features

The whole site has an air of dereliction, with some buildings extremely dilapidated. Figure 3 shows the general layout of buildings and features described below.

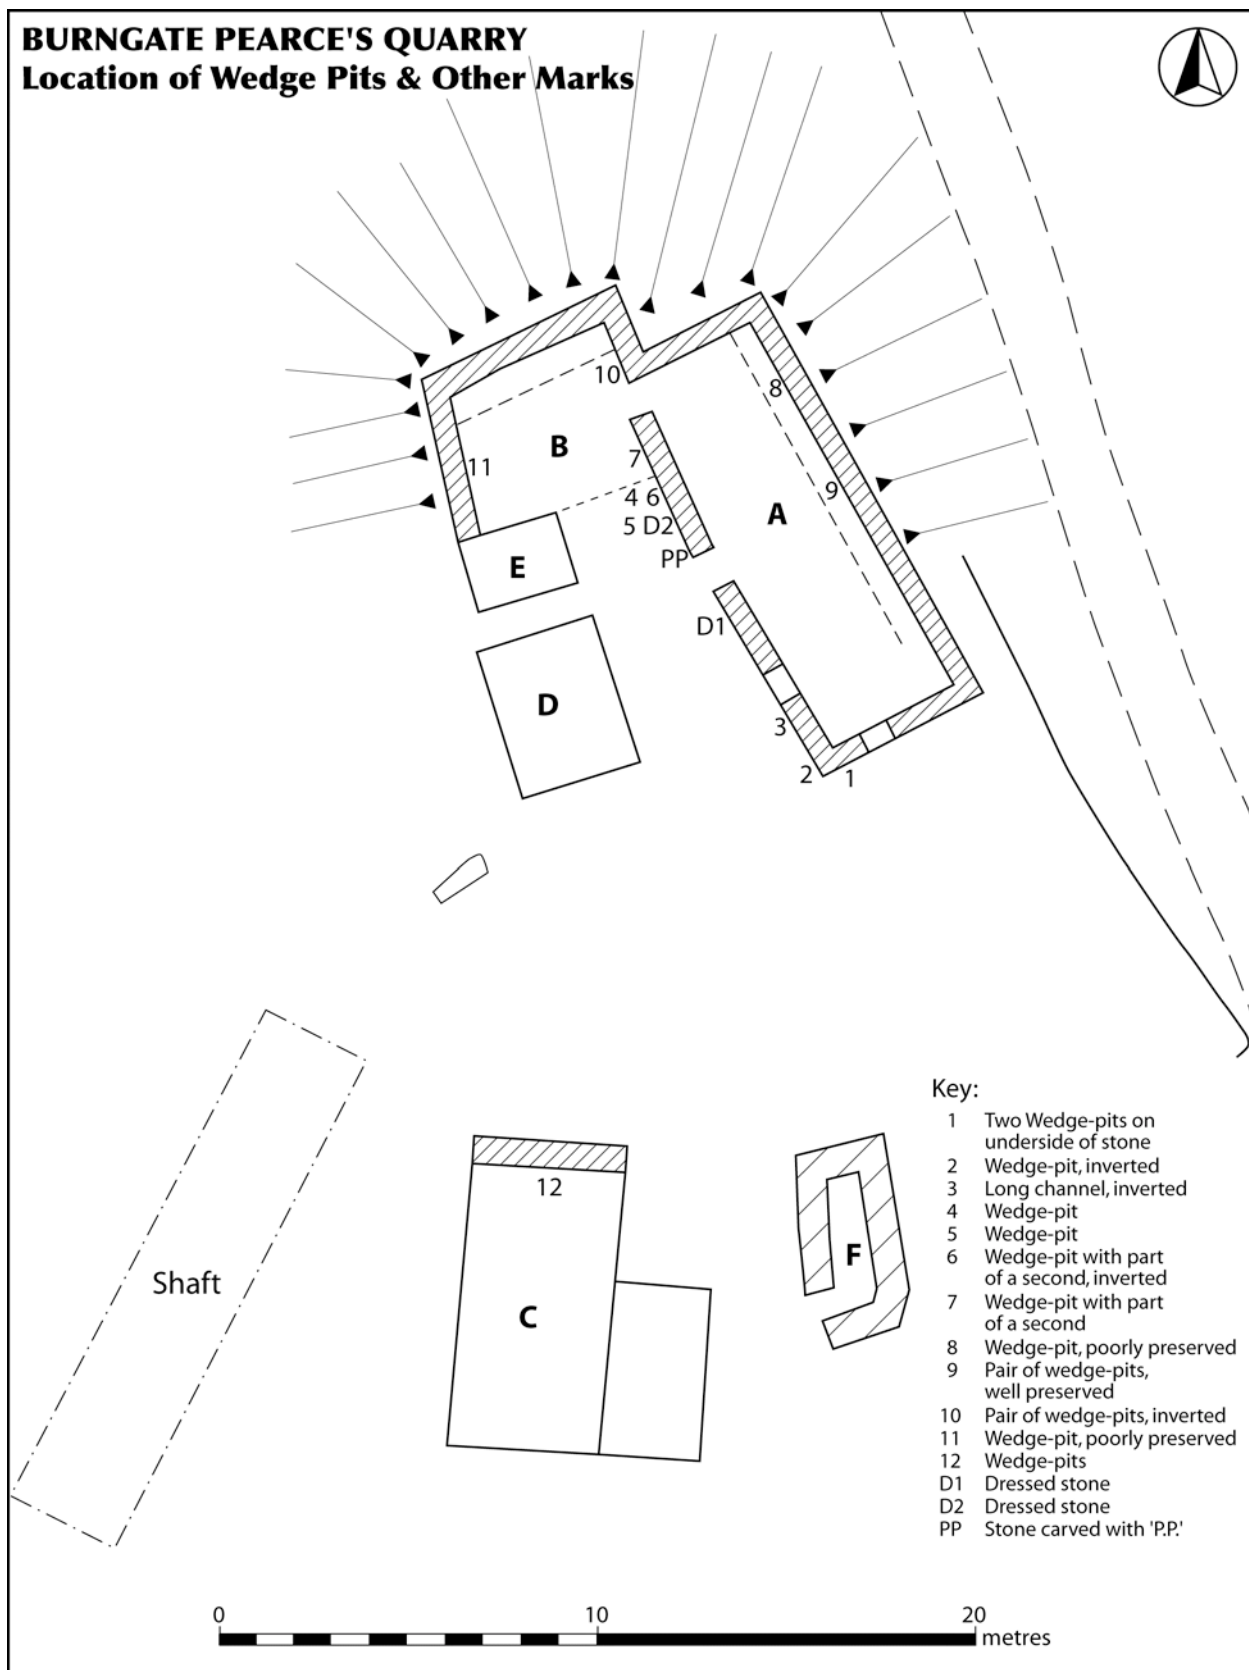
Figure 4: Plan showing location of wedge pits and other marks

The most significant features, apart from the randomness of the construction (this was built purely for the quarrymen), are the few stones in the walls which exhibit the marks or dressing or stone-cutting. The latter are shallow wedge-pits, which were chiselled out for inserting wedges to split the stone. There are at least seven outside and two inside the building (Figure 4).
