**'SERVICE ROOM', WALNUT FARM HOUSE, COWGROVE,
PAMPHILL, DORSET
Building Survey and Recording**

Report No. 3074.1

May 2002

Building Survey and Recording

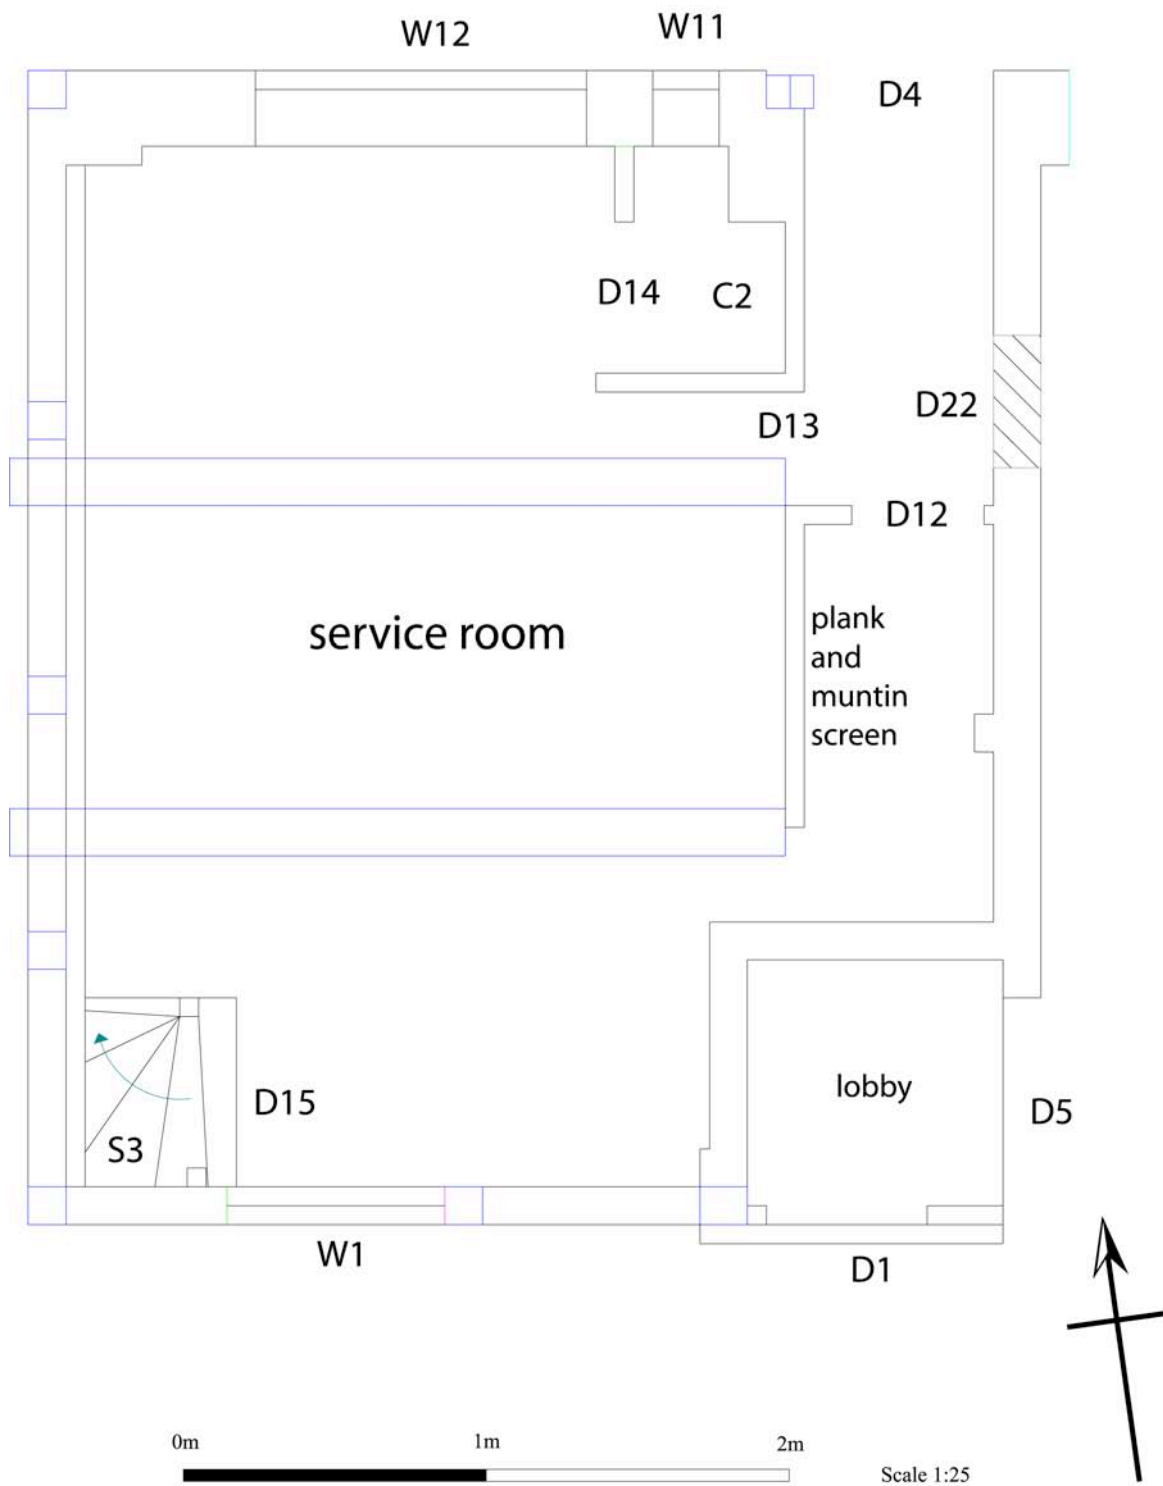
Figure 1: Plan of Service Room

The entrance to the service room is at the north of the building through an open doorway [D4], which leads into a through passage (Figure 1). The entrance was floored in large red quarry tiles. At the threshold the tiles were either missing or damaged. Made up ground could be seen below the tiles to a depth of c. 0.5 m. The passage was blocked to the north by modern concrete block

The ceiling of the through passage was plastered and damage to the ceiling exposed reed laths.
