**A1 DISHFORTH TO
NORTH OF LEEMING IMPROVEMENTS
CULTURAL HERITAGE
INITIAL ASSESSMENT OF THE BUILT HERITAGE**

Date	Originator	Checked	Approved	Status
January 1995	S Haigh (AWP)	E Dennison (AWP)	G Barton (AWP)	Final

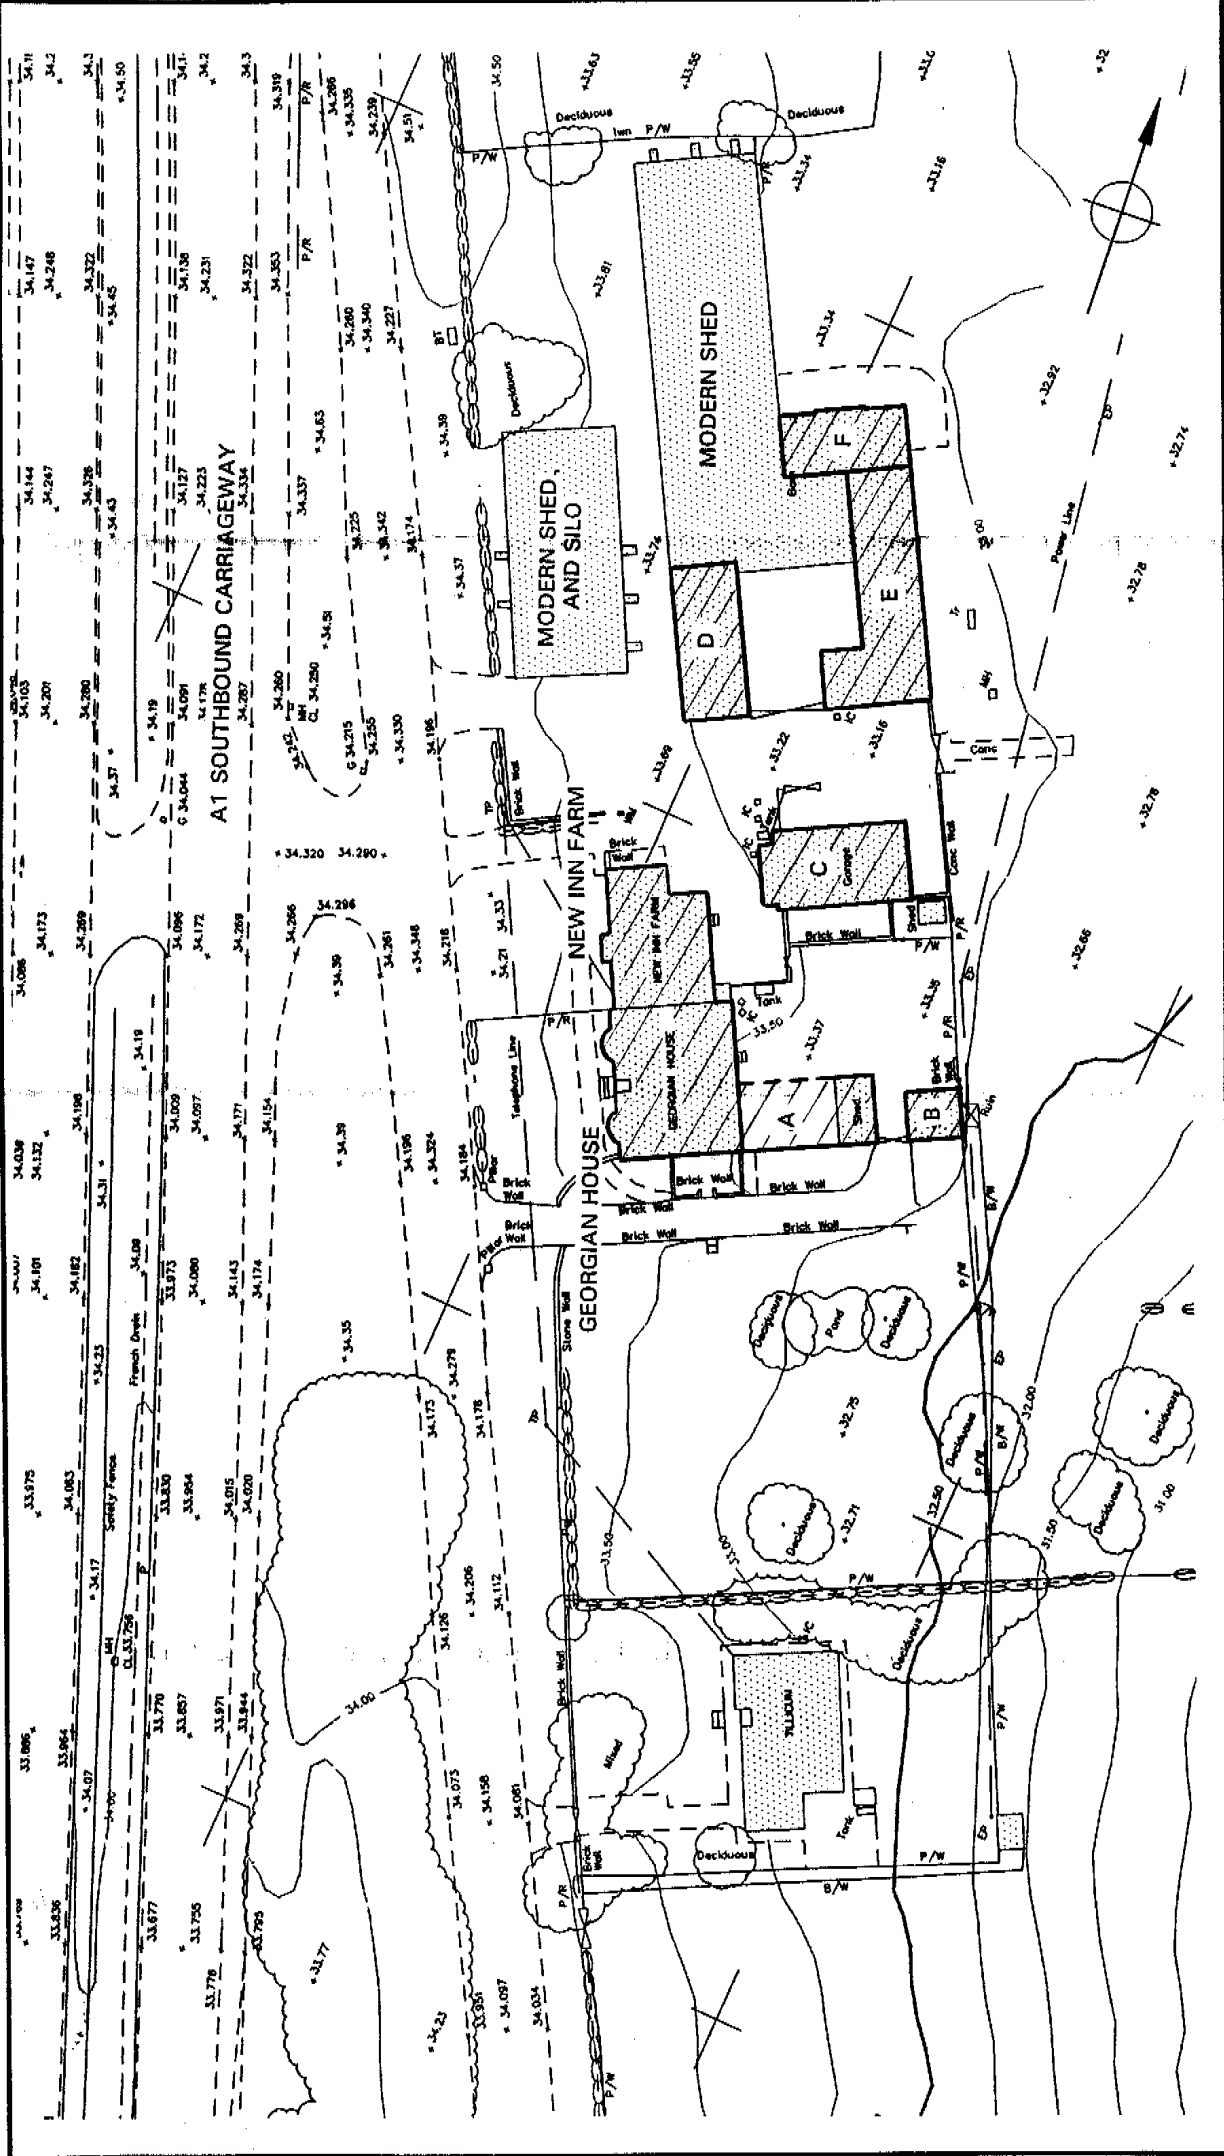
FIGURE
SITE 4/07 NEW INN FARM AND GEORGIAN HOUSE

- 5.9 The initial assessment indicates that a number of the buildings in this complex are of some architectural and historic interest. Their significance can be confirmed as being of district importance. While they are not of sufficient quality and importance to merit physical preservation, it is recommended that seven buildings in the complex are subject to more detailed architectural recording, prior to demolition.

- 5.10 At this stage, it is envisaged that, for the six agricultural buildings in this complex, this recording work would involve the production of measured ground floor plans. External elevation drawings would also be produced of the threshing barn, stable block and cowshed. Section drawings of these three buildings, together with records of any further significant details would be carried out as required. A detailed photographic record would also complement the architectural description. Further documentary research is also recommended, which might bring to light otherwise unknown details of the complex to complement the architectural recording.

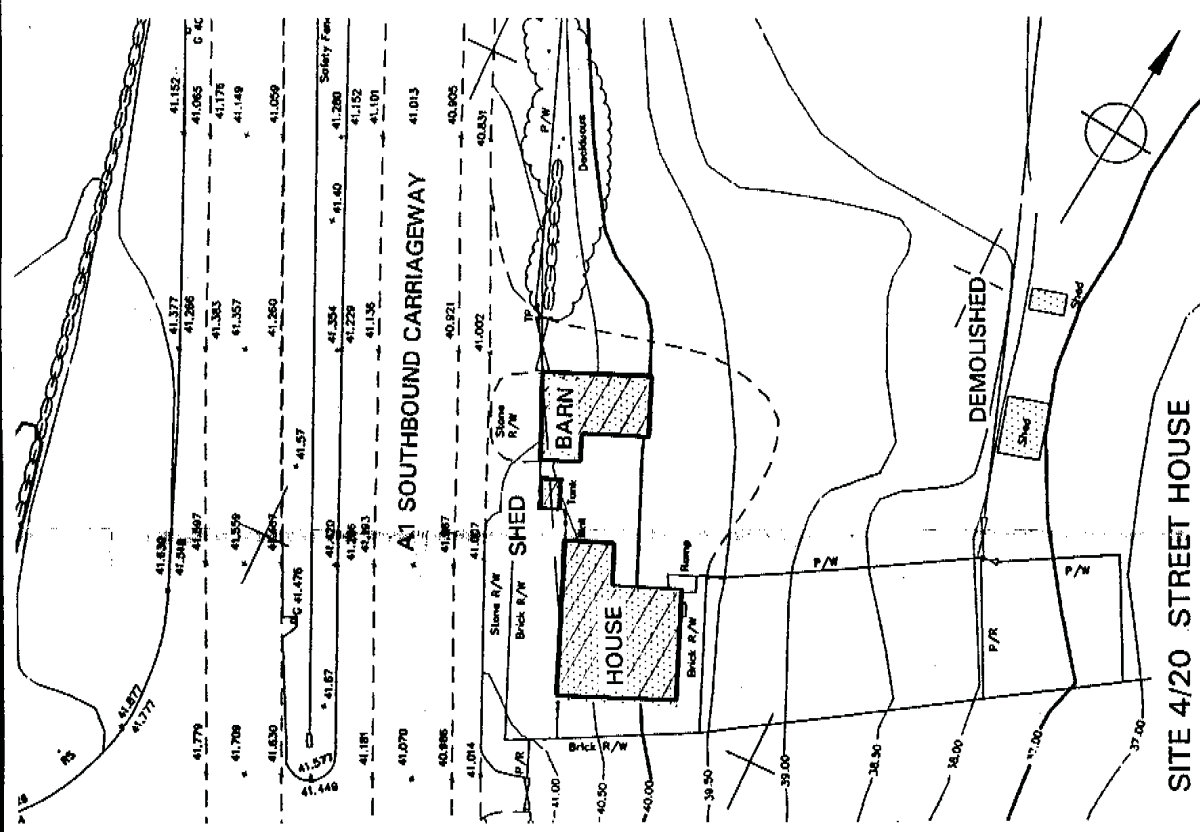
SITE 4/20 STREET HOUSE

3.5 Street House (site 4/20) (see figure 5 and plate 6)

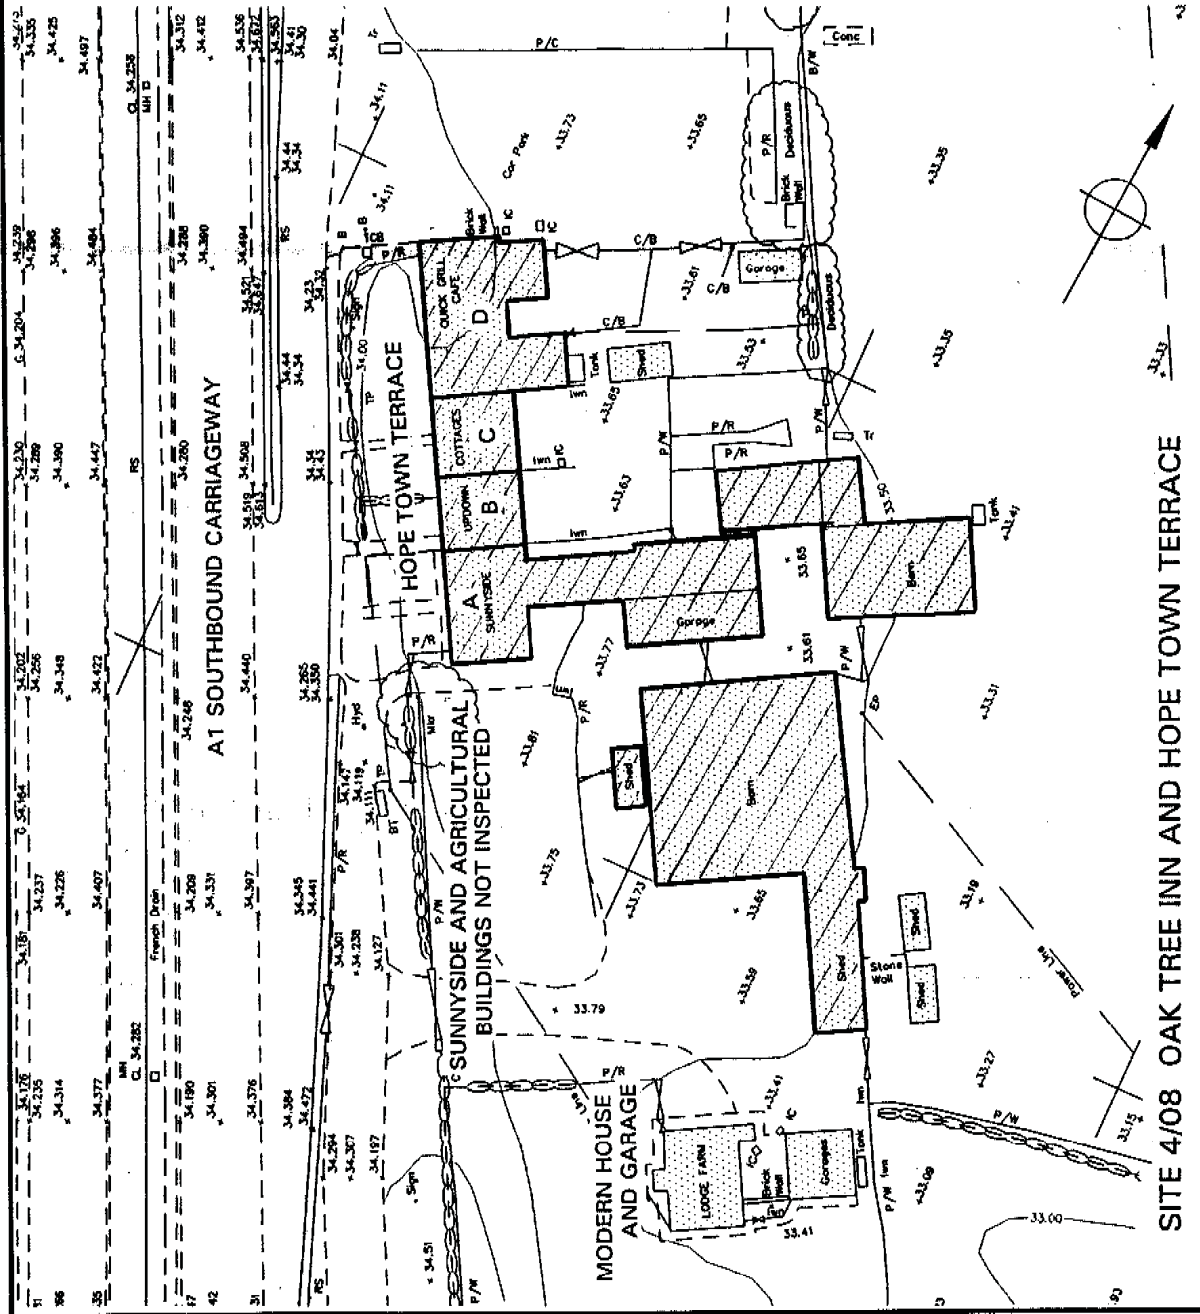
SITE 4/08 OAK TREE INN AND HOPE TOWN TERRACE

- 5.14 The assessment of this complex carried out to date indicates that it is of some architectural and historic interest; this significance can be confirmed as being of district importance. While it is not of sufficient quality and importance to merit physical preservation, it is recommended that the terrace is subject to more detailed architectural recording, prior to demolition.

- 5.15 At this stage, it is envisaged that this work would involve the production of measured ground and first floor plans and an elevation drawing of the west wall. One or more section drawings across the terrace, possibly showing the roof structure, and drawn records of any further significant details would be carried out as required and as access permits. Detailed drawings of a number of fittings including door furniture would also be made, as well as a detailed photographic record. It should be noted that those elements of the complex which have not been assessed due to access restrictions may contain features of greater significance, requiring more intensive recording.

- 5.17 Consideration should be given to commencing any programme of more detailed recording works as soon as the complex is vacated and access is possible. While parts of the terrace and Lodge Farm remain occupied, the threat of vandalism or architectural theft is slight, but on the vacation of these premises it is likely that these dangers will increase. It is therefore recommended that detailed recording of Hope Town Terrace begins as early as possible following vacation.
