**Church Street, Carlby**

**Archaeological Watching Brief**

**Anglian Water Services Ltd**

**LAS Report No. 363**

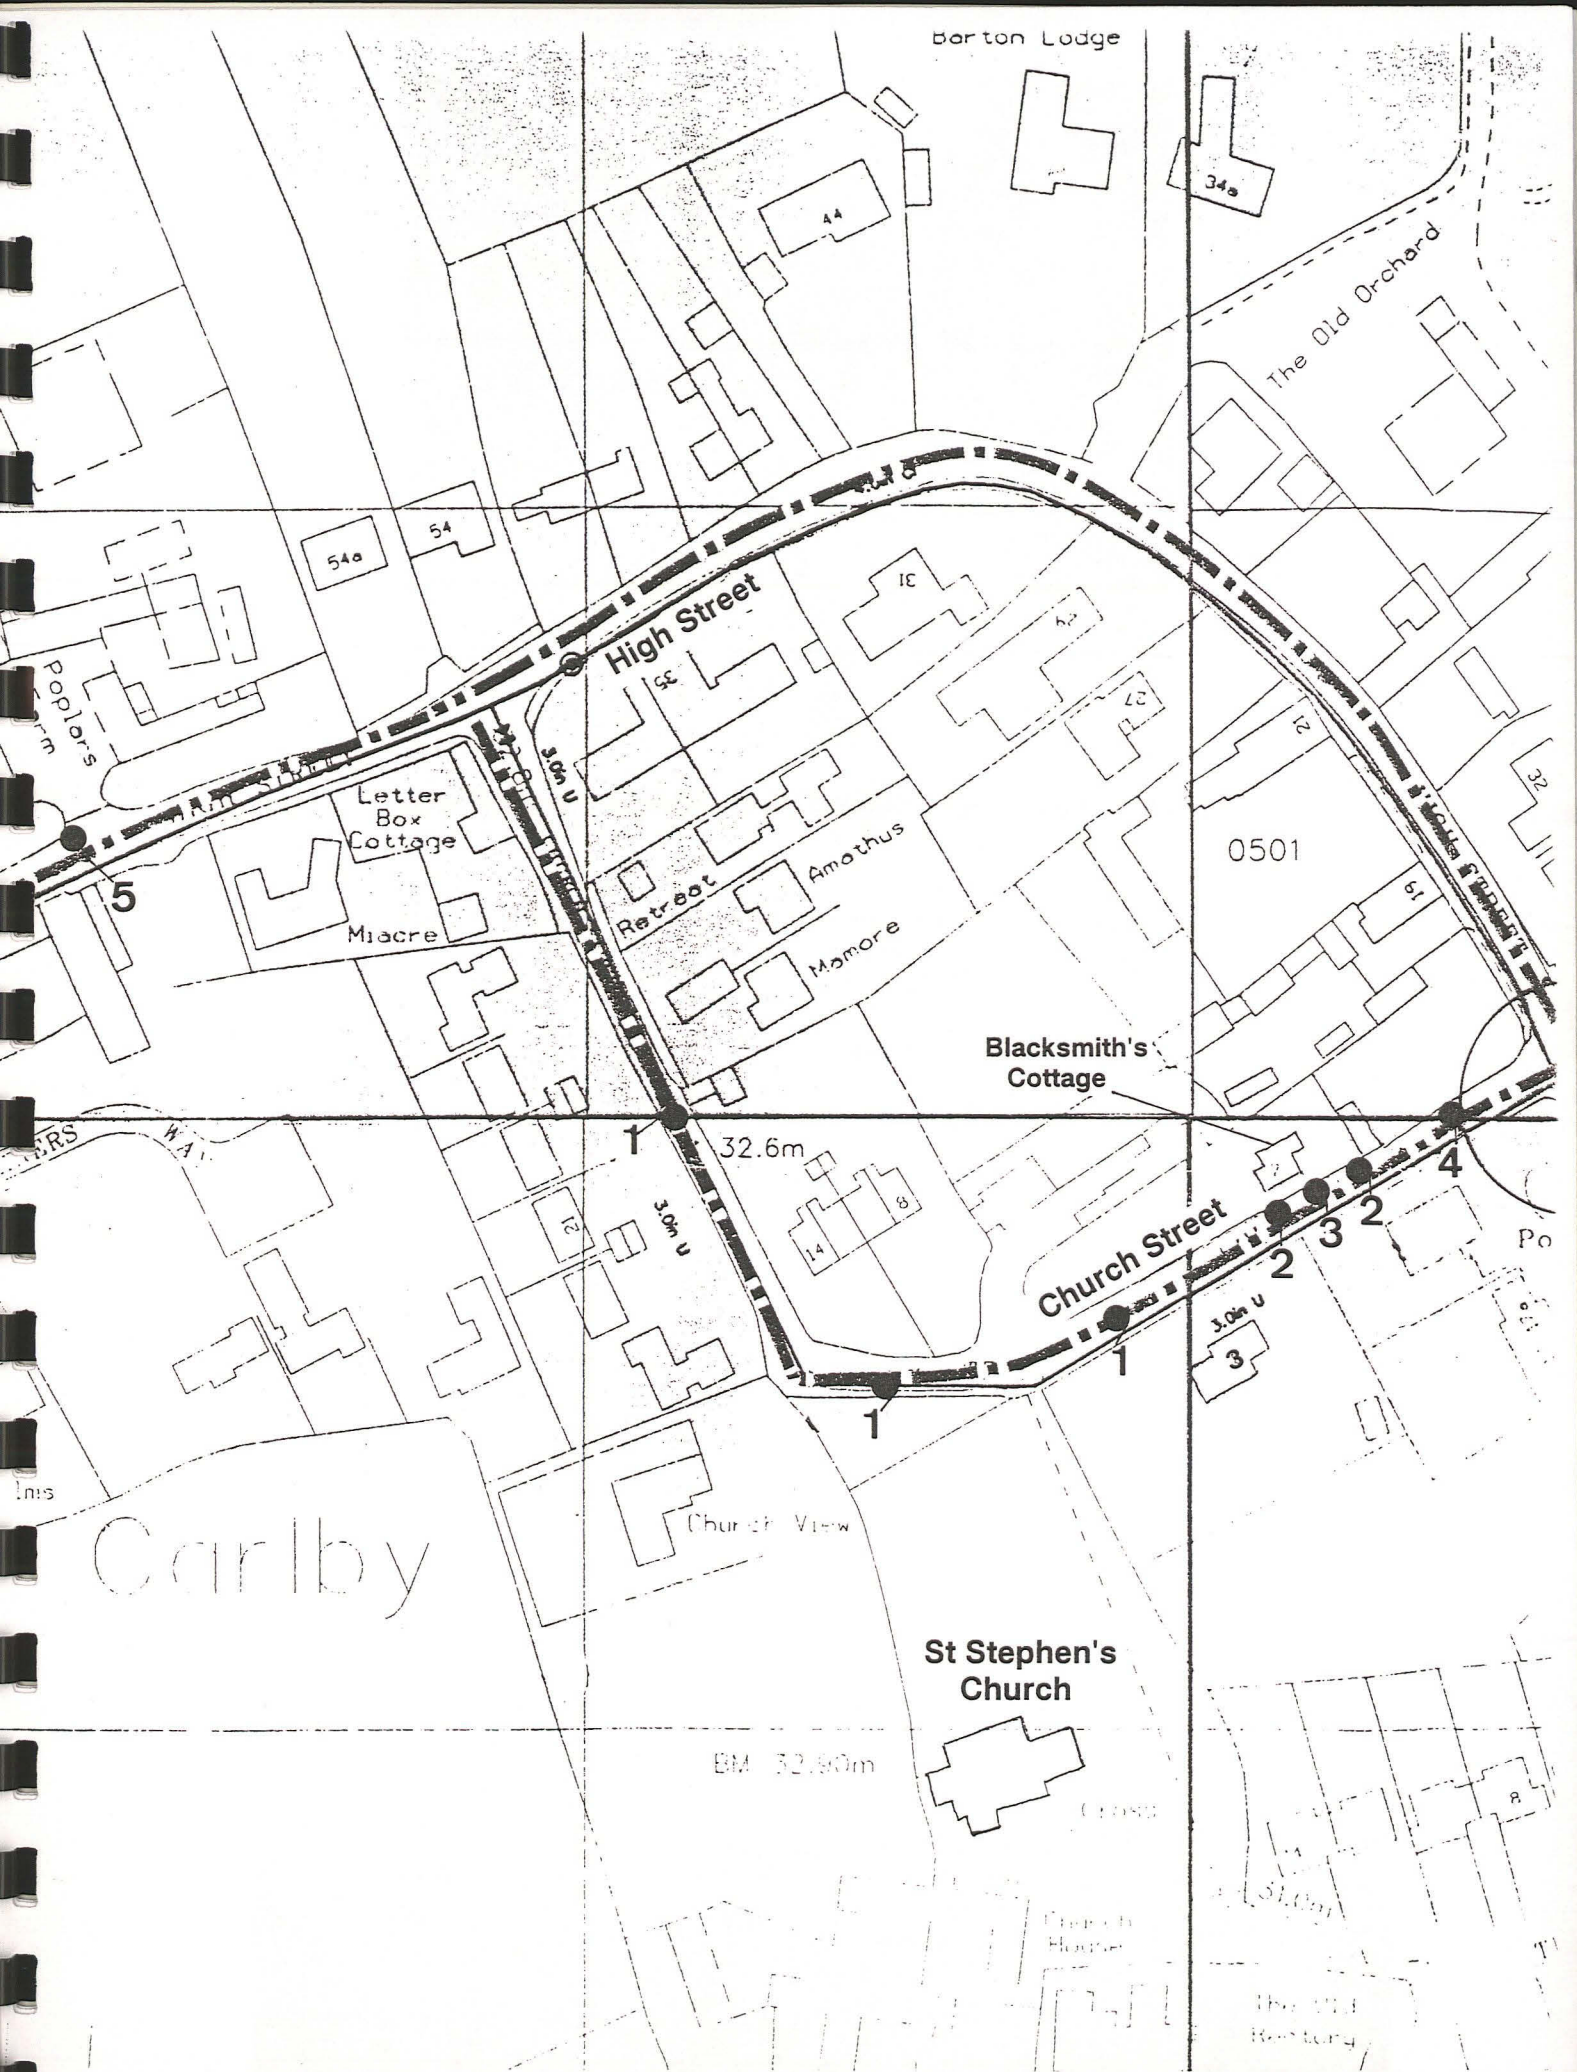
**Fig. 2 Church Street Carlby, showing the position of observations noted in the text (based on a copy of the 1:1250 plan supplied by Anglian Water Services, © AWS, dwg. WAT-02447-10a). LAS OS Licence No. AL 50424A.**
