LINDSEY ARCHAEOLOGICAL SERVICES

Lincoln, Glebe Park Mains Replacement Scheme

Archaeological Monitoring

LAS Report No. 608 September 2002 Conservation Services

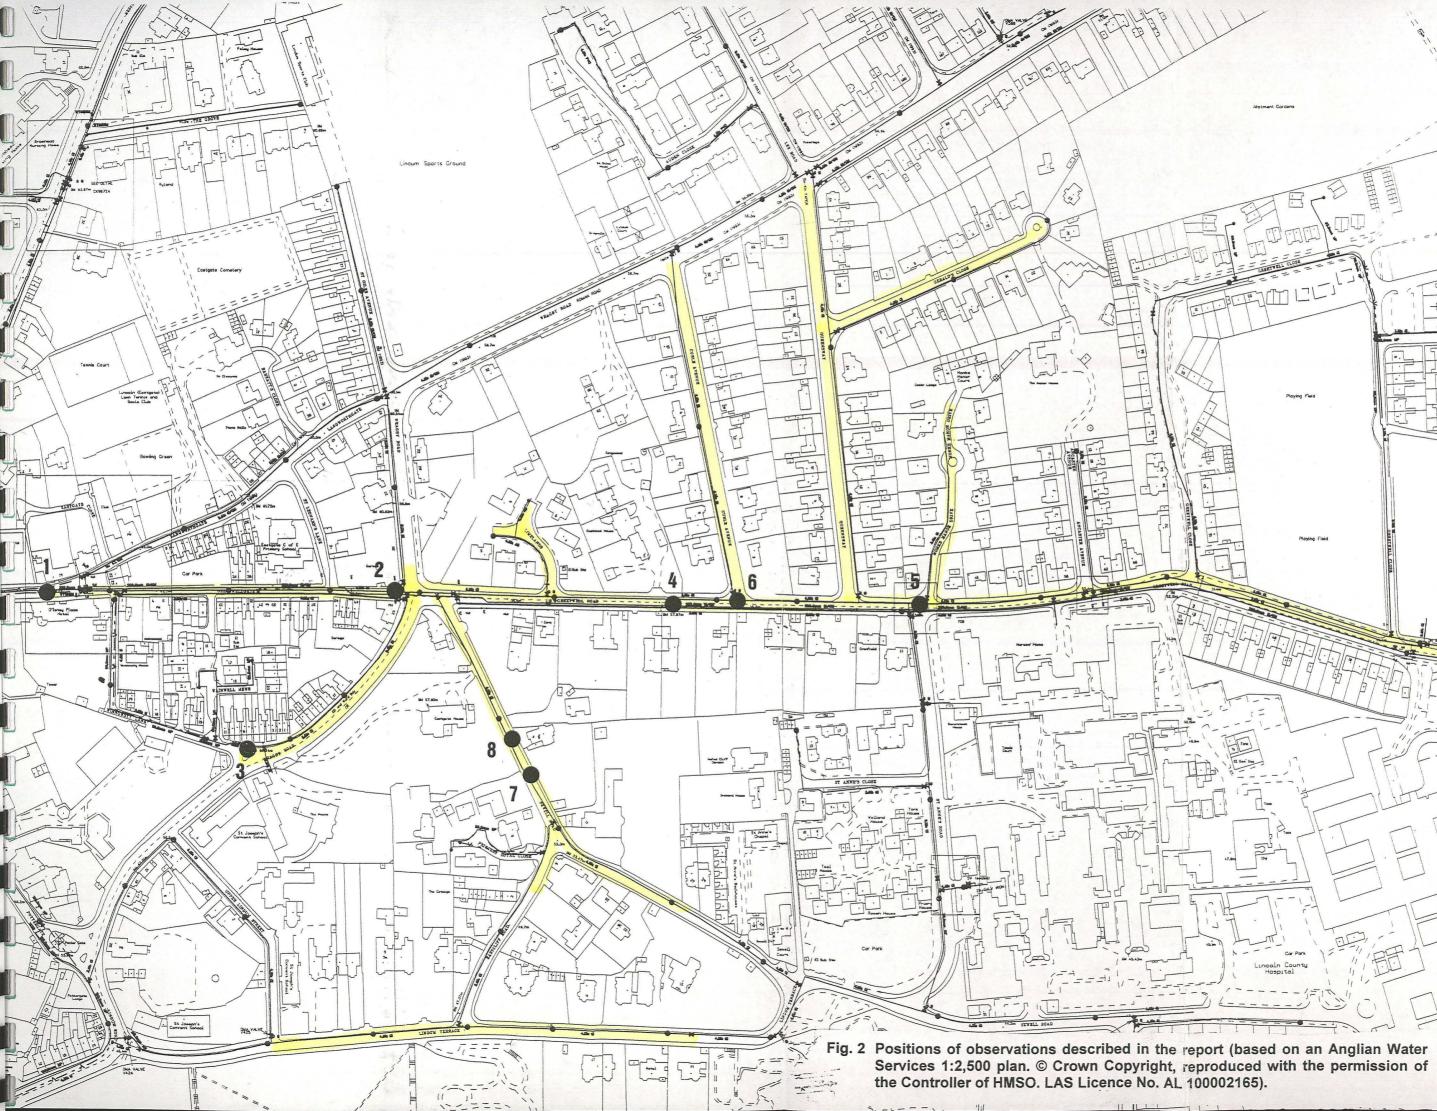
The new main was directionally drilled where this was possible. Machine-excavated trenches were inspected, and assigned numbers by LAS for recording purposes where observations were noted. The approximate positions of these trenches are marked on Fig. 2.

2. In the centre of the Wragby Road/Greetwell Road/Greetwell Gate road junction, the 0.6m thick modern road surface and bedding layer sealed 0.2m of yellow sand. Beneath the sand was compacted gravel, which extended below the trench base. In this location, the gravel has been introduced, and this would seem to mark a former road surface. The compaction was initially taken to indicate that this road may be Roman, but as no similar deposits were observed further to the east, this is unlikely. It is more probable that the section of Wragby Road southwards to Lindum Road was particularly well constructed in the post-medieval period.
