MANOR FARM, COLSTERWORTH. ARCHAEOLOGICAL WATCHING BRIEF AND STANDING BUILDING REPORT

Site Code:	MIFC03
NGR:	SK 9300 2396.
Planning Ref.	S02/0198/22
Accession No.	2003.15

Report prepared for Mansion Court Properties. by Alex Brett

> > August 2003

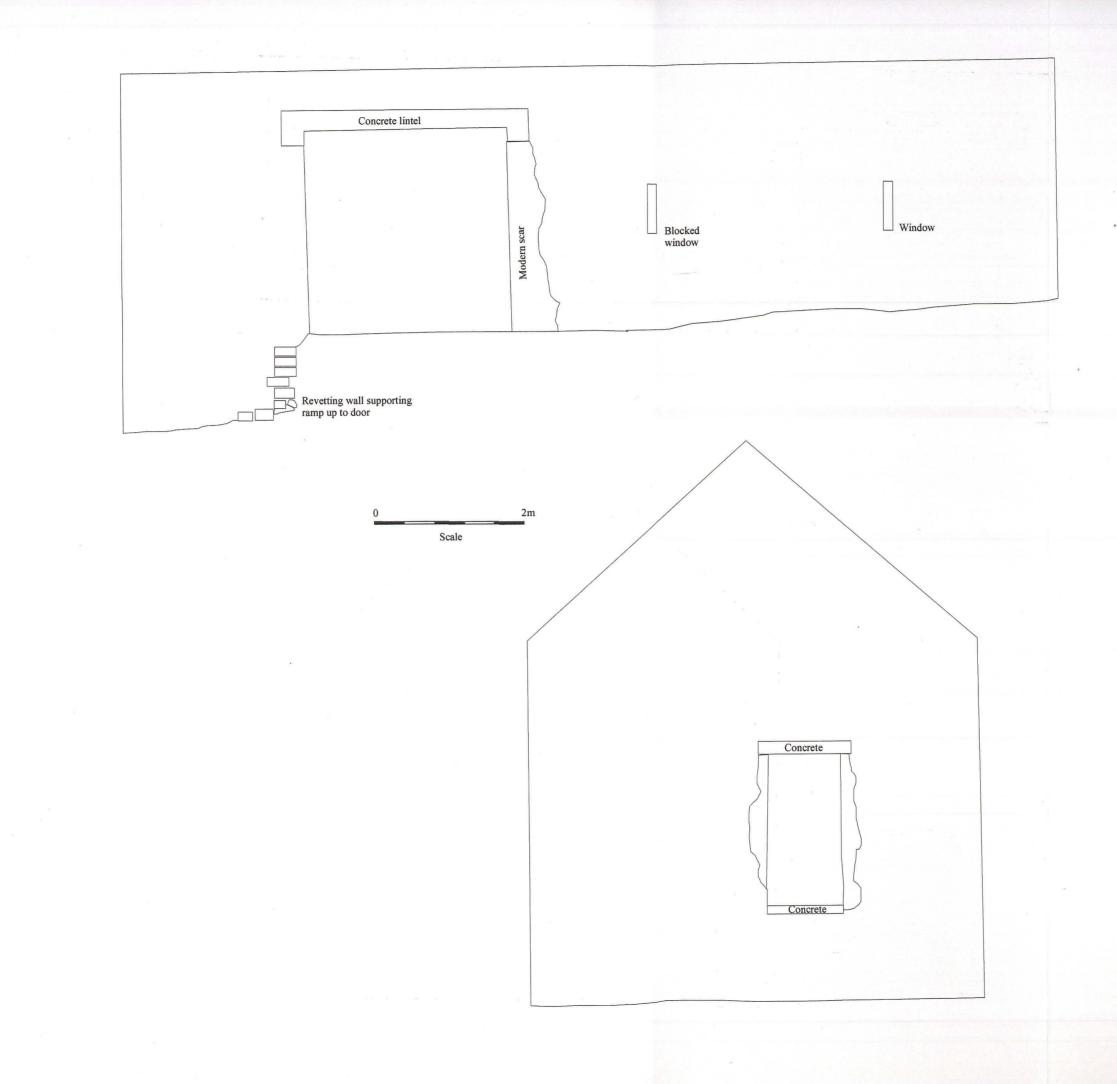
Fig. 3 : South and west elevations of barn, both at 1:50.

In the west wall was a smaller door, situated approximately 1.3m above ground level. This was probably for loading and unloading wagons. It had a modern concrete doorstep and lintel; the scars of which completely surrounded the doorway, making it impossible to establish whether or not this was a completely new feature or one that replaced an original opening.

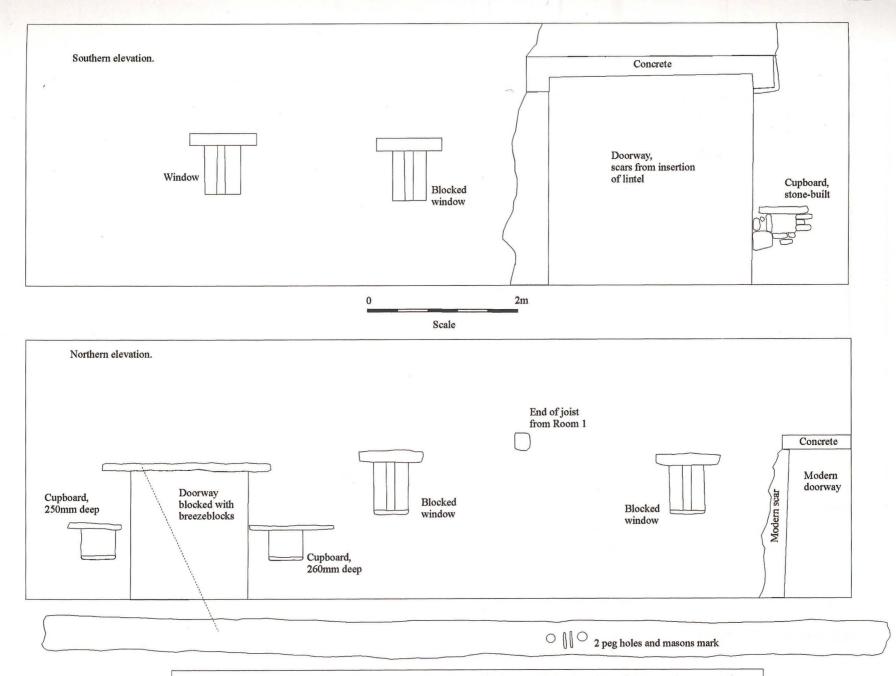
Fig. 4 : Internal elevations from barn plus detail of reused timber lintel from above nothern door. Elevations at 1:50, timber at 1:10.

A door was present in the north-east corner of the barn, and this too had a concrete lintel with a scar from its insertion along the western side. This was a secondary opening, as a scar was observed along the eastern edge where the wall was knocked through.

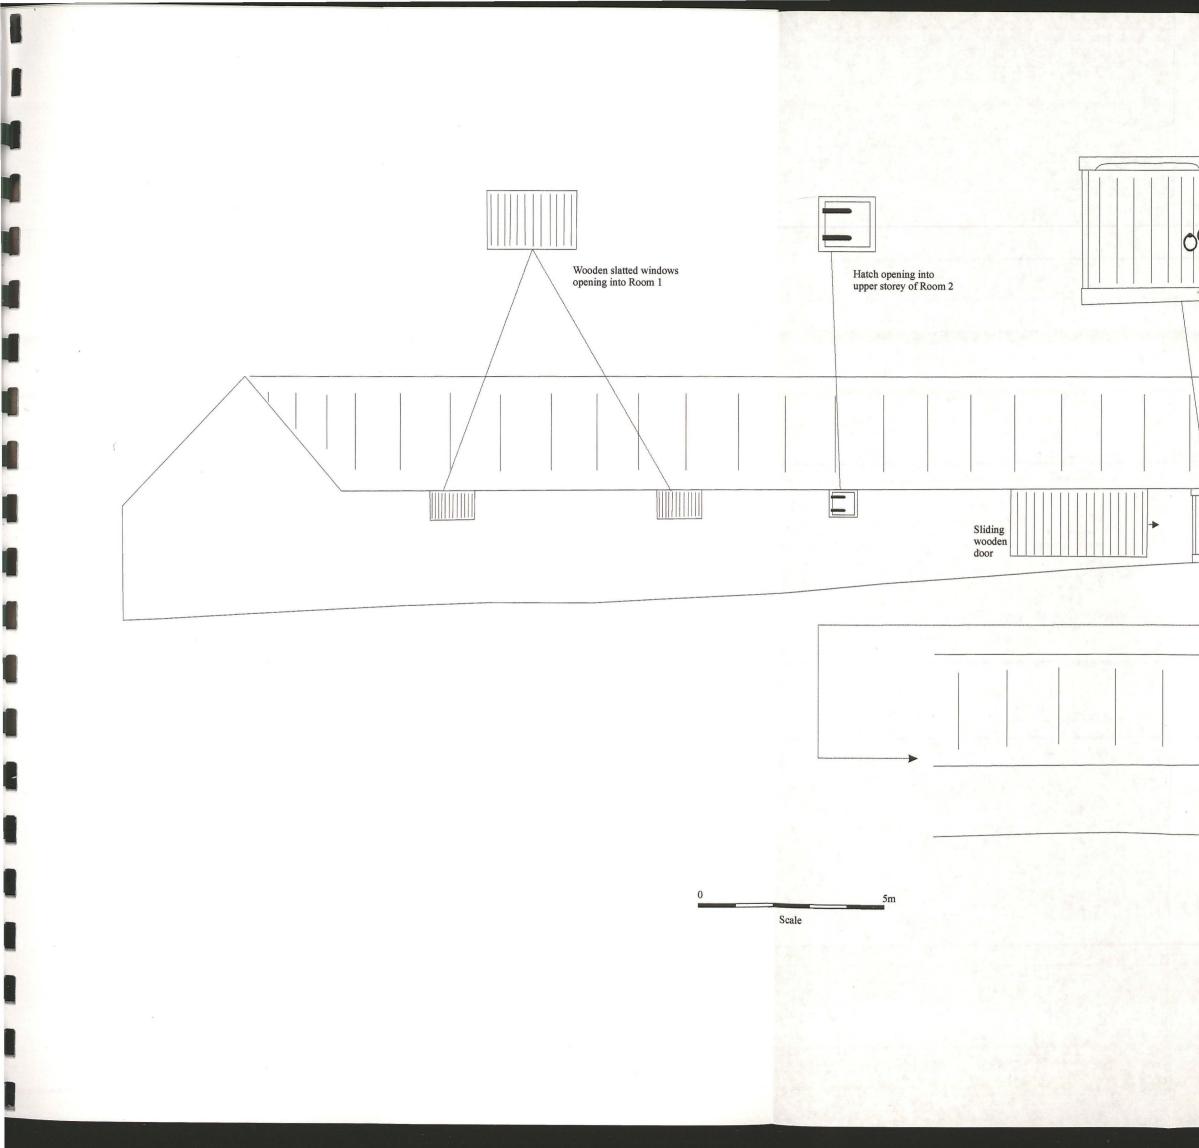
Fig. 9 : Eastern elevation. Main drawing at 1:100, detail of architectural features at 1:50

Wooden door with ornate fittings and carved lintel

Eastern wall of building continues to form boundary wall

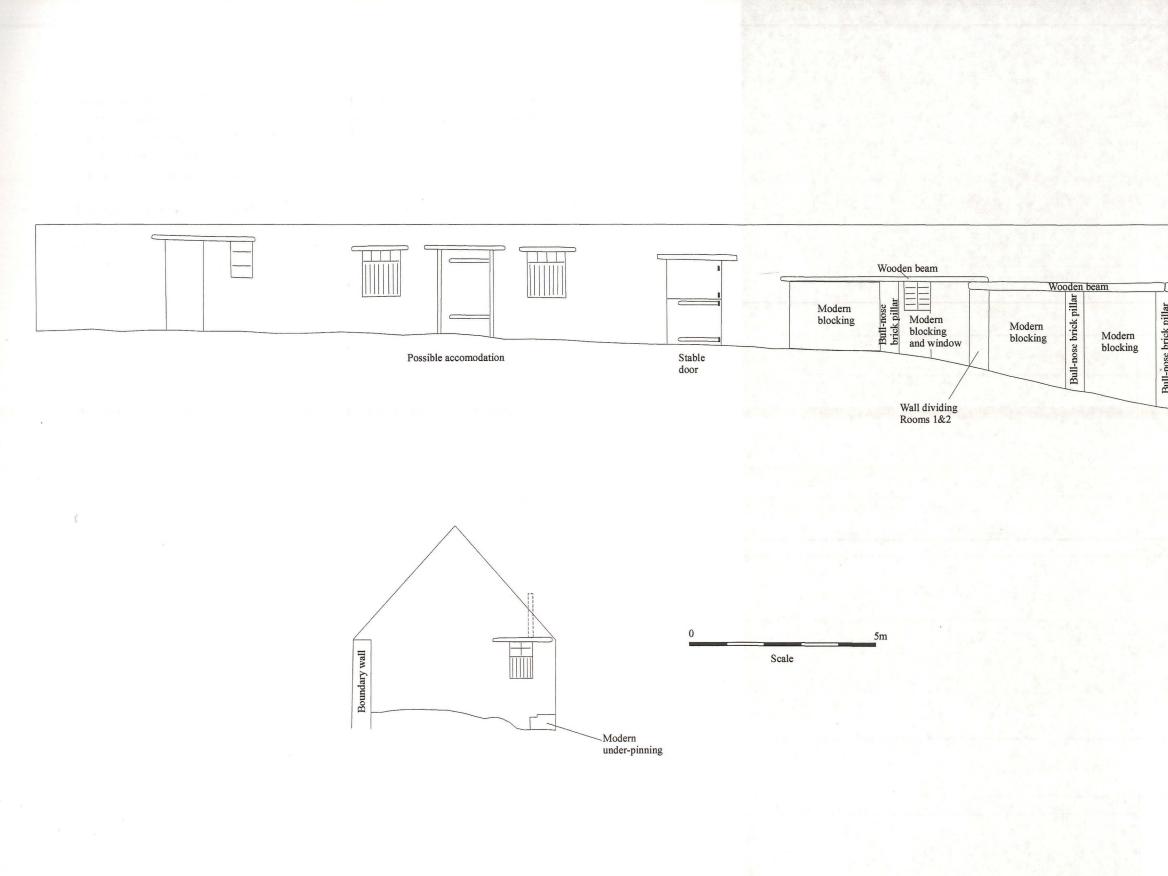
Fig. 10 : Western and northern elevations, both at 1:100.

To the north of Room 2 on the western side of the building was a door of two segments, the upper and lower portions capable of opening independently. Opposite this doorway on the eastern side of the building was a large sliding door. The former was clearly a stable door, with the latter presumably opening to the same space.

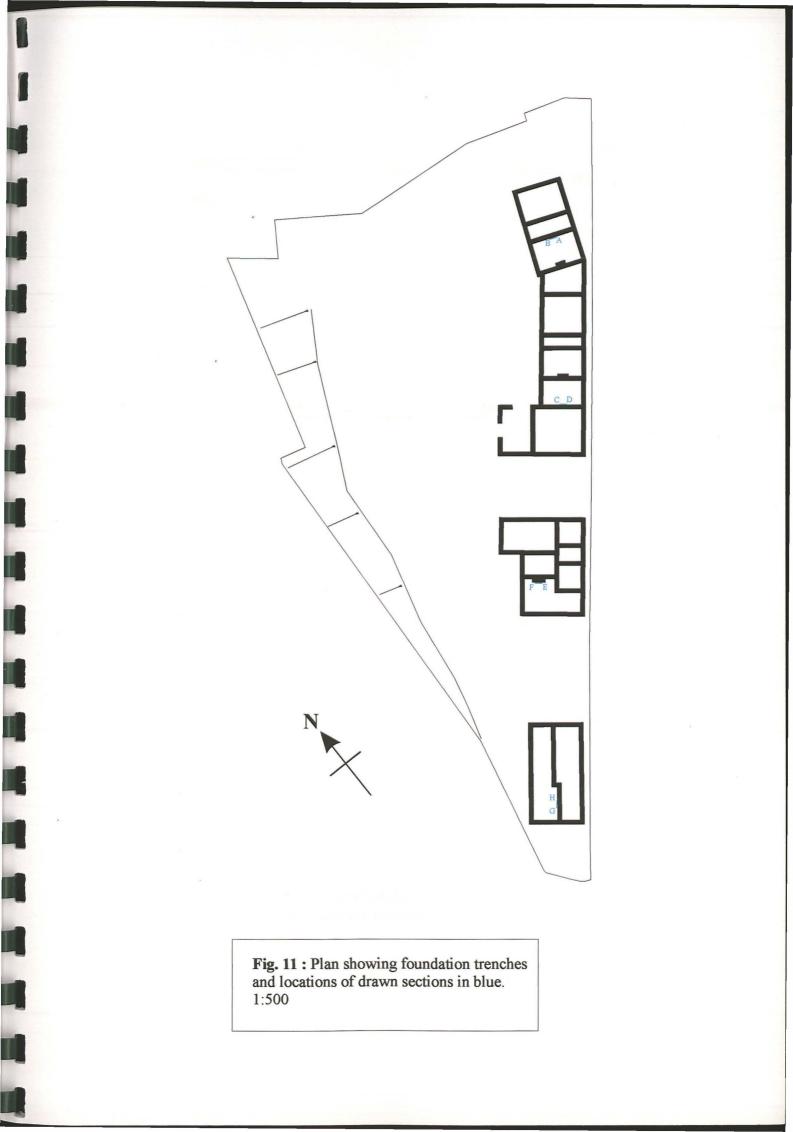
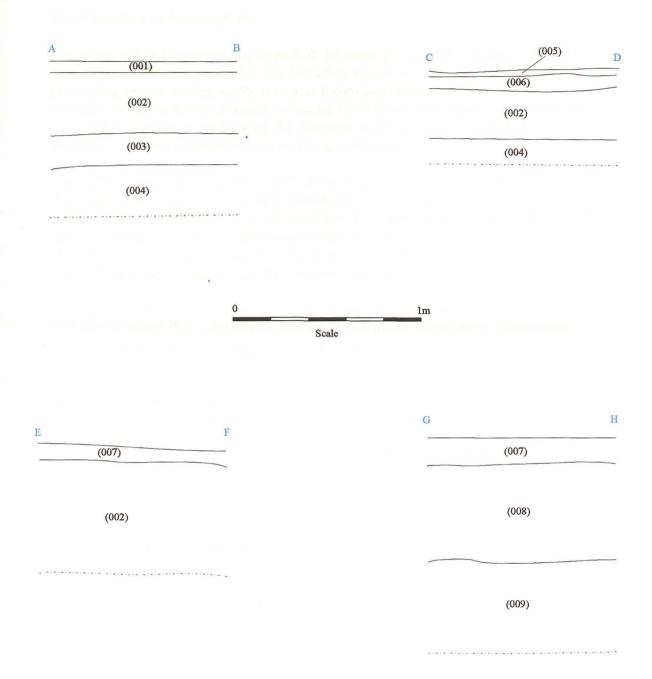
Fig. 12 : Sections recorded during the watching brief on the new building foundation trenches. All at 1:20.

Deposits removed during excavations for the new build foundation trenches varied across the site: in the northernmost areas (under the main block) the uppermost deposit was (001), dirty clayey sand containing rubble, deriving from the demolished buildings. Beneath this was (002), consisting of dirty white weathered limestone natural. This in turn sealed (003) a slightly orange/brown clayey layer containing occasional limestone gravel. This overlay (004), the limestone bedrock.

Towards the south of the foundation footprint, the sequence changed slightly. The uppermost deposit (005) comprised dark brown coarse sand, under which was (006), an identical material, which retained its original yellow/orange colour. Both contexts were interpreted as bedding deposits from the brick floor of the demolished building; the former having been stained by post-depositional processes.

The above layers overlay the weathered limestone (002), which rested over the bedrock; the clay layer (003) having lensed out.

To the south of the larger buildings, the new foundation trenches were no longer within the footprint of the former farm structures. Here, a modern topsoil (007) was directly over weathered limestone natural (002). The topsoil deposit was also observed in the southernmost foundation where it sealed (008), a mixed layer of redeposited limestone and clay containing occasional fragments of brick and tile. Beneath this was (009), mid grey sandy clay containing frequent limestone, charcoal, brick and tile fragments. Victorian pottery was observed within this context but was not retained.
