**HISTORIC BUILDING RECORDING AT  
59 SOUTH STREET  
CROWLAND  
LINCOLNSHIRE  
(CSSB10)**

Report Compiled by  
Vicky Mellor BSc (Hons)

Planning Application: H02-0800-09  
National Grid Reference: TF 2410 1008  
OASIS Reference Number: archaeo11-80274

A.P.S. Report No: **68/10**

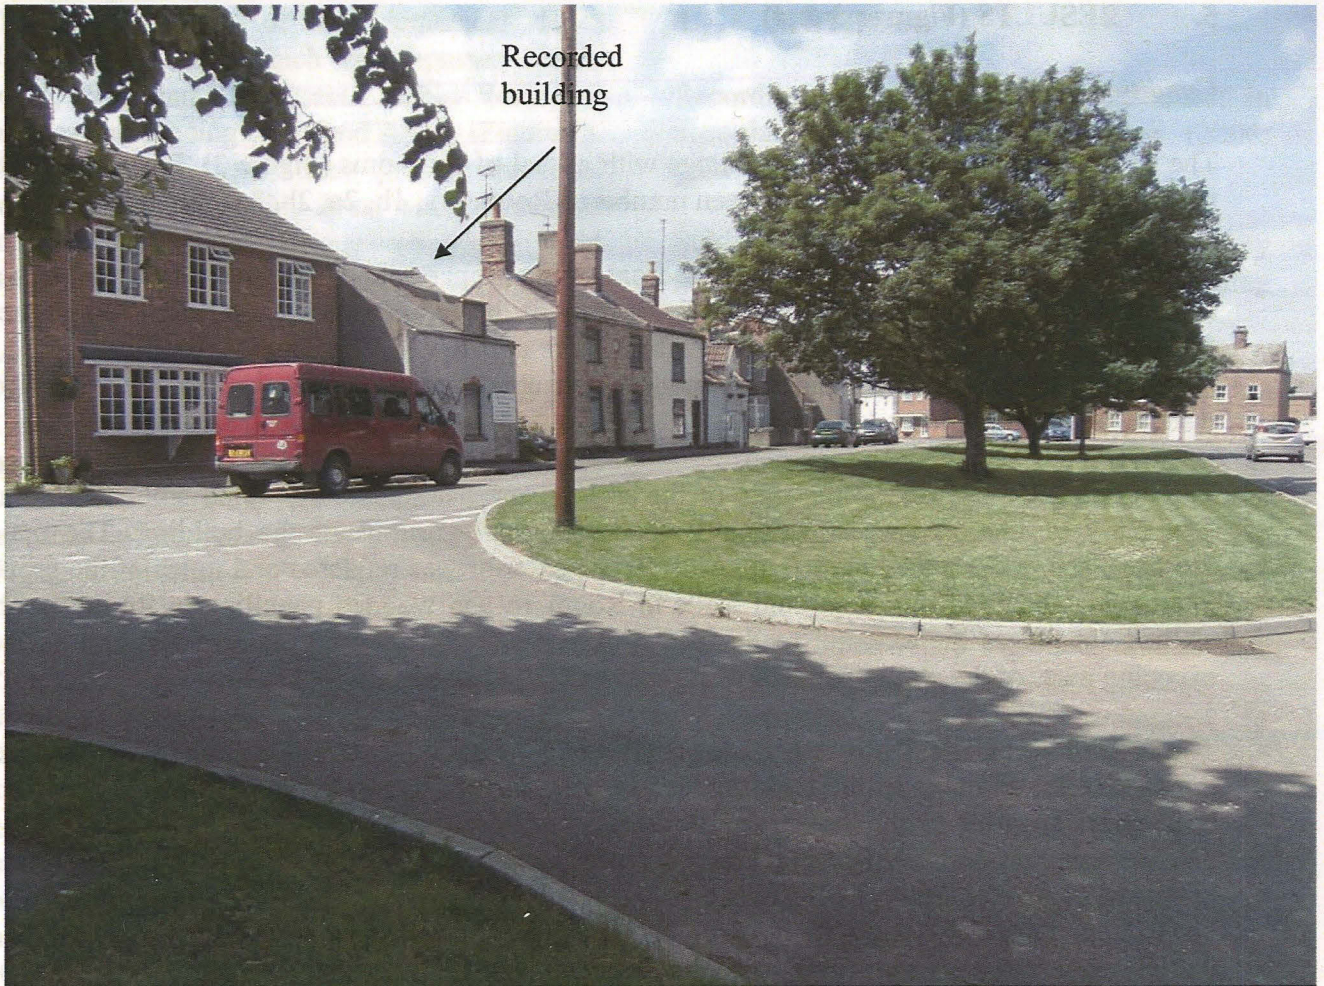
*Plate 1 General view showing South Street and recorded building, looking northwest*

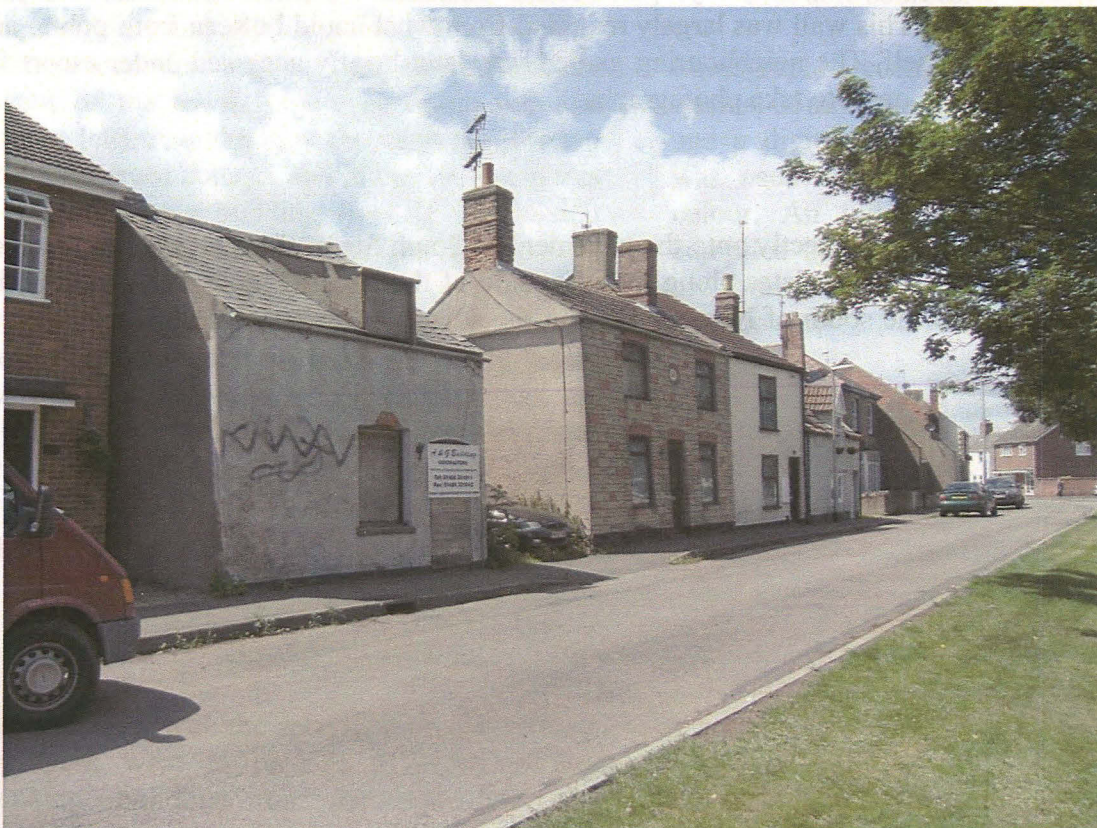
*Plate 2 View of recorded building showing its setting in South Street, looking northwest*

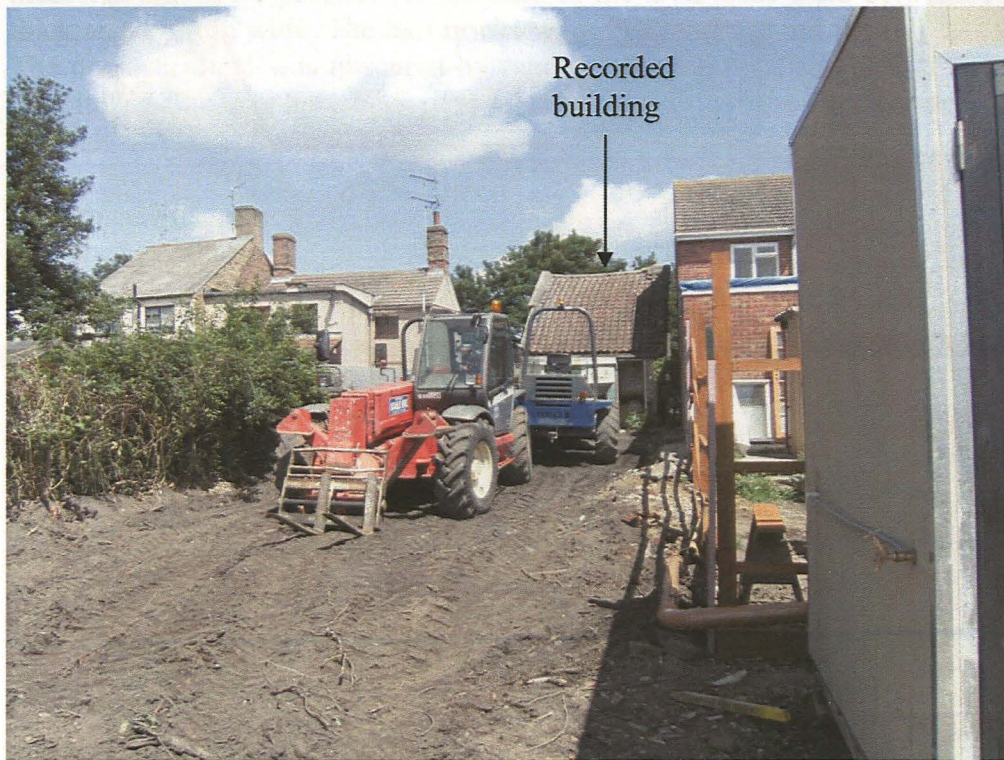
*Plate 3 General view of the rear of the property, showing part of lengthy plots behind South Street properties (full length of plot not shown), looking east*

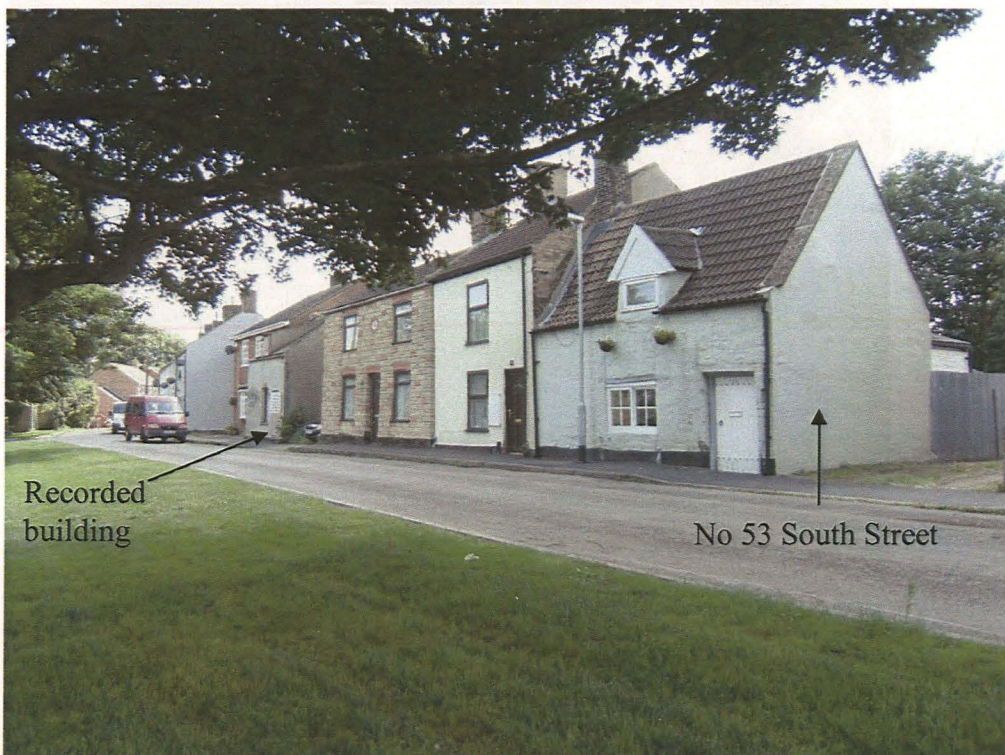
A cottage of similar date and layout to Number 59 is located a short distance to the north, at Number 53 South Street (Plate 4). This cottage is slightly larger and in much better condition than Number 59, but is of very similar type with the same pattern of fenestration at the frontage (compare Plates 2 & 4). Number 53 South Street is a Grade II Listed Building, Lincolnshire Historic Environment Record Number 25228.

*Plate 4 View along South Street showing recorded building and comparable cottage at 53 South Street, looking southwest*

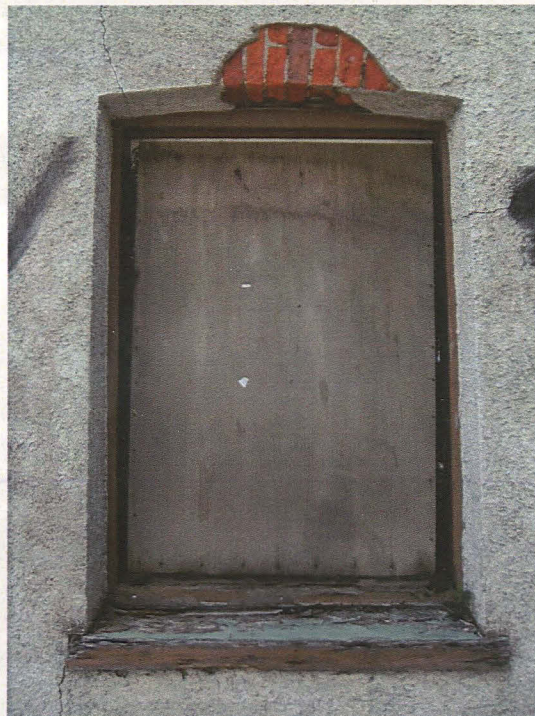
*Plate 6 Detail of window in frontage of building, ground floor window, looking west*

wooden sill and part of a brick segmental arch was visible over it (Plate 6). This arch was constructed using alternate half and complete handmade bricks, probably rubbers. Although the full lengths of the bricks of the arch were not exposed some width and breadth measurements were possible: at the base of the arch these were between 45mm and 60mm thick and 110mm wide. The half bricks were 110mm long and the full bricks >170mm long. The door surround was obscured by render, but had the shape of a similar segmental arch over it, and this may have been of similar construction to the window arch. The remainder of the wall was also obscured by render.

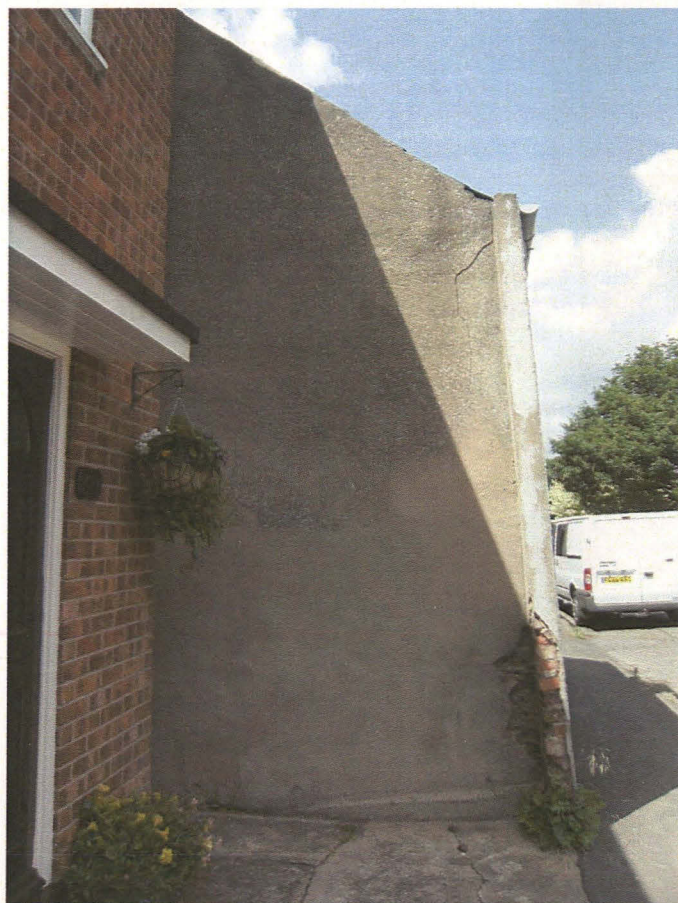
*Plate 7 South gable end of cottage, looking north*

With the exception of the 20<sup>th</sup> century extension (the exterior of Room 3a) at the west end, the south elevation was entirely rendered (exterior of Rooms 1a, 1b, 2a & 2b) (Plates 7 & 11). Breaks in the render at the southeast and southwest corners of the rendered area allowed some examination of brickwork. At the base of the rendered wall were slight projections where the wall thickened slightly at its base. This may reflect the thickening of the wall beneath the

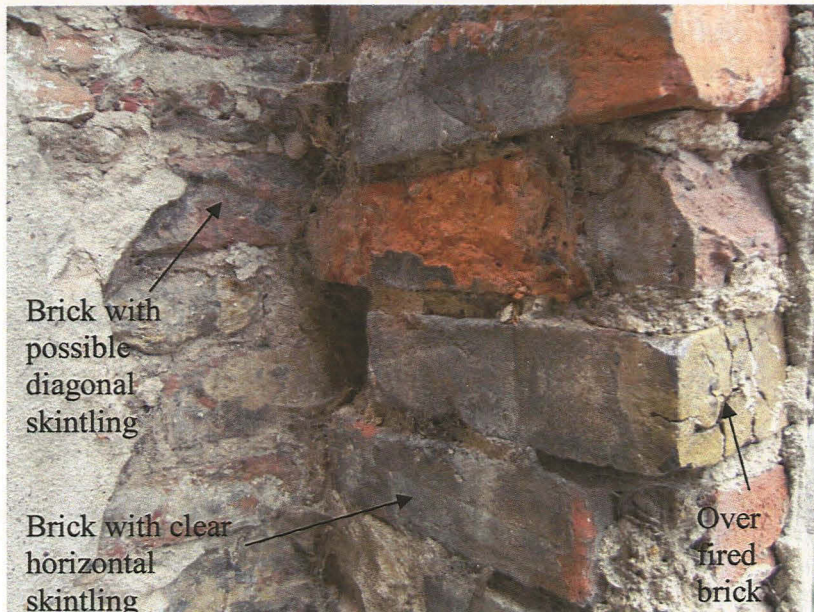
Some of the brickwork of this wall was visible in a break in the render at the southeast corner of the building (Plates 7-9). The relationship between the projecting portion of the east wall and the remainder of the cottage at this corner was not entirely clear, but it appeared that the projecting wall butted onto the building.

None of the handmade bricks of the south gable end were fully exposed here, but it was possible to measure the thickness of some of these, some being 50mm thick and others 60mm. Additionally, one brick in this wall had a possible diagonal skintling or hack mark. Surveys of dated buildings in the King's Lynn area (Norfolk) indicated that bricks with diagonal skintlings dated before about 1780 (James and Rose nd). It was noted by the South Holland Conservation Officer that some of the bricks of this building were of dimensions which suggested a pre-1776 date, but insufficient brickwork was exposed to provide any conclusive dating of brickwork in various parts of the building.

Bricks of the projecting wall were more clearly exposed. These were also handmade, and one of these bricks was over fired producing a clinkered end with a pronounced green-glazed appearance, and measured 225mm x 110-120mm x 60mm. Some of the other bricks of this wall had pronounced horizontal skintlings or hack marks, and one of these bricks measured 240mm x 110mm x 65mm. The horizontal skintlings may hint at a date after about 1780 for the projecting wall (James and Rose nd).

*Plate 9 Close up of exposed brickwork in south gable end and projecting wall at southeast corner of building, looking northeast*

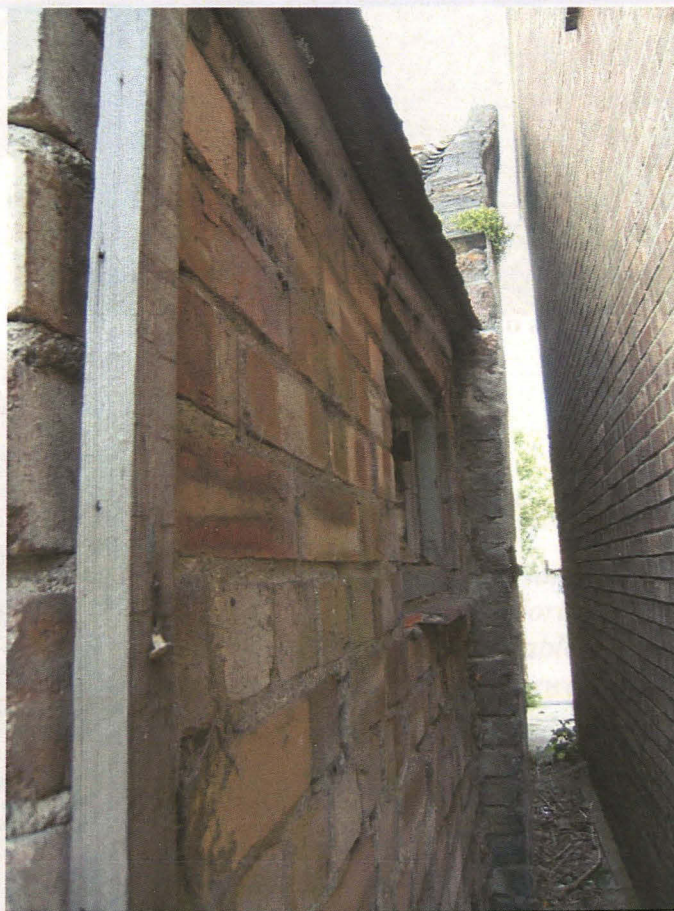
The western end of the south elevation comprised the single storey 20<sup>th</sup> century brickwork of the outside toilet (Room 3a) (Plate 10). This wall had a single window and abutted the remainder of the building to the east.

*Plate 10 View of southern gable end of cottage, looking east*

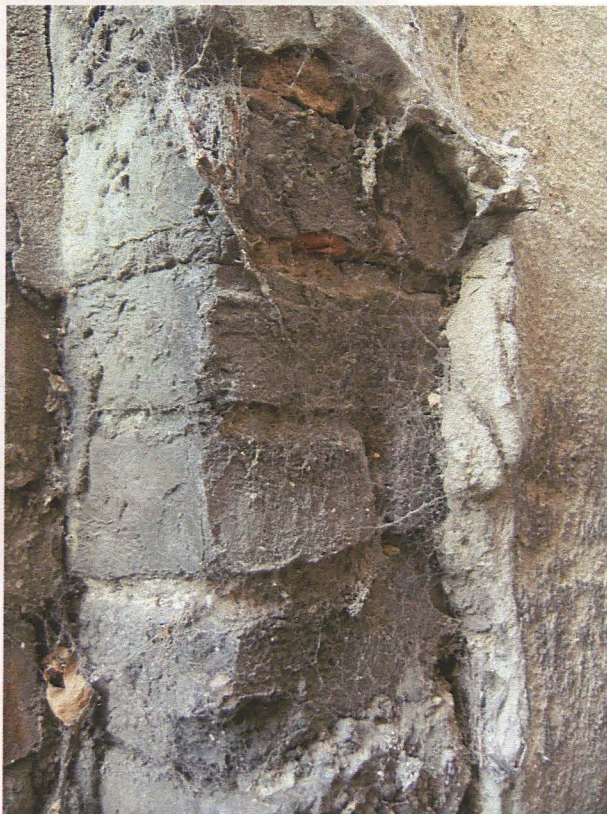
Some of the brickwork at the southwest corner of Room 2a was visible due to a gap in the render (Plate 11). The handmade bricks of this corner each measured >190mm x 100mm x 60-66mm and some horizontal skintling marks were evident on these (Plate 12). Again these skintling marks may perhaps indicate a date of 1780 or later.

*Plate 12  
Close up of  
exposed  
brickwork in  
southern gable  
end of cottage,  
looking east*

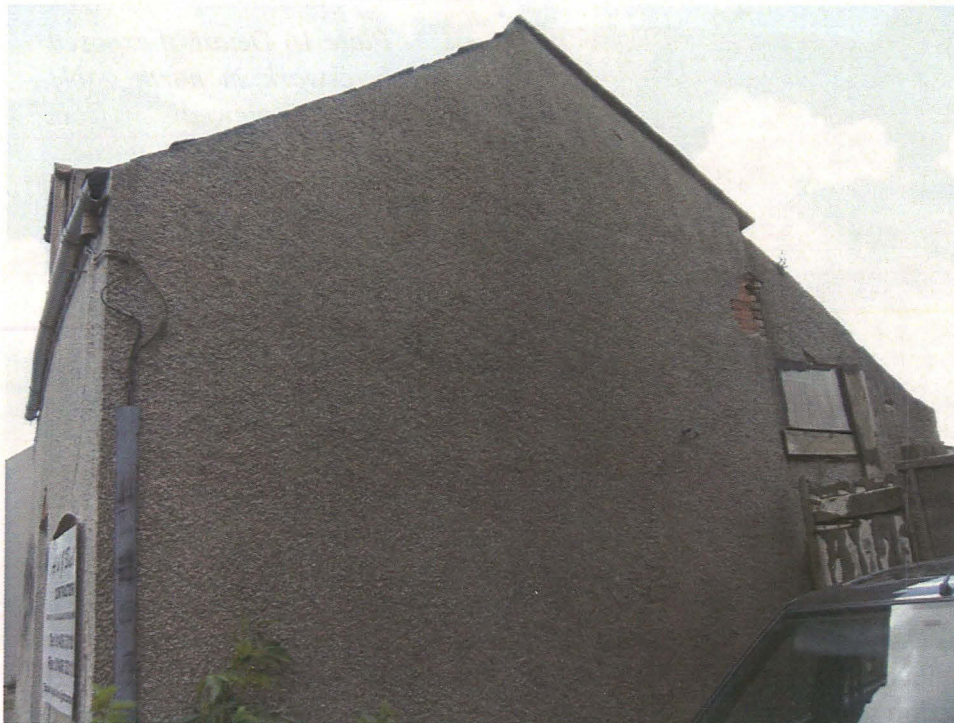
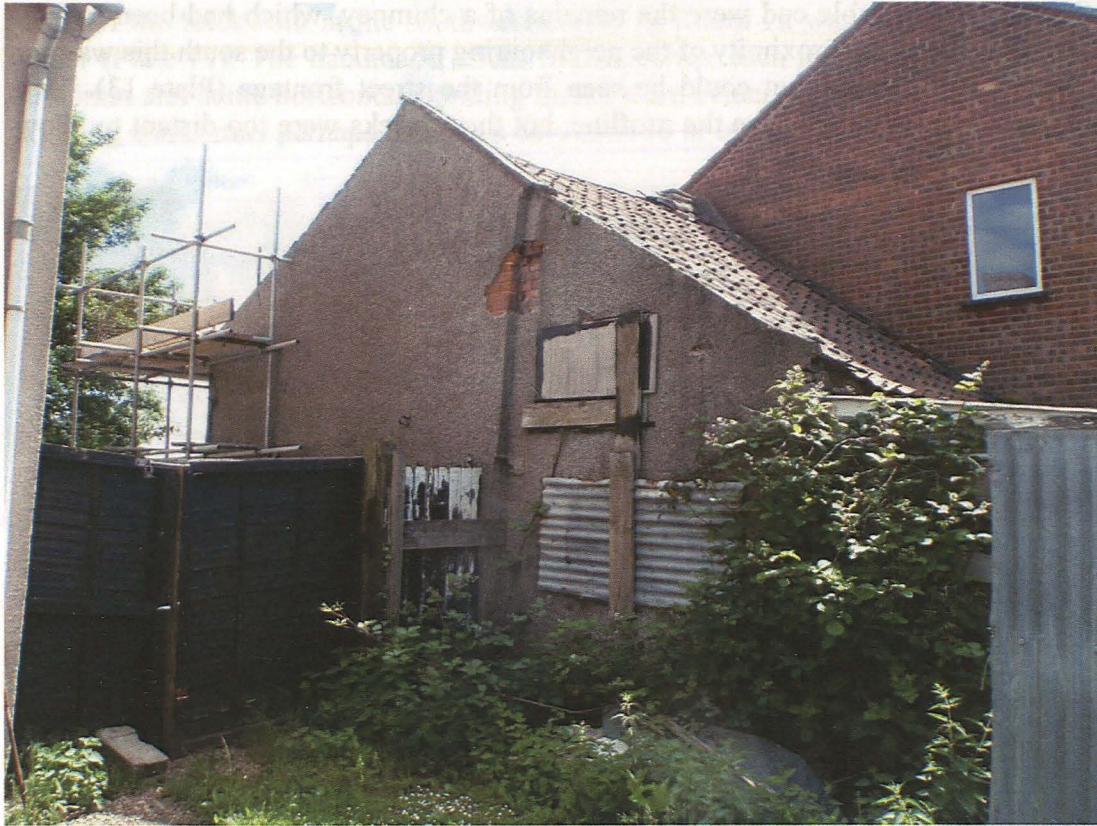
Most of the north gable end (Plates 14 & 15) was rendered, with the exception of a small patch of exposed brickwork at first floor level, at the junction between Rooms 2b and 1b.

*Plate 14  
North  
gable end  
viewed  
from South  
Street,  
looking  
southwest*

*Plate 15  
North gable  
end viewed  
from  
neighbouring  
garden,  
looking  
southeast*

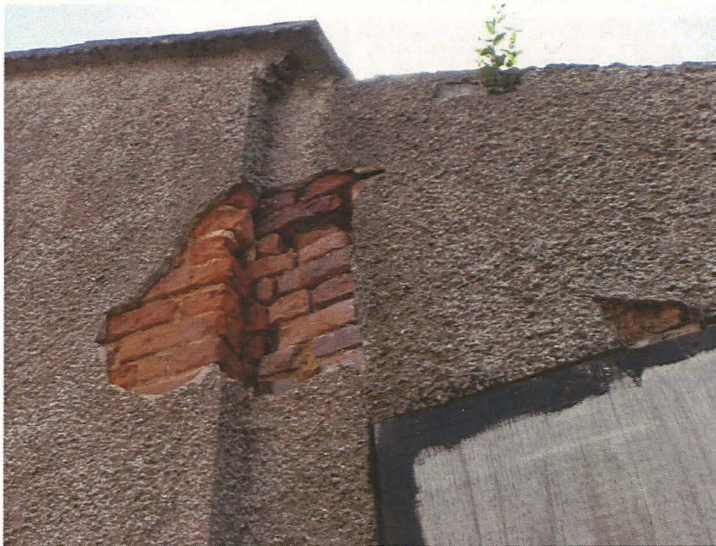
Externally, at this junction, Rooms 2a and 2b were set back slightly compared to the corner of Rooms 1a and 1b. The brickwork at this junction was not continuous between the two walls, and it appeared most likely that the wall of Rooms 2a and 2b was a later addition, with bricks at the corner of the original cottage (Rooms 1a and 1b) being partly removed to accommodate this extension. Due to the height of this exposed brickwork no brick measurements were possible.

*Plate 16 Detail of exposed  
brickwork in north gable  
end viewed from  
neighbouring garden,  
looking south*

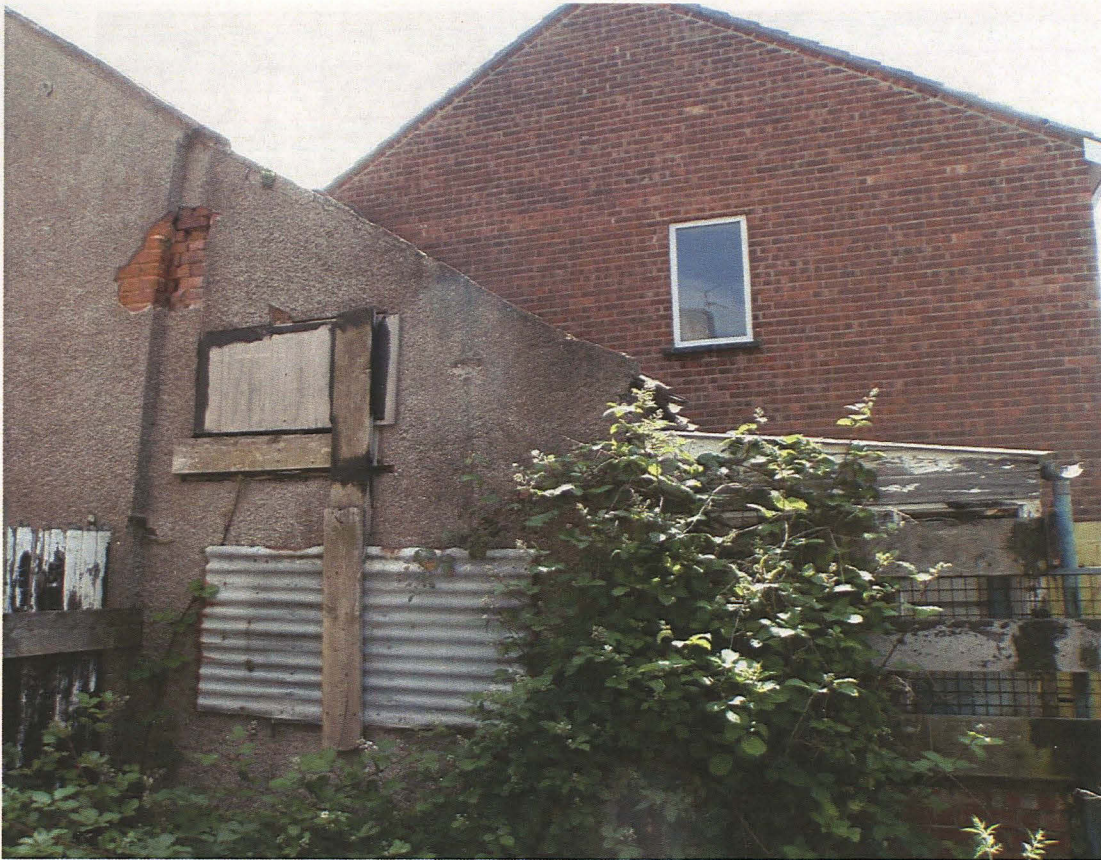
No details were visible in the gable end of Rooms 1a and 1b due to the render covering, save for two small low openings, presumably for air bricks for ventilation at ground floor level. Two windows, one to each of Rooms 2a and 2b, were boarded up externally (Plate 17). The western end of this elevation comprised the exterior of a conservatory (Room 3b), a 20<sup>th</sup> century brick construction topped by wood and glass.

Plate 17  
Western area  
of north  
elevation  
viewed from  
neighbouring  
garden,  
looking south

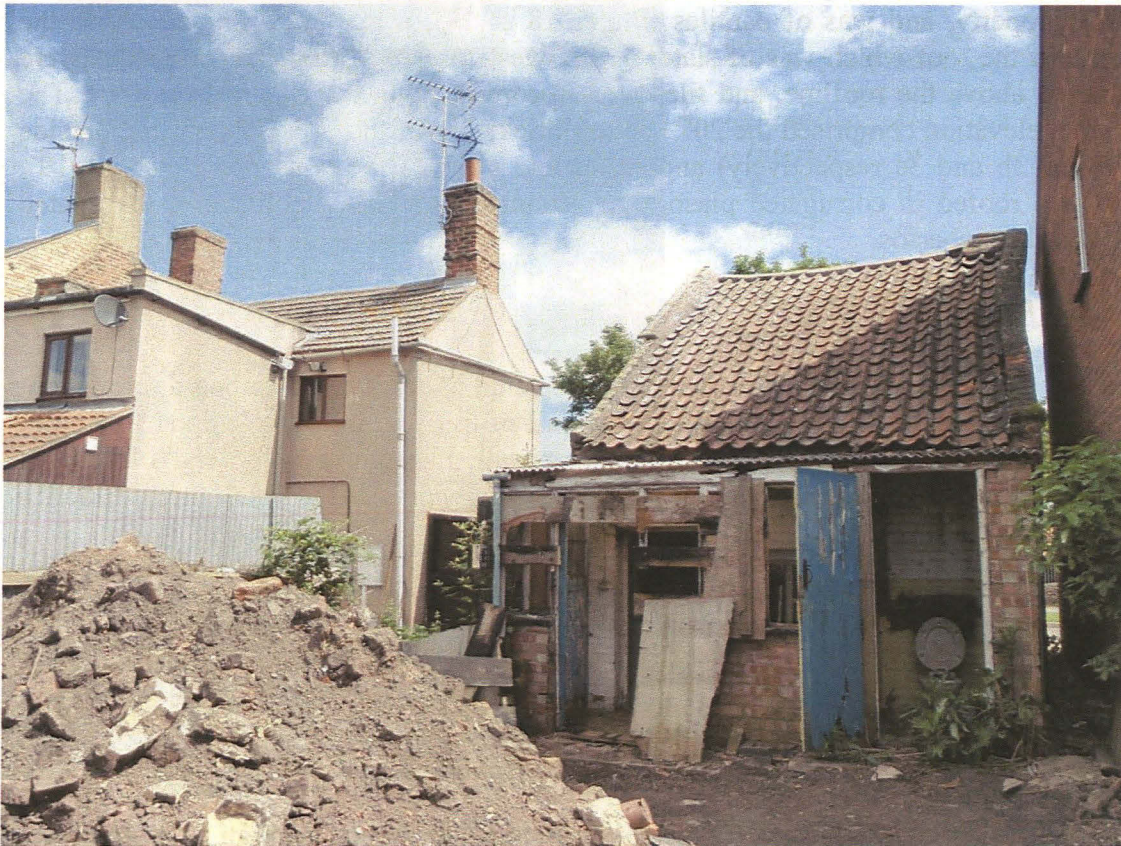
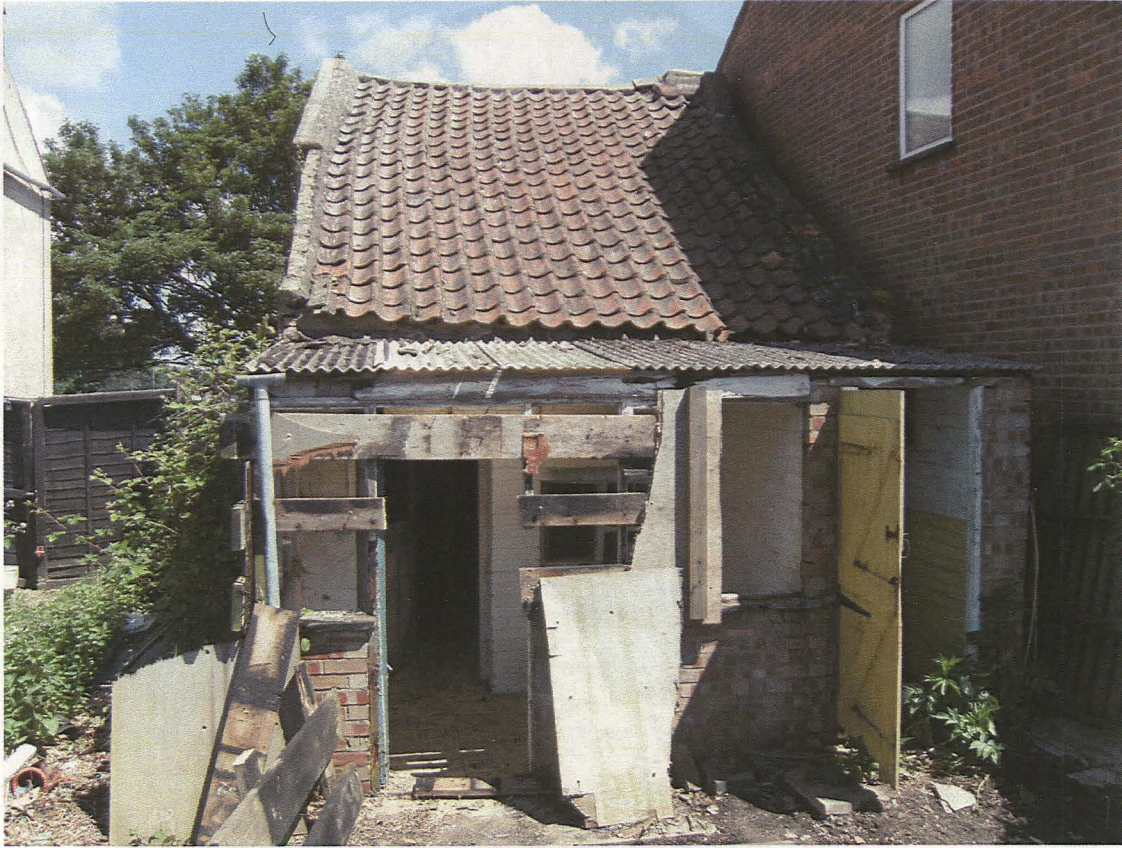
Plate 18 General view of west external elevation of cottage, looking northeast

*Plate 19 West external elevation of cottage, looking east*

The western half of the cottage roof, over Rooms 1b and 2b, was visible from the western side of the property, and was of pantiles (Plates 18 & 19), a marked difference from the eastern side of the roof which was of slate. At the western side of the roof the gables were slightly raised above the roofline, and tiles were recorded along the ridge of the roof. The west external elevation comprised the 20<sup>th</sup> century brickwork of the conservatory and outside toilet (Rooms 3b and 3a respectively) and wood and glass of the conservatory (Plate 19). Room 3b was roofed in corrugated plastic and Room 3a was also roofed in a corrugated material, possibly asbestos.

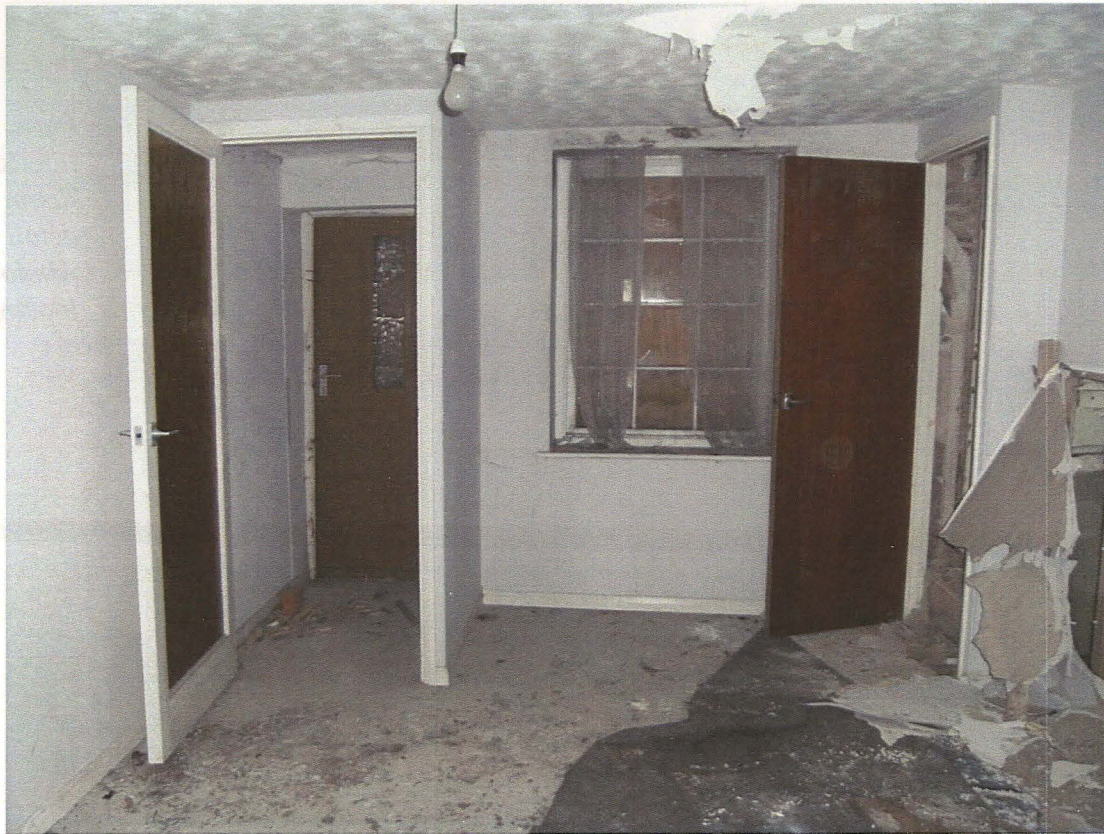
Room 1a had a concrete floor and the walls were covered in modern plasterboard throughout (Plate 20). No features were visible in the north wall of this room. A single door leading to Room 2a was the only feature evident in the west wall. Plasterboard stud walls had been inserted to the south of an external doorway to form a small porch at the South Street entrance (Plate 21).

*Plate 20  
Interior of  
Room 1a,  
looking east*

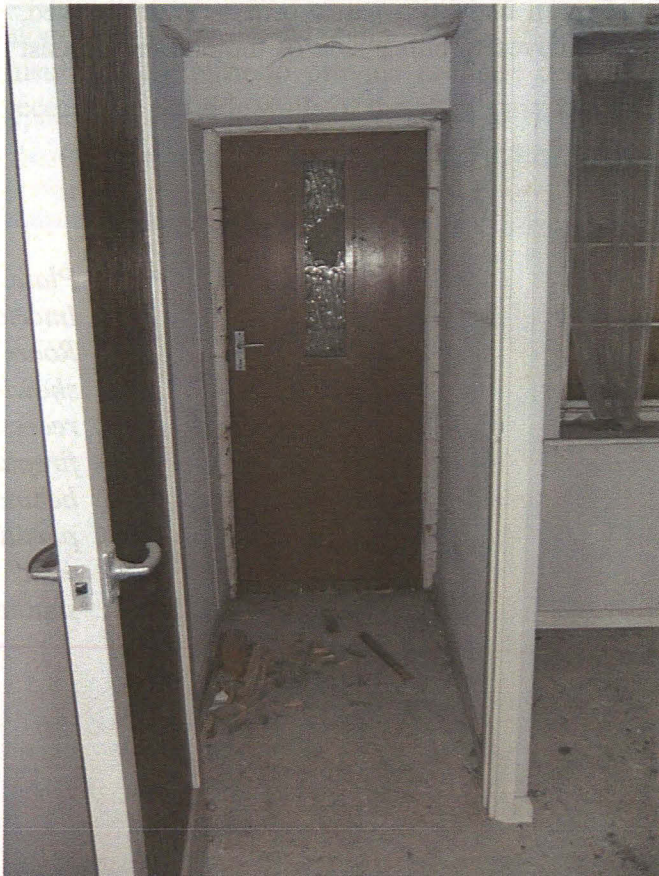
*Plate 21  
Interior of  
Room 1a,  
detail of  
doorway and  
stud partition  
porch,  
looking east*

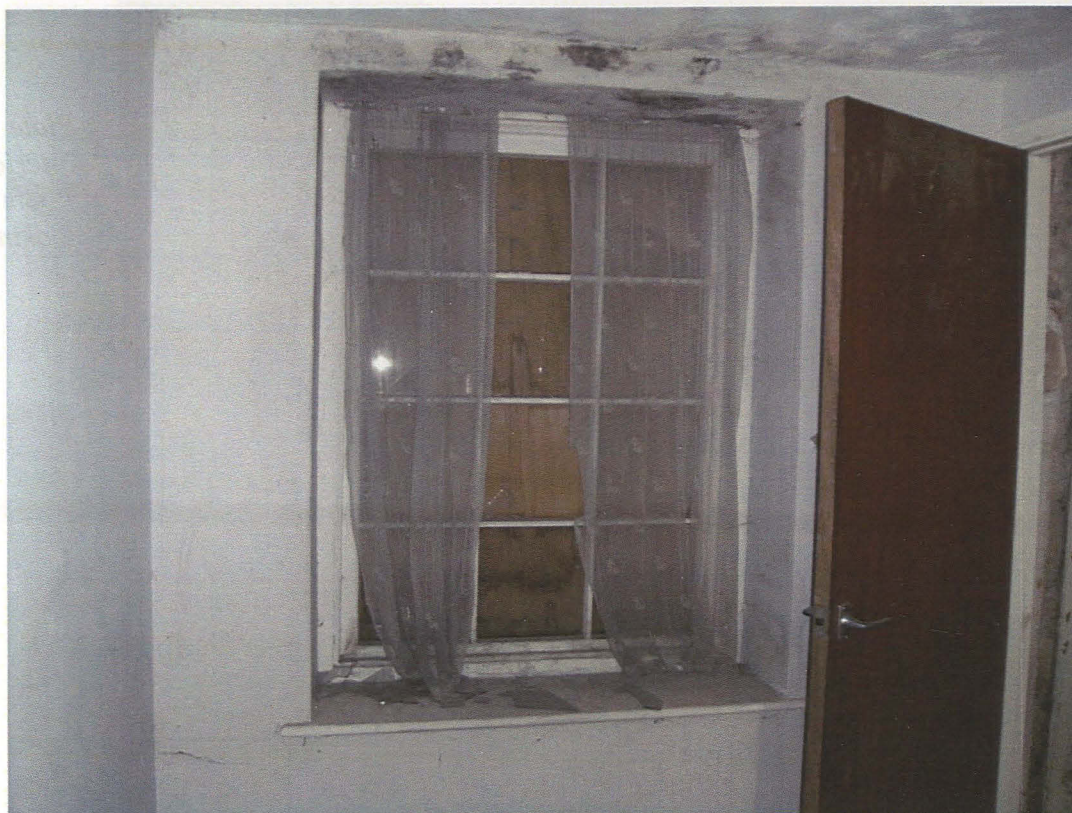
A window and its surround in the east wall (Plate 22) were not original to the building, although the window opening may be original. However, comparison of this window with that of the frontage of the similar cottage at Number 53 South Street suggests that the original opening at Number 59 might perhaps have been rather smaller (Refer to Plate 4).

Plate 22  
Interior of  
Room 1a,  
detail of  
window,  
looking east

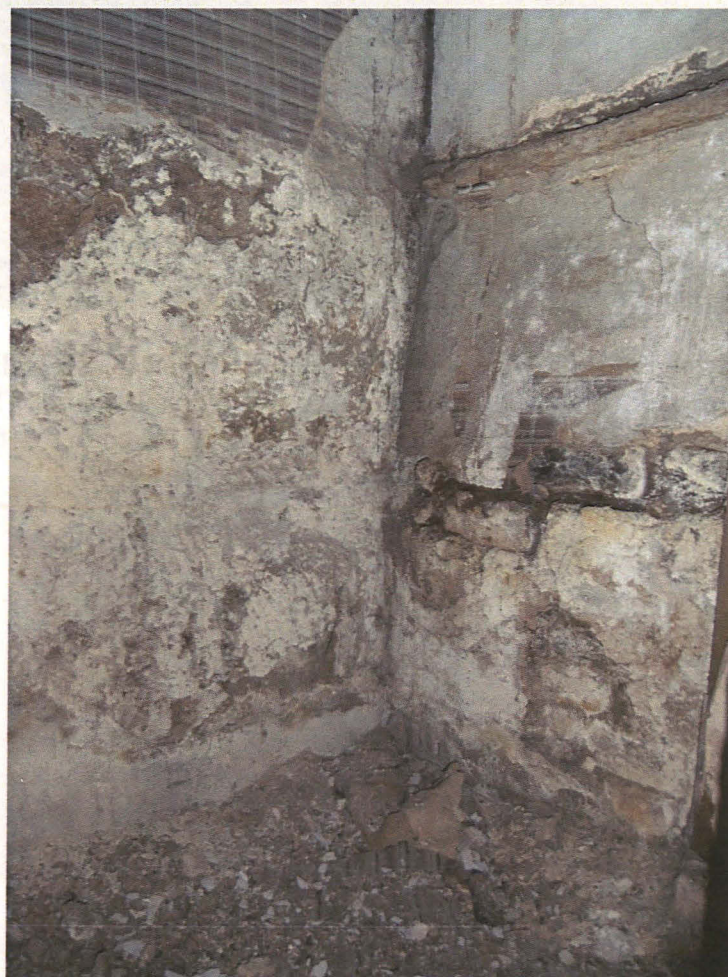
Behind the stud wall to the west of the chimney breast was an alcove. Some brickwork and stonework was exposed behind plaster and wallpaper layers in this alcove, although this was insufficiently clear to provide accurate descriptions of these materials (Plate 25). Several recesses in the side walls of the alcove marked the former position of shelves across it.

*Plate 25 Interior of  
Room 1a, detail of  
interior of alcove  
behind stud partition  
wall at southwest  
corner of room,  
looking southwest*

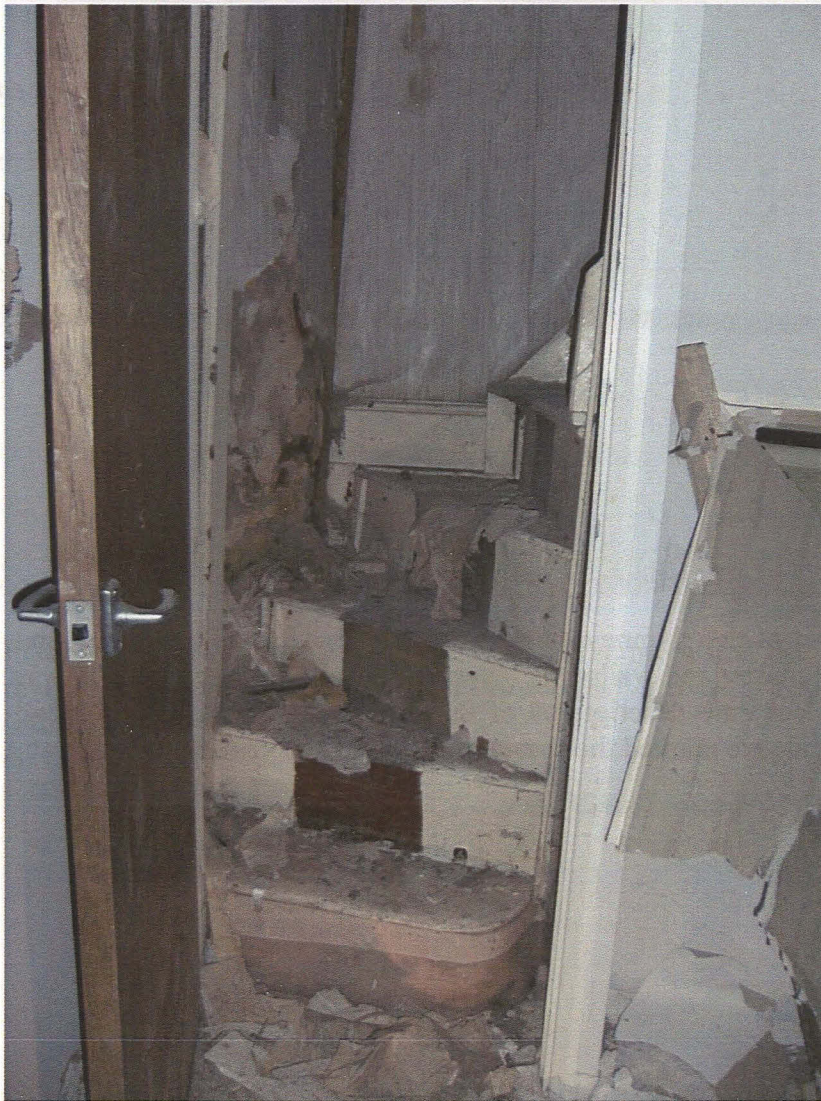
A wooden staircase rose from the southeast corner of Room 1a, leading up to Room 1b above, and is likely to be part of the original building (Plate 26).

*Plate 26 Interior of Room 1a, detail of staircase, looking south*

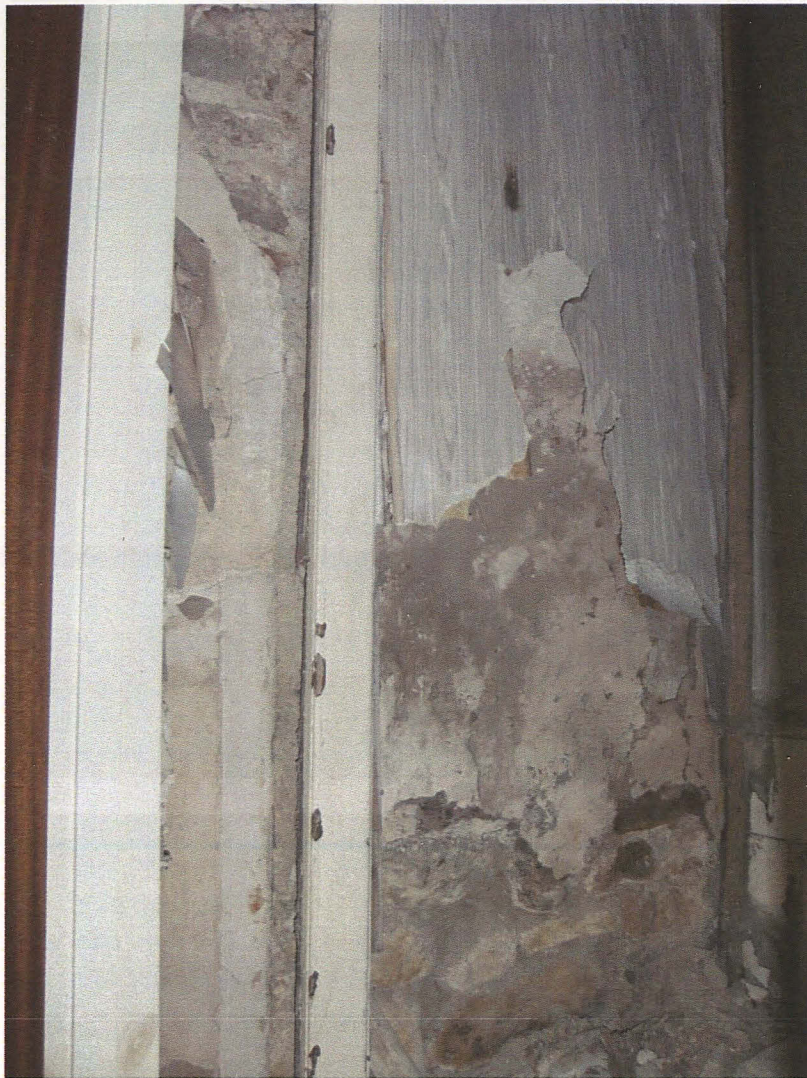
At the bottom of the staircase an area of plaster and wallpaper had been removed from the east wall (Plate 26), exposing some of the wall fabric. This included roughly squared stone blocks, with some brick being just visible at the corner of the wall (Plate 27).

*Plate 27 Interior of Room 1a, detail of exposed walling materials at bottom of staircase, looking southeast*

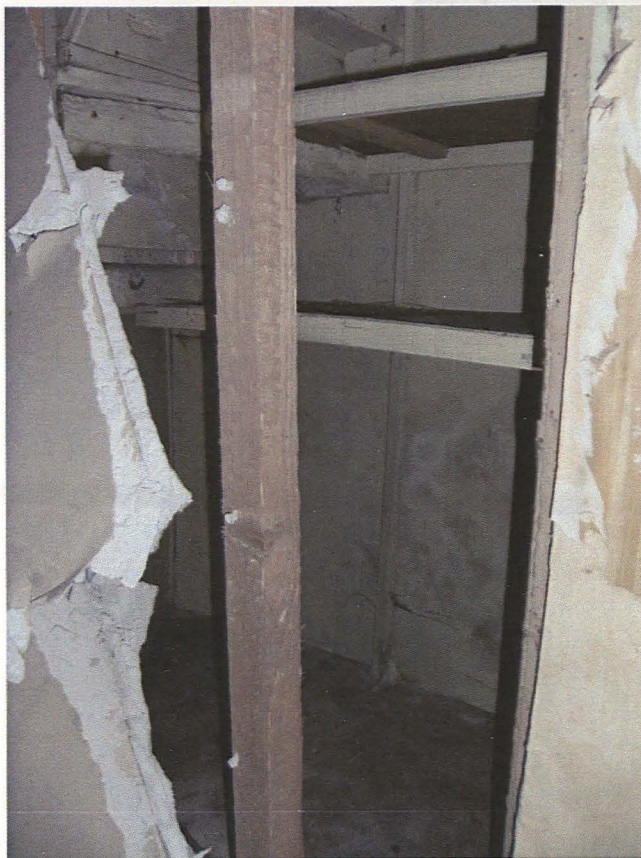
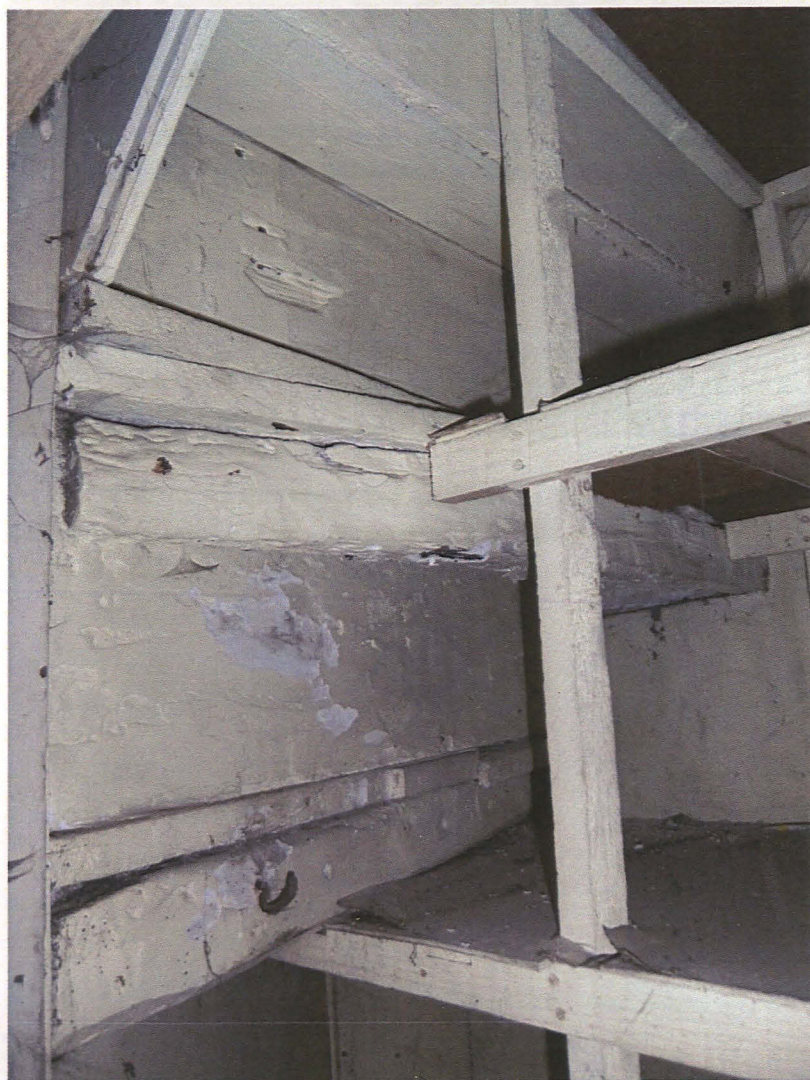
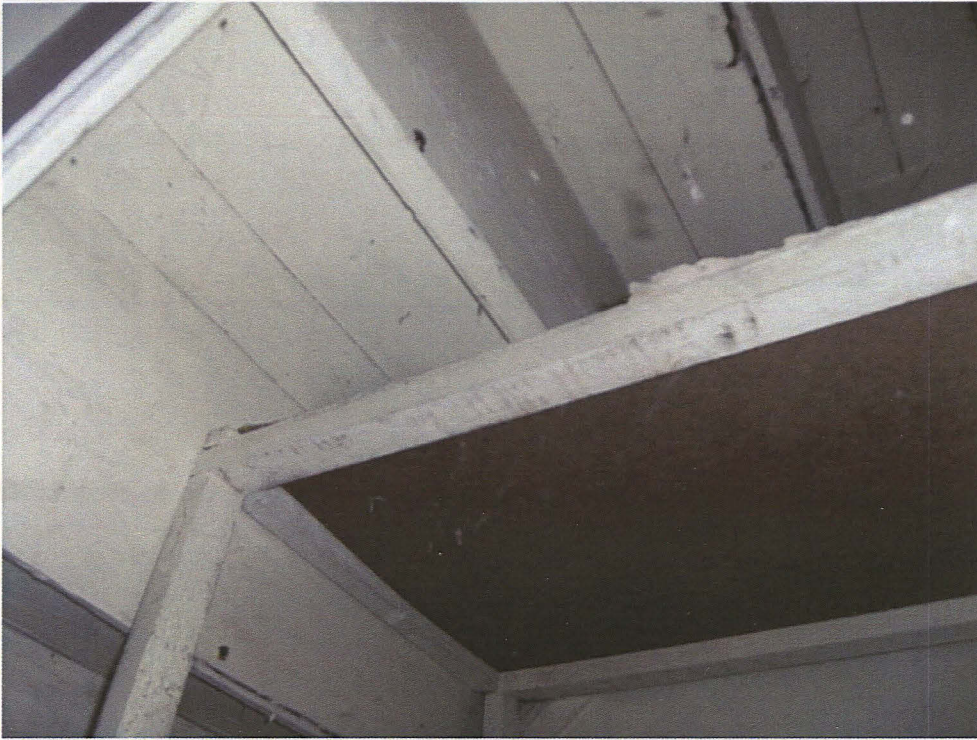
An under-stairs alcove had been concealed by a stud wall, and where this had been broken through, the underside of the stairs was visible (Plates 28-30). Wooden shelves had been constructed within this alcove, but these appeared to be relatively modern.

*Plate 28 Interior of Room 1a, detail of underside of staircase and shelving in alcove behind stud partition wall, looking southeast*

*Plate 29 Interior of Room 1a, detail of underside of staircase and shelving in alcove behind stud partition wall, looking southeast*

*Plate 30  
Interior of  
Room 1a,  
detail of  
underside of  
staircase and  
shelving in  
alcove  
behind stud  
partition  
wall, looking  
southeast*
