**HISTORIC BUILDING RECORDING AT  
59 SOUTH STREET  
CROWLAND  
LINCOLNSHIRE  
(CSSB10)**

Report Compiled by  
Vicky Mellor BSc (Hons)

Planning Application: H02-0800-09  
National Grid Reference: TF 2410 1008  
OASIS Reference Number: archaeo11-80274

A.P.S. Report No: **68/10**

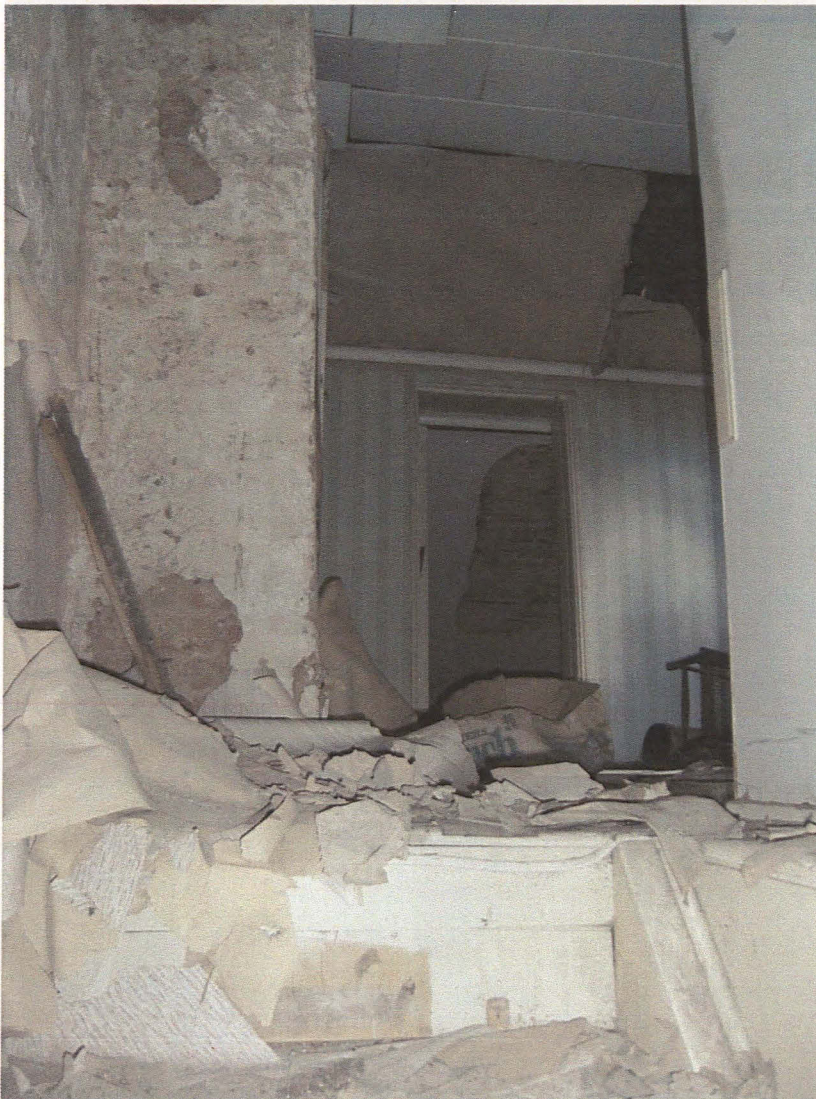
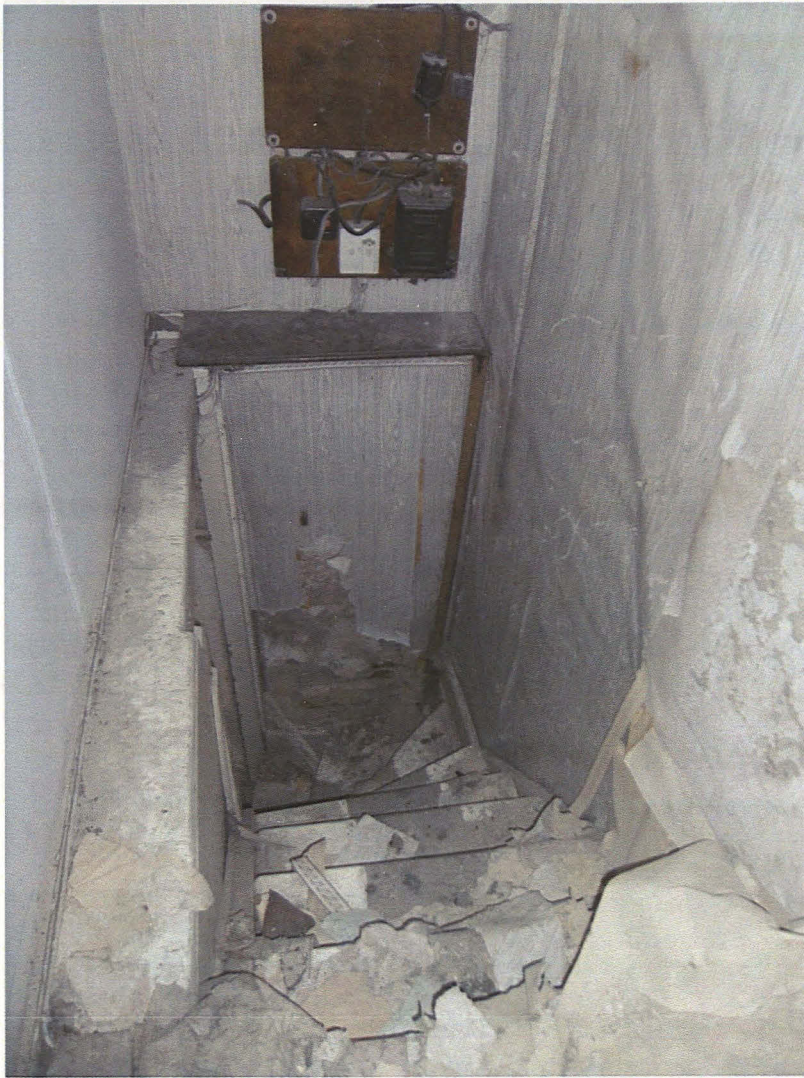
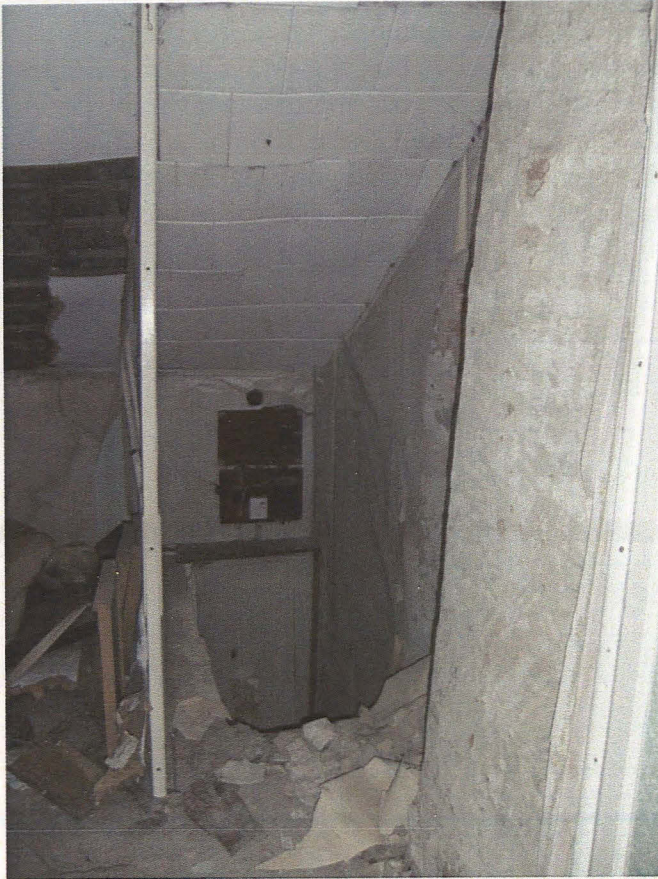
*Plate 31  
View from  
staircase  
looking west  
into room 1b*

*Plate 32  
View down  
staircase,  
looking east*

The top of the stairs opened directly into Room 1b (Plates 31-33), where a modern stud wall had been inserted along one side of the staircase. Much of the ceiling was covered in polystyrene tiles or paper, including a partial suspended ceiling of polystyrene tiles at the centre of the room (Plates 34 & 35). Also at the centre of the room, parts of the ceiling had collapsed, and daylight was clearly visible through the partially collapsed roofing here.

*Plate 33 Interior of  
Room 1b, looking  
east towards  
staircase*

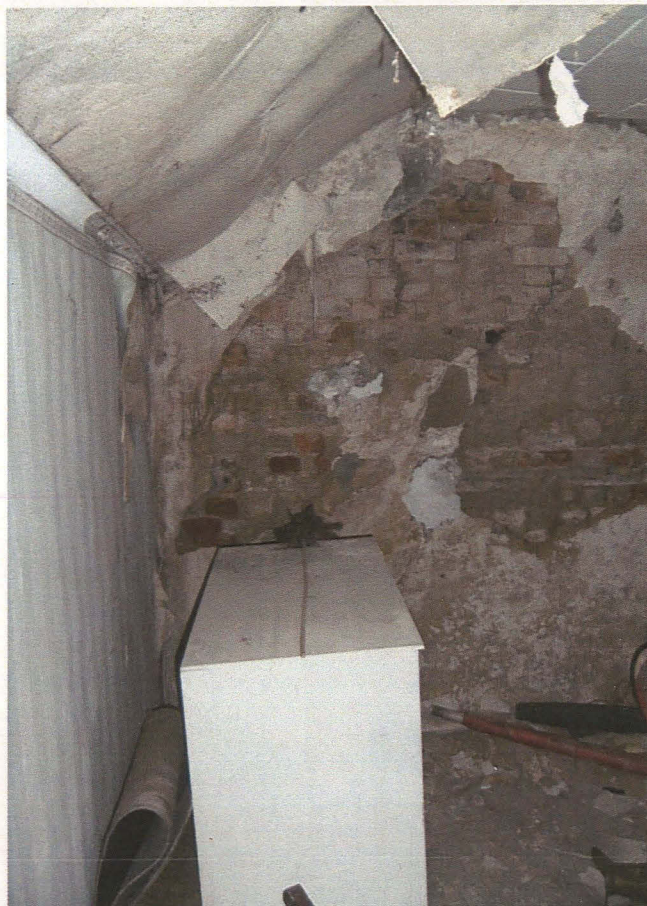
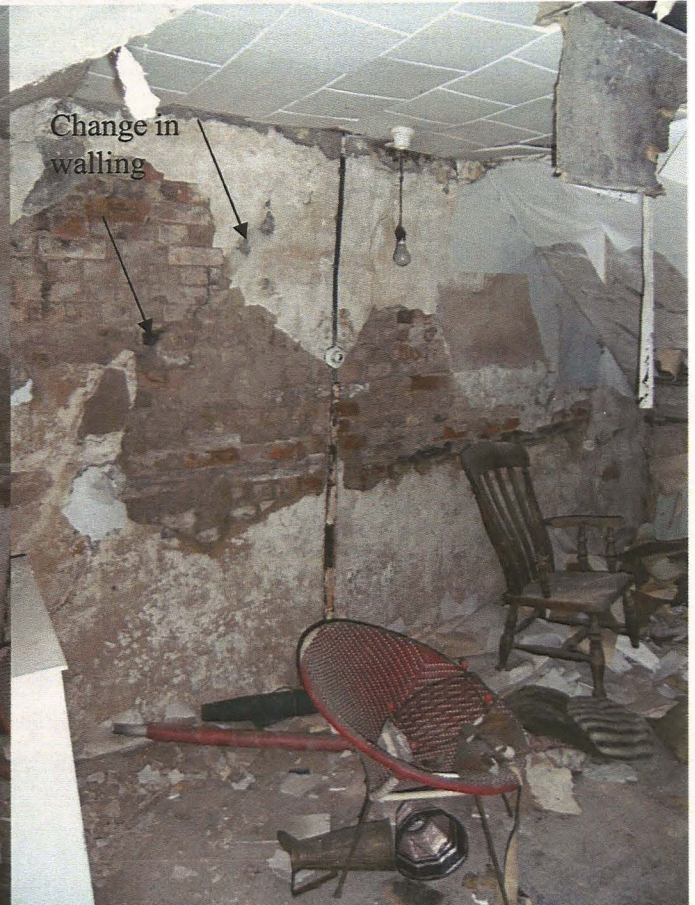
Patches of plaster had come away from both the north and south walls of Room 1b, revealing some of the brickwork (Plates 34-36, Plate 44).

*Plate 34 Interior of Room 1b, looking  
north*

*Plate 35 Interior of Room 1b, looking  
northeast*

On the whole, the brickwork of the northern wall was of handmade brick in English Bond, with alternate rows of headers and stretchers, although the bonding was rather variable (Plates 34-36). A horizontal course of wood was recorded in this wall, approximately 1.00-1.10m above the floor. One brick below the wood course of this wall was c.100mm x 55mm, and another brick above the wood measured 110mm x 56mm. A change in the brickwork was recorded at the west of the wall, above the level of the wood course. This appeared to mark a former roofline of the cottage. Some of the bricks used in this part of the had clear horizontal skintling marks, one of these bricks measuring 210mm x 64mm, and another 223mm x 61mm. A brick possibly of the same type was 108mm wide. A brick which lacked any skintling measured 230mm x 65mm. Several of the bricks in this part of the wall had what appeared to be kiss marks, although it was not entirely clear if these variations in colour might instead be as a result of the remnants of plaster on the wall or other surface deposits. The bricks of this wall with horizontal skintlings may post-date around 1780 (James and Rose nd).

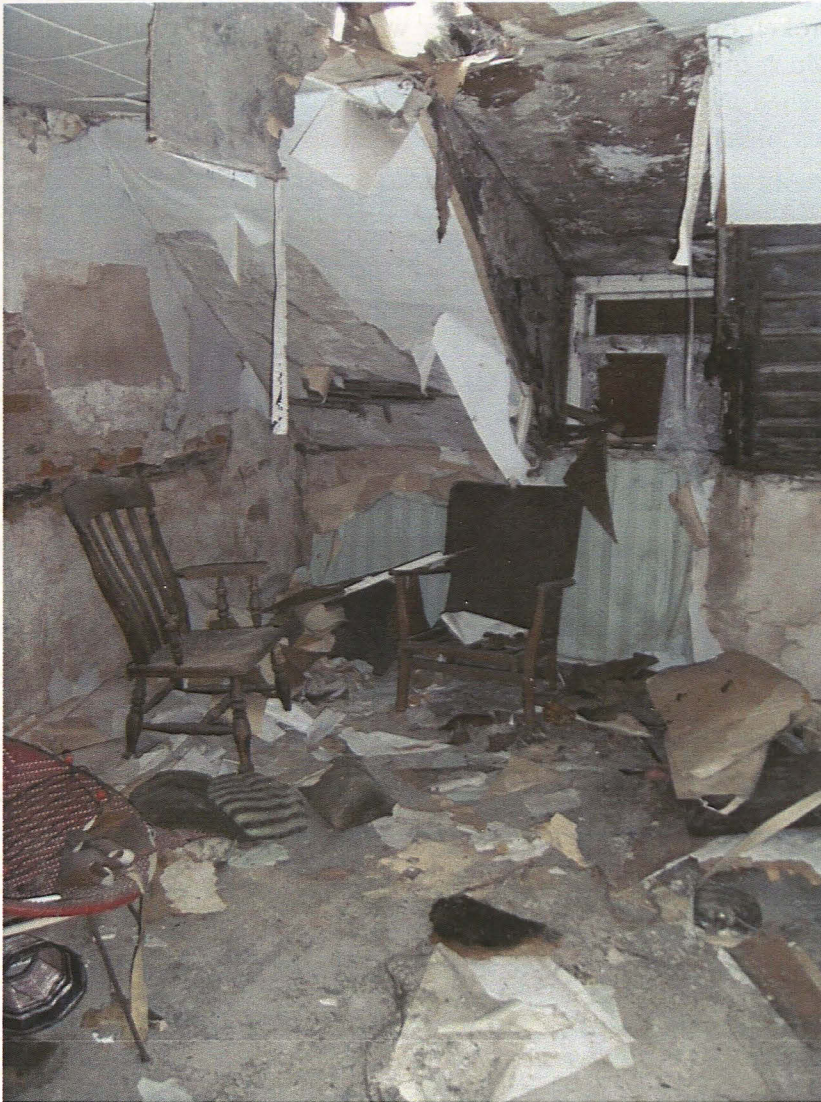
*Plate 37 interior of Room 1a showing dormer window, looking northeast*

The ceiling in the eastern part of the room sloped (Plate 37), and where part of the plaster of the sloping ceiling had come away laths were exposed (Plate 38).

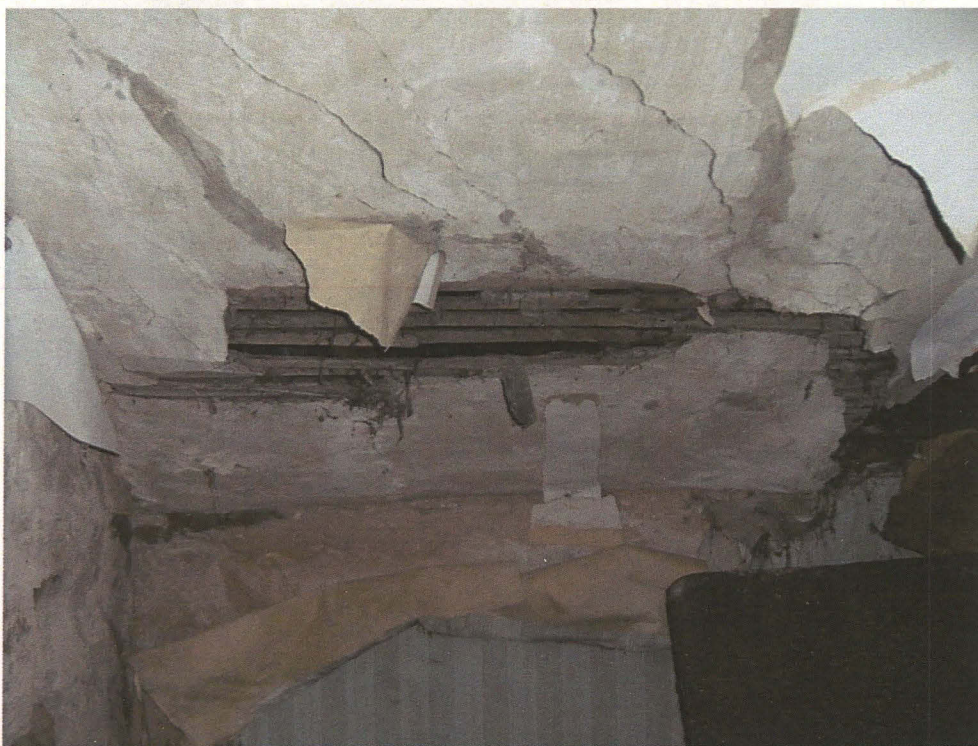
*Plate 38 Interior of Room 1b, detail of laths in northeast corner of room, looking east*

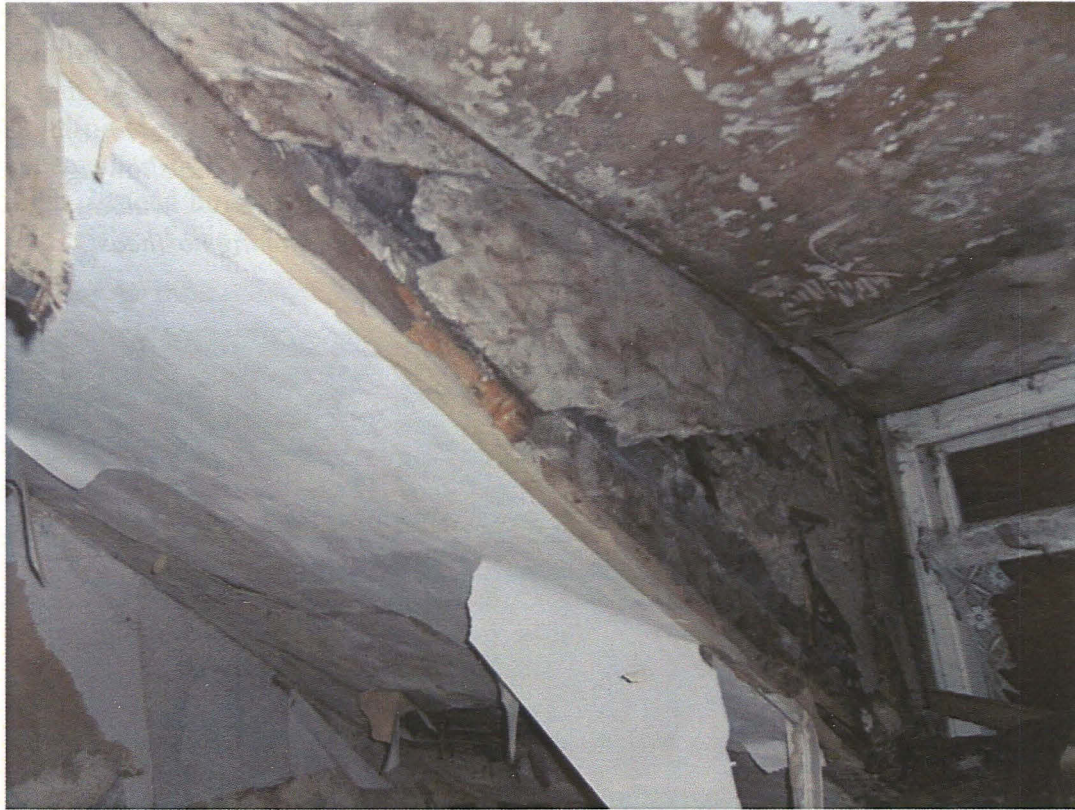
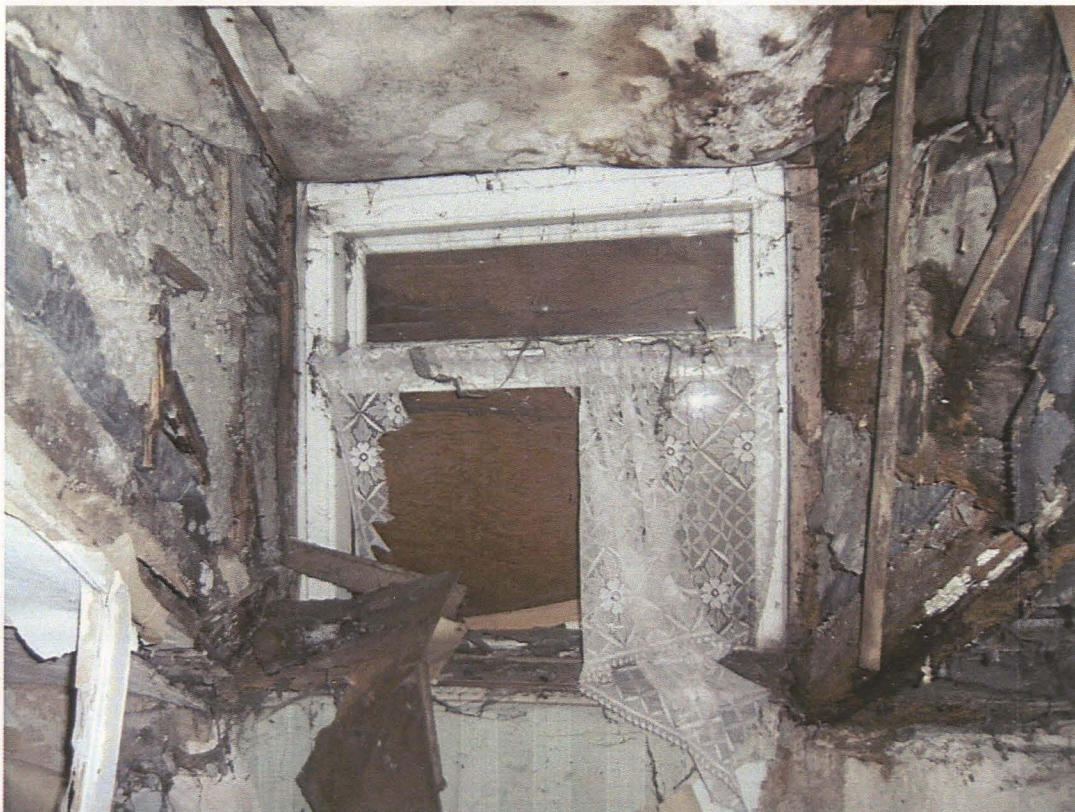
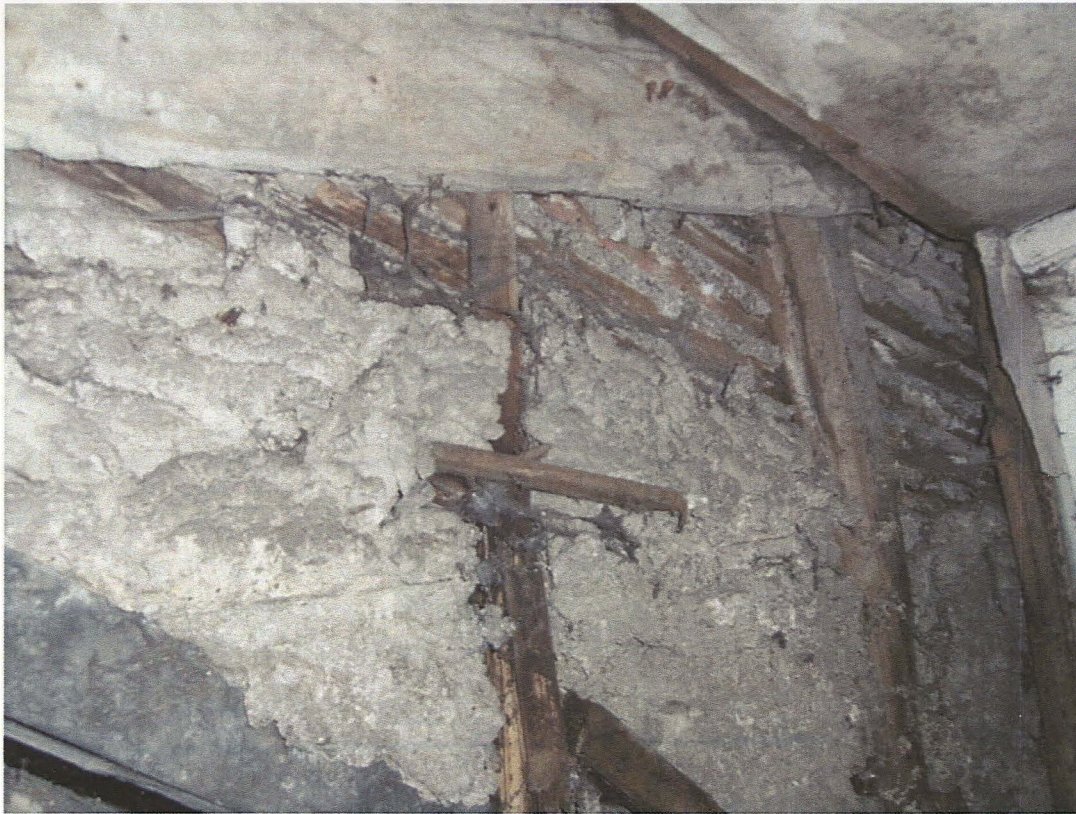
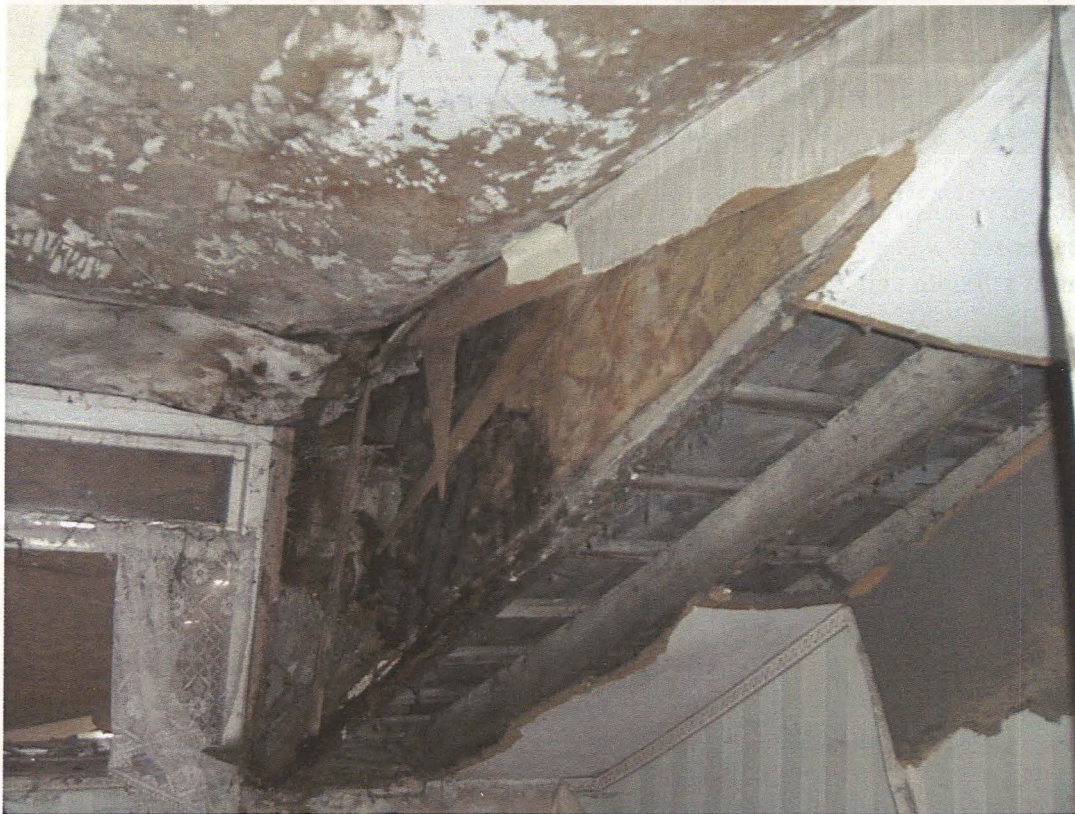
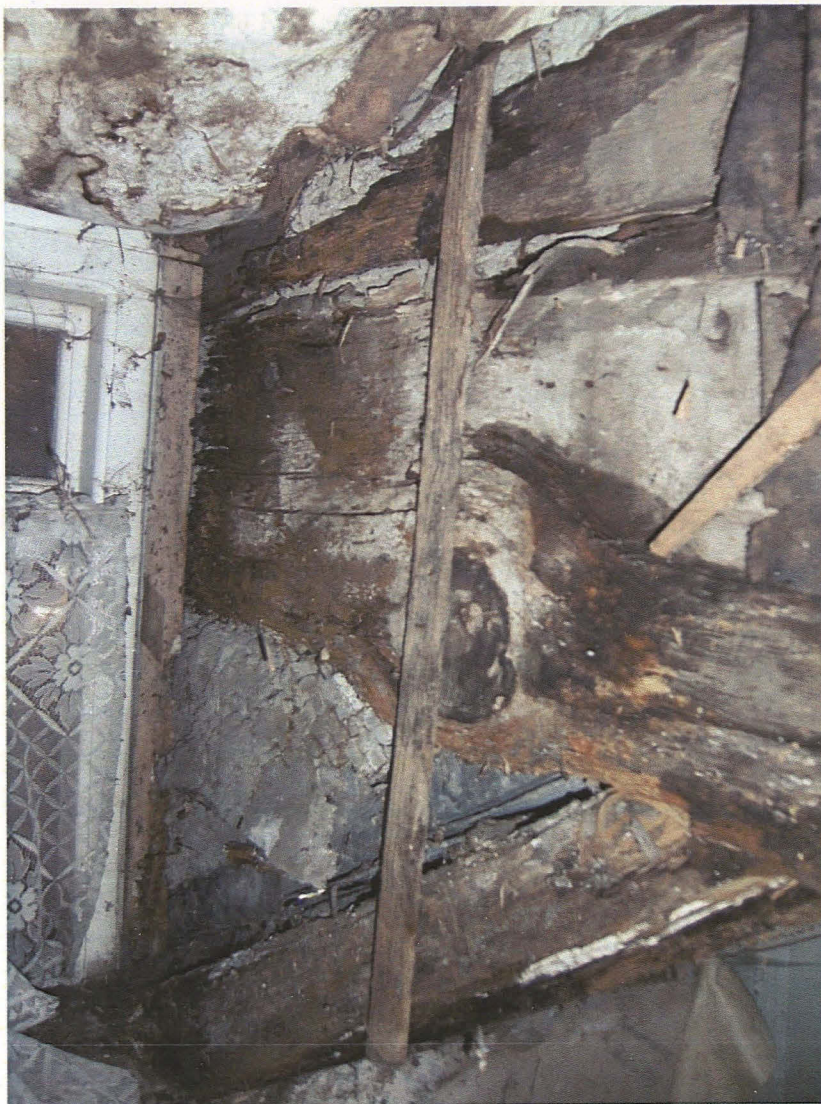
The sloping ceiling here was broken by a near-central dormer window (Plate 37), which also had a sloping ceiling over it. Much of the construction of the dormer cheeks was visible, and this appeared to be heavily patched and repaired with a variety of materials (Plates 39-43). Both sides included thin wooden planks, and laths were visible behind planks in parts of the northern cheek (Plate 41).

*Plate 39 Interior of Room 1b, detail of construction at north cheek of dormer window, looking northeast*

*Plate 40 Interior of Room 1b, dormer window, looking east*

*Plate 41 Interior of Room 1b, detail of laths and timber of north cheek of dormer window, looking northeast*

*Plate 42 Interior of Room 1b, south cheek of dormer window, looking southeast*

*Plate 43  
Interior of  
Room 1b,  
detail of  
construction  
at south  
cheek of  
dormer  
window,  
looking  
southeast*

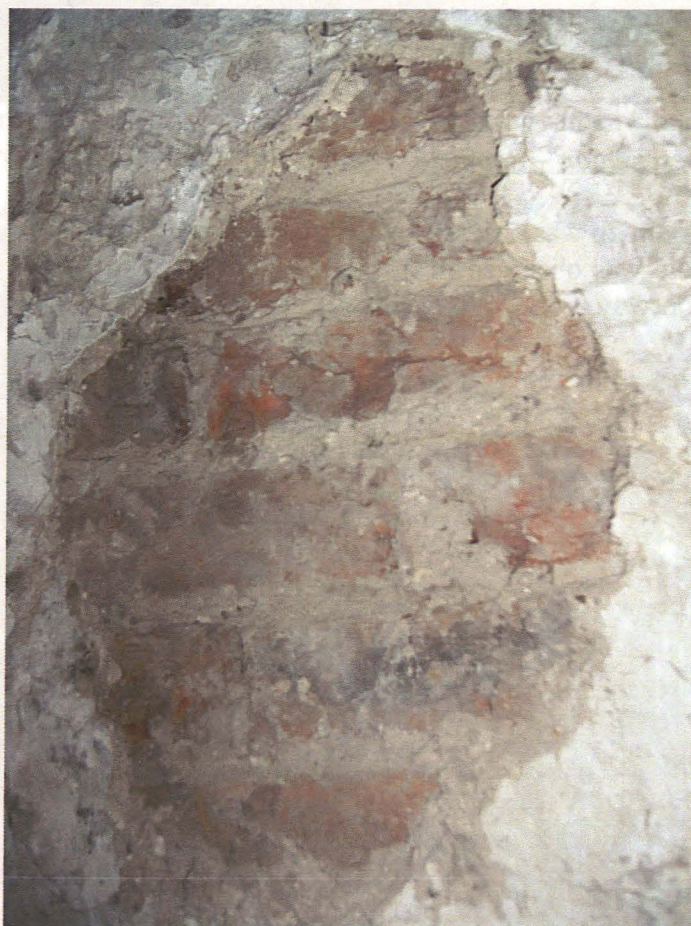
Part of the brickwork of the chimney in the south wall was exposed (Plates 45 & 46). Many of these bricks had horizontal skintlings, again hinting at a date after around 1780. It was only possible to measure the depth of these bricks, which was 58mm.

*Plate 46 Interior of Room 1b, detail of exposed brickwork of chimney breast, looking west*

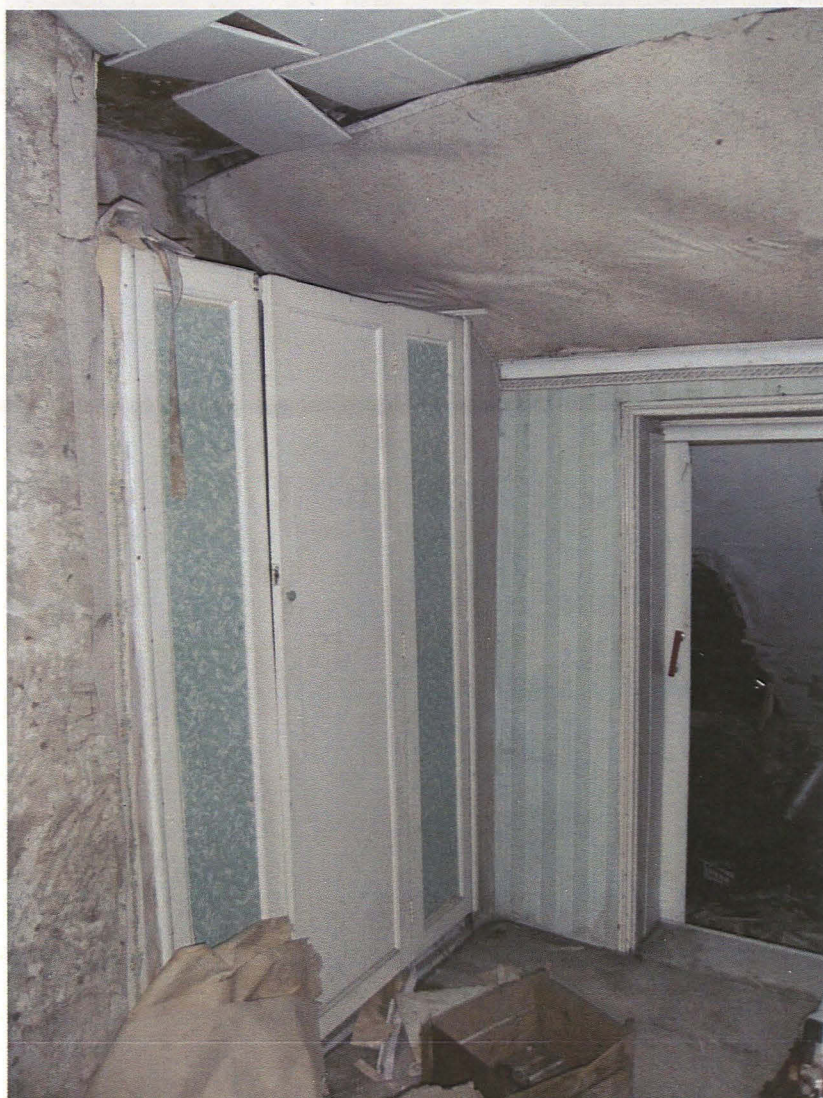
At the west side of the chimney breast was a built-in wardrobe (Plate 47).

*Plate 47 Interior of Room 1b, built-in wardrobe at southwest corner of room and doorway to Room 2a, looking southwest*

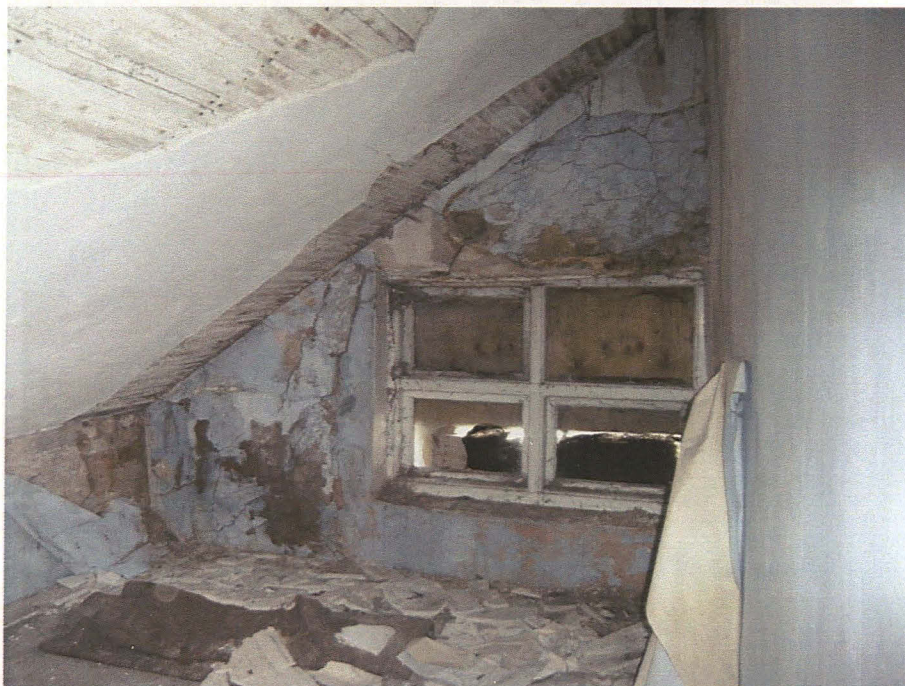
Much of the plaster of the sloping ceiling of Room 2b had come away, revealing laths behind (Plates 48-50). A single window was present in the north wall (Plate 49).

*Plate 49 Interior of Room 2b, looking north*

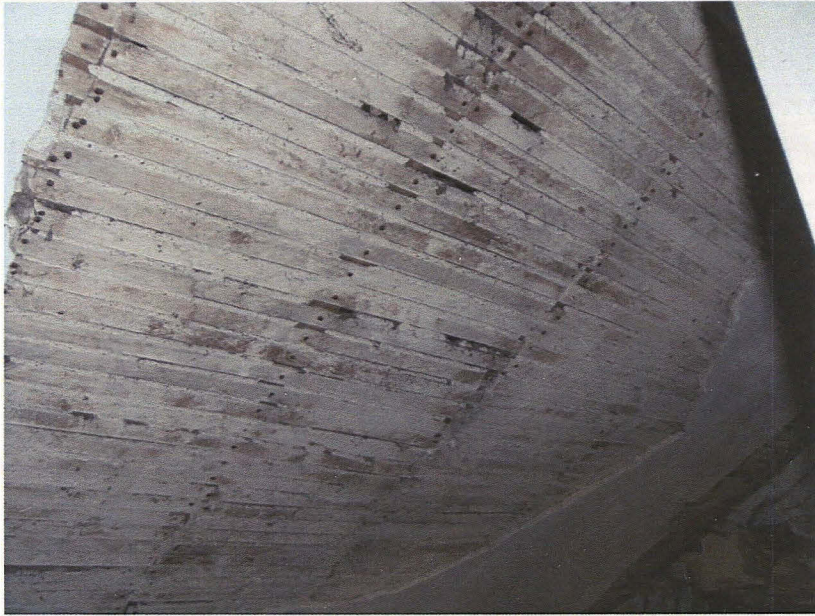
*Plate 50 Interior of Room 2b, showing laths of ceiling, looking northwest*

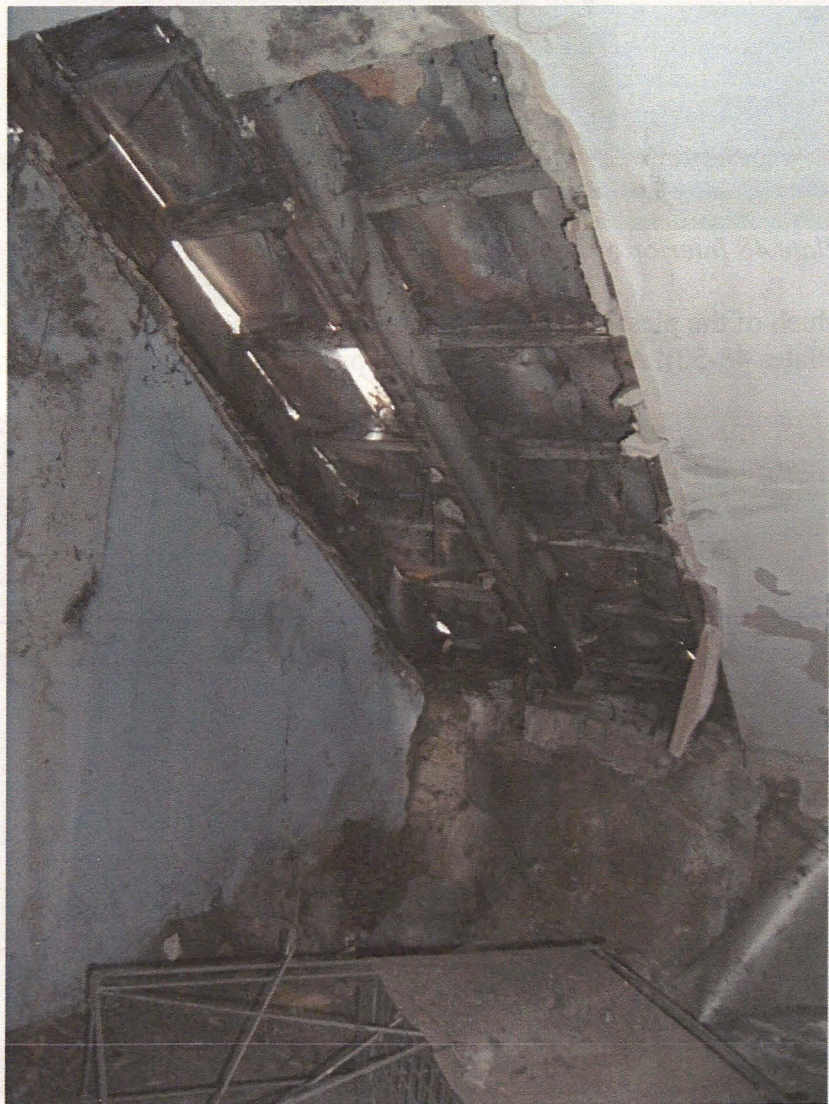
At the southwest corner of the room much of the ceiling had come away from the roof, leaving the underside of pantiles exposed (Plate 51). Directly below this was a hole in the flooring.

*Plate 51 interior of Room 2b, showing roof structure with pantiles and hole in corner of floor, looking southwest*

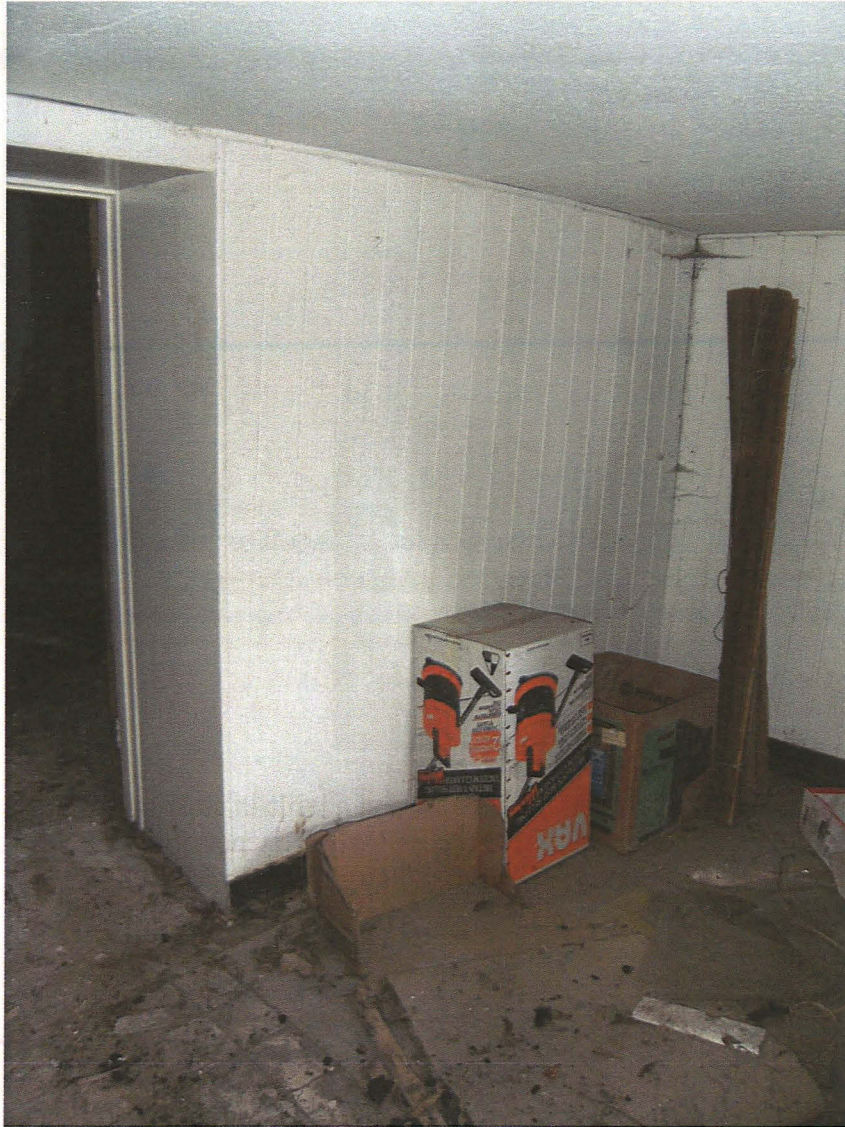
Room 2a, on the ground floor of the building, was accessed from Room 1a via a doorway, the floor sloping down slightly at this doorway from Room 1a to Room 2a (Plate 52). Much of the walling at the west, south and east was obscured by wood panelling (Plates 52, 53 & 55). The ceiling was covered in woodchip, and a hole in the ceiling at the southwest corner matched the position of the hole noted in the floor of Room 2b above (Plate 53). Both the east and west walls of this room were thick, although this thickness included the plasterboard of Room 1a, the wood panelling of this room and a possible modern brickwork skin to Room 3b (Plates 52, 53 & 55). A single window was present in the western wall of Room 2a, looking out into Room 3b (Plate 53).

*Plate 52  
Interior of  
Room 2A  
showing thick  
wall and  
doorway to  
Room 1a,  
looking  
southeast*

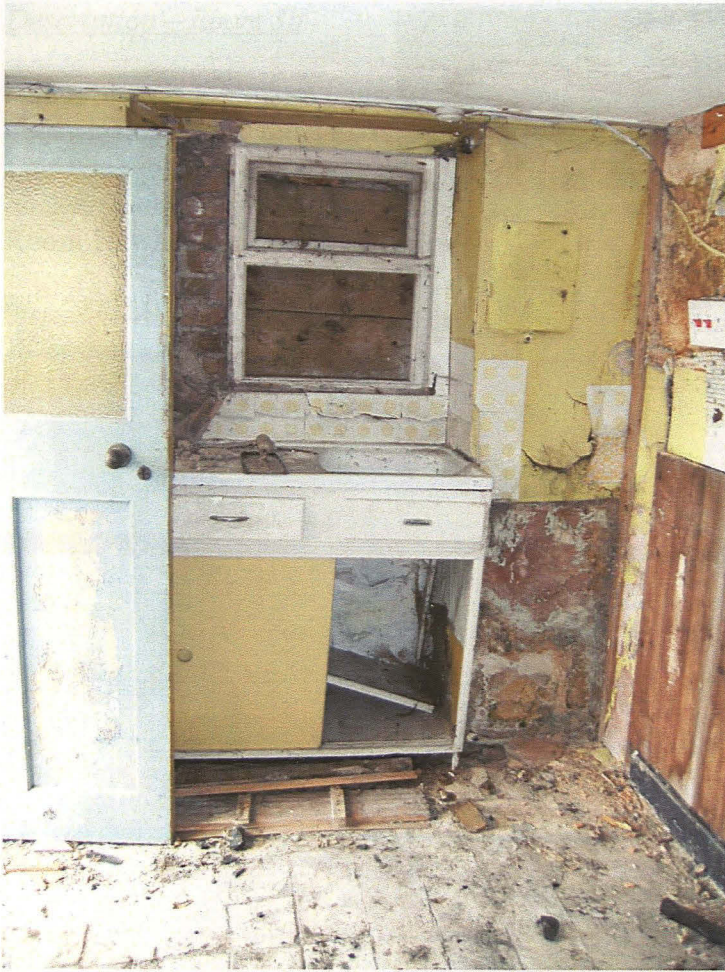
The northern wall of the room had a single boarded up window and a built-in sink unit (Plates 54 & 56). The window and unit were within a wider recess, and it is possible that this represented the position of a former external doorway, although as the brickwork was largely obscured this could not be confirmed.

*Plate 54 Interior of Room 2a, looking north*

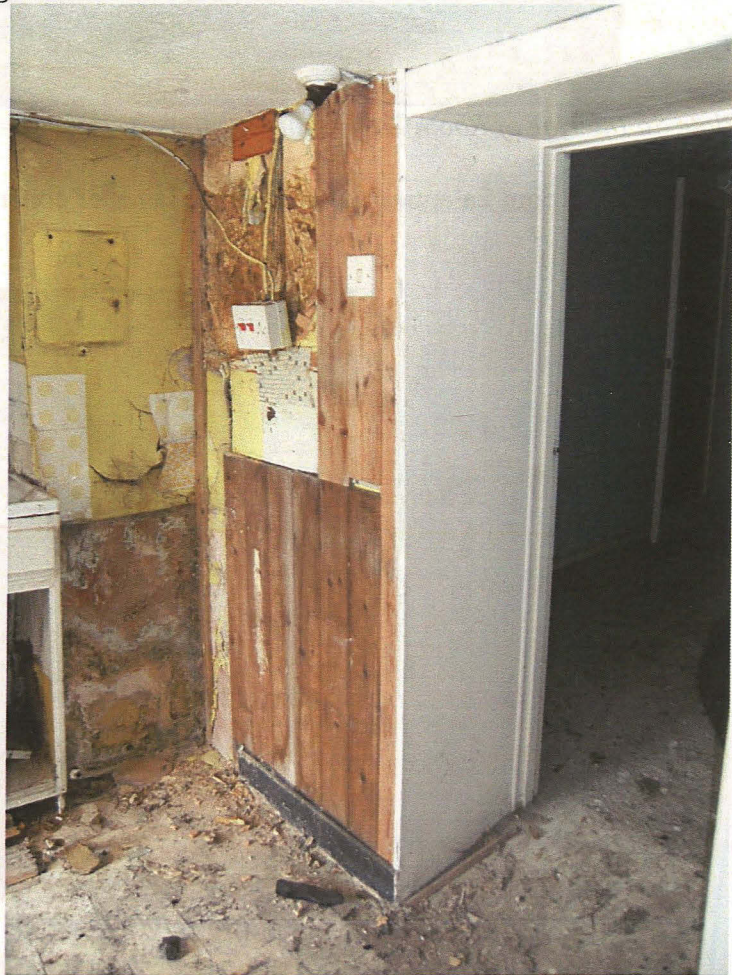
*Plate 55 Interior of Room 2a, looking northeast*

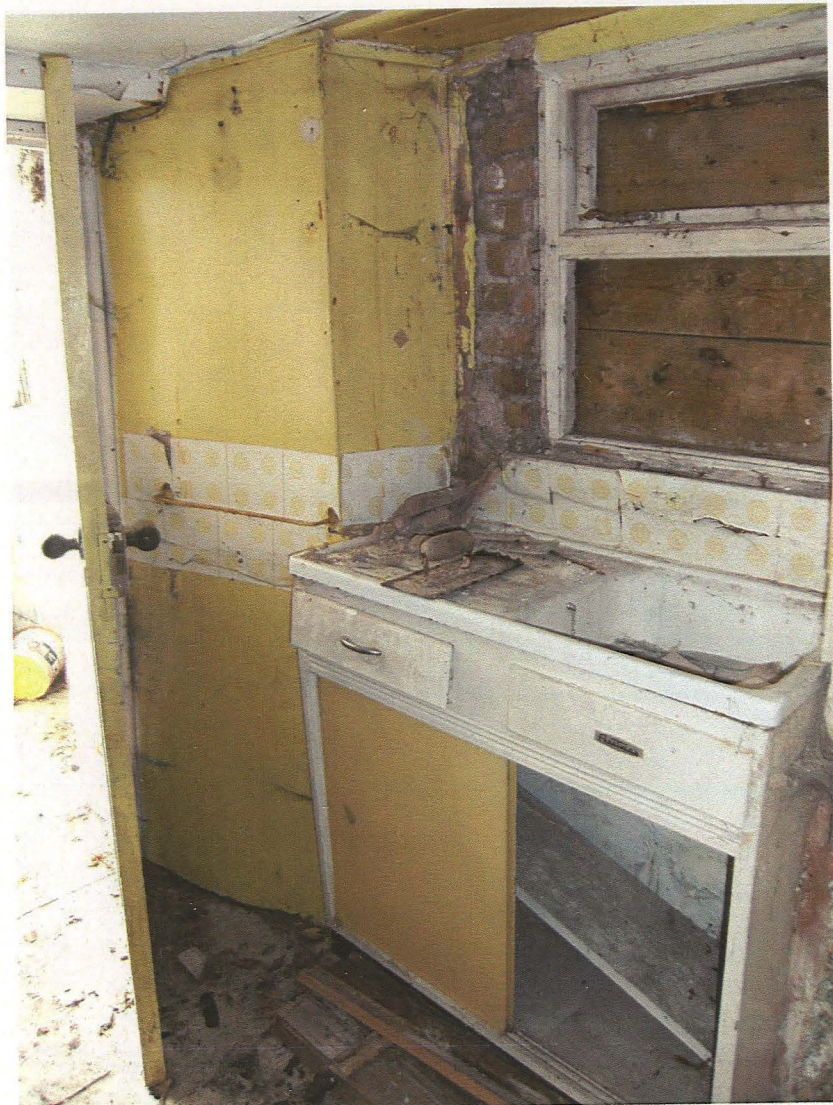
*Plate 56 Interior of Room 2a, looking northwest*

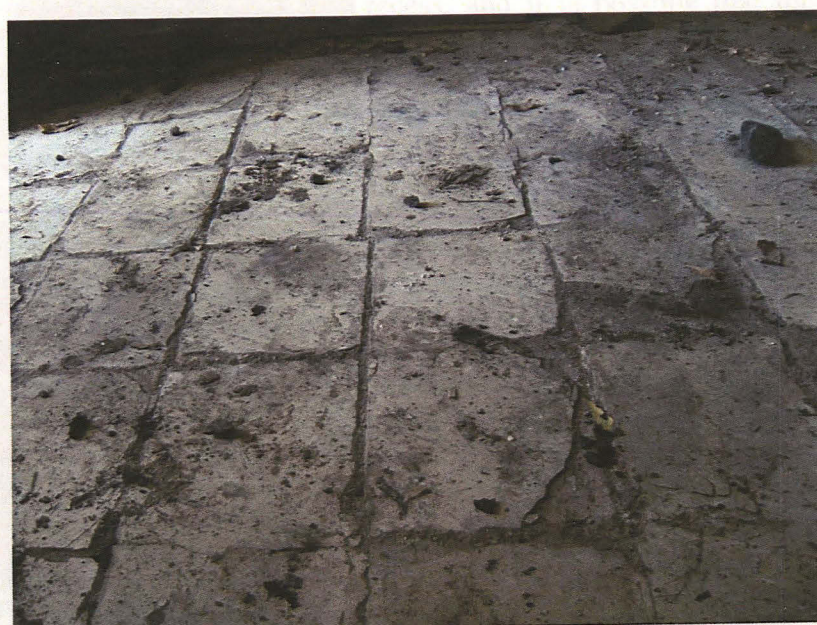
The floor of Room 2a appeared to be a thin layer of concrete poured over ceramic tiles (Plate 57).

*Plate 57 Interior of Room 2a, detail of flooring of concrete, apparently poured over ceramic tiles, looking north*

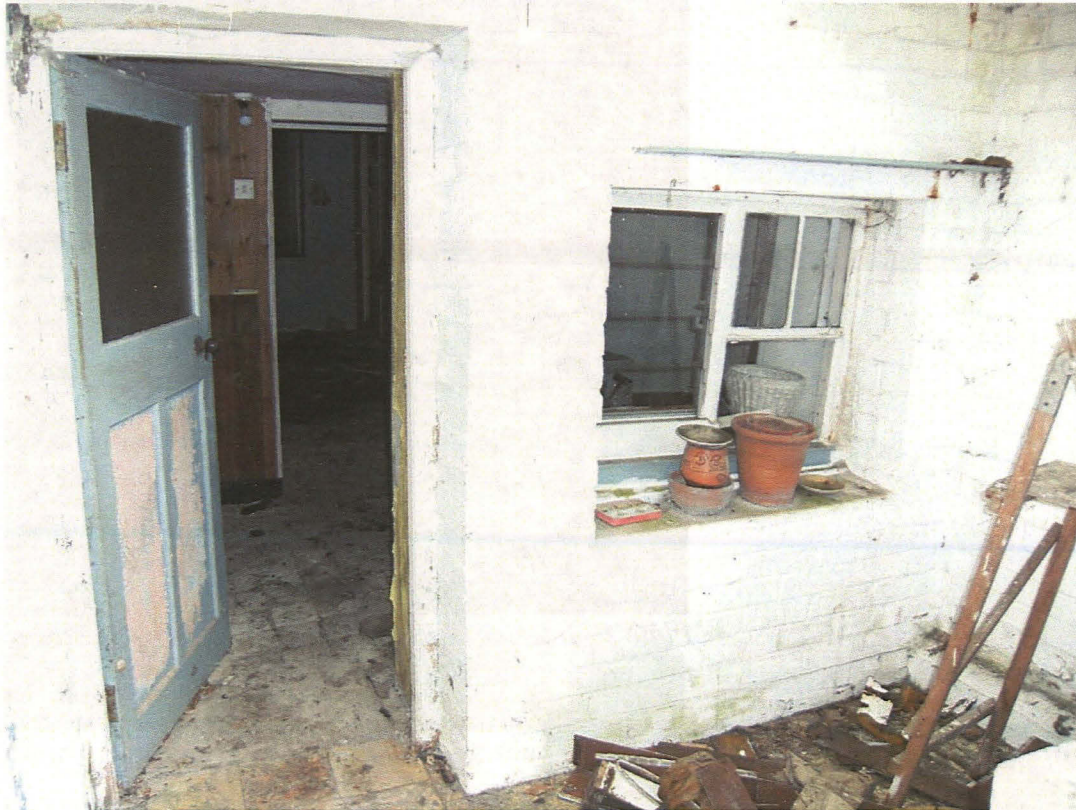
Room 3b was a modern conservatory, accessed from Room 2a via a doorway, with a further doorway leading to the exterior of the property (Plates 58 & 59). Much of the brickwork of all four walls of this room was whitewashed, but appeared to be of 20<sup>th</sup> century date. Although unclear, a skin of modern brickwork may have been added to the wall between this room and Room 2a when the conservatory (Room 3b) was built.

*Plate 58 Interior of Room 3b showing looking east towards Room 2a*

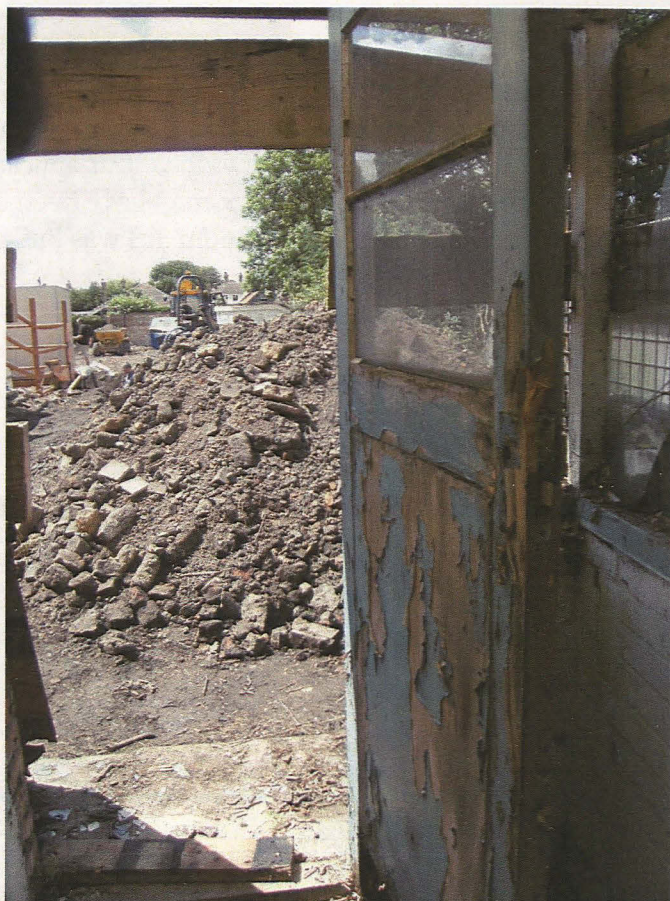
*Plate 59 Interior of Room 2a, looking west to rear of property*

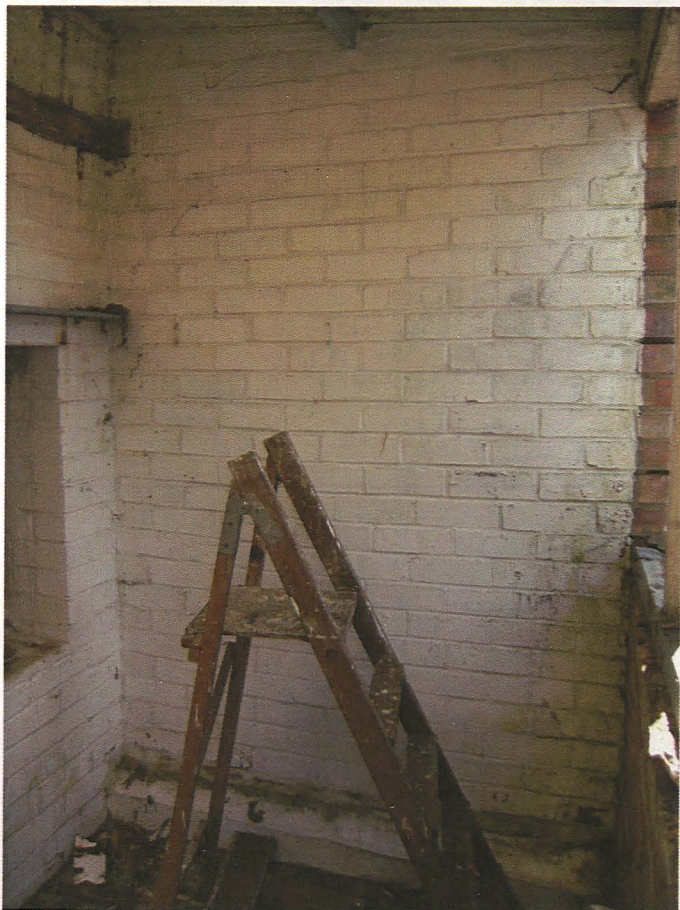
*Plate 60 Interior of Room 3b, looking south*

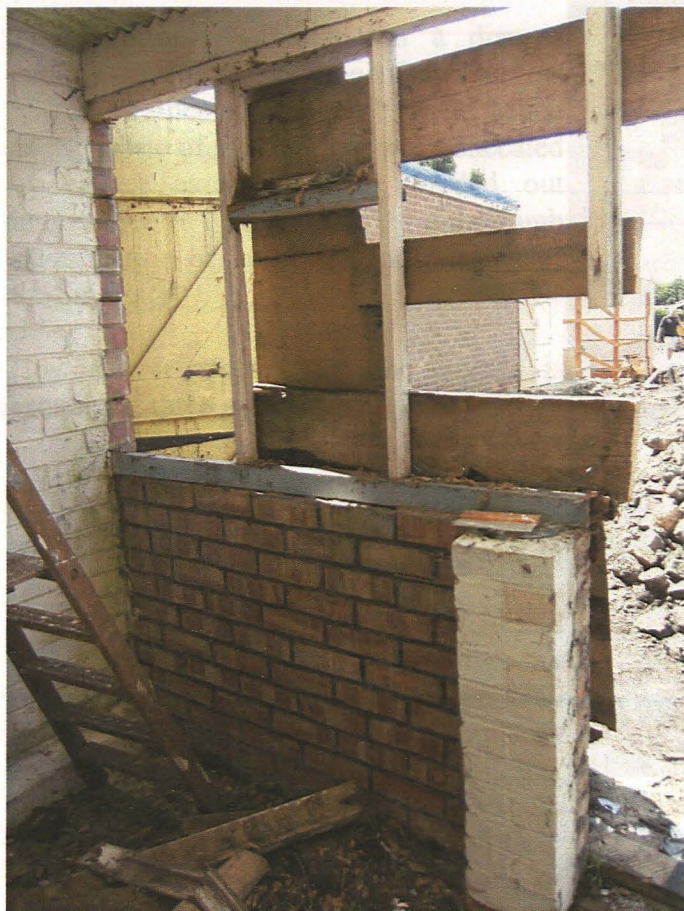
The east and south walls of Room 3b were the full height of the room, but the west and north walls were each low brick walls topped by wood and glass, forming a conservatory (Plate 61).

*Plate 61 Interior of Room 3b, looking southwest*

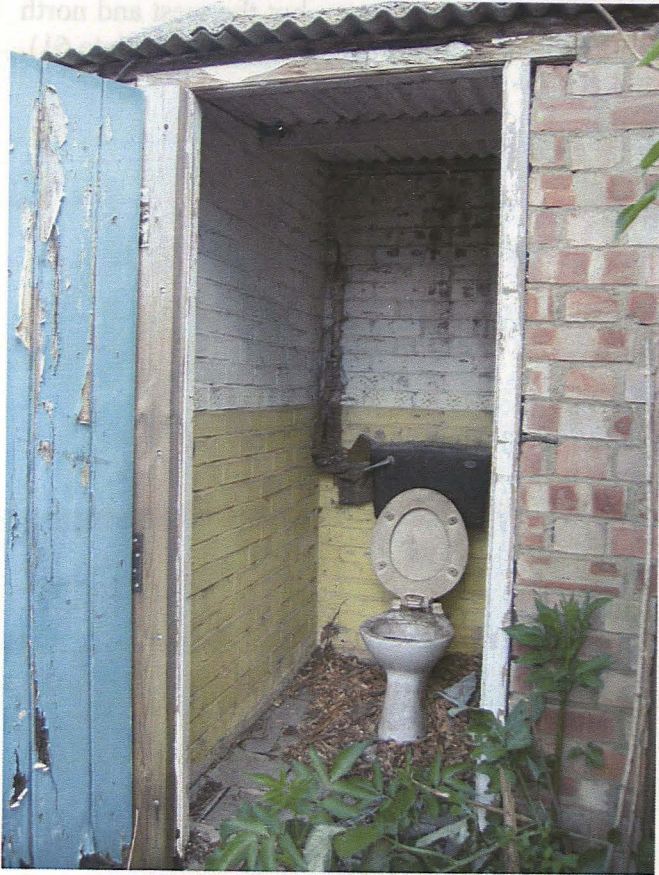
Room 3a was a small outside toilet, all four walls being of 20<sup>th</sup> century brick which was whitewashed internally (Plates 62 & 63). This room had a single window in the southern wall (Plate 63) and a single door at the west.

Plate 62 Interior of Room 3a, looking northeast

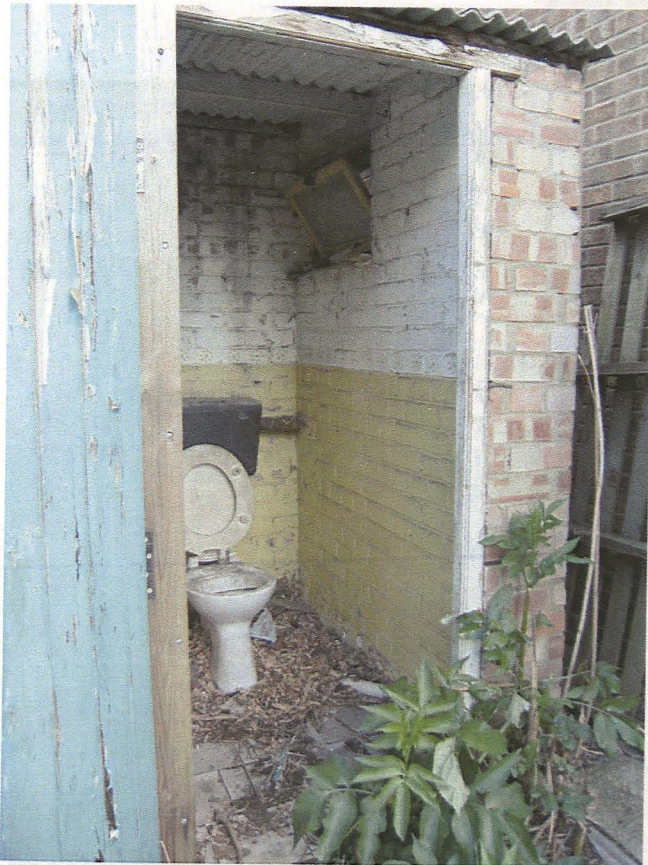
Plate 63 Interior of Room 3a, looking southeast
