8, ST. LAWRENCE STREET, HORNCASTLE

PHOTOGRAPHIC BUILDING SURVEY

NGR: TF 2589 6963
PCA job no. 08-569
Site code: SLHL 09
LCNCC Acc No: 2009.119

September 2009

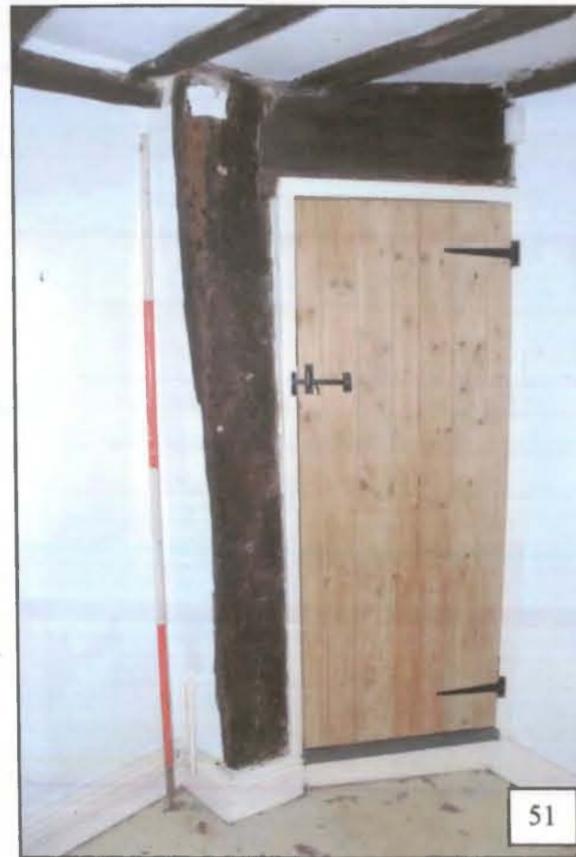
54

This room again displayed elements of the timber-framed origins of the property. Three posts were present in the room. Two posts were present in the south wall, the western of which was built into the wall adjacent to the stair door. This post was 5½" (N-S) x 9" (E-W) and had a 4" x 3" (plaster-filled) mortise near to the ceiling. A further 8" high mortise was present 38" from its base on the east side, which had a hole for a peg on the north face.

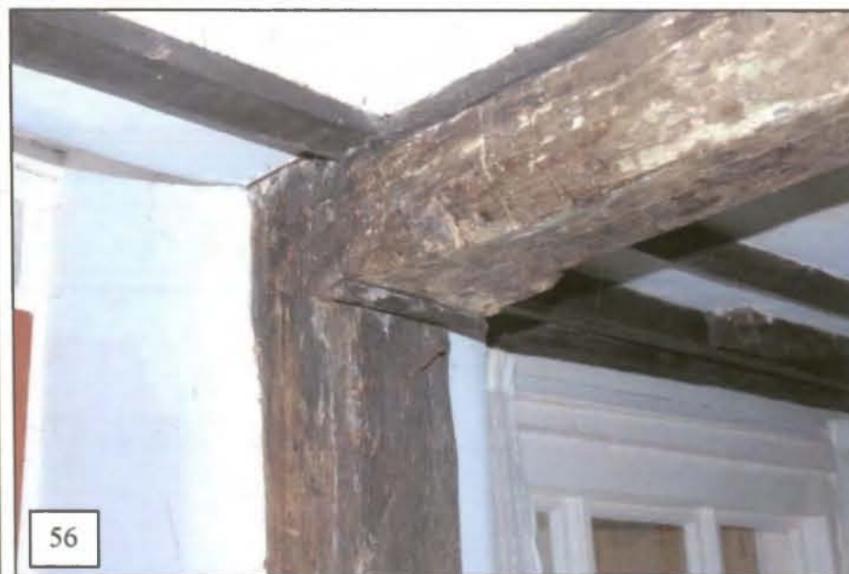
55

A similarly-sized ceiling beam ran west from this post; this was chamfered on its underside, with stops 6" from the post, but was extended at its west end with a scarf joint further secured by a bolt. The exposed joists of the first floor were of sawn 3" timber, suggesting that this floor, and perhaps the beam, had been renewed.

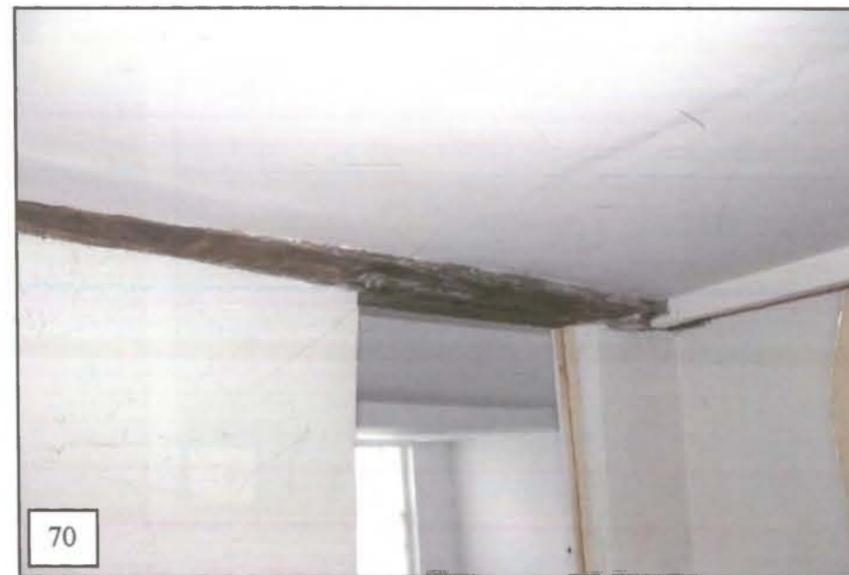
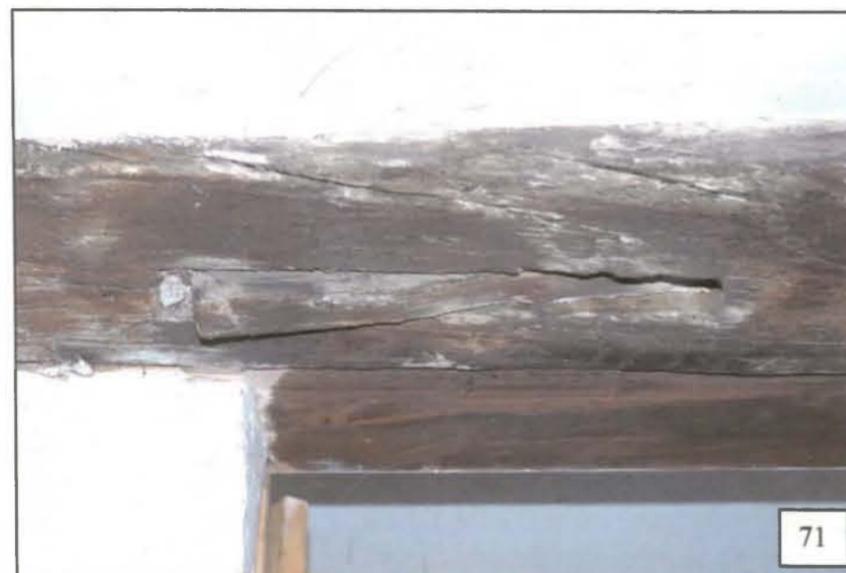
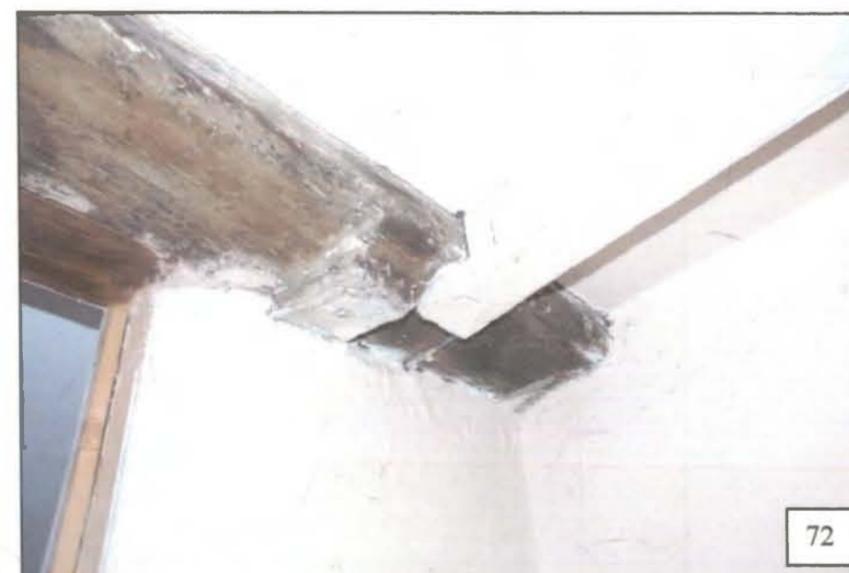
A large post was present in the southwest corner of Room 5; at its base it measured 7" (N-S) x 5½" (E-W, as exposed), flaring to the north to form a jowled head in excess of 14" in width. A diagonal brace was present here, mortised into the post and pegged at its lower end, and rising to the east to a presumed wall-plate which had been boxed in. This brace was 6½" x 3" in size.

A further beam ran from the top of the post to the north across the full width of the room. Exactly how this was joined to the post was obscured, but a 4" x 1½" mortise was present adjacent to the post, with a sawn off tenon still in situ. Further along the beam, another sawn-off tenon was present in the soffit of the beam above the door to Room 6; this occupied a mortise 12" in length.

A further beam was present on the north side of the room, trenched into the northern end of the beam discussed above, and running back to the east. This appeared to be of sawn timber 2½" x 3" (as exposed) in size, and painted white. This represented a more recent renewal or, most likely, was placed when the building was divided.

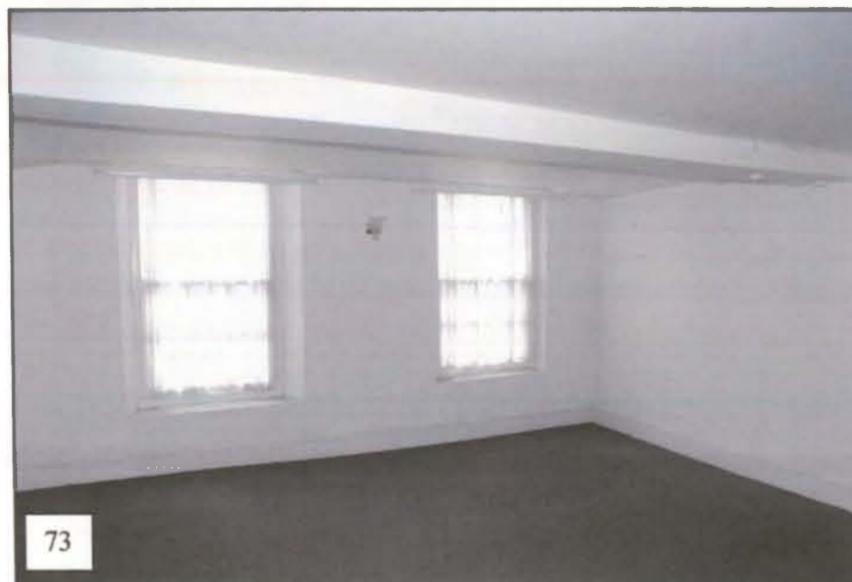
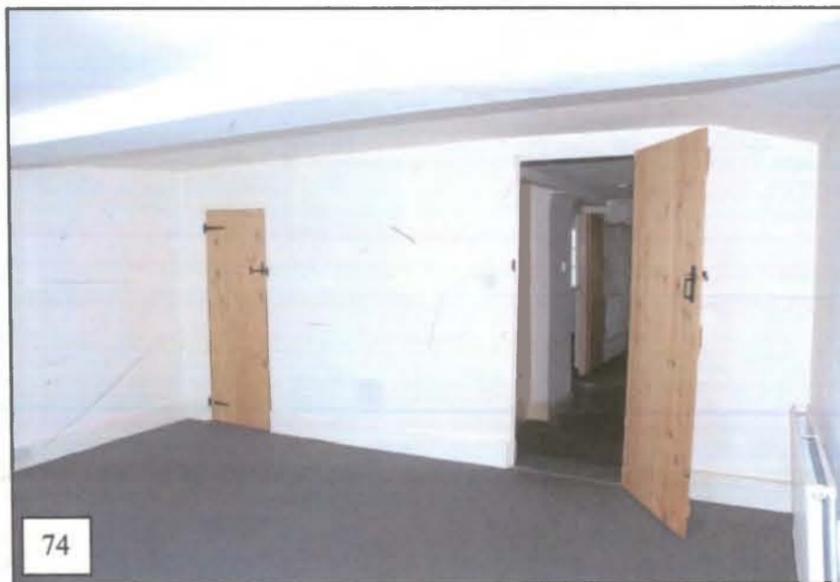
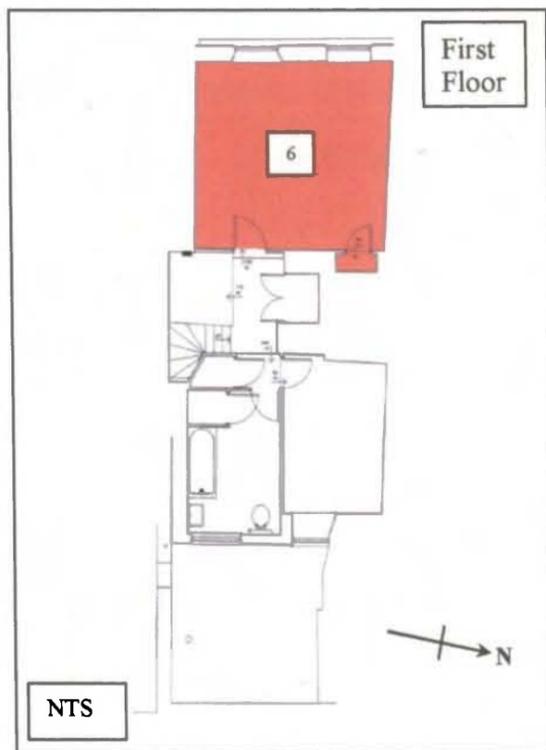
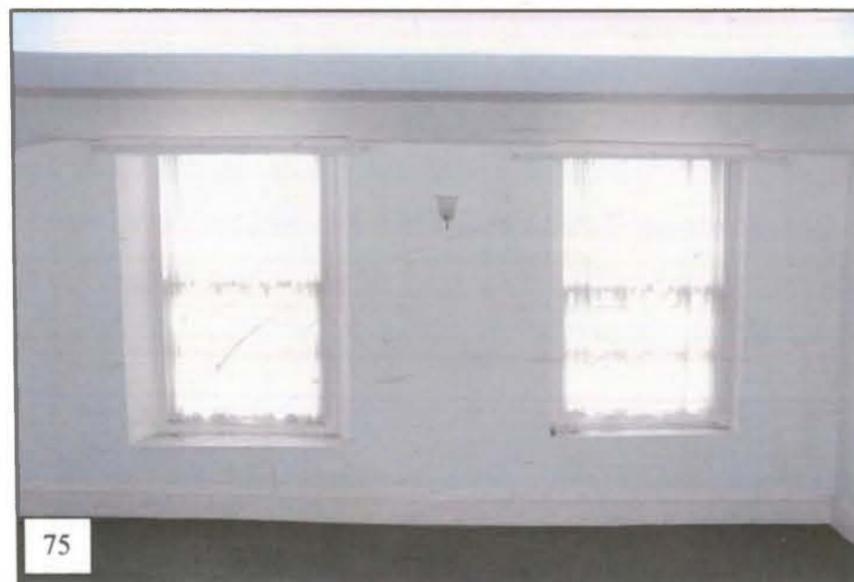
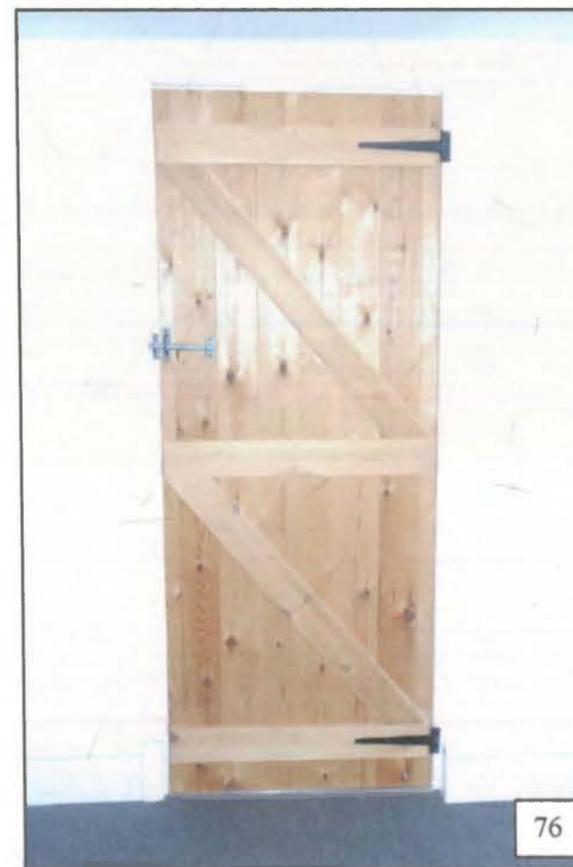
This room was the largest room at first floor level, and occupied the western (street front) part of the building. It had entirely modern decoration, with a painted plasterboard ceiling – a north-south oriented boxed beam bisected the room - hipped on the south side.

The floor covering was a modern fitted carpet, and the floor below appeared to have been renewed in modern fibreboard. The skirting boards were of modern type, similar to those seen throughout the property, but 7" high. A small cupboard was present at the north side of the east wall; this had a modern plank door, which matched that of the room itself and was identical in construction with that at the foot of the stairs.

The room was lit by a pair of matching sash windows, each having twelve panes, in 2½" bead-edged frames. It is interesting to note that the openings did not match, as the southern window occupied a flared opening.

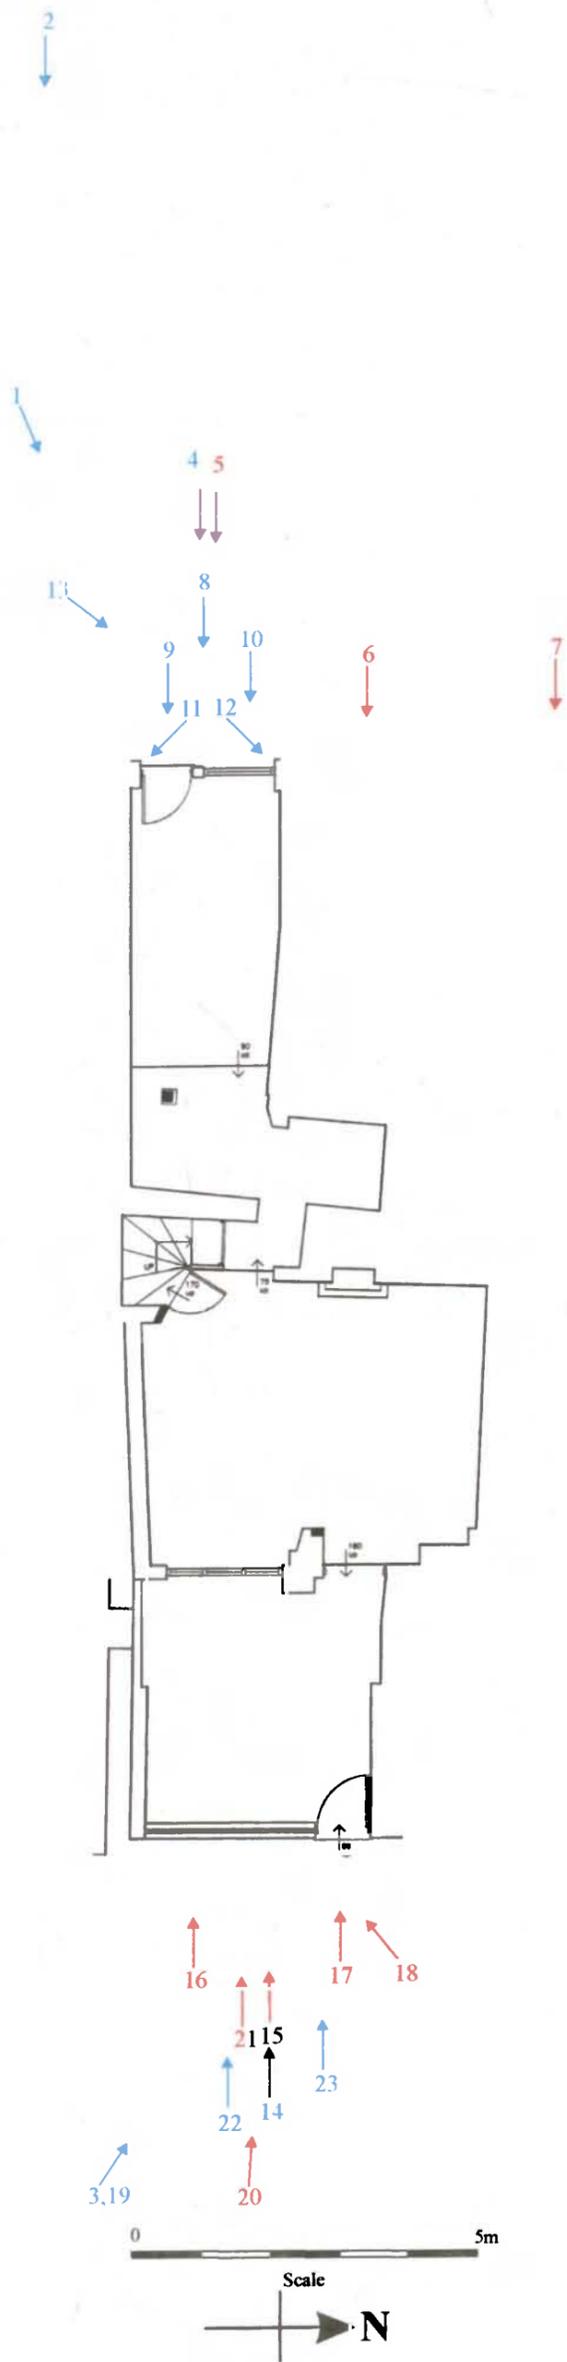
Plan showing the locations and directions of exterior photographs used in this report.
Scale 1:100
(Plan supplied by client)

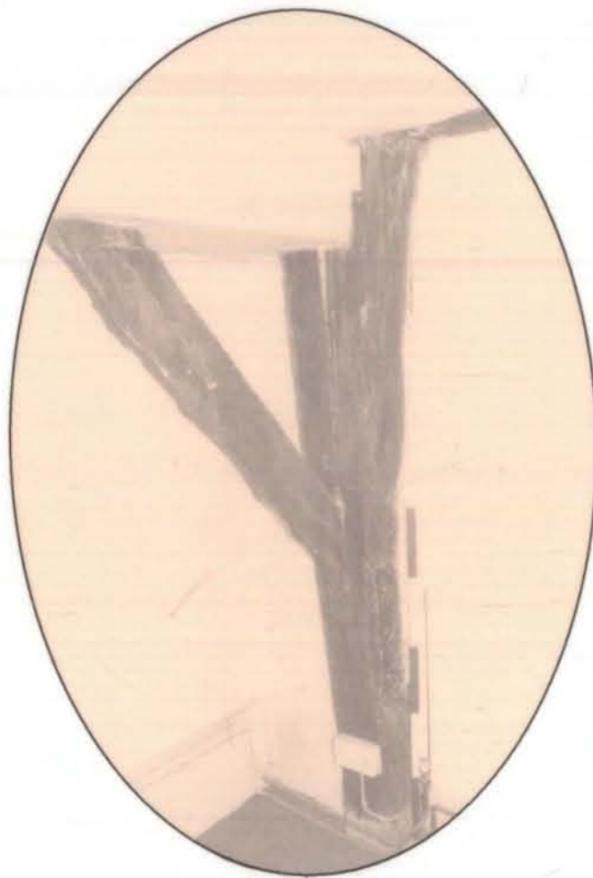
Back Cover Photograph: Detail of the timber post with diagonal brace on the first floor of the building.
