**HISTORIC BUILDING RECORDING OF  
BARNs AT  
BOUGHTON HOUSE FARM,  
ASGARBY,  
SLEAFORD,  
LINCOLNSHIRE  
(ABH05)**

Work Undertaken For  
Steve Dunn Architects Ltd

March 2005

A.P.S. Report No. 41/05

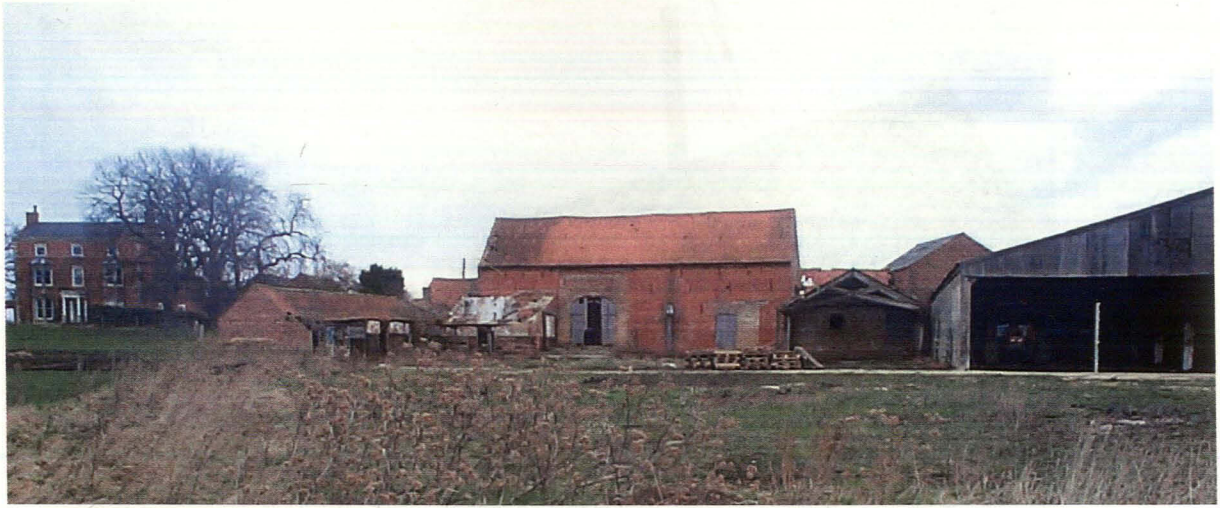
Plate 1 General view of barns, including Boughton House at left, looking north

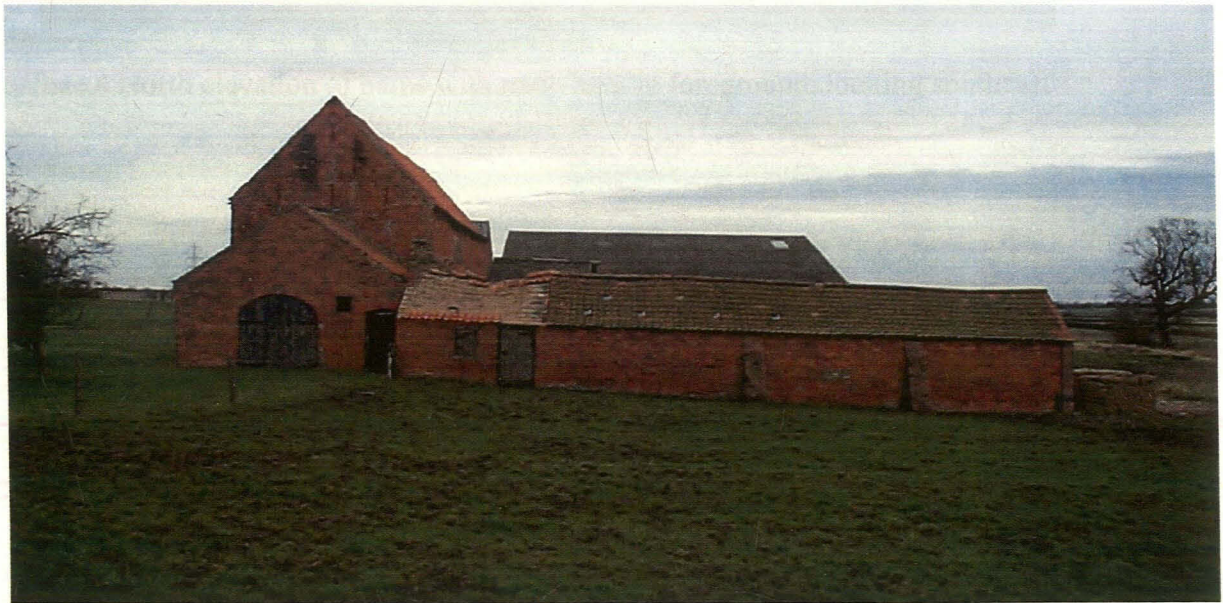
Plate 2 West elevation of buildings including main barn and sheds at left and north-south range at centre and right, looking east

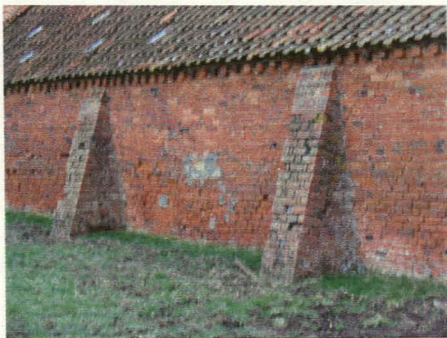
Plate 3 Detail of west elevation of north-south range of buildings showing buttresses and dentilled eaves, looking northeast

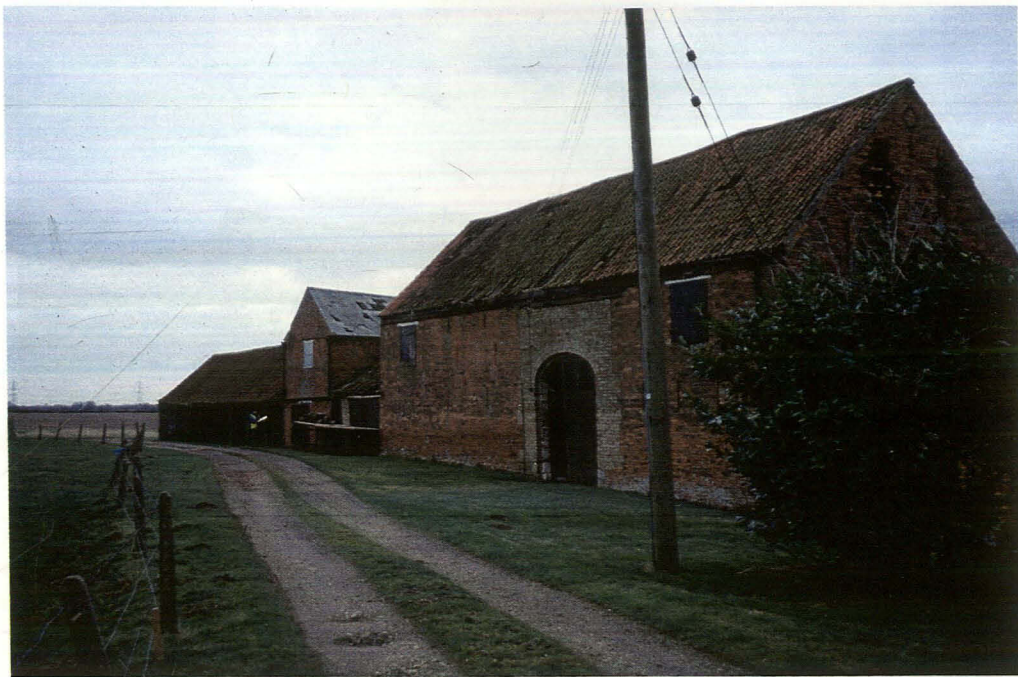
Plate 4 North elevation of barns with main barn in foreground, looking southeast

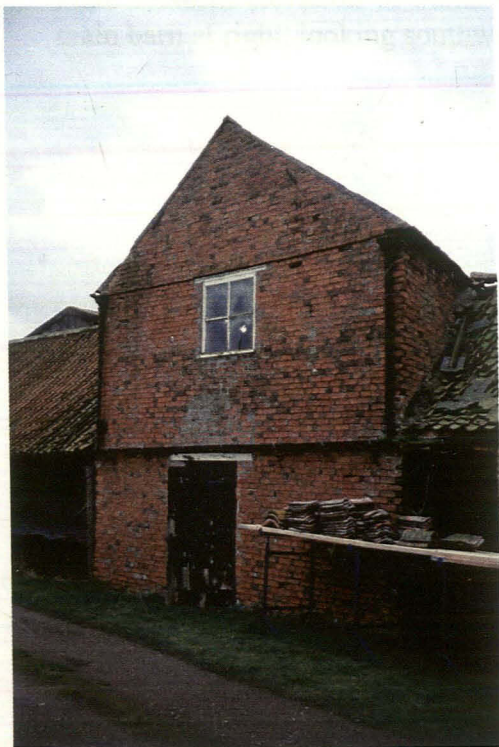
Plate 5 Two-storey northwest-southeast angled range, north elevation, looking southeast

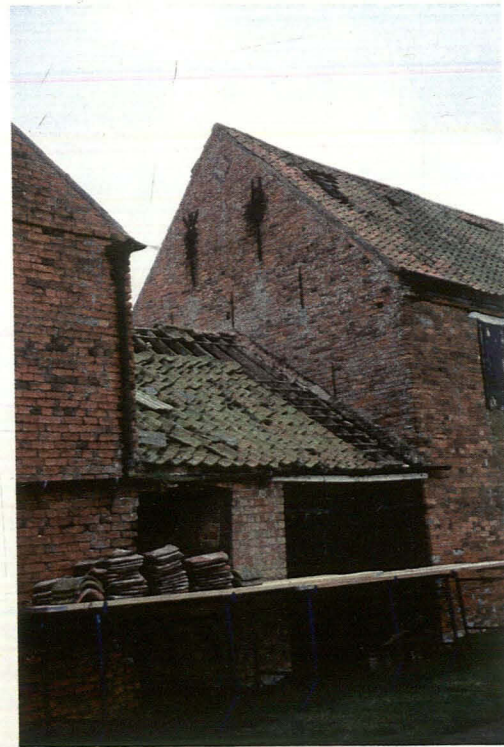
Plate 6 single storey covered passageway and garage, north elevation, and east elevation of main barn with initials 'W H' formed by stay plates, looking southwest

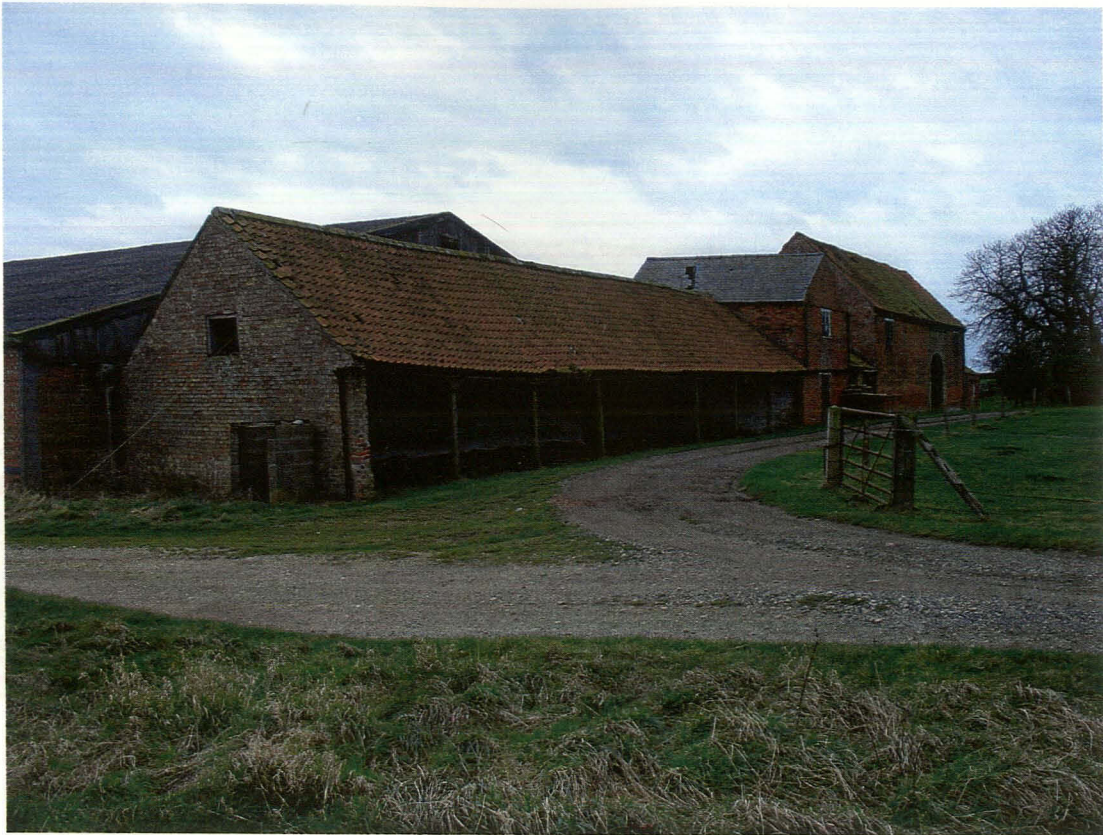
Plate 7 North elevation of barns with east elevation of cart/shelter shed at left and main barn at right, looking southwest

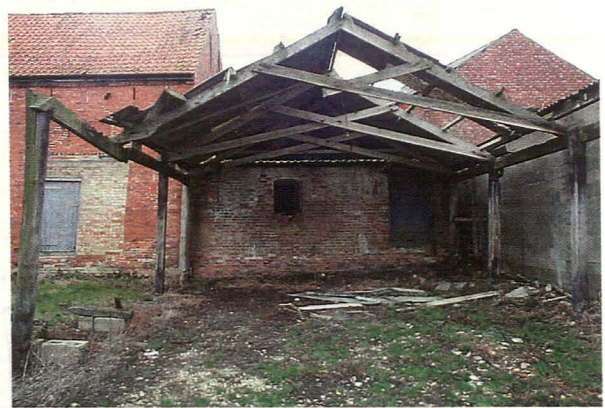
Plate 11 Open-sided shelter forming part of yard covering, blocked doorway in south elevation of main barn at left, window to garage at the centre and door of single storey roofed passageway at right, looking north

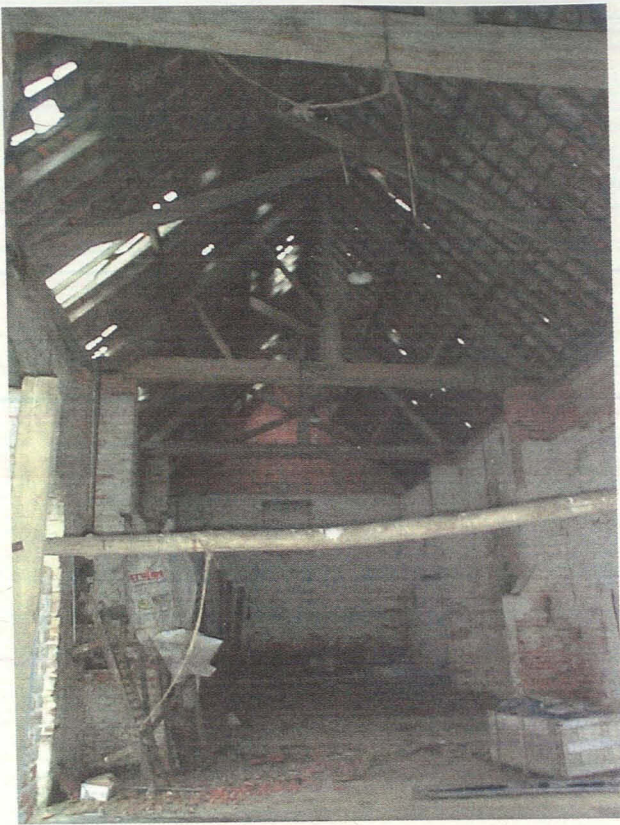
Plate 12 Interior of main barn, looking east

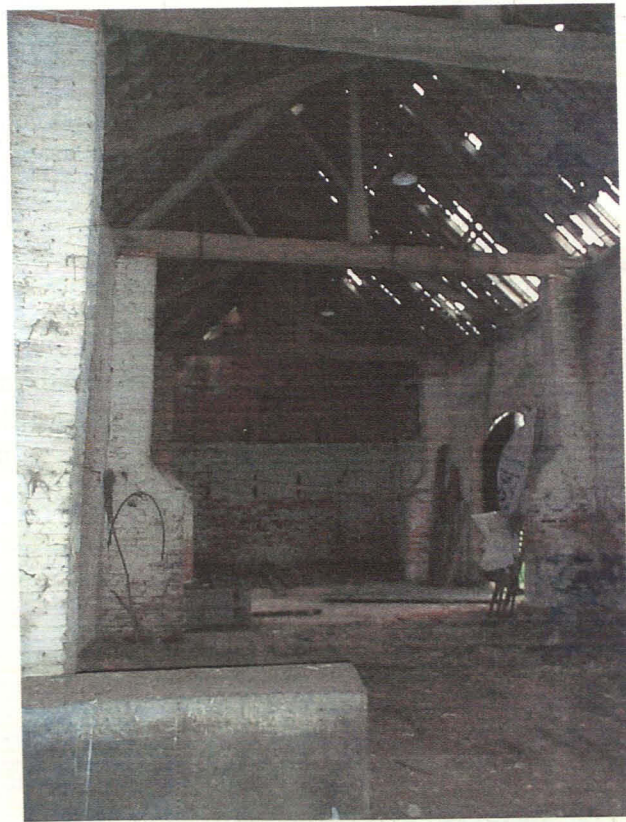
Plate 13 Interior of main barn, looking west

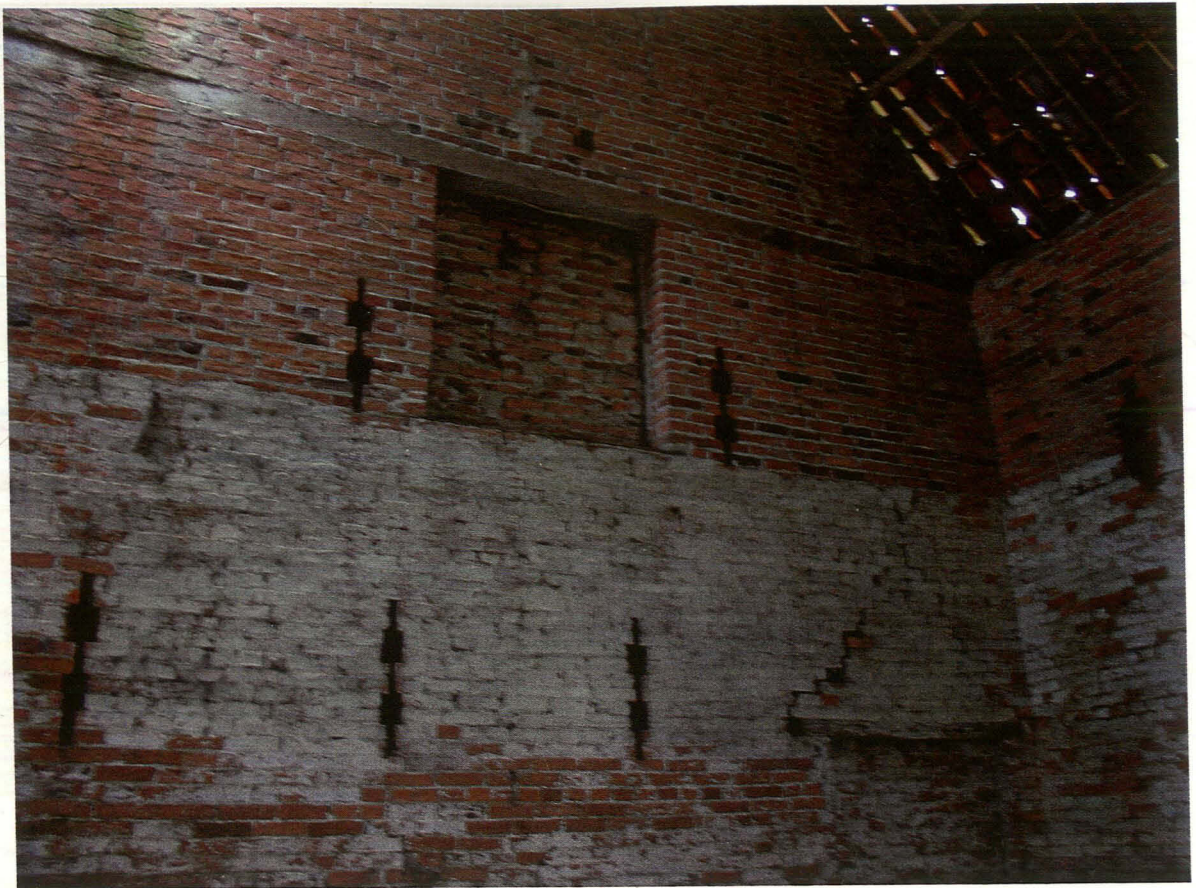
Plate 14 Interior of main barn, east facing elevation, west wall, showing breather slits, blocked window or pitching hole and blocked doorway, looking northwest

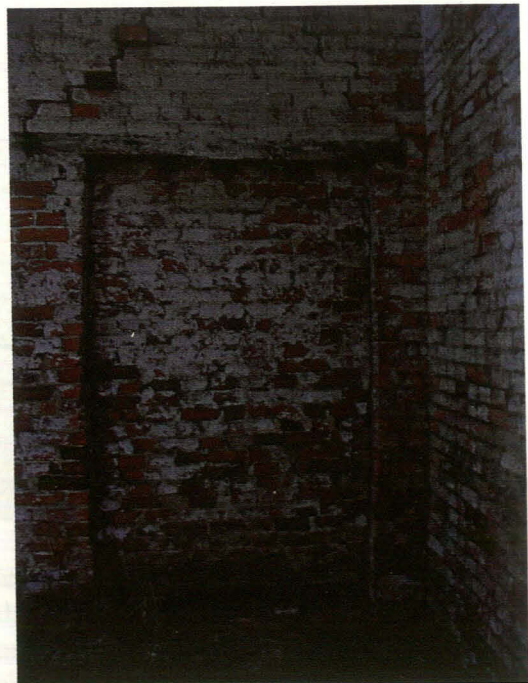
Plate 15 Interior of main barn, detail of east facing elevation, west wall, showing blocked doorway, looking west

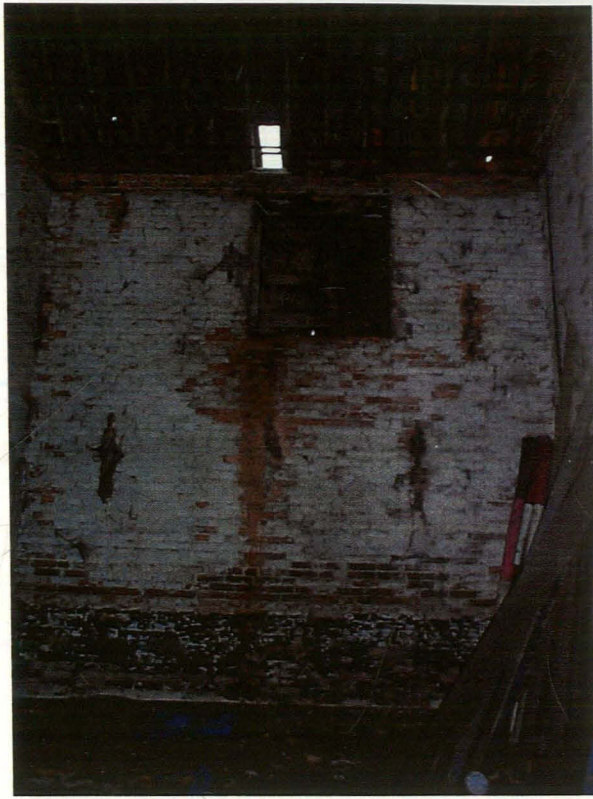
Plate 16 Interior of main barn, east end, south facing elevation, north wall, including shuttered window or pitching hole and breather slits blocked with sacking, looking north

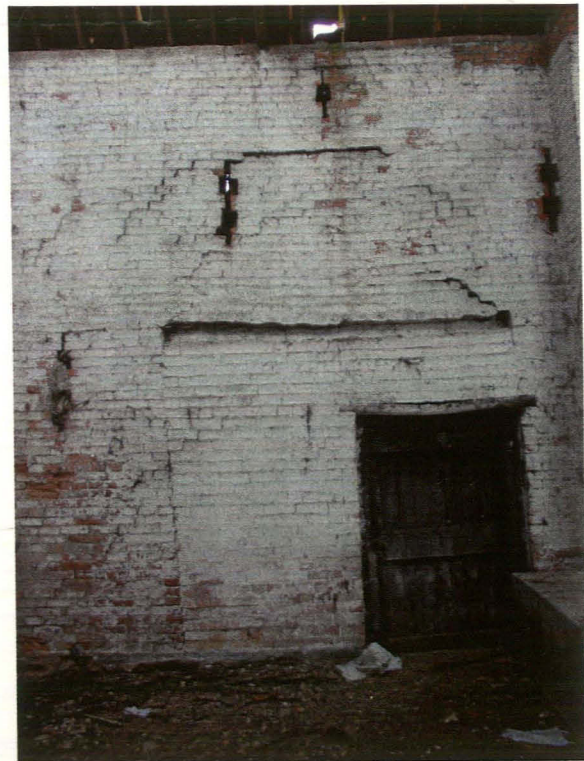
Plate 17 Interior of main barn, east end, north facing elevation (south wall) including partially blocked doorway and breather slits blocked with sacking, looking south

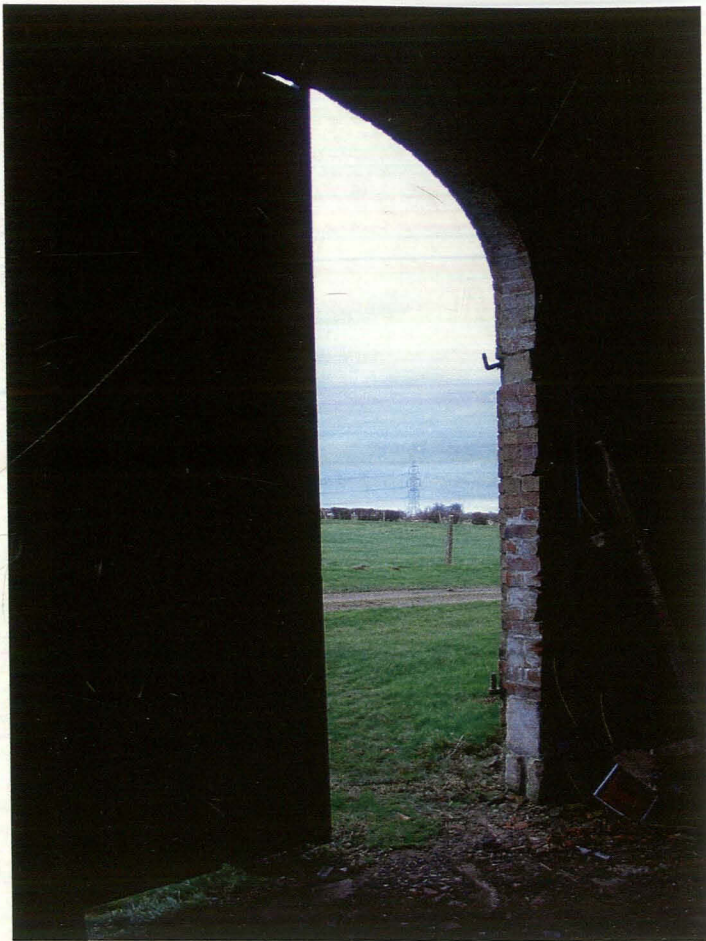
Plate 18 Interior of main barn,  
view of northern doorway  
including groove at base of door  
jamb, looking northeast

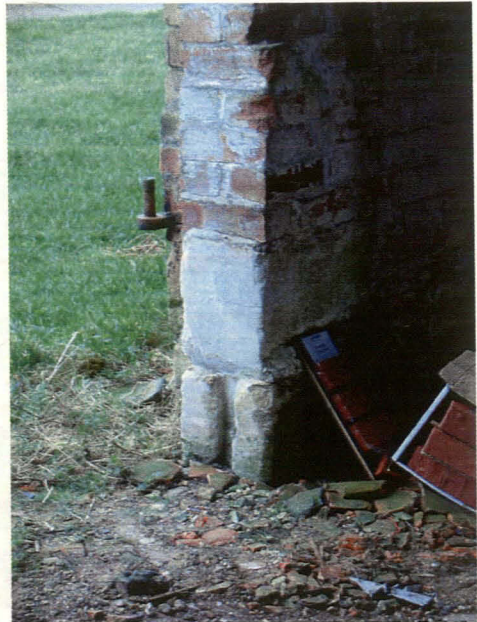
Plate 19 Interior of main barn, detail  
of east side of northern doorway,  
groove at base of door jamb,  
looking northeast

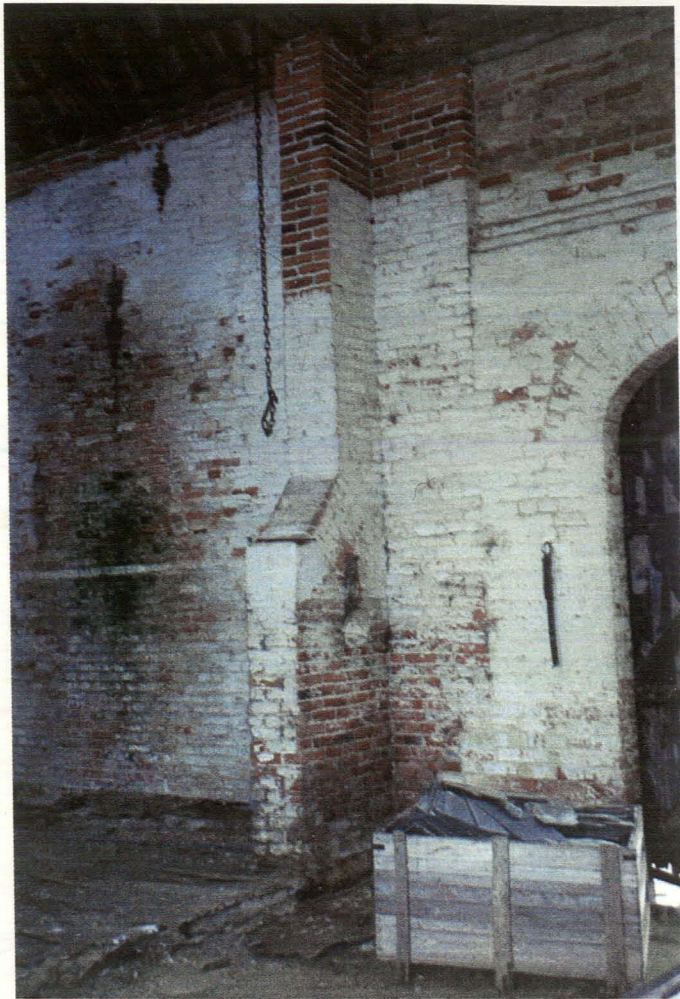
Plate 20 Interior of main barn detail showing infill around east side of southern doorway and plinth construction of barn, looking southeast

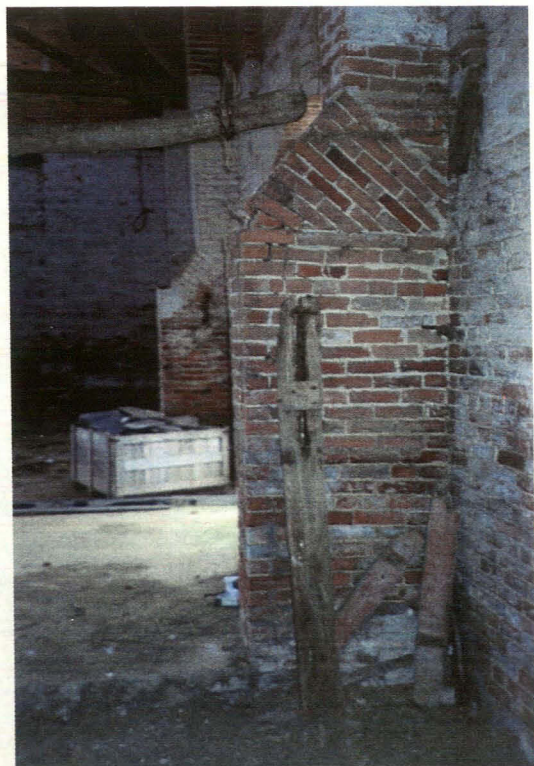
Plate 21 Interior of main barn showing plinth construction, plinth shown at west side of south door, looking east

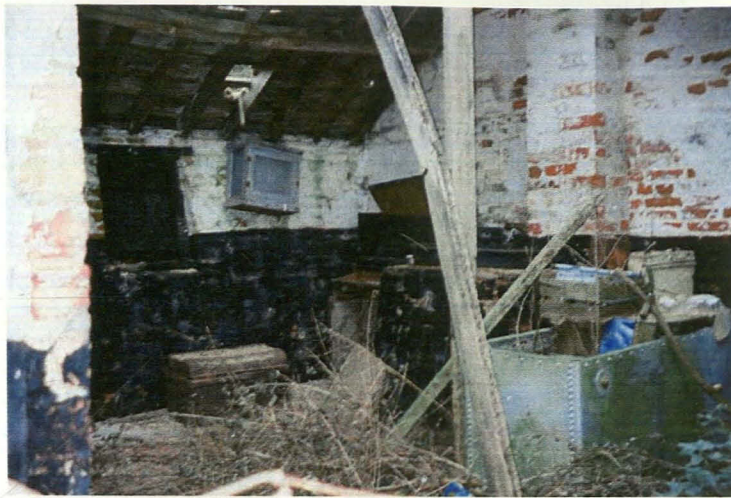
Plate 24 Interior of tack room from southern doorway, wood-shuttered window at left and brick boiler hearth built into chimney at centre, looking northwest

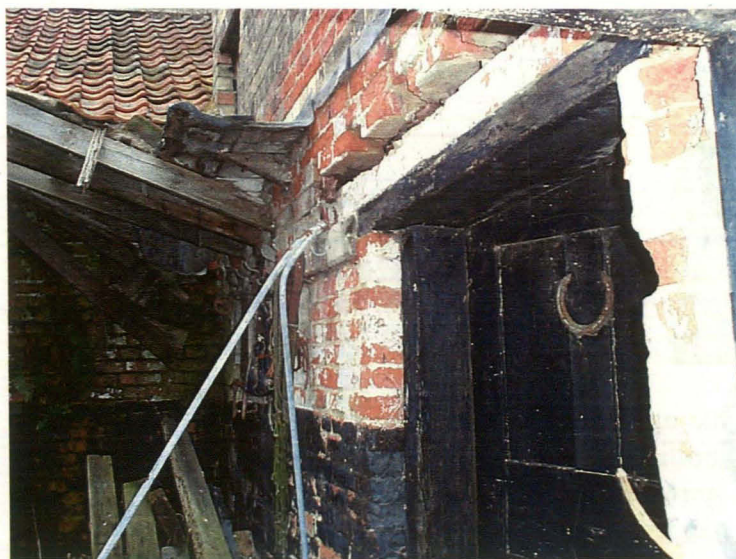
Plate 26 Interior of tack room from southern doorway, door to stables at right and peg row with tack still present at centre, looking northeast

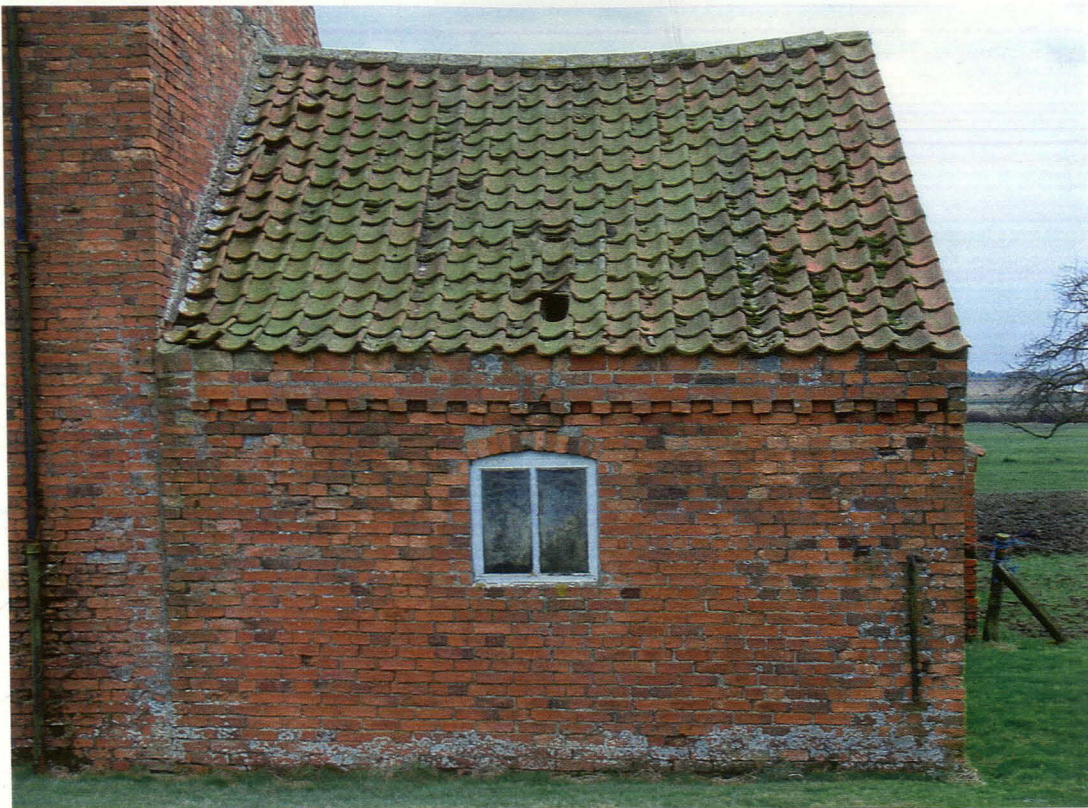
Plate 29 North elevation of probable shed addition to main barn, looking south

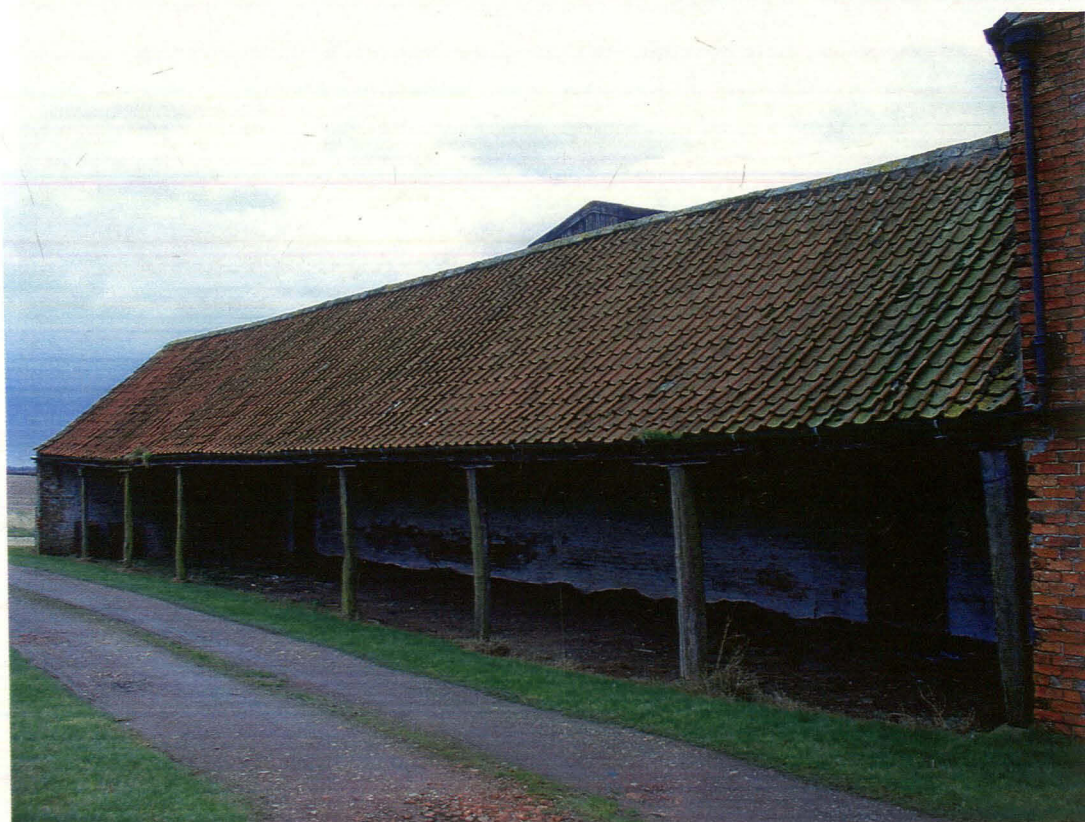
Plate 30 North elevation of shelter/cart shed at northeast corner of range, looking southeast

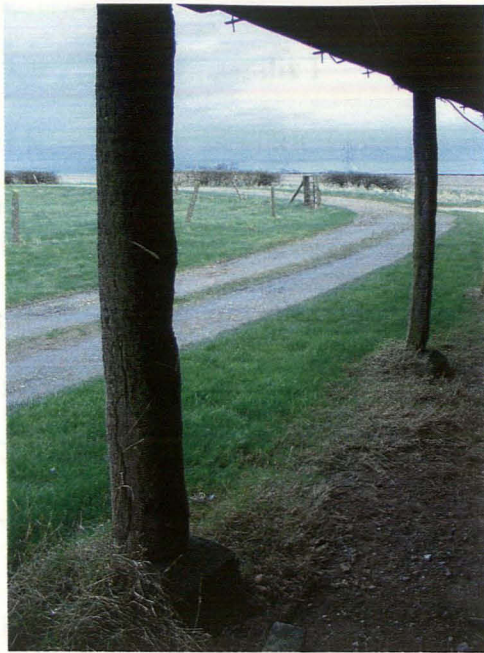
Plate 31 Shelter/cart shed at northeast corner of range,  
detail of shed construction, looking northeast
