**THE LANGTON ALMSHOUSES,
LANGTON, HORNCastle, LINCOLNSHIRE**

**STANDING BUILDING APPRAISAL
AND PHOTOGRAPHIC SURVEY**

November 2005

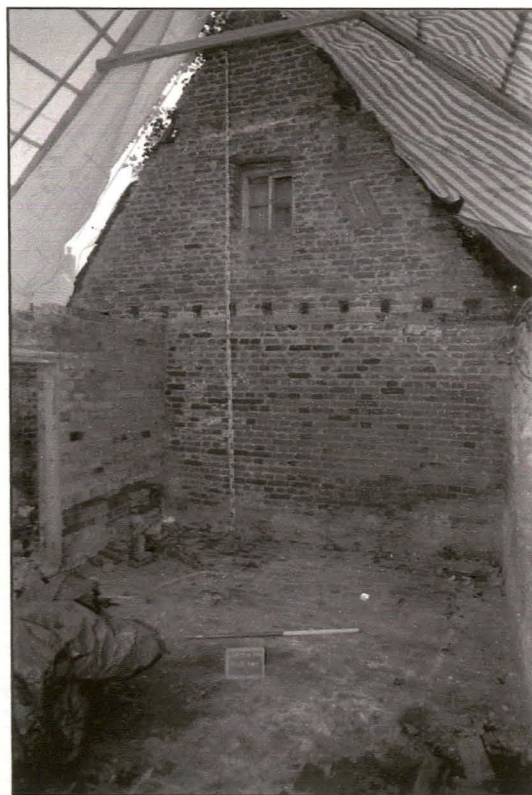
Plate 11: Interior view of the primary window in the front (South) Elevation.
