LEVEL 1 BUILDING SURVEY REPORT
WELLWOOD FARM, DIGBY FEN, LINCOLNSHIRE

Planning Reference: N/22/1515/03
NGR: TF 1250 5452
AAA Site Code: DIWF 08
LCCM Accession Number: 2008.128
Oasis reference: Allenarc1_46329

Allen Archaeological Associates
Report Number 2008/045

July 2008

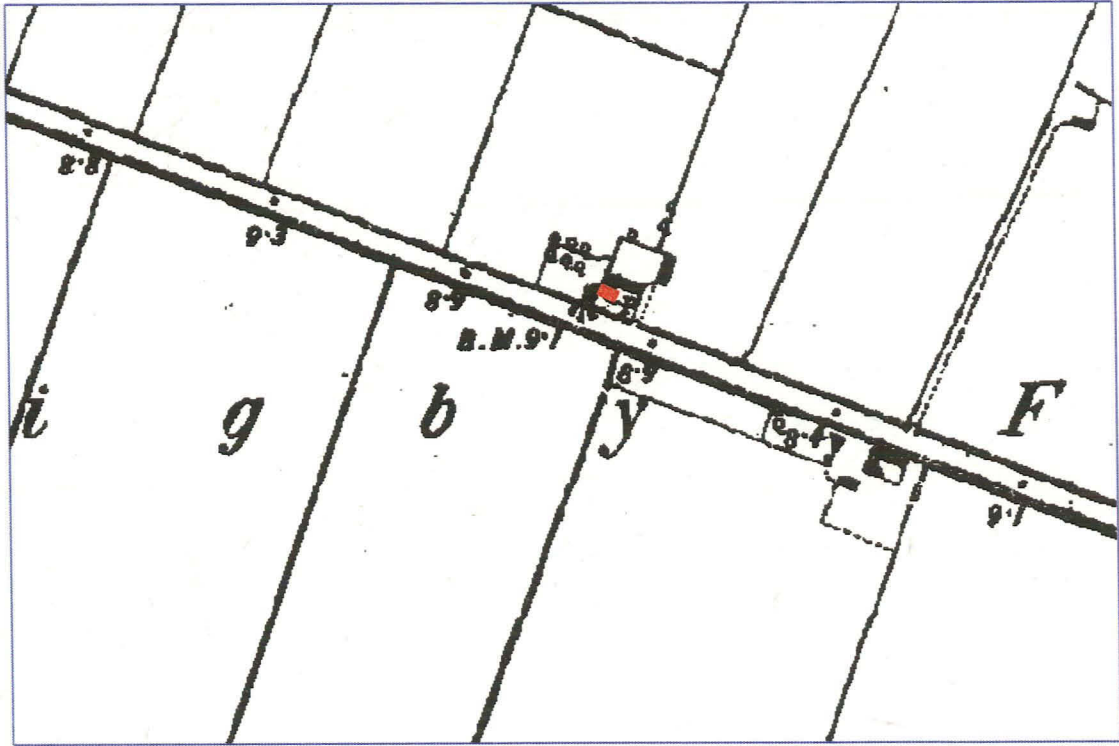
Figure 5: The Stable block shown in red on the 1891 First Edition Ordnance Survey Map (not to scale)

- 6.6 The 1891 Ordnance Survey Map (Figure 5) depicts the stable block within a complex of contemporary farm buildings, and it represents the last remaining extant structure from the 19th century phase of the farm.
- 6.7 The internal spaces of the building retain few features of historic character as a direct consequence of changes in the function of the building over the years. The only original internal feature of architectural significance is the chamfered brickwork of the door jambs and windows.
- 6.8 The external elevations are in a fair state of repair and despite the blocked in windows and doorway and the insertion of additional openings to the rear, the historic fabric of the building remains intact. The replacement of the roof in the 20th century is also in keeping with the 19th century vernacular tradition and does not detract from the character of the building as a whole.
