**MEASURED SURVEY AND  
ARCHAEOLOGICAL BUILDINGS  
ASSESSMENT  
7-13 BRIDGE STREET  
HORNCastle**

SITE CODE: HBS01

**REPORT**

February 2003

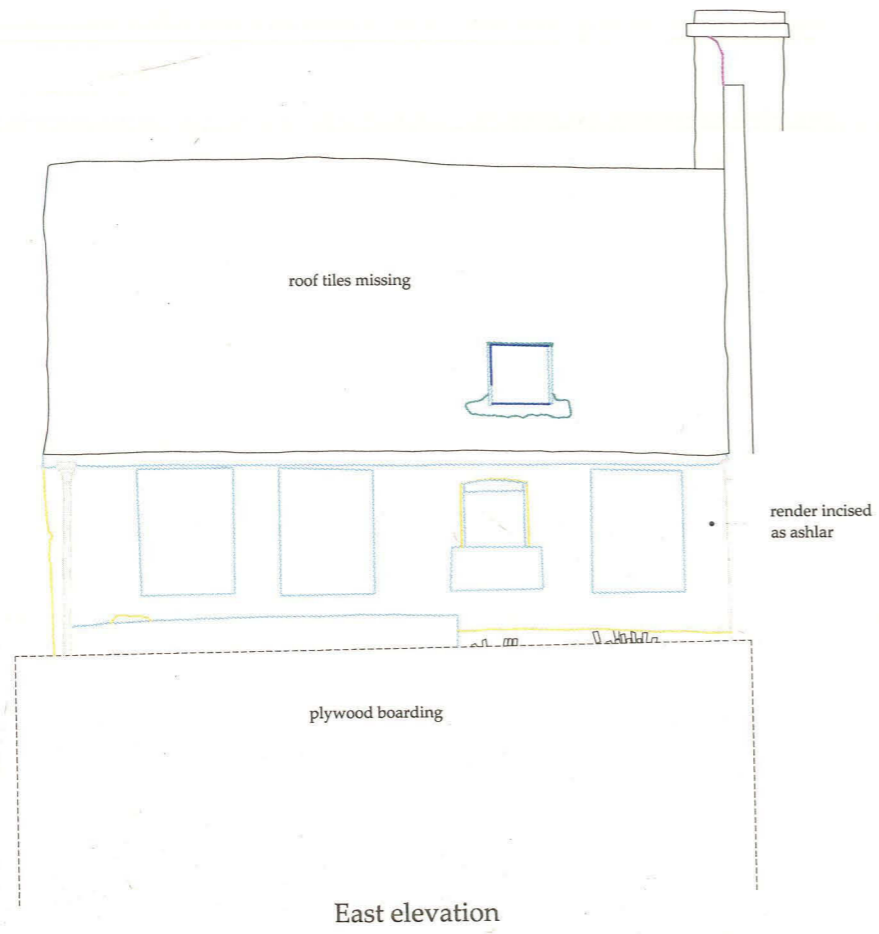
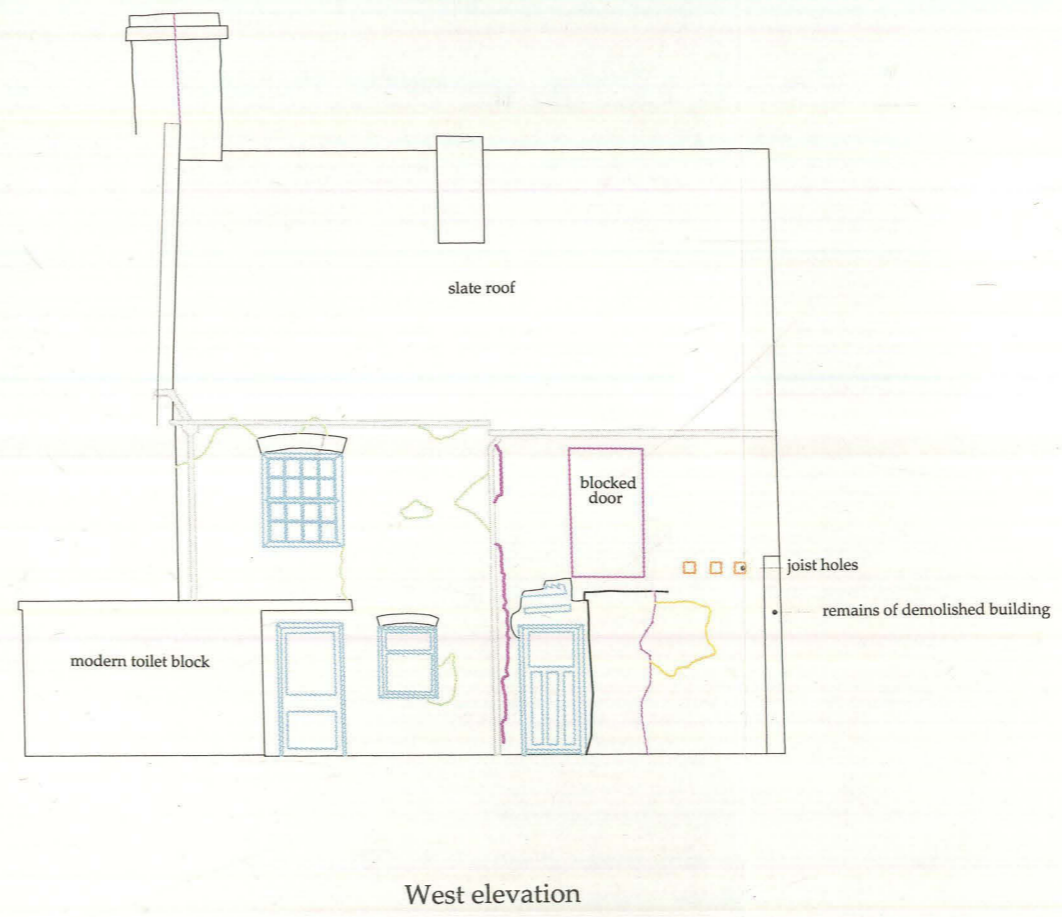
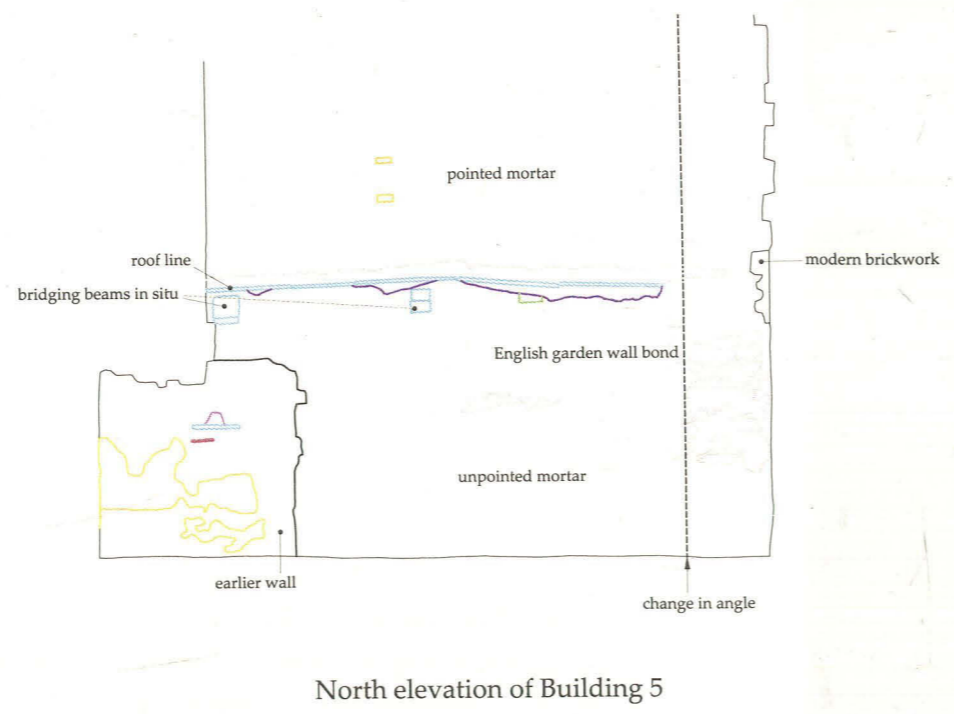
Scale 1:100 Figure 2

Elevations of 7-9 Bridge Street

The Bridge Street frontage (east elevation) is largely rendered and is concealed by plywood boarding below first-floor level (Figure 2). Internal evidence for the arrangement of the ground floor highlights extensive alteration. Present openings represent 20th century interventions, including a plate glass door flanked by large single-pane windows, reflecting contemporary commercial activity on the site. Four openings are evident on the first floor, all boarded. Internally, it is apparent from the remaining frame, that these represented hung sashes under segmental brick heads, although that to the north has been completely removed and blocked with breeze blocks during recent shoring work. At attic level, there is a single inserted dormer window to the north, with six-pane sliding sashes.

To the rear of the property (west elevation), the ground floor is pierced by two doorways, that to the north leading into the commercial area, and that to the south providing access to the upper levels (Figure 3). Between the two doorways is a late 20th century window, within an earlier opening. Further division is provided by an open straight joint which runs up the entire elevation dividing Numbers 7 and 9. This joint marks a small change in wall alignment, and thus while the external junction is packed with mortar, the internal joint is left hungry at first-floor level. A second break can be found at the northern extreme of the elevation, above the 20th century extension, marking the junction between Numbers 9 and 11.

At first-floor level, there is a single window above the north doorway. In style it mirrors those at the front of the property, being of sixteen-pane hung sash type. There is a further opening above the south door, which has since been blocked with brick and is only visible externally as a series of straight joints and a timber lintel. The height of the opening suggests a doorway rather than window and may link the building to a second construction to the west, no longer in extant. Further evidence for this building is found along the north gable wall of Number 5 Bridge Street (Figure 2). The lower part of the elevation includes a single roofline, below which are large areas of mortar and render and a series of exposed bridging beams to suggest further extension. This is reinforced by the rear wall of Number 7, where the whitewash terminates in a vertical line and a line of joist holes have been packed with tile. There is also a small brick stub keyed into the south gable of Number 7 which represents part of the demolished structure.

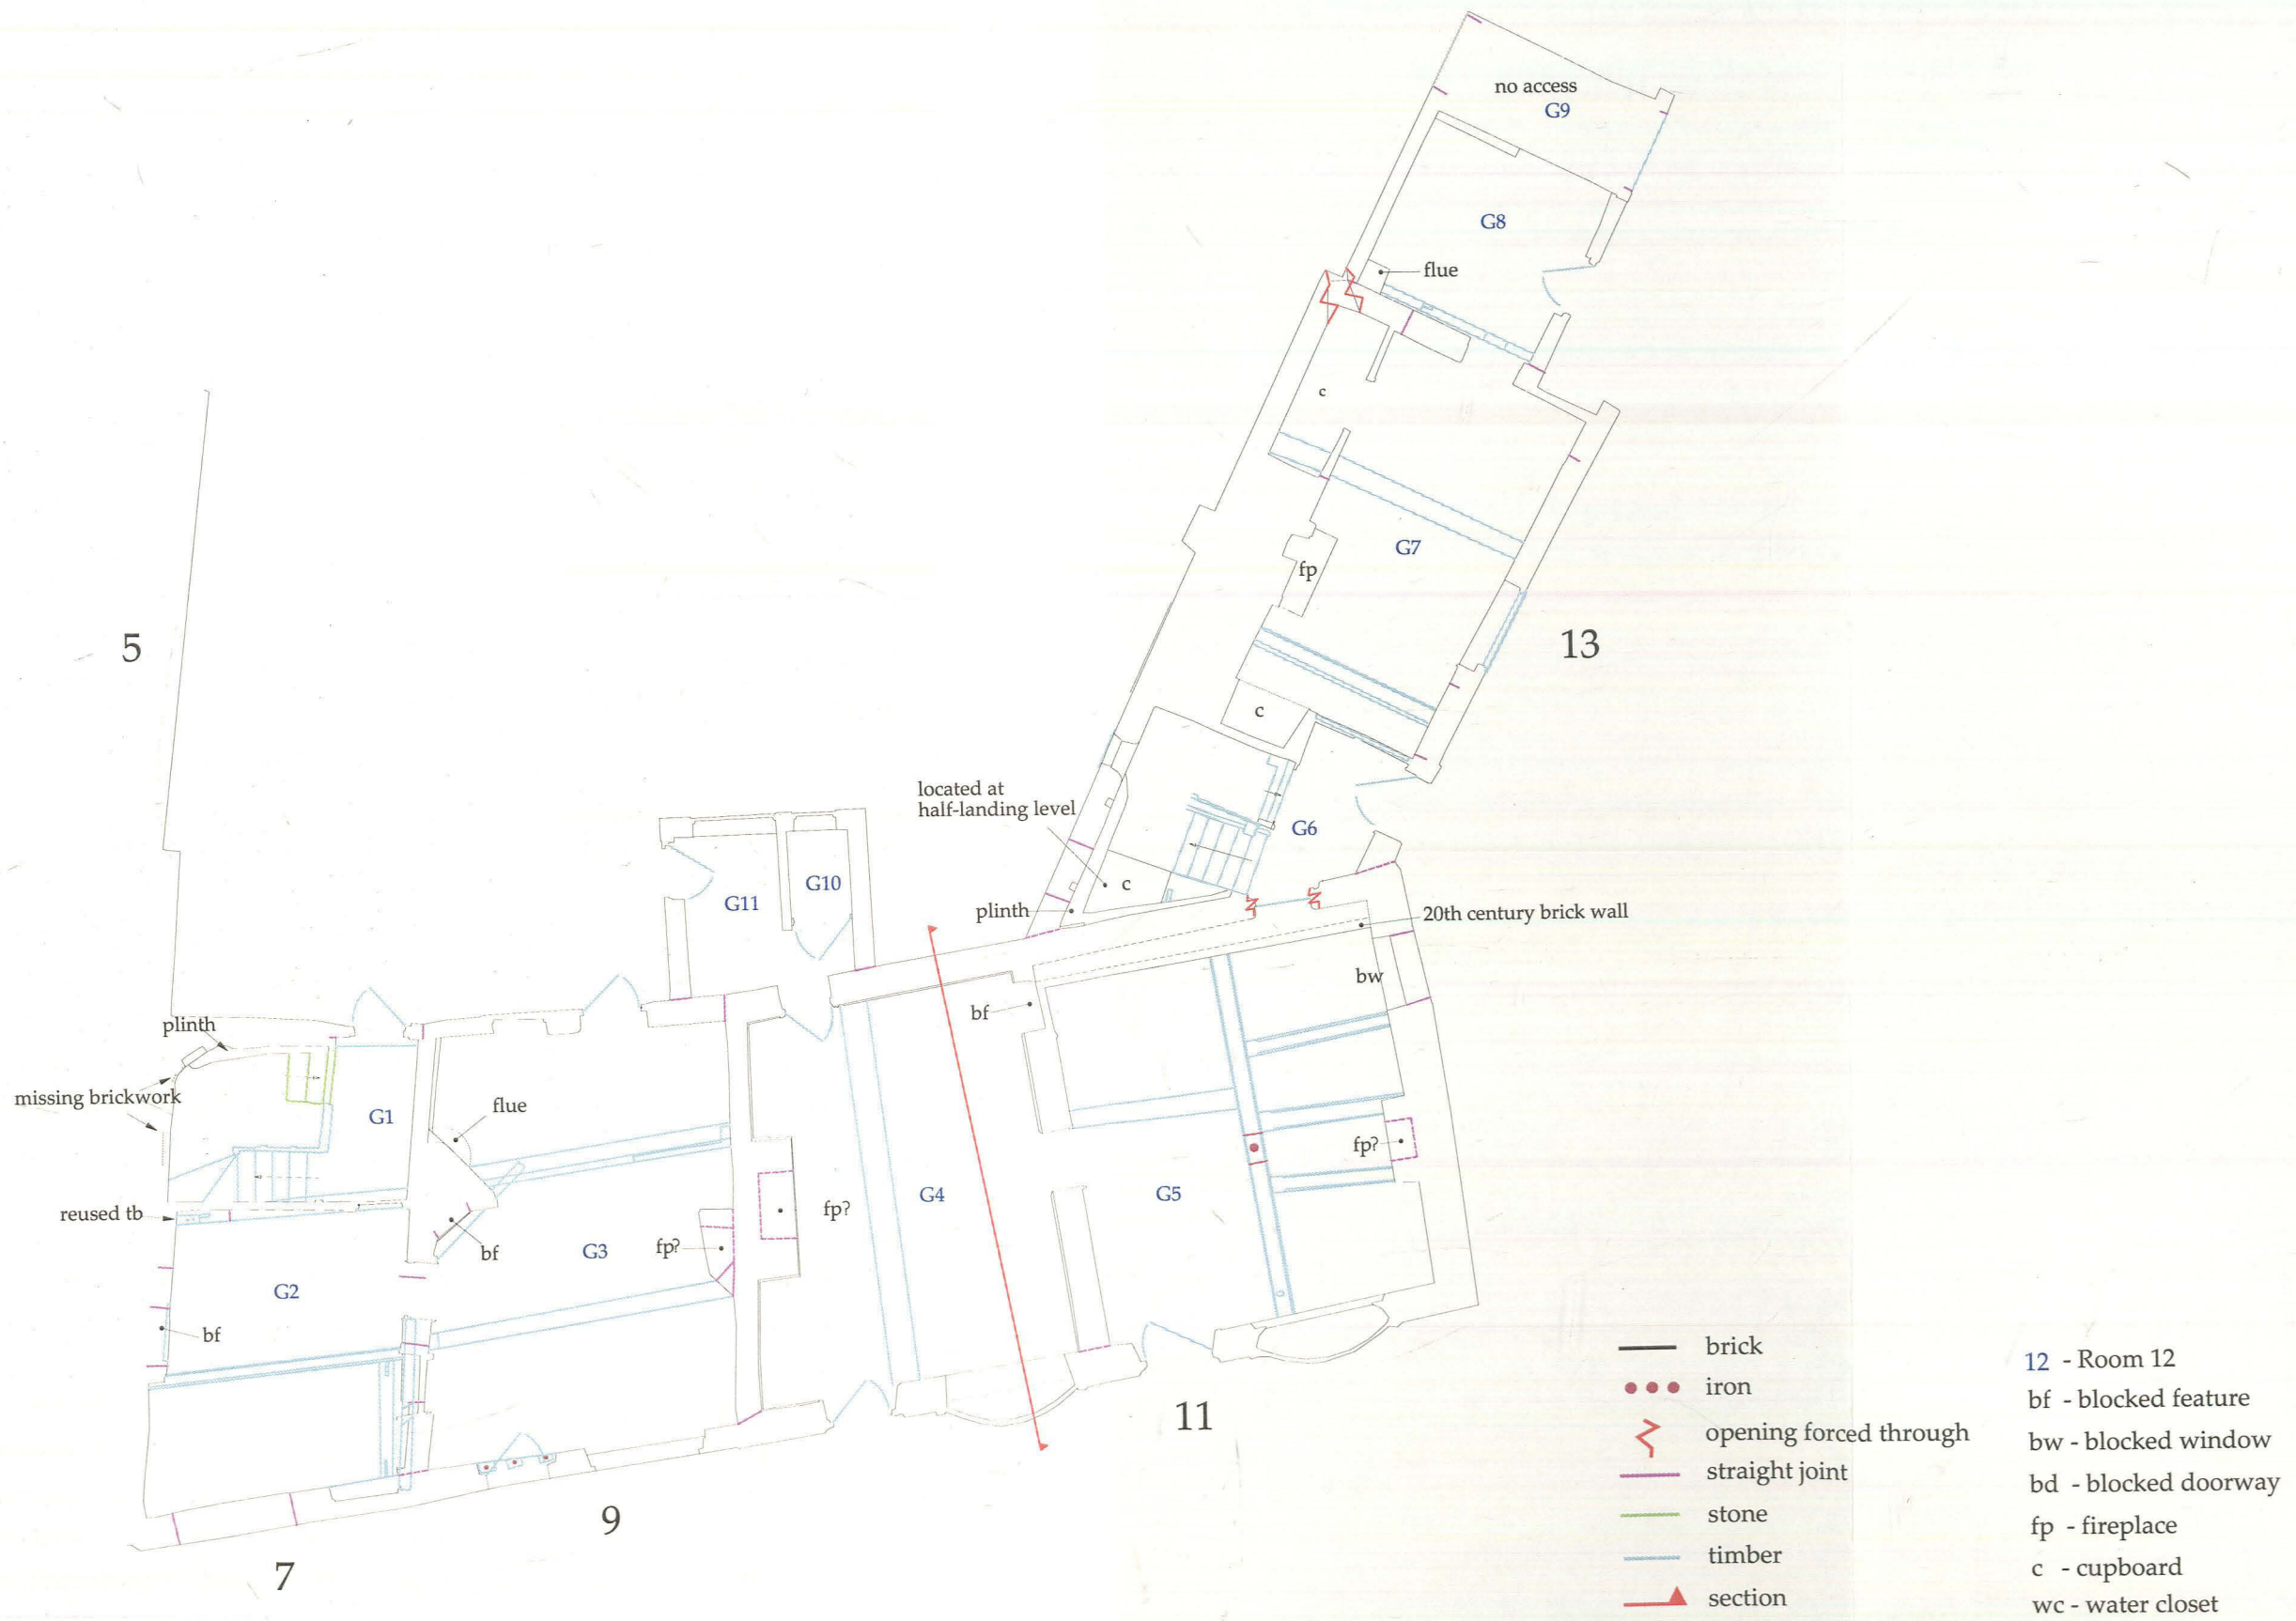
Figure 3

The ground floor is divided into three distinct rooms (Figure 3). Room G3 extends the full length of the building and has both front and rear access. Along the north wall a chimney stack has been constructed abutting the earlier chimney in the gable wall of Number 11, and possibly sharing its flue. Although the straight joint for the addition is visible on the east, it could not be detected on the west. Similarly, only the eastern side of the blocking in the fireplace is visible. To the west of this feature

Ground floor plan

is a single post which supports the north-south bridging beam. The east wall demonstrates substantial 20th century alteration. Along the south wall a second chimney is clearly visible, located at an angle. One again, any evidence of the fireplace has since been lost, but two parallel straight joints suggest its former position. Also within the south wall is a doorway connecting Rooms G3 and G2, breaking through the substantial brick partition. Above this door a single straight joint runs to the ceiling suggesting a later shift in position. Further breaks in coursing can be found to the east, below a large timber lintel which also covers an internal hatch opening which represents a later insertion. The west wall has been substantially re-decorated in the 20th century with an inserted casement window and panel door.

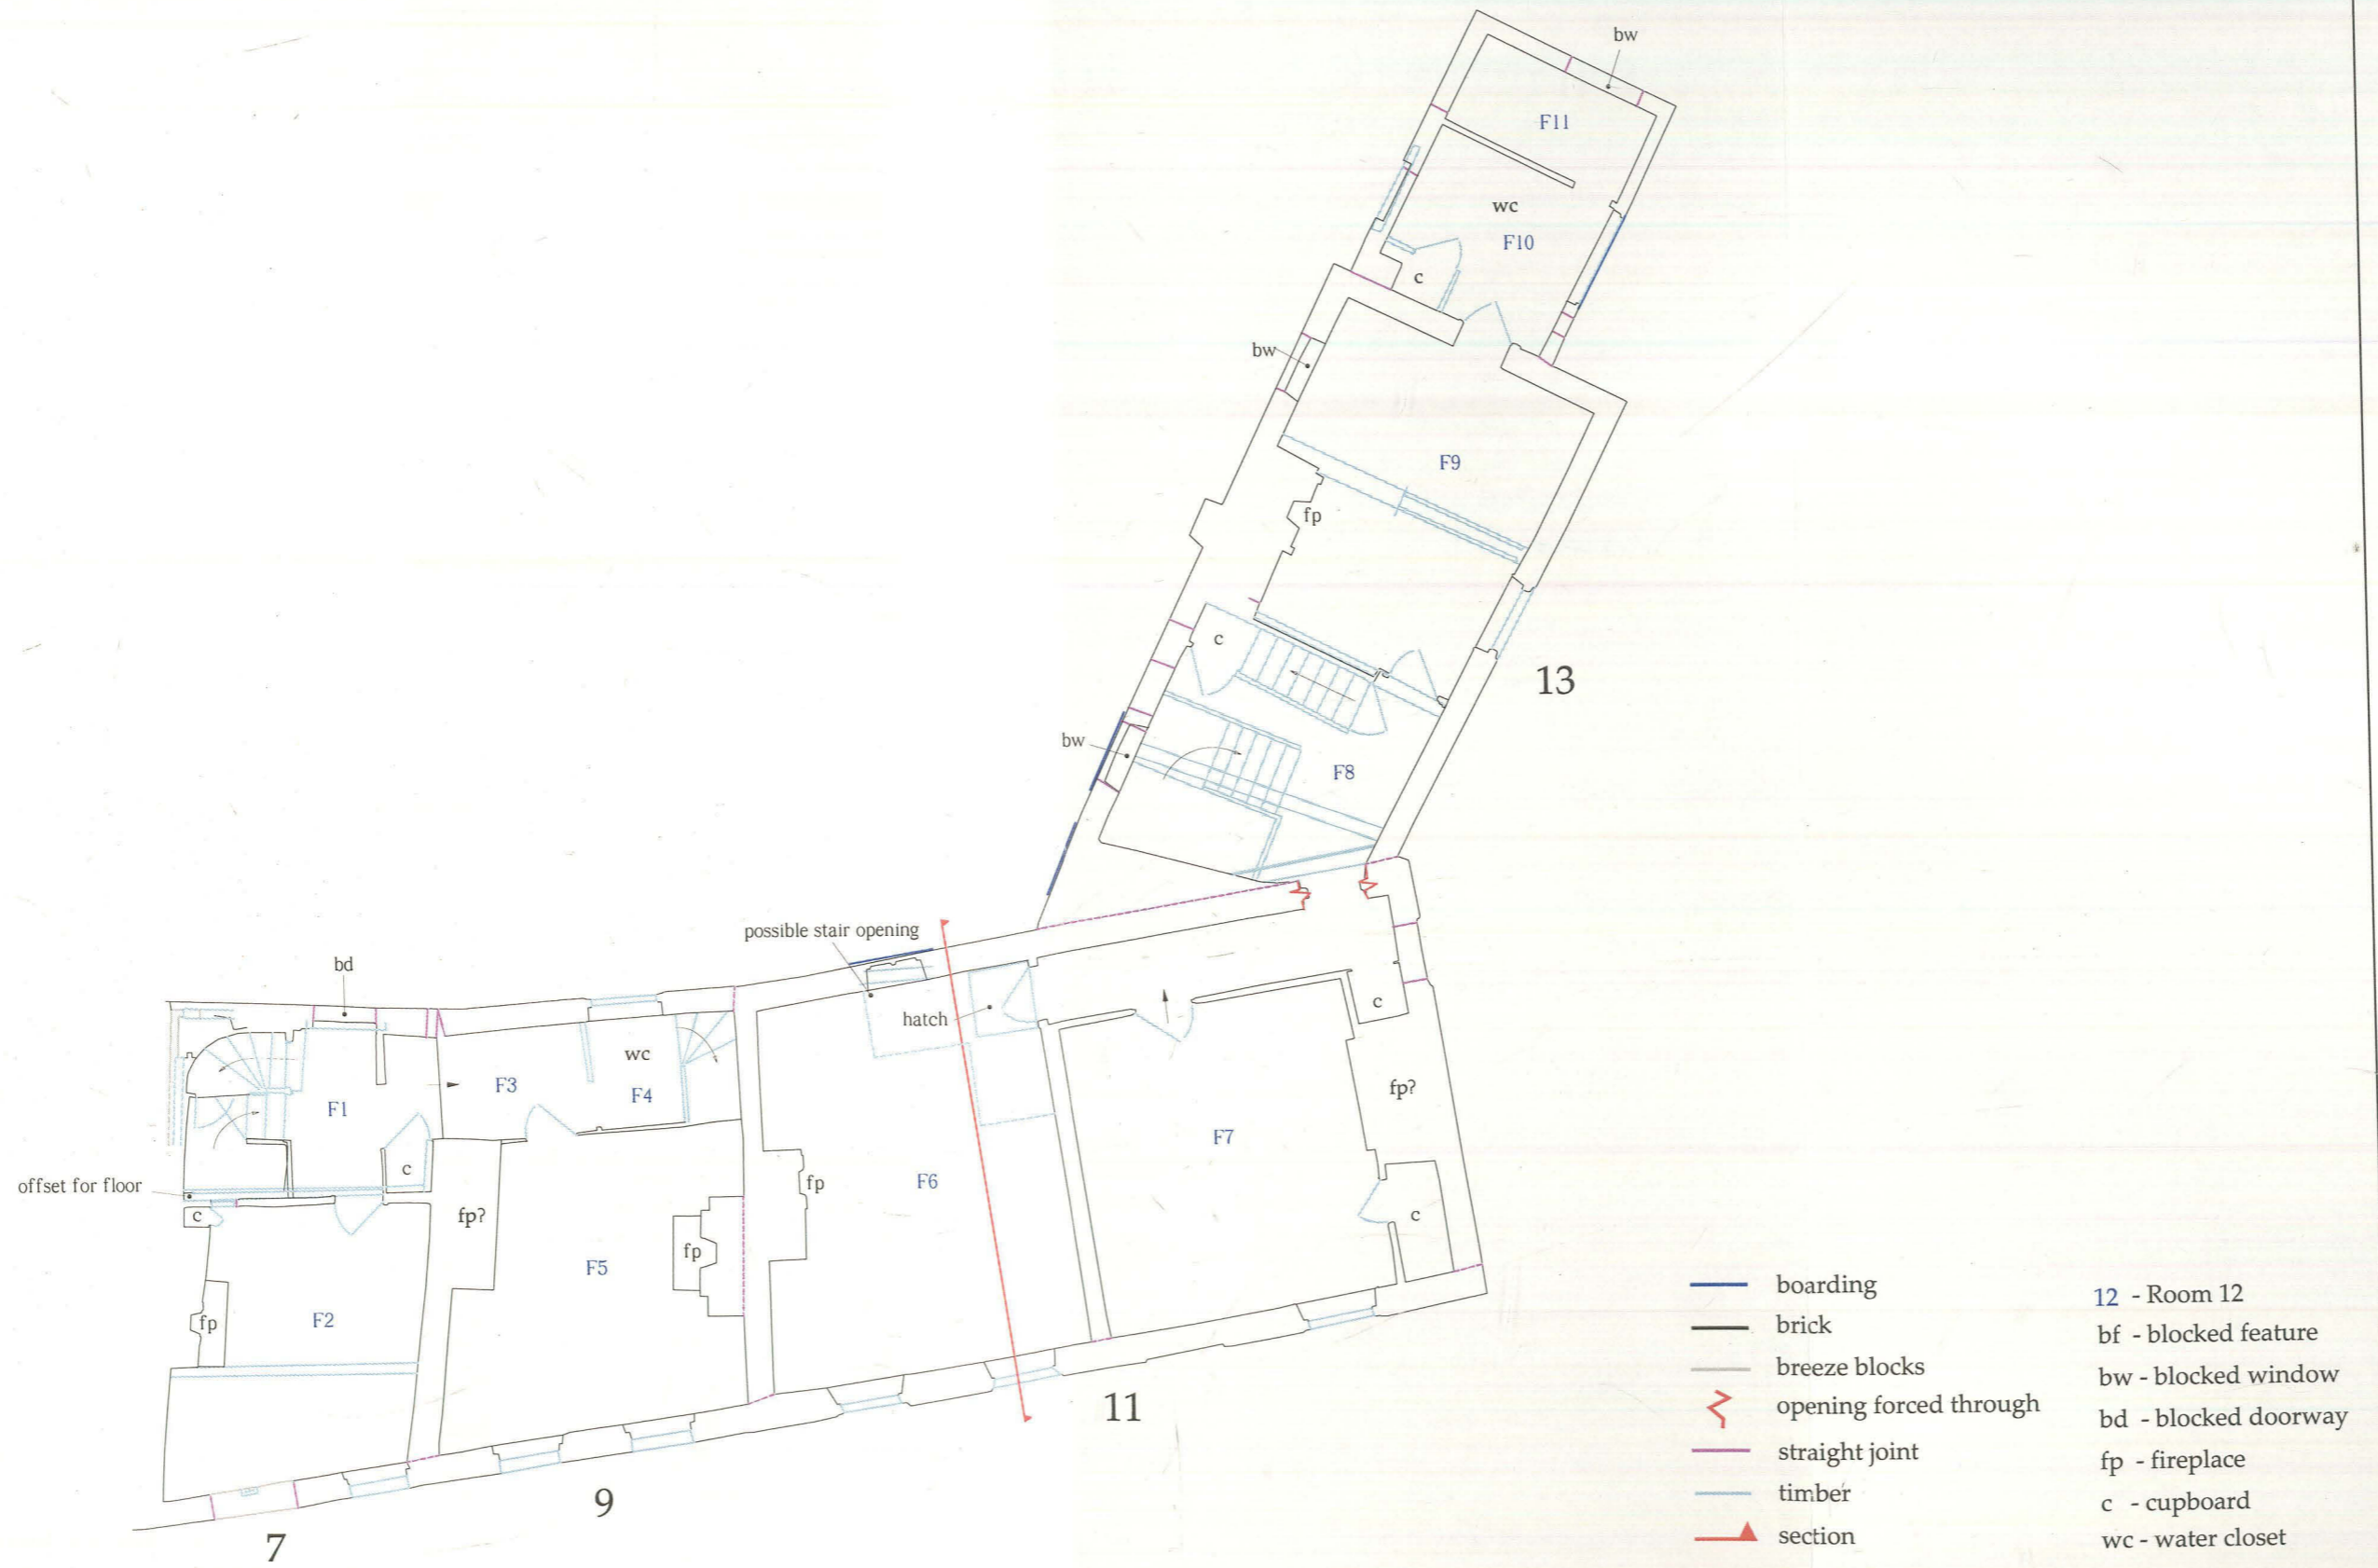
In the ceiling of Rooms F1 and 2, two bridging beams mirror the arrangement below, both chamfered. However, evidence in F5 is obscured by a later plaster ceiling. As below, this room contains two chimneys, but only one fireplace, located in the north wall and dated to the 20th century. The west wall is represented by a simple plank partition.

First floor plan

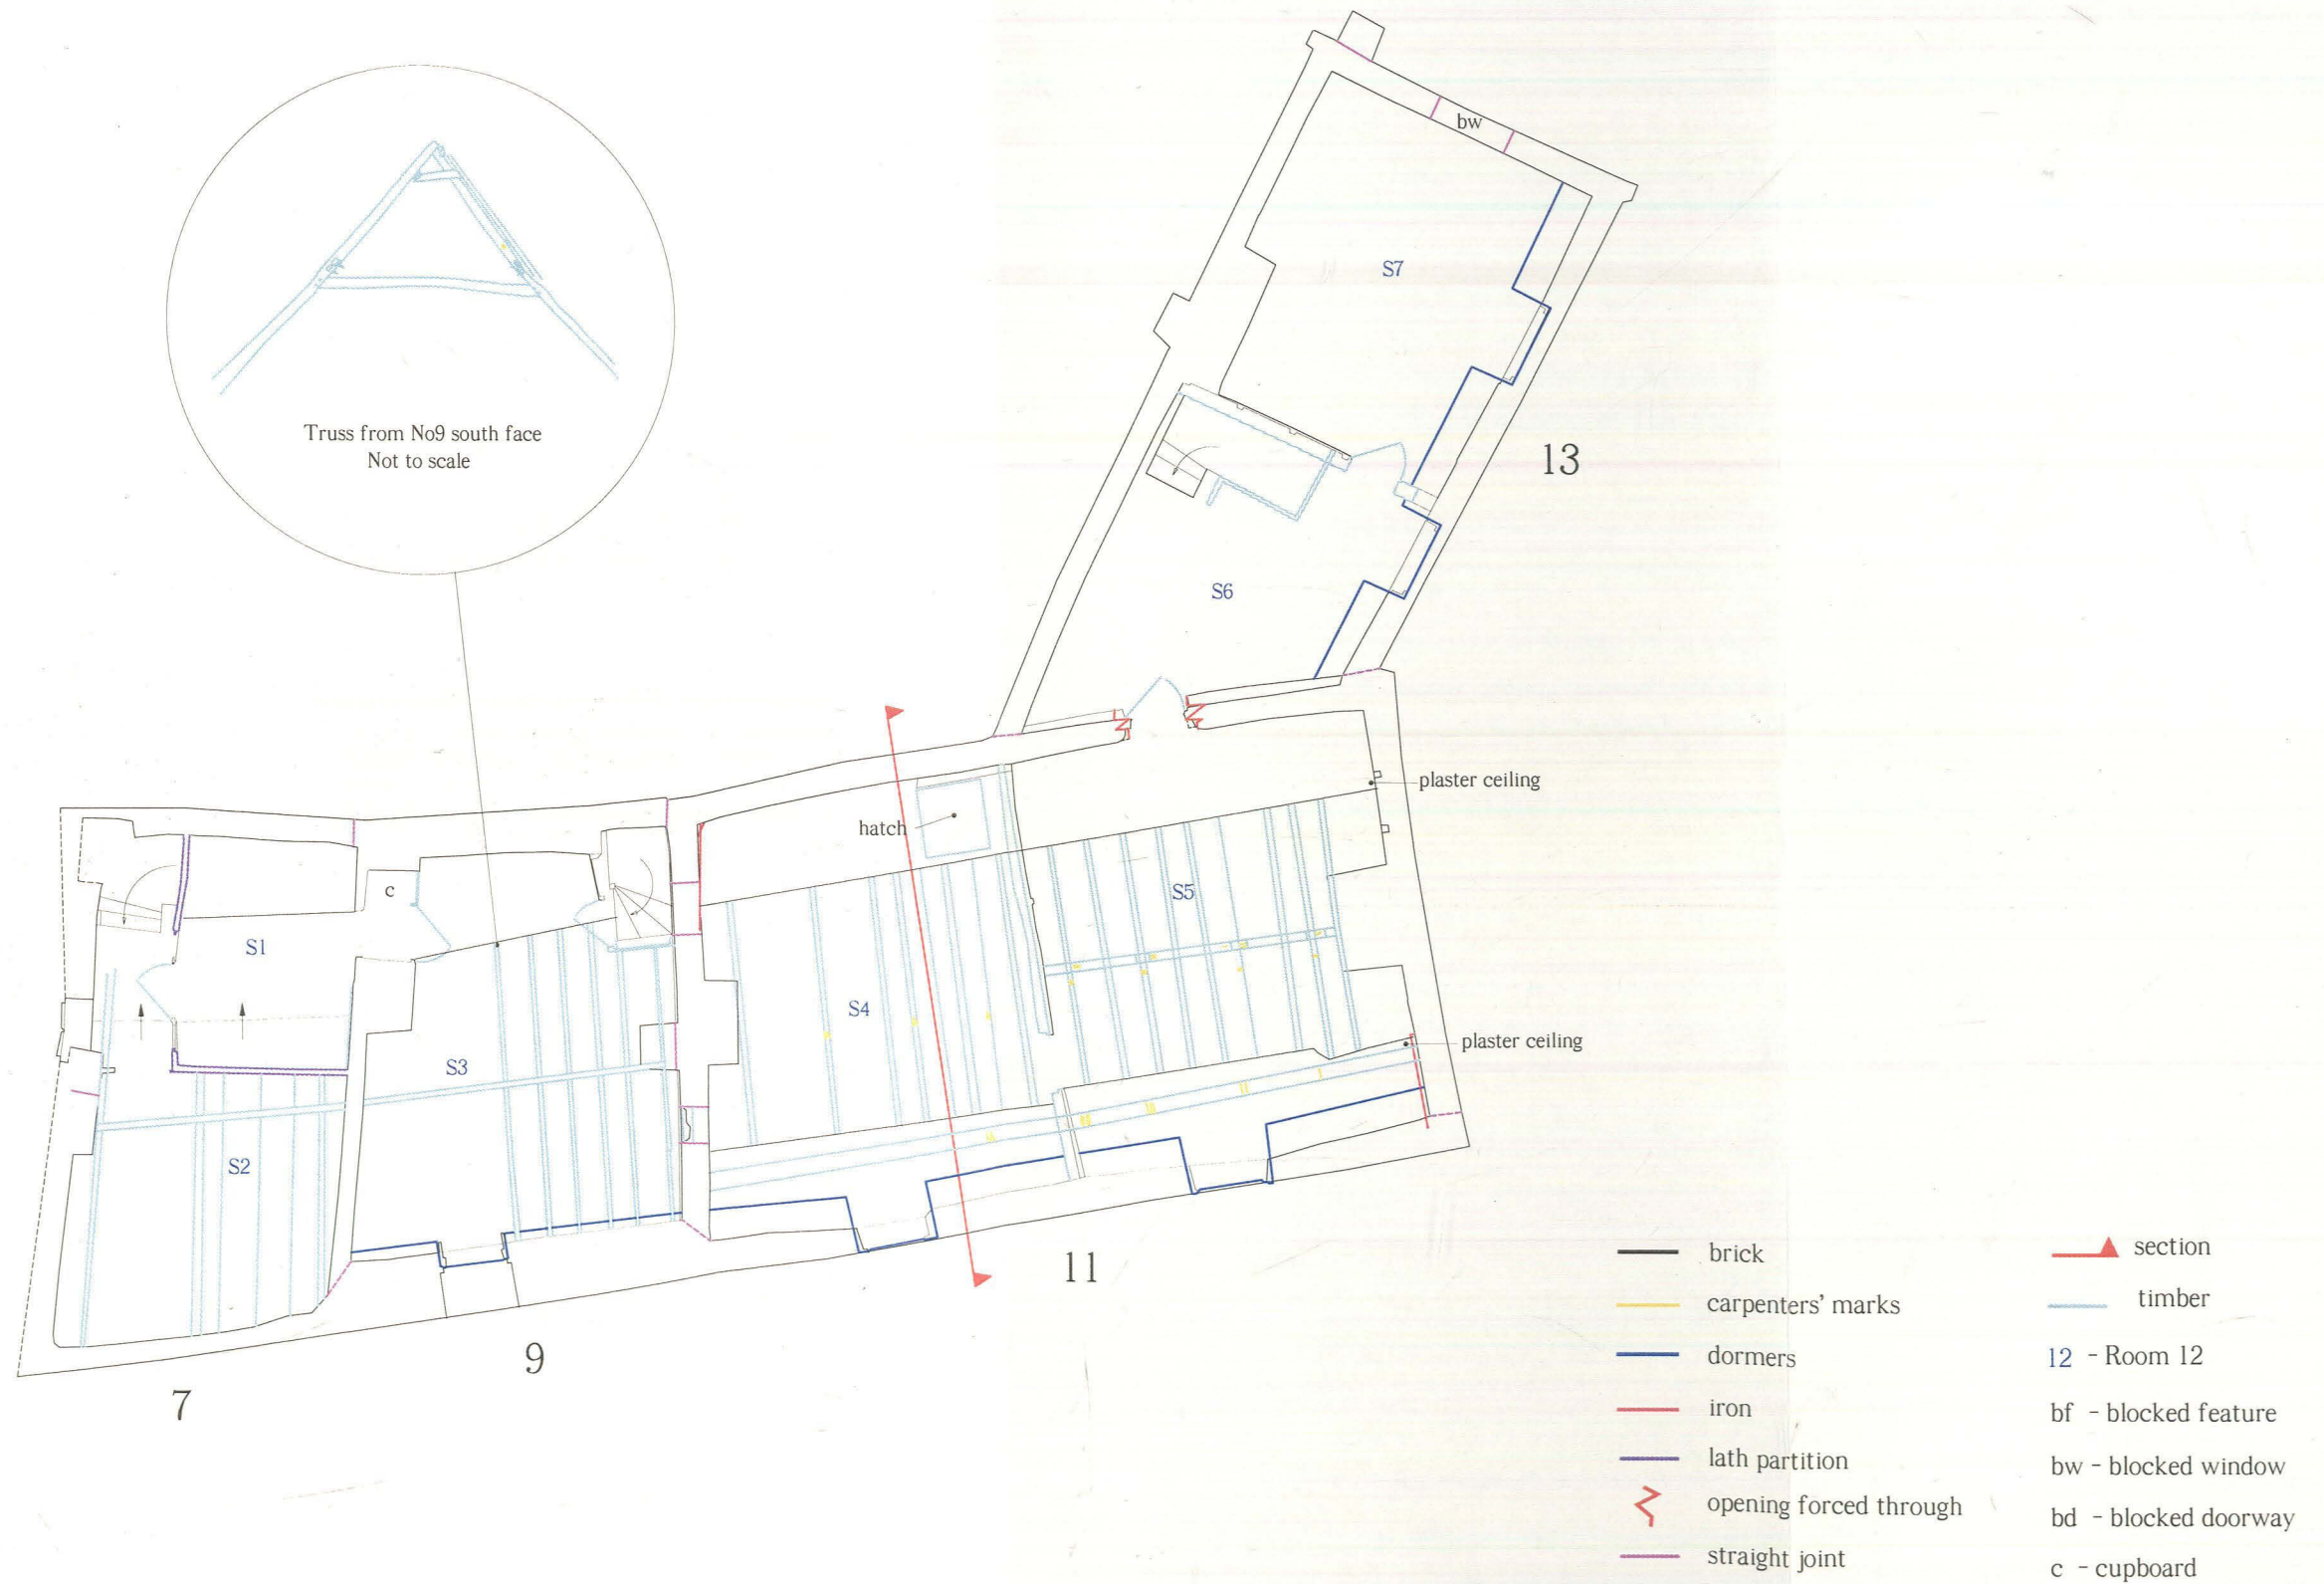
Second floor plan and roof truss form

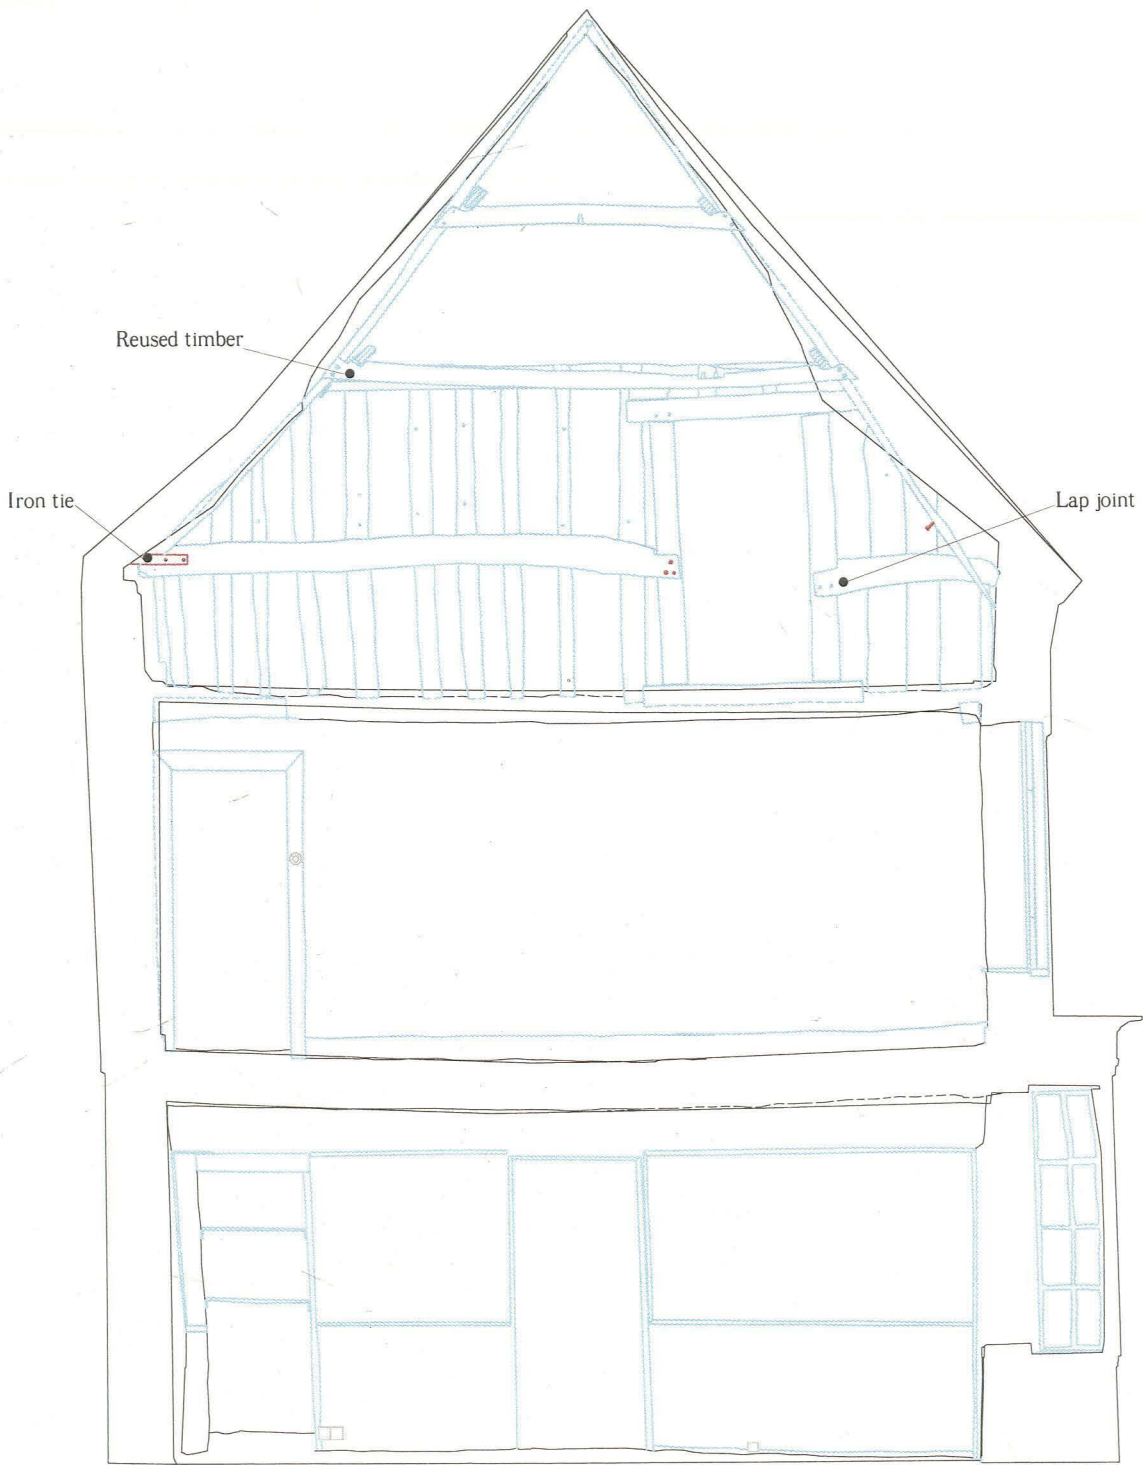
Cross-section through Building 11

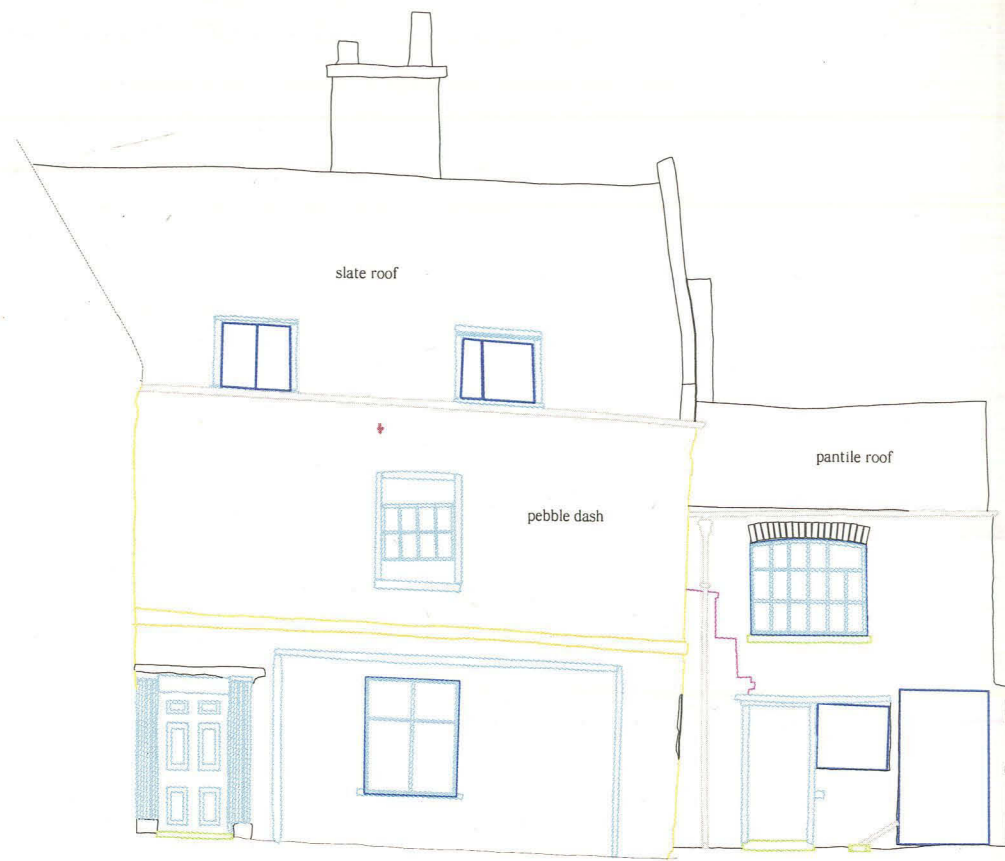
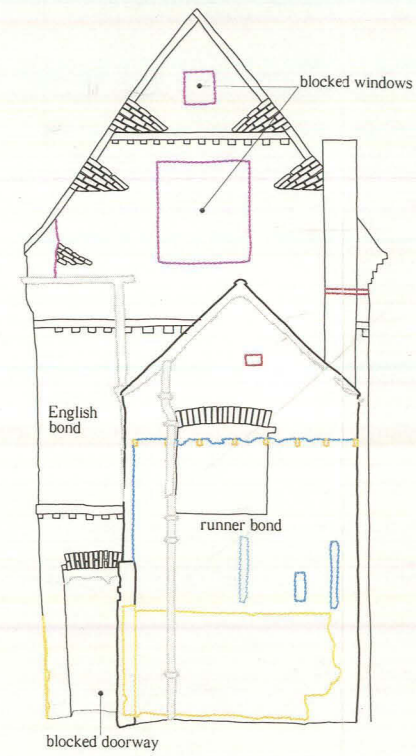
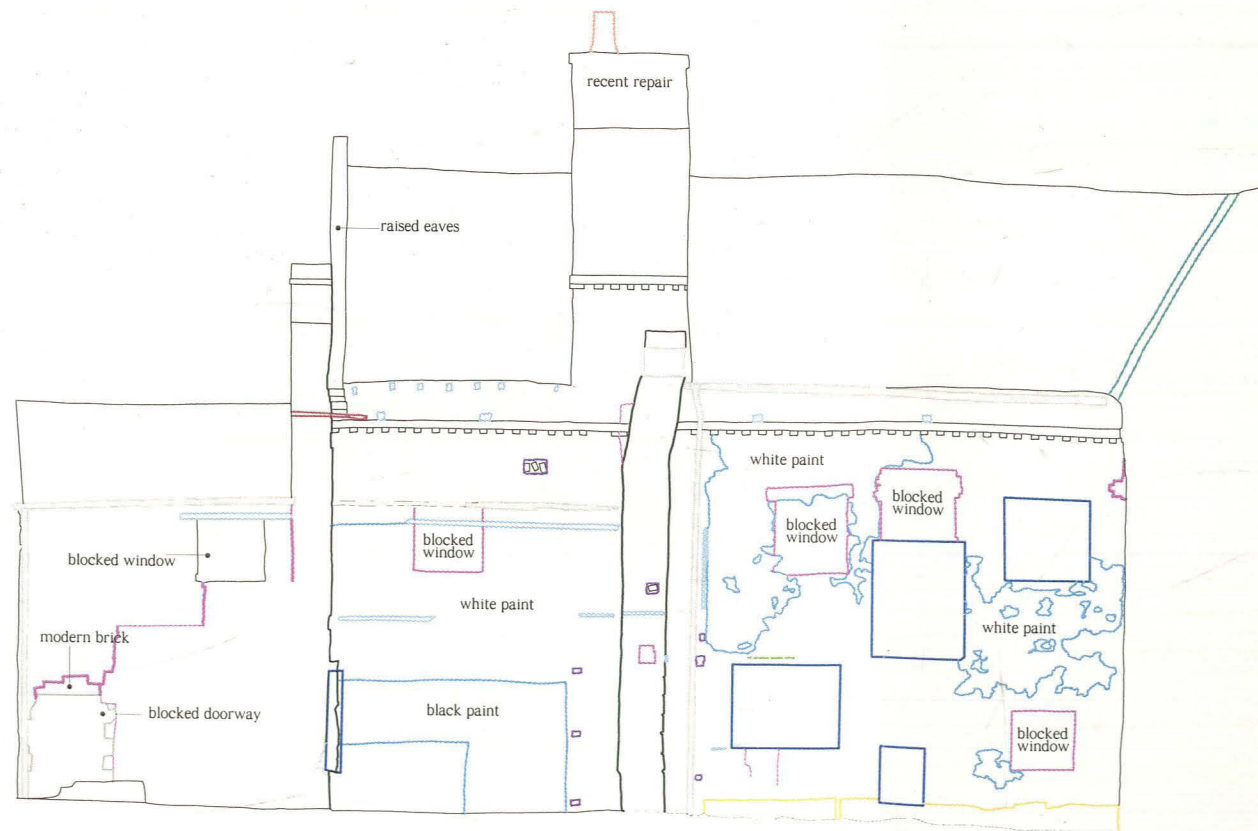
The north facade, although rendered, displays a decorative stringcourse at first, but not second-floor level (Figure 8). The presence of an eaves stringcourse on the west gable, and continuing into the rear, suggest that it was present on the north, but was removed at a later date, possibly when the elevation was rendered. It is also significant that the first-floor band is at a higher level than is seen on the gable of Number 11.

The rest of the ground floor area is reached via the later extension, although access was originally provided by a doorway in the gable end (Figure 8). From the plan, it is evident that a large part of Room G7 is occupied by the chimney breast. This is pierced by a small cast iron range with a fireplace to the right and double oven to the left (Plate 13), suggesting that the room has been used as a kitchen; this may also explain the enlarged chimney. To the west of the flue is a large, walk-in cupboard which contains an angled corner window, mirroring that found in Number 7. However, the walls dividing off this area appear to be later in date, suggesting that the room was originally of open plan, and that the window was broken through to provide light to the area after the construction of the extension. The doorway into G8 is later, as shown by the brick and breeze-block infilling to the right. The

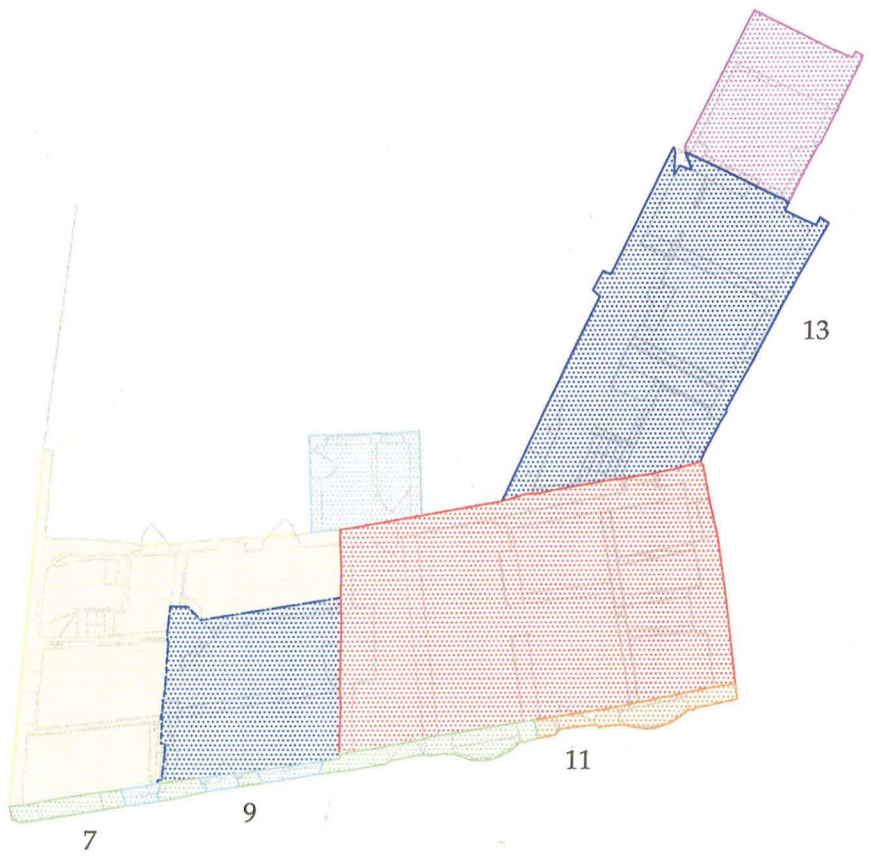
Figure 9

The first known phase of construction on the Bridge Street site is represented by Number 11 (Figure 9). Originally, it stood independently of its neighbours, fronting the main street and flanked by the River Bain. Despite the introduction of later shop frontages and subsequent rendering, much of the evidence for the original structure remains visible internally.

- Phase 1 - c1700
- Phase 2 - mid 18th century
- Phase 3 - late 18th century
- Phase 4 - 18th century
- Phase 5 - early 19th century
- Phase 6 - late 19th century
- Phase 7 - 20th century
