**HISTORIC BUILDING SURVEY REPORT:
HARDINGS FARM, LISSINGTON,
LINCOLNSHIRE**

Planning Reference: 125521
NGR: TF 0994 8485
Site Code: LIHF 10
LCCM Accession Number: 2010.110
OASIS Reference Number: allenarc1-80430

By
Allen Archaeology Limited
Report Number 2010043

August 2010

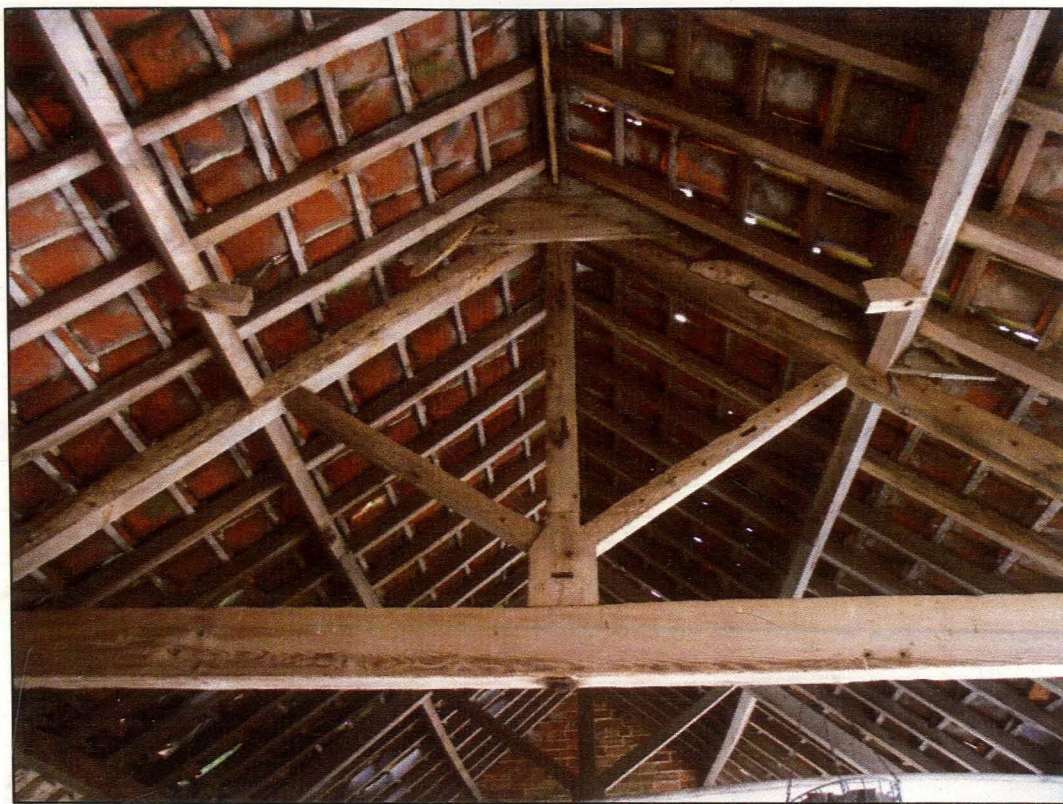
Plate 5 (Shot 13): Roof structure of animal shelter A1, looking north-north-west

- 6.1.3 The roof structure in animal shelter A1 consists of three trusses each comprising a tie beam supporting a kingpost with diagonal struts extending to the principal rafters with trenced side purlins (Plate 5). There are brick built feeding troughs along the west-south-west elevation as well as a wooden hay rack (Plate 6). An opening to the north-north-west leads into storage room A2 which has an uneven brick floor with a slight raise in the middle; signs that this space may have been used to shelter a wheeled vehicle causing depressions where the wheels would have worn down the surface (Plate 7). The roof structure comprises a ridge piece with side purlins and common rafters (Plate 8).

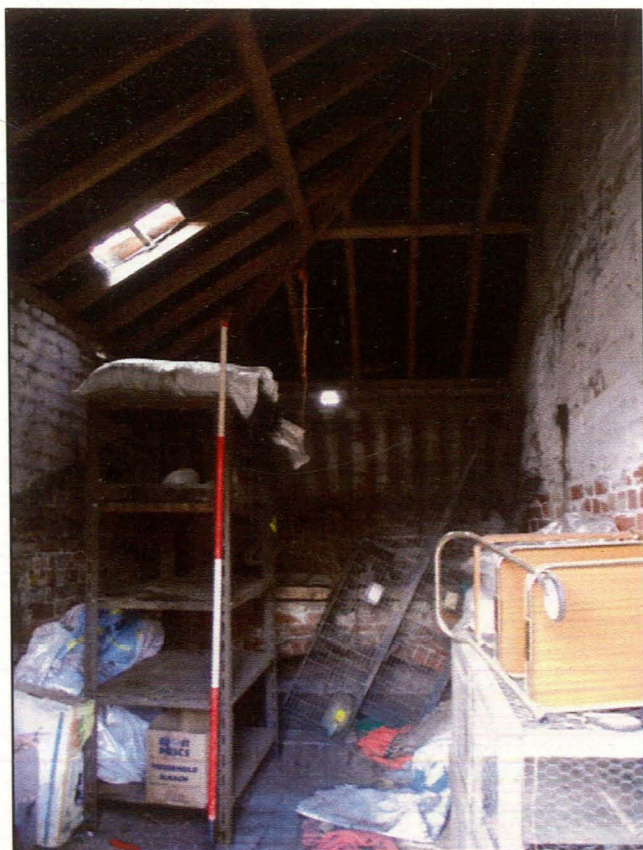
Plate 18 (Shot 42): General shot of barn B1 interior, showing vaulted brick built feeding trough and wooden hay rack. Looking west-south-west

- 6.2.4 Barn B1, probably a stable or animal shelter, was at the time of survey used as a storage area. It had a brick floor, and a vaulted brick feeding trough and wooden hay rack were recorded on the west-south-west elevation (Plate 18). In the north-east corner an opening leads into store B2. No feeding troughs or animal tethering rings could be found in this space; however a gutter or drain ran along the floor probably to carry away animal waste, indicating that it originally may have been constructed to hold livestock (Plate 19).

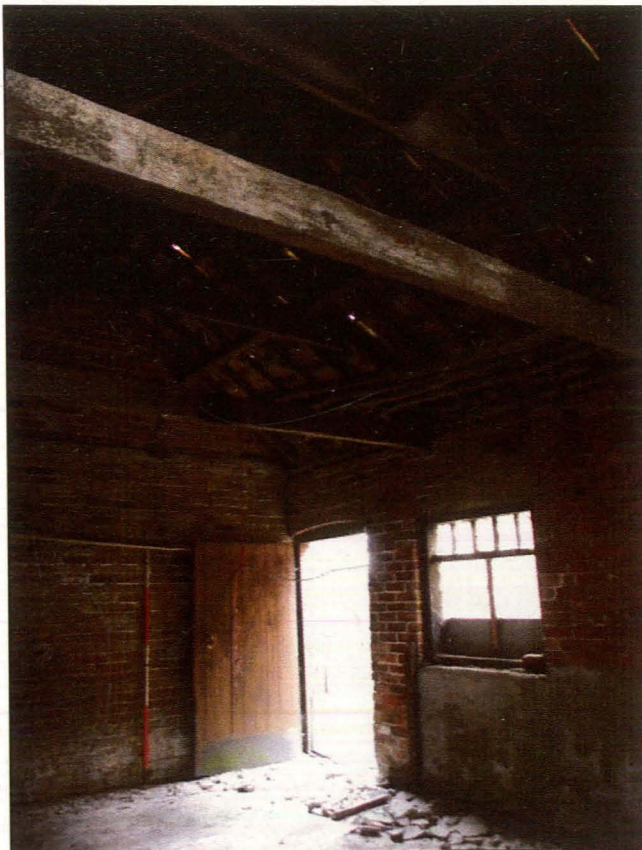
Plate 22 (Shot 50): General view of the western door and window of barn B4, looking south-south-west

- 6.2.6 Elements of barn or store B4 were in a poor state of repair, with the eastern wooden door hanging off its hinges and an unstable roof structure, possibly a result of the raised roof above the double door opening in the north elevation (Plates 21 and 22). A probable machinery opening supported by a wooden lintel had been made through the adjoining wall with B6. The coupled rafter roof consisted of through purlins and two collar beams with a ridge piece and several ad hoc modifications (Plate 23).
