COGGLESFORD MILL, EASTGATE, SLEAFORD

PHOTOGRAPHIC BUILDING SURVEY (LEVEL 3)

S. A. Savage

July 2007

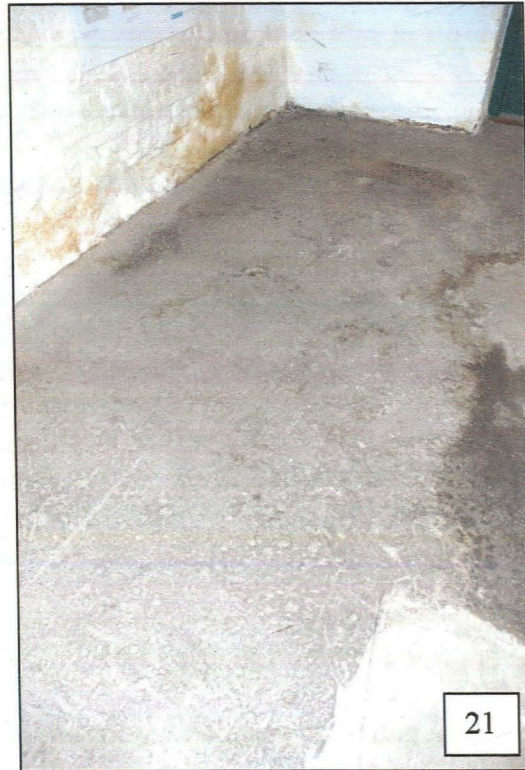
Plate 19: general view of the floor in Room 1, looking south. A patch of modern tarmac is in the foreground.

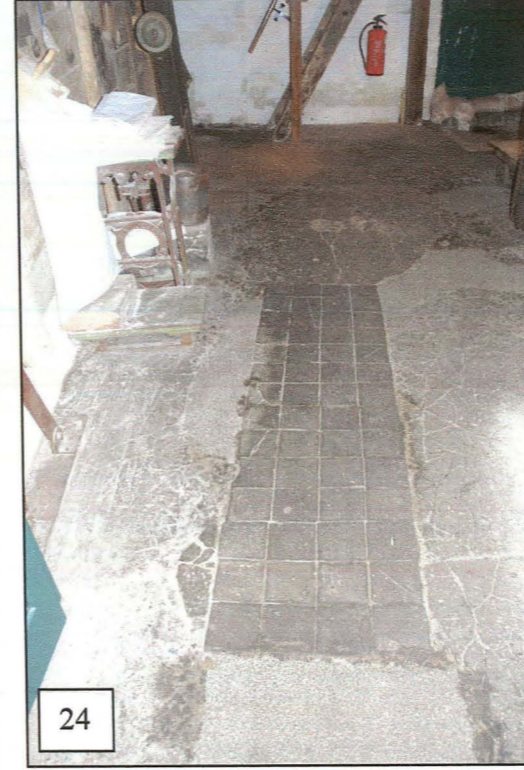
Plate 22: The floor on the east side of Room 1, looking north. Another patch of modern tarmac is in the lower left of the picture.

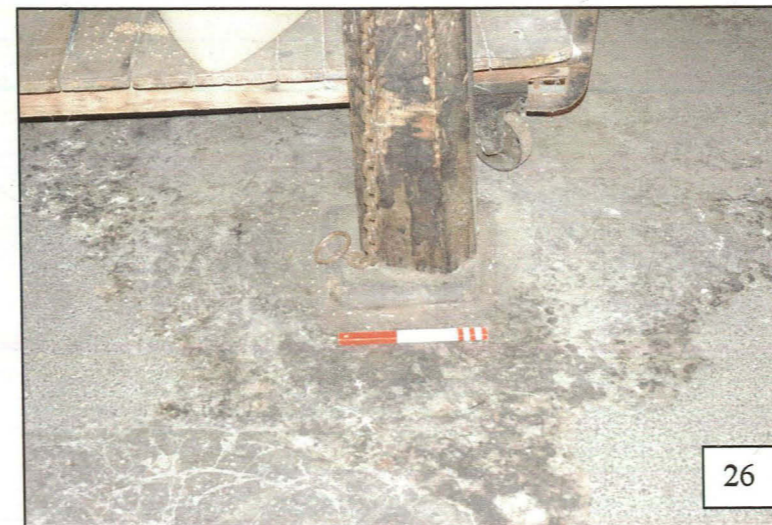
Plate 27: The patch of concrete in Room 1 below the grain hoist trapdoor, at the west side of the quarry tile area, looking east.

Immediately below the first floor trapdoor (through which the sacks of grain are lifted to the bins on the second floor) is a large patch of concrete. This does not appear modern, and has been worn smooth. Leading away from this in the direction of Room 2 is an area of quarry tiles, four tiles (or 2ft) in width and 14 tiles (or 7ft) in length.

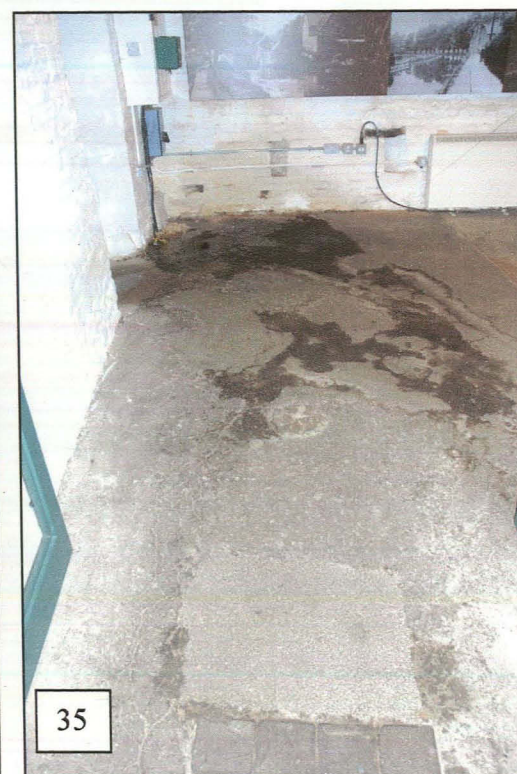
Plate 37: The tarmac floor on the north side of Room 2, looking north.

To the north of the timber floor, the floor in Room 2 is again of asphalt (or tarmac). A clear joint between this floor and that of Room 1 is visible adjacent to the modern glazed doors which separate these rooms. This floor is again heavily worn and has been repaired. The southern edge of the earliest asphalt appears to have been laid on a diagonal line between the door into Room 3 and the northeast corner of the room. A patch of more recent asphalt follows a divergent diagonal to the south of this strip, while modern asphalt has been used to fill in the space between this and the timber floor.

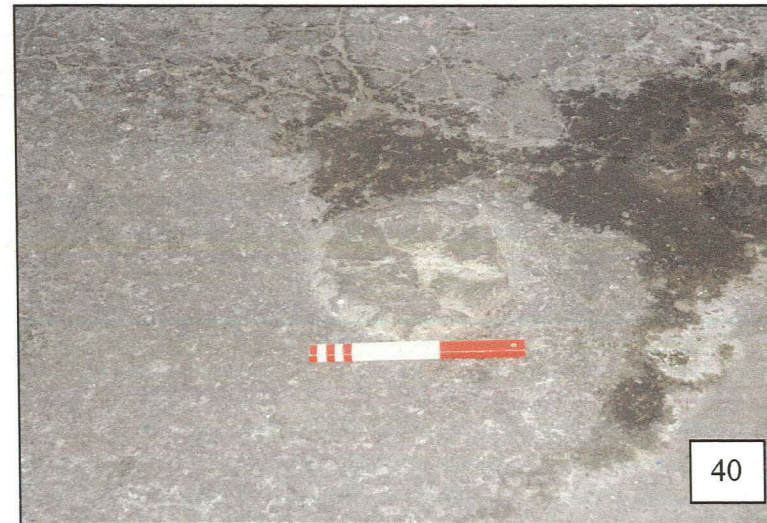
In two places the asphalt floor has worn through and in these locations a small area of underlying stone has been exposed; a further stone protrudes through the floor and is probably a padstone for a supporting post (no longer evident). The stones are discoloured and heavily fragmented making identification impossible.

Plate 40: detail of padstone in the floor (see plate 39).

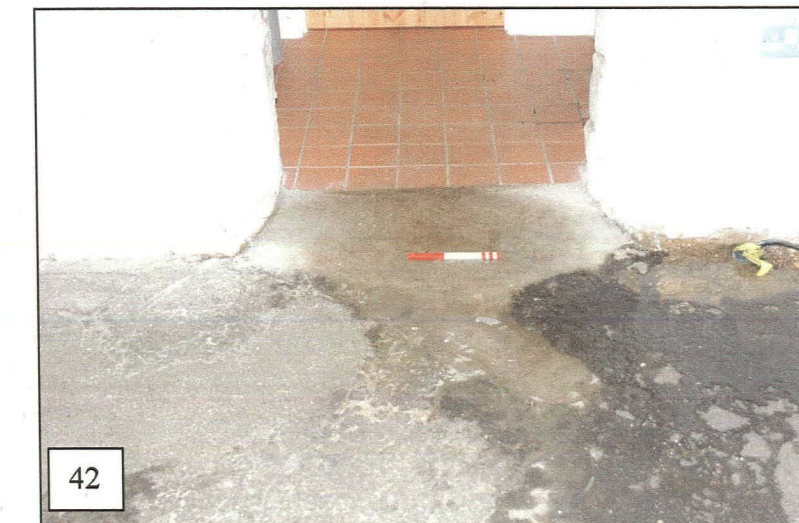
Plate 42: View of the tarmac floor in Room 2 from Room 3. The two slots for drivebelts can be seen in the wall opposite.
