FARM BUILDINGS AT 65, HIGH STREET, HEIGHINGTON, LINCOLNSHIRE

PHOTOGRAPHIC BUILDING SURVEY

Report prepared for J. H. Walter LLP (Agent)

March 2010

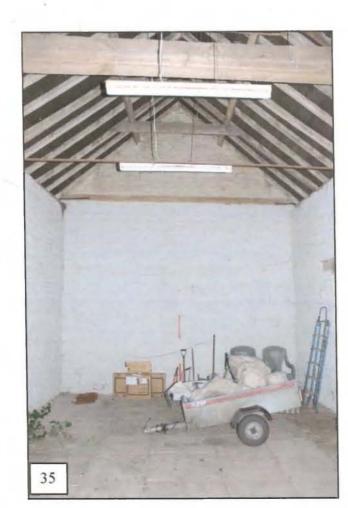
The east elevation was completely blind, and only a timber tie-beam (above which the masonry was untreated) was present, fixed to the wall plate with iron stirrups.

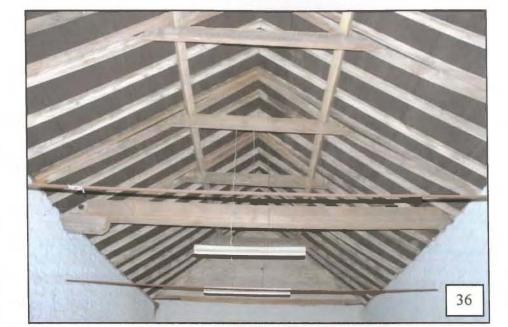
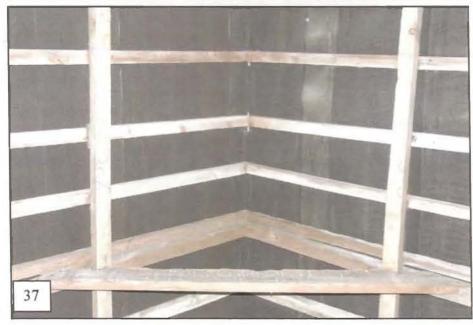
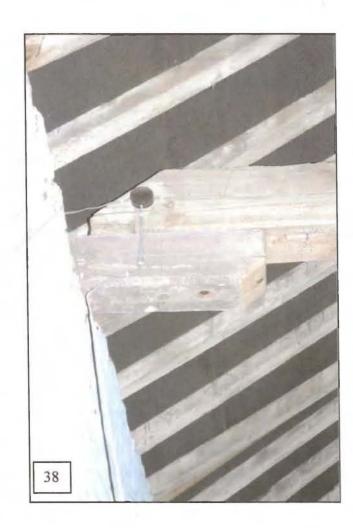
Roof detail

The roof structure was clearly exposed here; this was of collar-rafter construction with clasped through-purlins, a collar bracing every third pair of rafters.

A heavy tie beam spanned the centre of the building, but the north wall bowed so significantly as to require a timber corbel to be inserted below it. Supplementary reinforcement has occurred by adding extra rafters adjacent to those with collars.

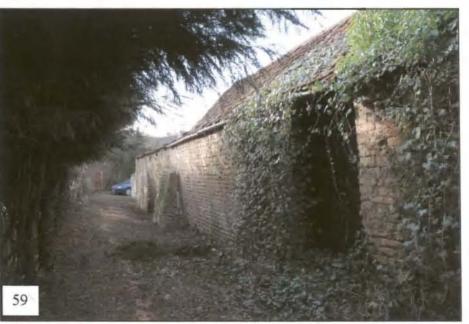
West Elevation

The building was originally open-fronted and the west elevation comprised a variety of weatherboarding with two openings, neither of which retained their doors, but the hinges and fastening rings of stable-type doors remained in their frames.

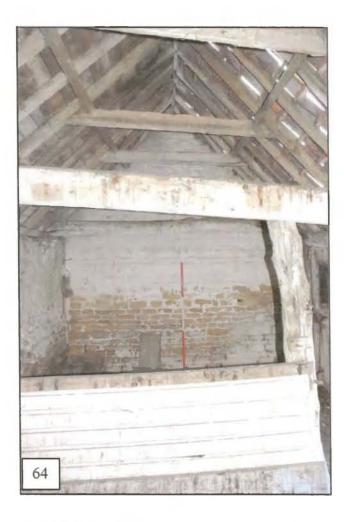
North Elevation

At ground floor level, a door opening with a timber lintel has been forced through the north wall. This appeared to have occurred when Building E was added on the north side, and gave access from the cowshed to the loose-box.

Above this door, it could be clearly observed that this building abutted the former threshing barn (Building A)

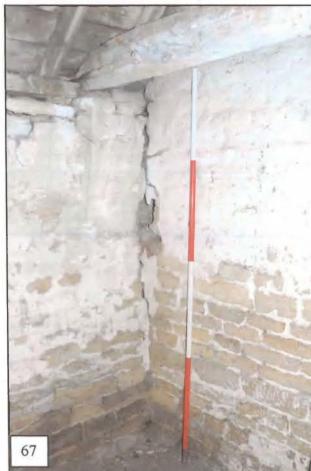
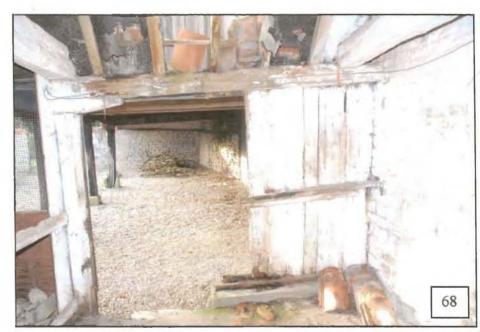
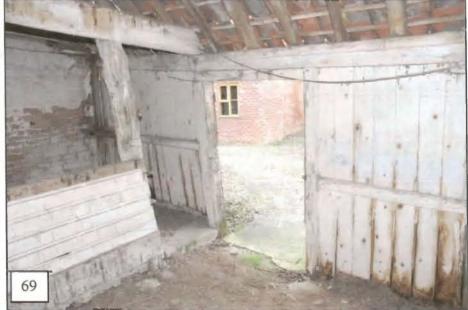
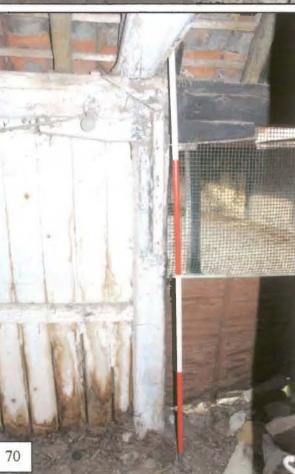
East Elevation

The deflection in the east wall observed on the exterior was more noticeable on the interior, where the timbers of the partition walls had been cut to allow for the shape of the wall.

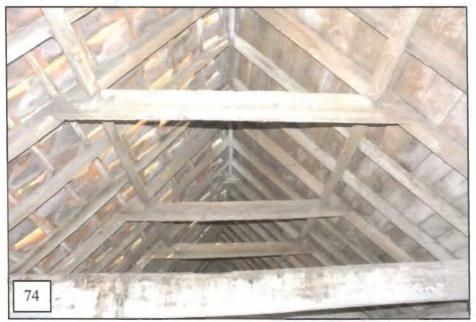
Roof detail

The northern half of the roof covering had been renewed, with roofing felt placed below the tiles.

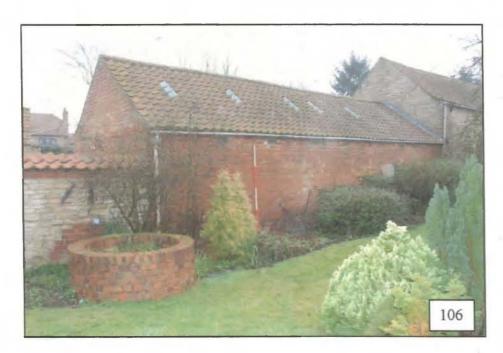
North Elevation

The modern brickwork continued from the east side to block a door opening here, which had a lintel of engineering bricks. The unusual coursing of the original brickwork could be seen here, with odd pairs or fours of headers occurring in the same course, these courses generally separated by three courses of stretchers: a form of English Garden Wall bond.

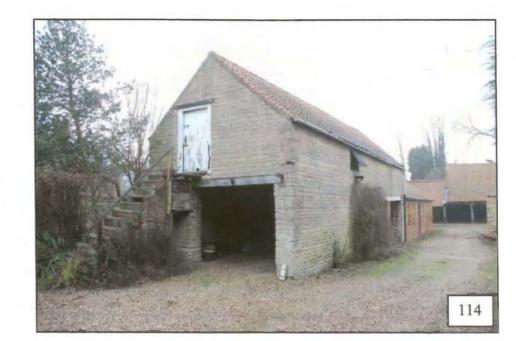
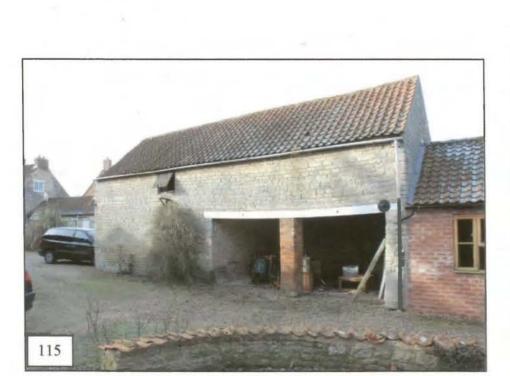
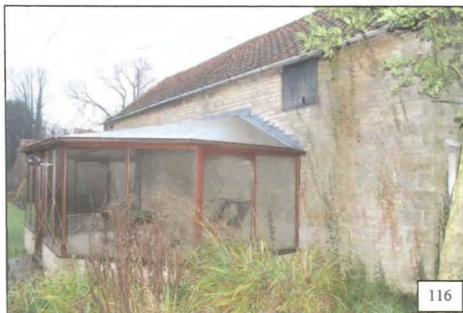
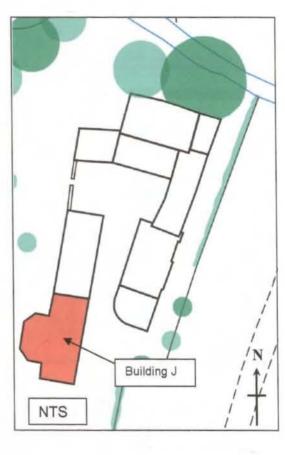
South Elevation

The south side of the building was dominated by a large inserted ground floor opening with a heavy timber lintel. At first floor level, the door opening appeared to be original.

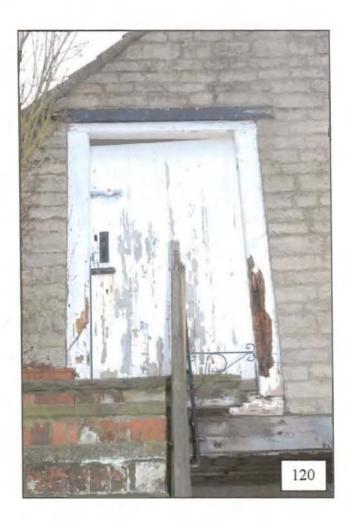
First floor access

The first floor door was accessed by a set of thirteen 2½" thick York stone steps supported on a pair of 9" brick walls (brick size: 9" x 4½" x 2¾"), in 3-course English Garden Wall bond. These led to a York stone landing and had a timber safety rail on the east side.

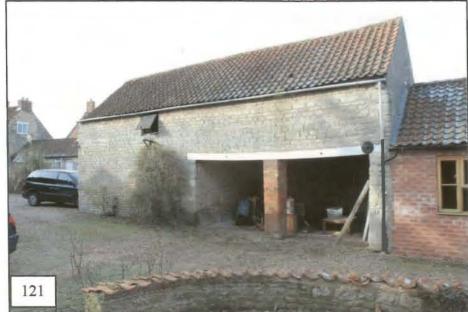
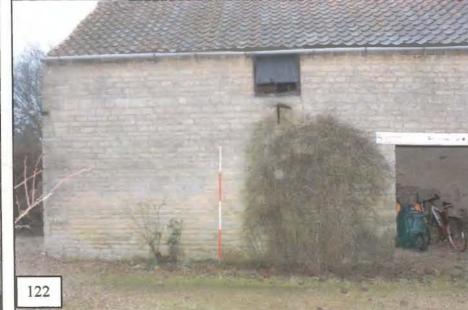
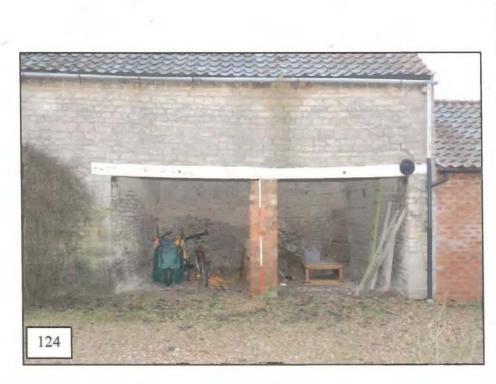
East Elevation

The east elevation had a large opening at the north side at ground floor level, with a very heavy timber lintel with a central 19" square brick pillar (brick size: 9" x 4½ " x 3").

A loading door was present below the eaves at the south side, while a bullseye tie-bar endplate was visible at first floor level at the north end of the large opening.

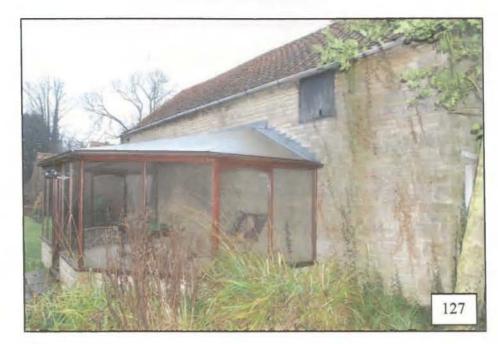
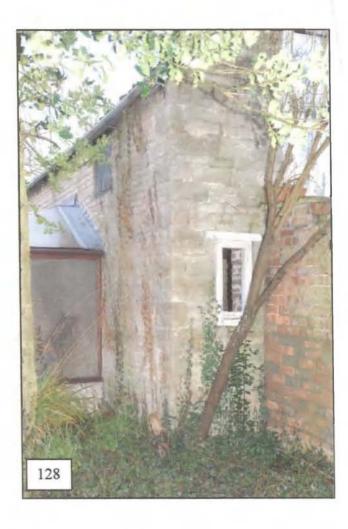
West elevation

The west elevation had a loading door at first floor level corresponding to that of the east side. The elevation was otherwise blind, but a modern glazed lean-to conservatory had been constructed below the loading door as a garden room.

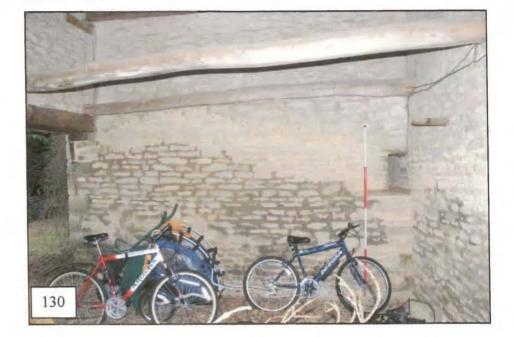
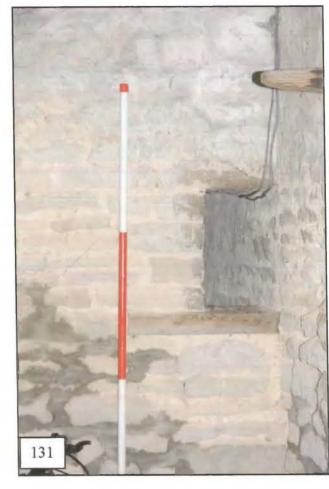
South Elevation

On the west side of the south wall, a small opening with a timber lintel connected this room and the northern ground floor room.

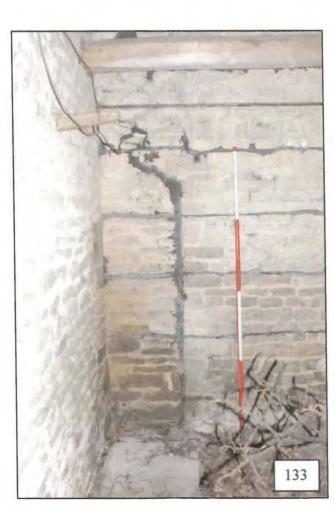
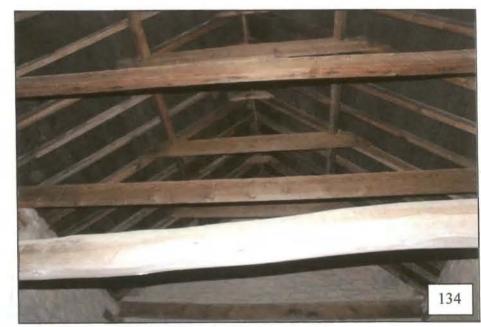
North Elevation

A blocked opening was present on the west side of the north wall, across which a series of modern tie bars had been inserted using a dark-coloured cement mortar.

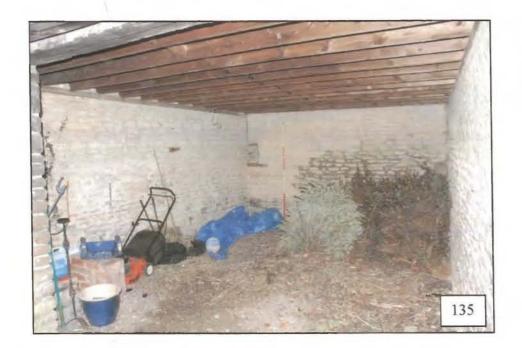
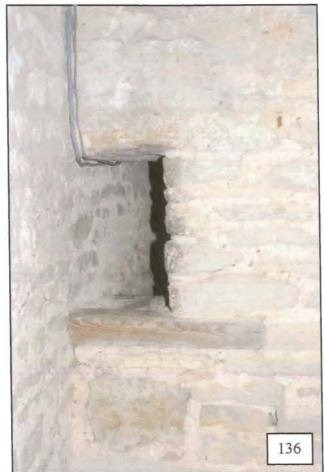
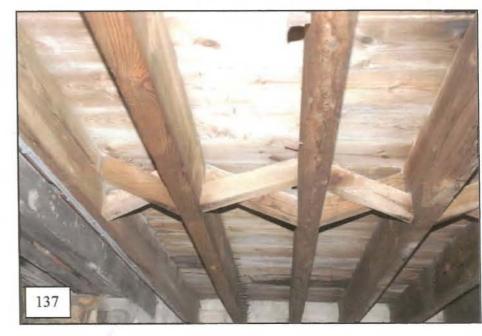
First Floor detail
The first floor was supported on a series of east-west 8" x 3" timber joists with 3" x 2" scissor bracing running north-south at mid span.

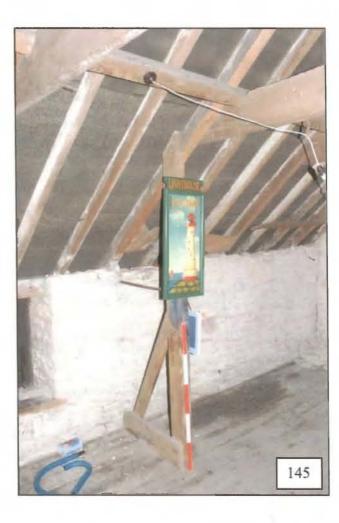
The roof construction observed in the northern ground floor room continued here. The principal rafters (4" x 3") occurred every third rafter, and each had a collar. The central collar had separate supporting posts of 5" x 3" timber, braced in 3" timber, suggesting that a tie beam had been removed here.
