**PHOTOGRAPHIC SURVEY REPORT:
BARNs AT SWINTHORPE, LINCOLNSHIRE**

Planning Reference: 122174
NGR: TF 0630 8060
AAA Site Code: SWIN 08
LCCM Accession Number: 2008.168
Oasis reference: allenarc1_50974

Allen Archaeological Associates
Report Number 2008/060

November 2008

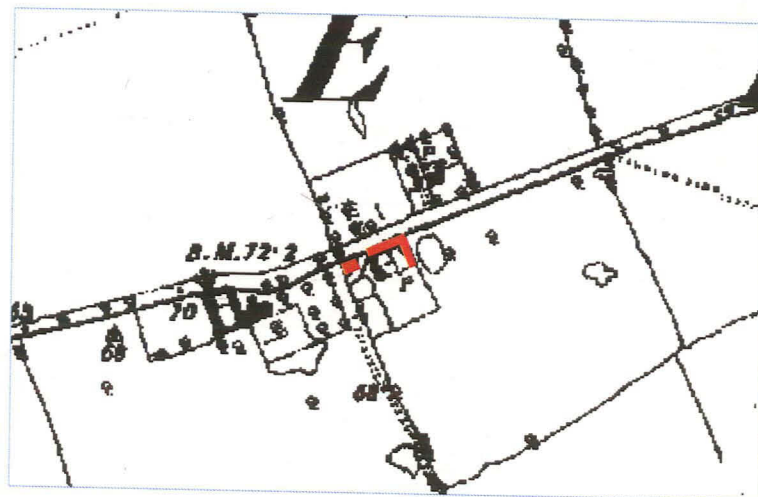
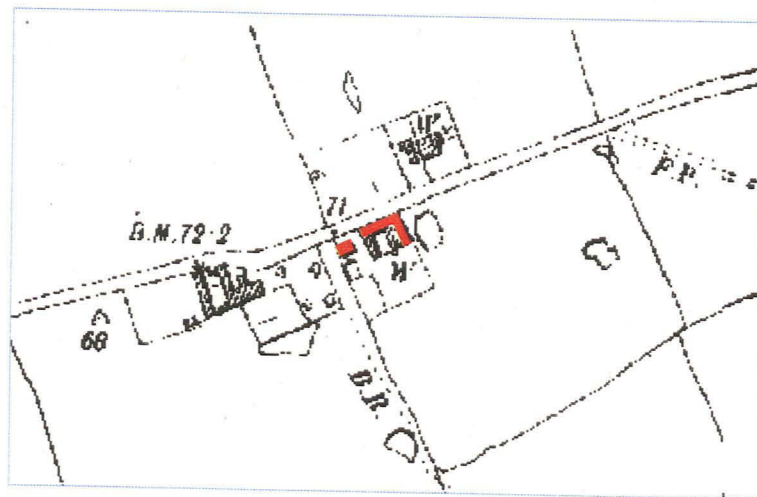
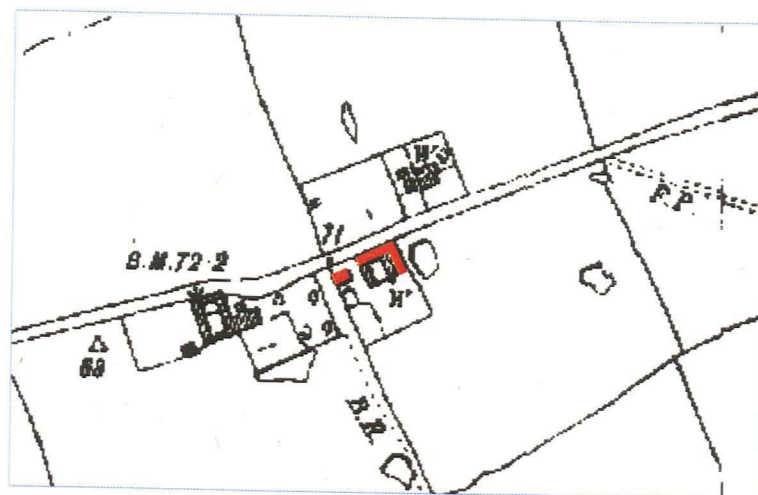
Figure 5: Historic maps of the site, with the existing buildings shown in red. At scale 1:5000.

- 5.2.4 The south elevation has two windows, each with bull-nose brick jambs and a basket arch, also of bull-nose bricks (Plates 5 and 6). A load-bearing wooden lintel is visible inside each window, supporting the brickwork above. To the east is a partially bricked up doorway with a segmental arch of alternating stretchers and headers, with the eastern jamb formed of bull-nose bricks and three unevenly spaced chamfered stone blocks. The partial blocking of the doorway has formed a window in the pper part of the former doorway. The western side of the doorway is abutted by a brick wall that is a remnant of a demolished range of buildings extending to the south. A roof scar for this range of buildings is also evident, suggesting a two storey, double pitched gabled roof structure, the apex of which is immediately below the roof line of the existing building (Plates 5 and 7). Given the position of the windows in the existing buildings, it seems likely that the demolished range was added later. This hypothesis is supported by the position of the single pitching hole in the first storey of the south elevation. The location of the pitching hole, directly over the east wall of the demolished range would have made it very difficult to use after this range was built. This range is evident on the historic maps consulted (Figure 5), and was therefore constructed before 1890, and demolished after 1948.
