Pittrichie Home Farm steadings and doocot
Pittrichie, Oldmeldrum, Inverurie, AB51 0AE

Alison Cameron, Cameron Archaeology Ltd
June 2012

A level 2 survey was carried out on the steading buildings and doocot. It is recommended that no further archaeological work is required during the current development subject to agreement by Aberdeenshire Archaeology Service.

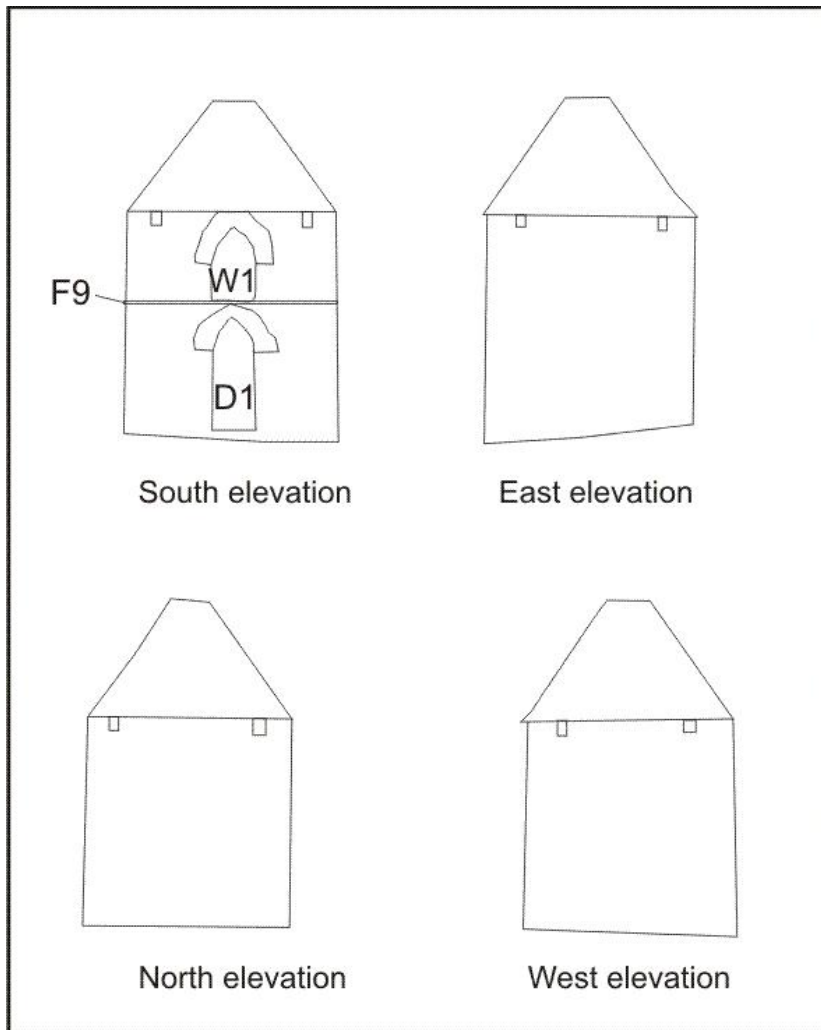
Illus 4 Elevations of doocot (from originals by Annie Kenyon Architects)

The doocot at Pittrichie is in a field SE of the Home Farm and is 4m x 4m in size externally. Inside each wall is 3m long and the building is constructed of large dark grey granite blocks with roughly dressed quoins (Illus 3). It is two storeys high and has an arched door (D1) in the south face of the ground floor and window on the first floor (W1) above. These are constructed of red granite and white quartz blocks in contrast to the grey granite walls. The door frame retains hinges but no door is present. On the south face above the door and forming the sill of the upper window is a perching ledge (sometimes wrongly termed a rat-ledge).

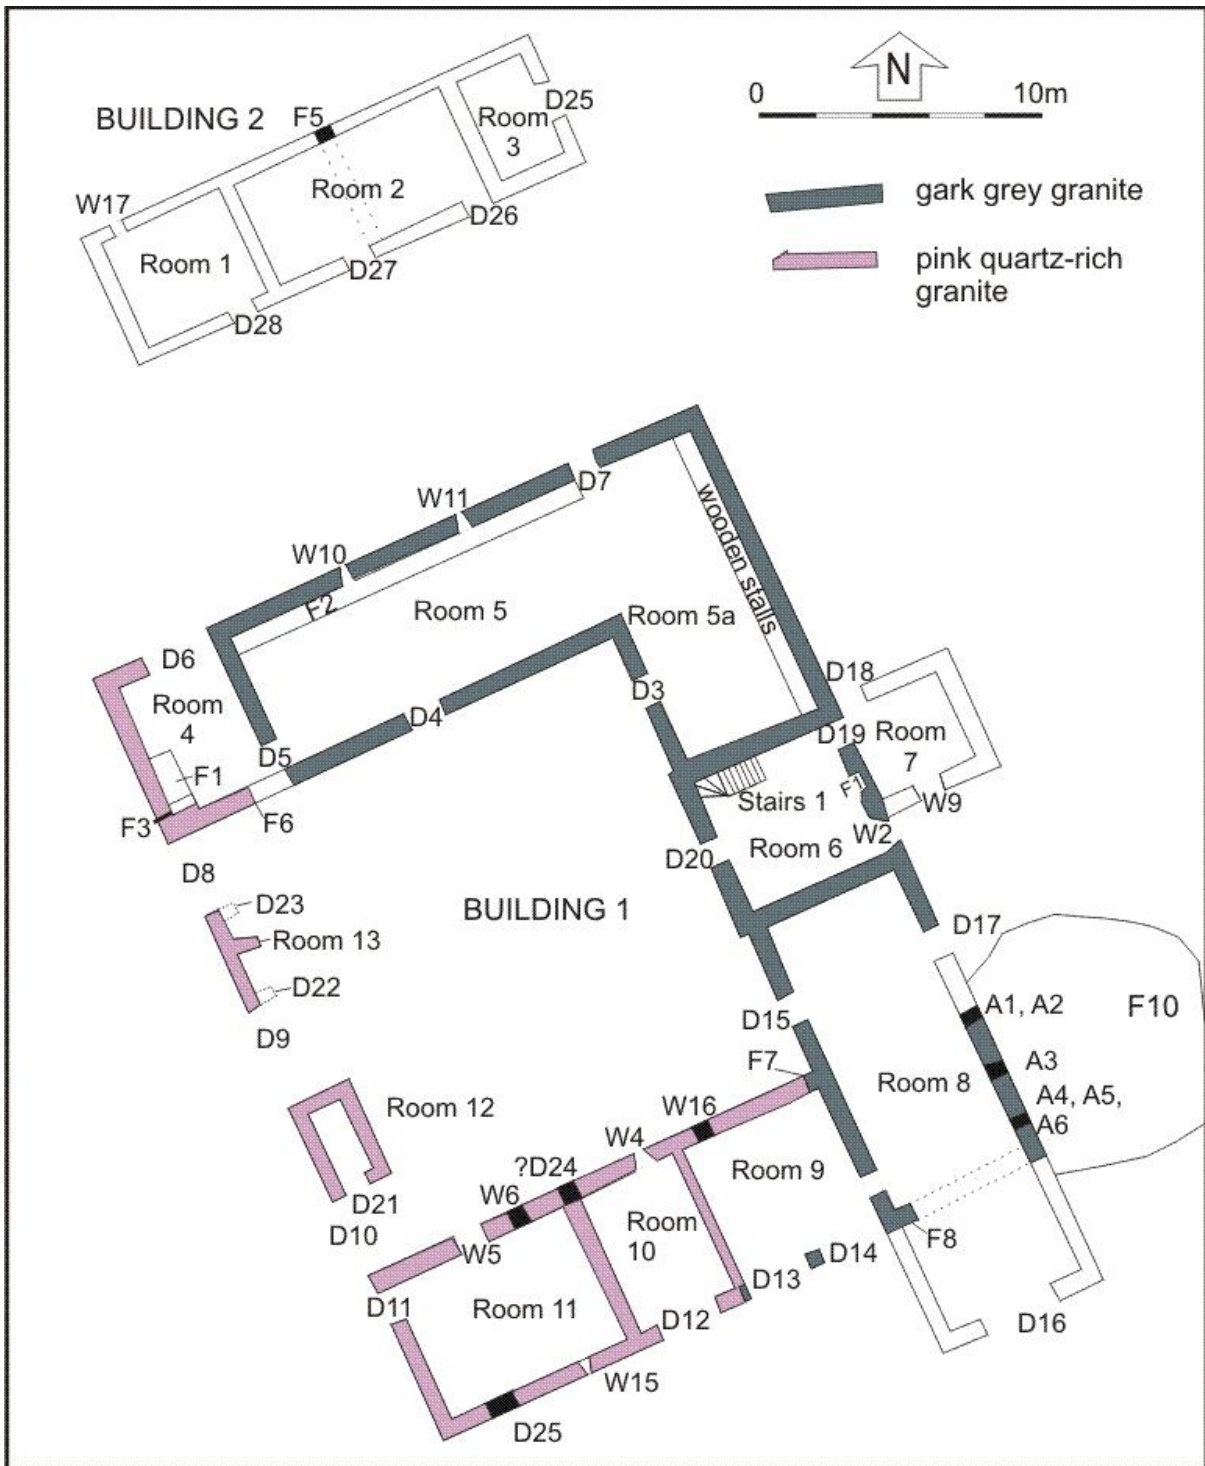
Illus 8 Plan of the buildings, room, door, windows and other features

Rooms 4 and 5 form the north side of the courtyard. Room 4 is small with a large door on the north side; it has been partitioned off from the remainder of the building or this wing may have originally been constricted as a series of small rooms which have since been combined. Room 4 has a granite plinth (F1; Illus 9) in the SW corner and this may have been the base for a water tank. The water may have been pumped from the well to the west of the complex and gravity fed into the building. Metal pipes survive at the rear of F1 and also through the wall to the exterior (F3).

Room 5 is a large room with doors to Room 4, a door to the courtyard, one to the north and two small slit windows facing north. Along the interior of the north wall is a stone and concrete foundation (F2) probably a foundation for feeding troughs for cows. In Room 5A wooden stalls for horses survive suggesting that this is a recent use of the room (Illus 11). The two small windows facing the north (and there is one in the south wall, W15) are 70cm high and 30cm wide internally and 6cm wide externally (Illus 10). Windows of this type are not common on vernacular buildings but are common in castle and other defended buildings where they are known as loop-holes or arrow slits. On a building of this type they are for adding light and ventilation; there is one on the steading at Craignish Castle in Argyll and Bute which is of the more common cross-shape. The building is constructed of large blocks of dark grey granite with fieldstones. There are several areas of rebuilding and the height of the roof appears to have been raised by adding an extra course of stones to the top of the wall. The quoins on the corners of this building and the lintels are all of fine-grained light grey sandstone suggesting a high quality building. Bricks around both doors 5 and 7 indicate that they have probably been altered in size.

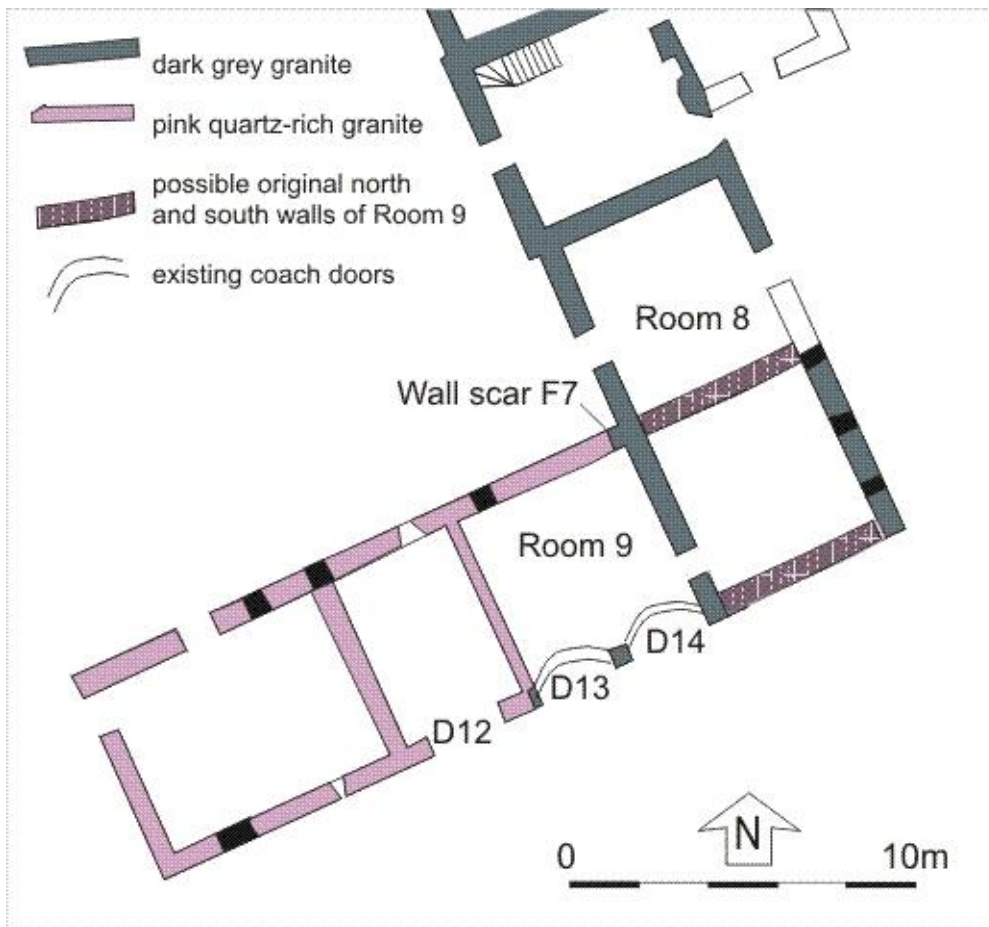
Illus 22 Plan showing wall scar F7 between pink and grey granite walls and coach doors

On the south side of the courtyard are a series of three rooms 9, 10 and 11 (Illus 19). They are constructed of pink quartz-rich granite blocks and these rooms have been butted onto the east wing; a scar (F7; Illus 18) shows the earlier black and dark grey granite structure and this later pink granite addition.

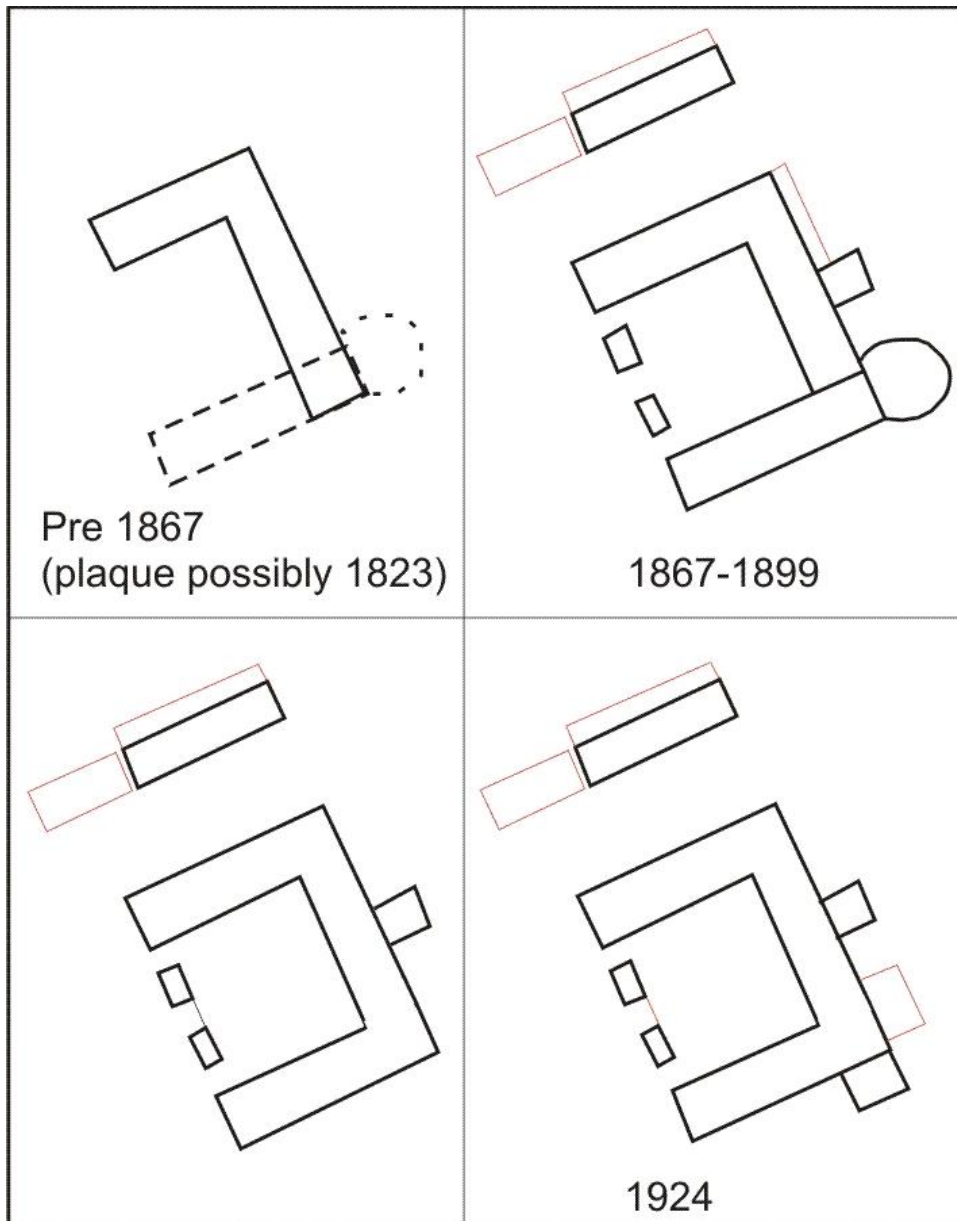
Illus 28 Possible phase plan based on recorded remains (black) and OS maps (red)

On the south wall of Room 2 is a scar (F6) between the pink quartz-rich granite to the west and grey granite fieldstones to the east. This section of wall appears to have been added on to the main building and it is possible that this range was extended to the west or was repaired and rebuilt (see phase plan Illus 28).

Several phases of development can be seen on these buildings and these have been summarised below (Illus 28).
