Bowbutts Farm, Strachan,  
Banchory AB31 6NN

Alison Cameron  
Cameron Archaeology  
23.8.12

# Bowbutts Farm, Strachan, Banchory, AB31 6NN

## Report on Standing Building Survey

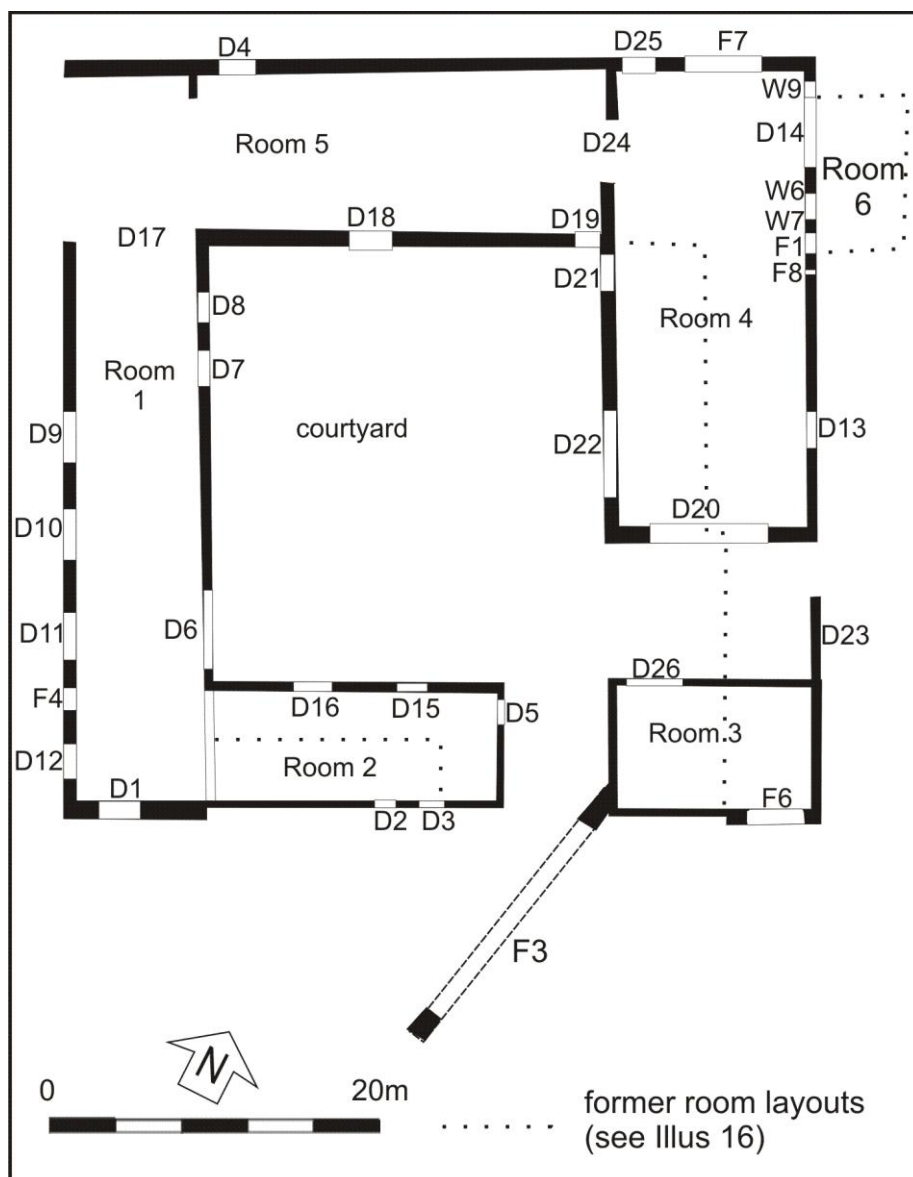
Illus 4 Plan showing all features, apertures and rooms

Rooms 1, the north and east portions of Room 2, the east end of Room 3, the north and east portions of Room 4 and Room 5 formed parts of the earliest phase of this farm steading. The walls of these Phase 1 structures are mainly constructed of large blocks of pink granite (Illus 5, 6). Original uses of the rooms are unknown apart from Room 4 which probably incorporated a threshing mill. A pond and sluice at the NE corner of the farm can be seen on the First and Second Edition Ordnance survey maps; this area has been redeveloped in the recent past and no evidence of this survives. A sluice would have fed the water from the pond through the threshing mill and the water would have exited the farm through stone drain F3 (Illus 4, 9). Scars on the east wall of Room 4 indicate where a building (Room 6) has been demolished (F1, F2; Illus 8) and blocked apertures show where drive shafts would have passed through the wall.

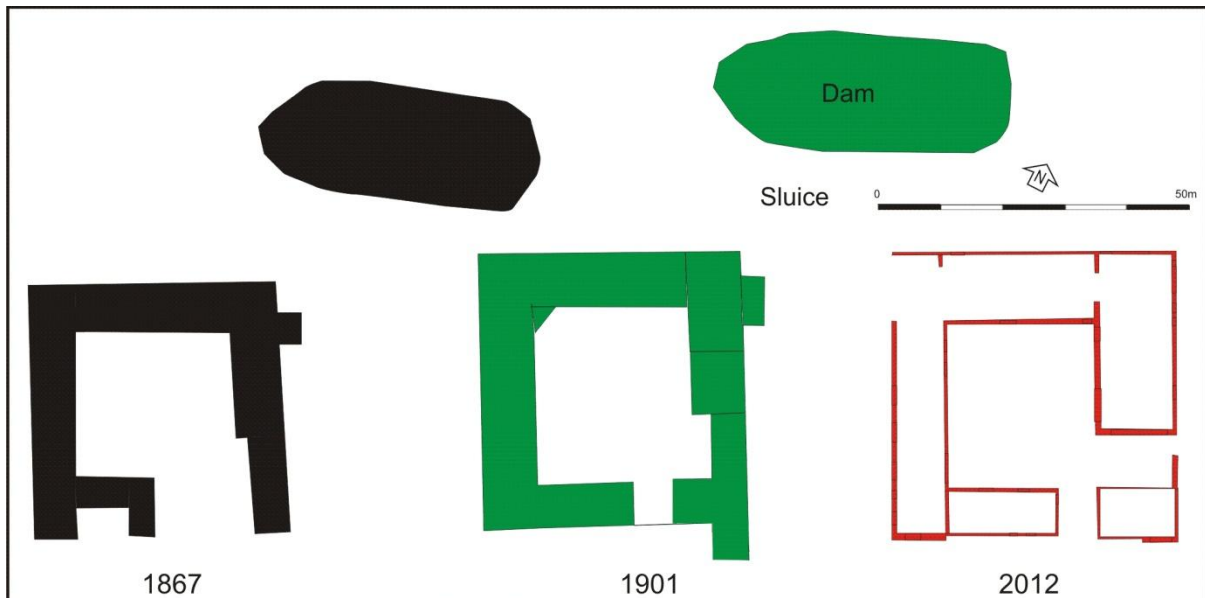
The standing buildings survey and study of relevant maps have revealed that these steadings have been altered, extended and adapted several times from the early 19th century (Illus 16). The open courtyard was eventually closed to form a more sheltered area and the buildings appear to have been at their height in the early 20th century. Later alterations and demolition have removed all original internal fittings but blocked apertures indicate original layout, including the mill, presumably for threshing.

Illus 16 Phase plans showing footprint of farm steadings from First Edition Ordnance Survey (1867; left) Second Edition (1901; centre) and from this survey (right)
