**Victoria House, 84 West North Street, Aberdeen, AB24 5HT**  
**Standing Building Survey and watching brief**

**Alison Cameron**  
**Cameron Archaeology Ltd**  
30 November 2012

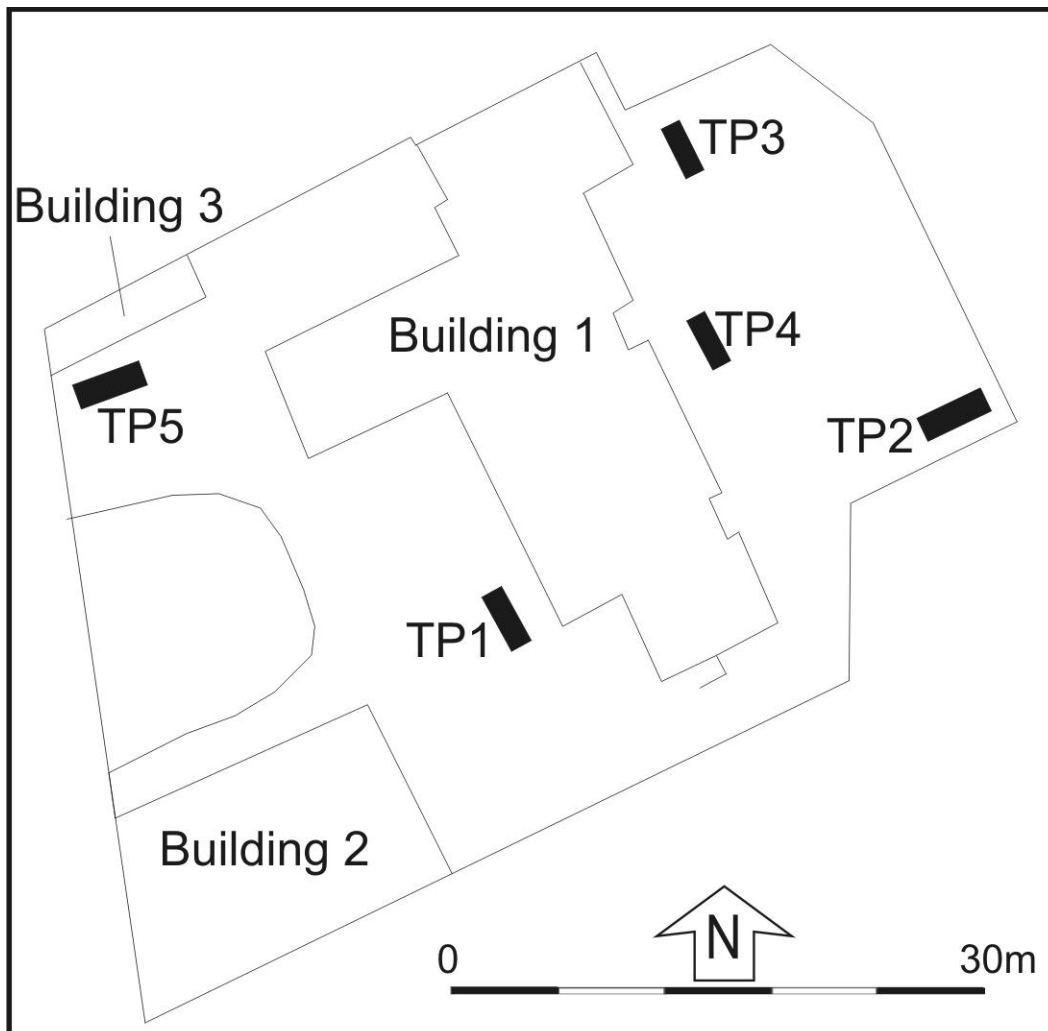
Illus 3 Plan showing test pit locations (from plan copyright Mott MacDonald)

A watching brief was maintained by Cameron Archaeology staff on the digging of test pits on 12-15 November 2012. Five trial pits, three in the rear (east) garden and two at the West North Street side of the building (Illus 3) were observed.

In TP2-4 in the rear garden there was 0.7m wet garden soil above the clay natural subsoil but this did not contain any finds. Above this 0.8m very dark grey enriched light garden soil contained sparse 19th-20th-century finds including a dog skull and ceramic sherds. In TP3 a dump of brick, stone and mortar below the topsoil was probably from building or demolition work at the site; the north wing was partially demolished in the late 19th century as was part of the brick garden wall. TP4 contained a dump of stone, brick, mortar and plaster (7) including hand-made bricks 225 x 110 x 65mm in size in a pit cut down to the natural subsoil. This had also come from a building or demolition event at the site.

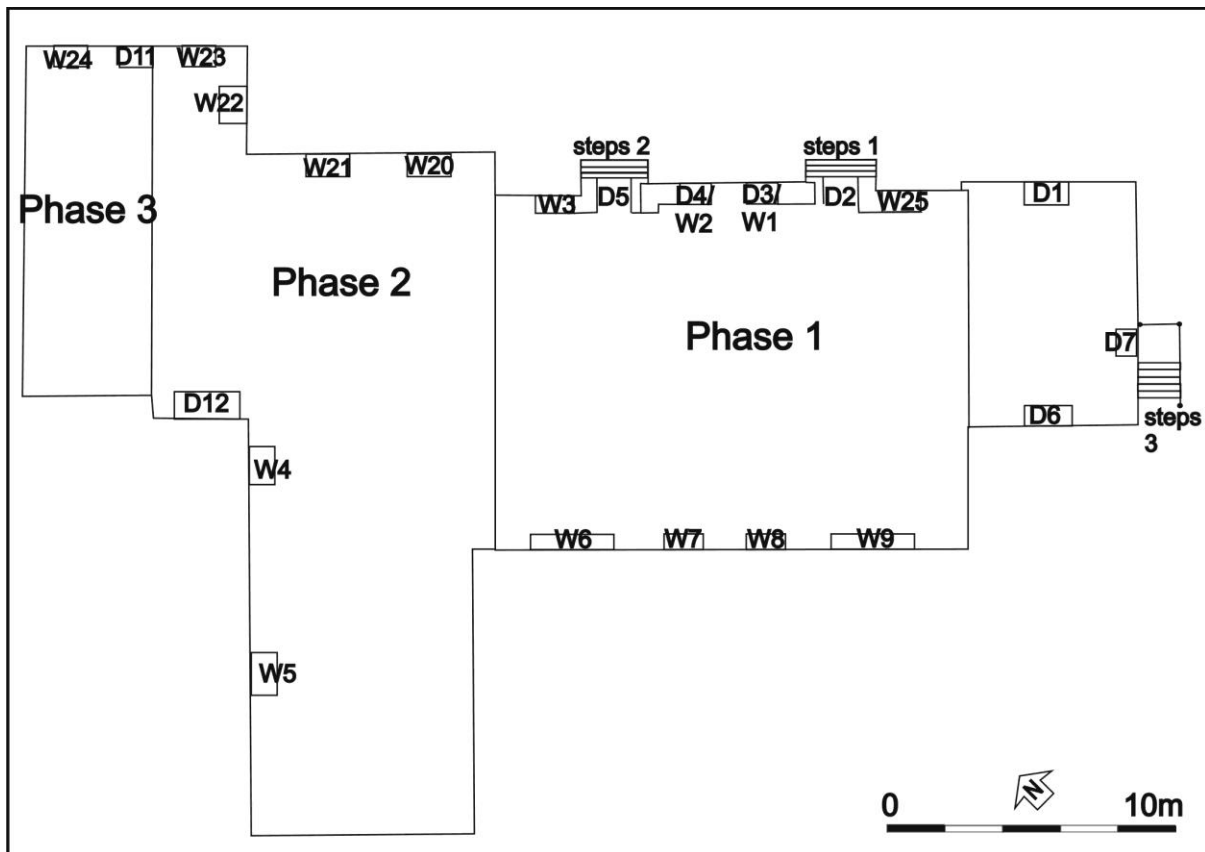
Illus 12 Plan showing Building 1 main features

Building 1 was 16.3m long and 12.5m wide and the front (east) facade is constructed of roughly worked grey granite blocks with pink grey granite blocks around the windows. The side and rear walls are of plain grey granite blocks. The building has a two bay centrepiece and William Adam-style portico (Illus 6). The building had a single-storey wing at each end and one survives at the SE end. It is of brick and sandstone construction (Illus 8) and is entered from the SW by balustraded steps to the basement (Illus 10). This wing is constructed of a lean-to shed with a single-thickness wall facing onto the front (east) side which creates an impressive facade from King Street (Illus 9).

A further extension was added on to the NW of the house, probably in the 20th century (Illus 12).

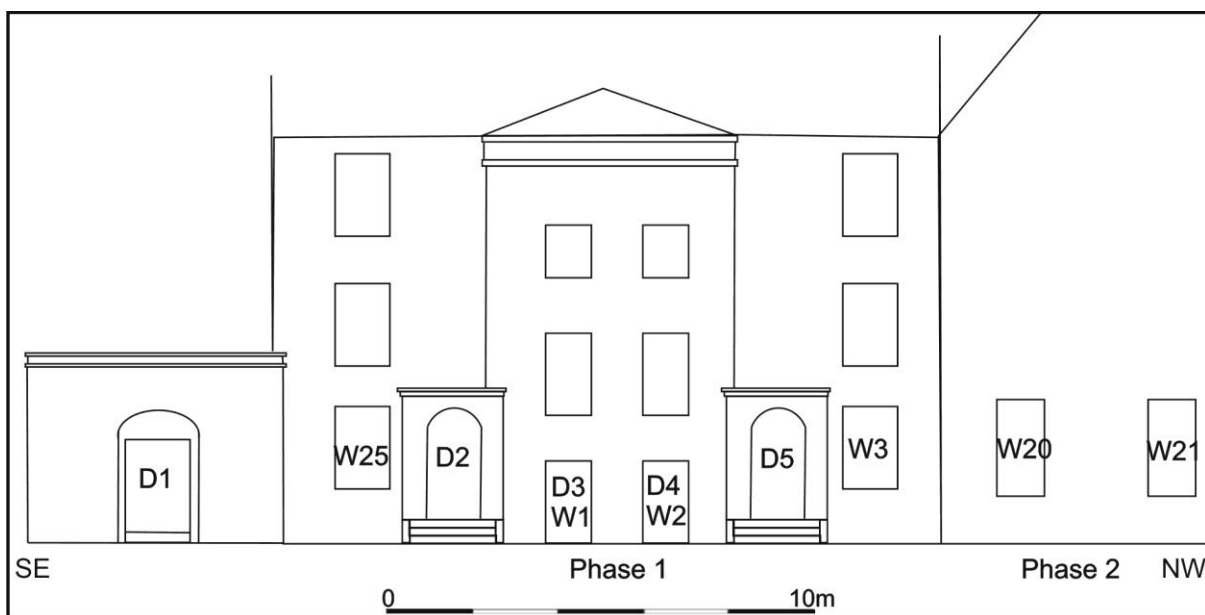
Illus 13 Building 1 NE front elevation facing King Street

The facade of this building and the Georgian style chimney stacks suggest that the building might originate in the 18th century.

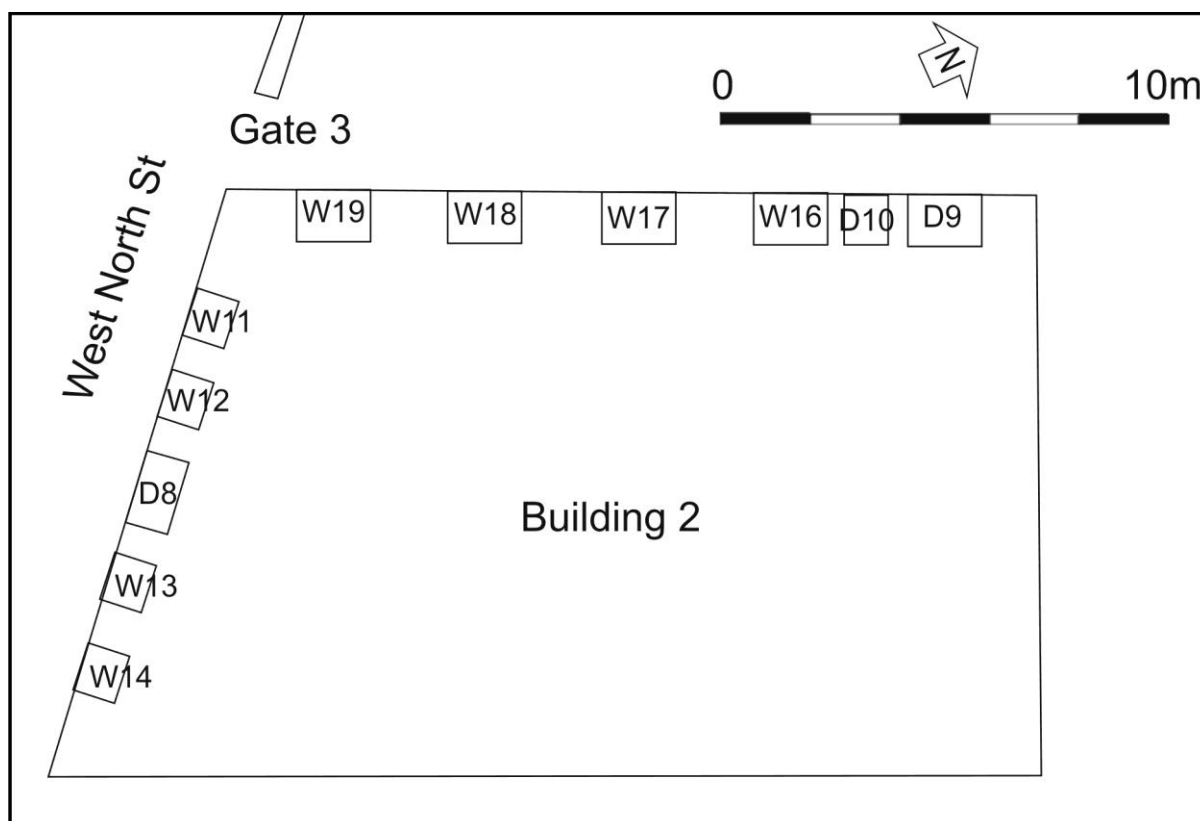
Illus 17 Building 2 plan showing main features

Building 2 is a hall and is on the First Edition Ordnance Survey map. It is probably 19th century in date and is 15.4-20.5m long and 12m wide and is constructed of grey and red granite roughly dressed fieldstones with cherry cocking (Illus 19-20). The building has been constructed to fit into the corner of a trapezoid-shaped corner; the NW facade has four arched windows and one door constructed of fireclay bricks 220 x 100 x 80mm in size. The SW facade on West North Street is of grey granite blocks with a central door, flanking pairs of windows and a circular window near the top of the gable.

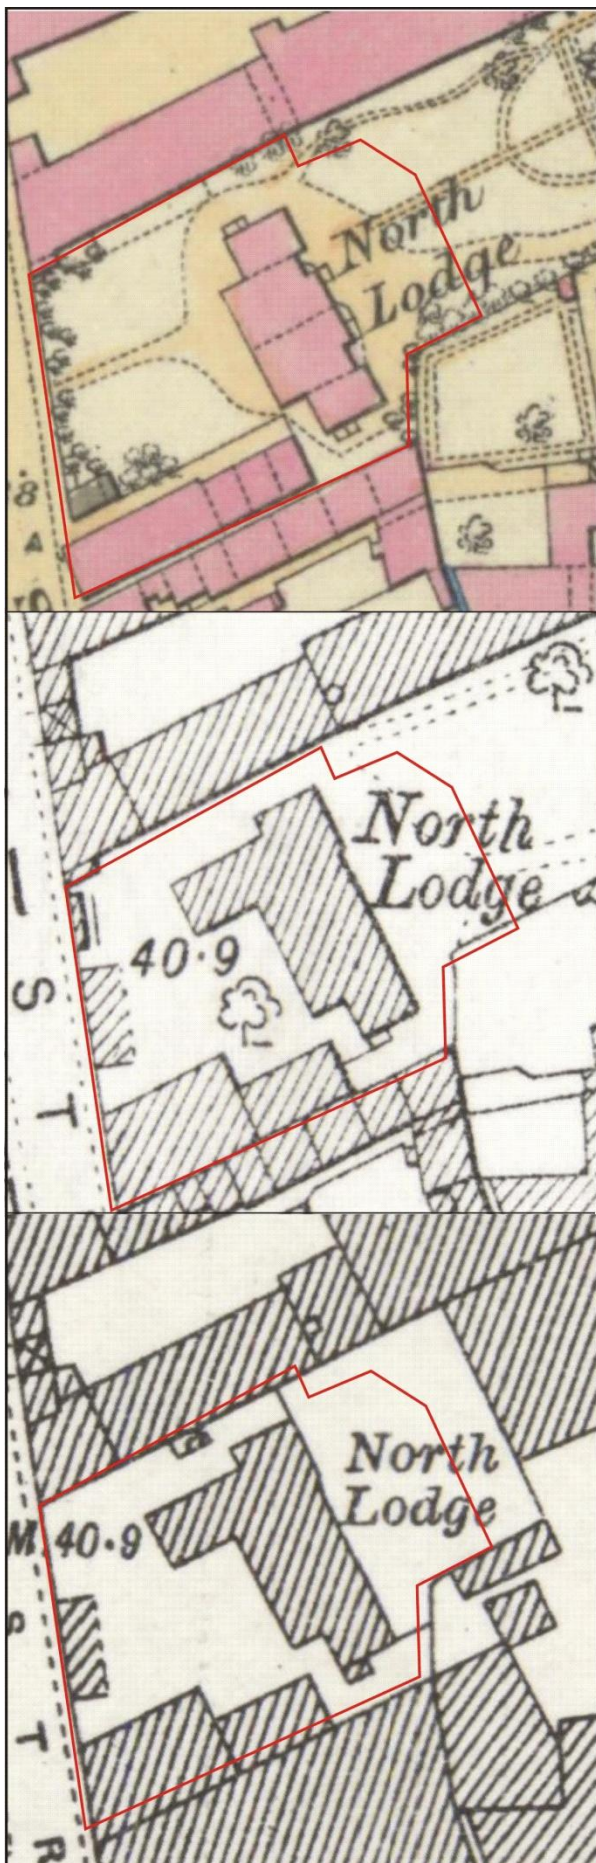
Illus 26 First (top), Second (middle) and Third (bottom) Edition Ordnance survey maps of North Lodge

Three phases have been recorded in Building 1 (North Lodge) and these are reflected in the Ordnance Survey maps (Illus 26). A phase plan (Illus 27) shows the Phase 1 house, possibly 18th century in date and the additions added in the 19th and 20th centuries.
