**Easter Tulloch
Aberdeenshire, AB51 7NB
Report on the Standing Building Survey**

**Alison Cameron
Cameron Archaeology
5 April 2013**

A Level 1 standing building survey was carried out on 26 March 2013 and it is recommended that no further work is required during this development.

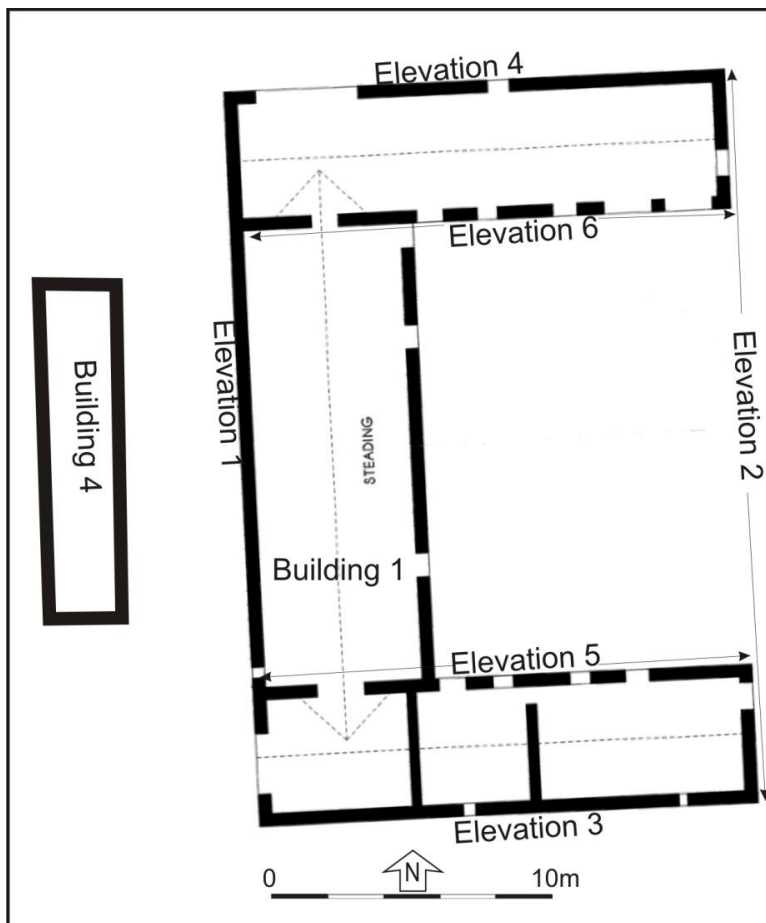
Illus 3 Plan of Buildings 1 and 4 showing location of elevations (Illus 5). Building 1 is to be converted and Building 4 demolished.

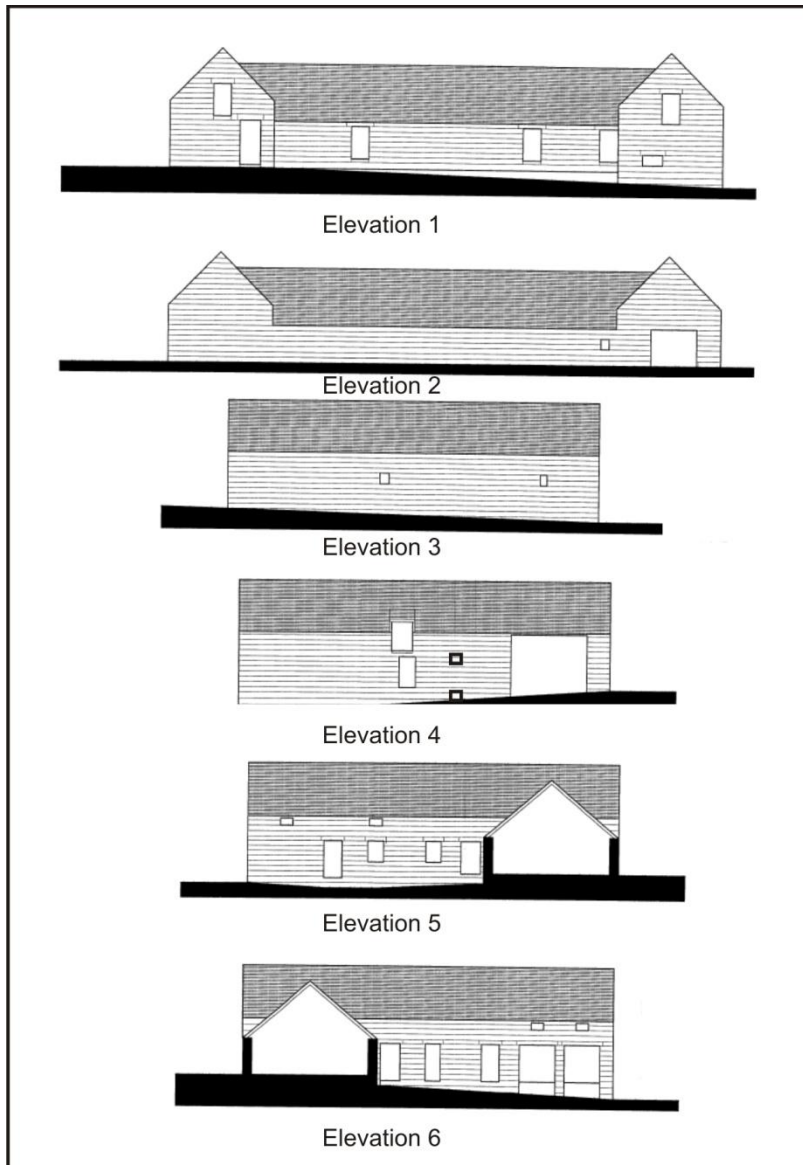
Illus 5 Building 1 elevations

Building 1 is a U-plan standing 24.5m long and the north and south wings are 6.3m wide. The walls are 0.55m thick and are constructed of pink and grey granite blocks and the interior courtyard wall with smaller granite blocks with cherry cocking.

Building 1 appears to have been built in one phase and the north wall of the north wing has two blocked apertures which may have originally held mechanism for a threshing mill. No evidence of that exists in the maps of the farm. There are several replacement doors in the north wing and this has undergone a partial rebuild, probably after the mill mechanisms were removed.
