Standing Building Survey
'The Granary', Ennets Farm, Tornaveen
Torphins, Banchory, AB31 4PE

Alison Cameron
Cameron Archaeology
2 May 2013

Standing Building Survey

The Granary, Ennets Farm, Tornaveen, Torphins, Banchory, AB31 4PE

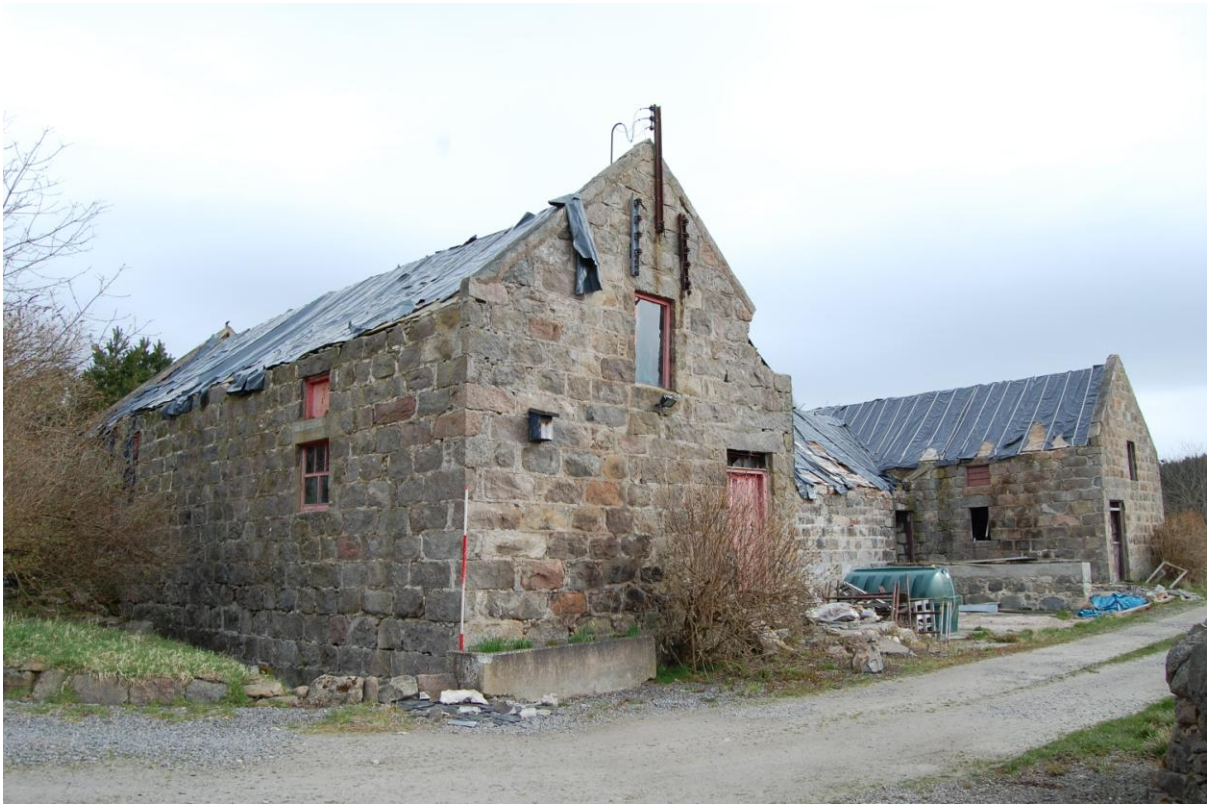
Cover (top) Room 3 (left) the mill building; (bottom) the mill race now culverted with restored wall showing former location of mill wheel
