FYVIE CASTLE, AB53 8JS Watching brief on garden wall repair FYC13/1

Alison Cameron Cameron Archaeology 21 March 2014

From 27th September - 28 October 2013 an archaeological watching brief was maintained during the repair of a garden wall. The wall was recorded and characterised but no reused stonework was identified and the wall was then repaired and restored. It is recommended that no further archaeological work is required during this work.

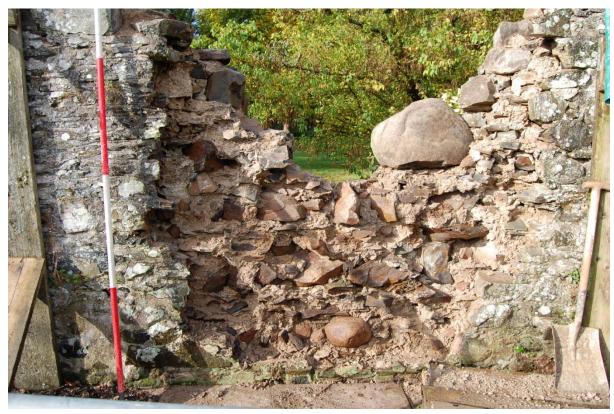
Cover The main section of repaired wall (top) facing west; (bottom) section facing NW

The wall is 2m high and 0.45m wide and is constructed mainly from small and medium fragments of slatey stone which formed much of the facade of the wall and some of the core. Large and medium granite fieldstones were also used in the wall (Illus 4). As a result of the poor quality of the stone and its proportions there were areas which required to be dismantled and rebuilt. Several areas were dismantled and the stone were inspected but no red sandstone or other reused stone was identified.

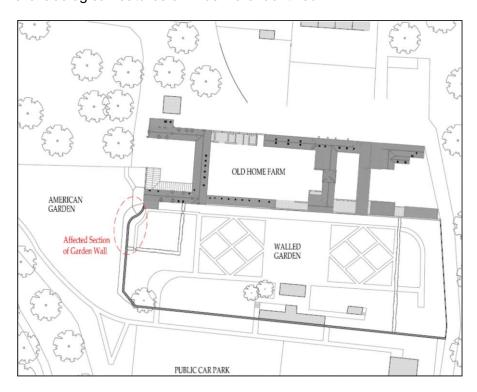
Illus 2 Plan showing location of the works (NTS OS licence 100023880)

Cameron Archaeology maintained a watching brief in September and October 2013 during the preparation for, dismantling and repair of a garden wall between the Old Home Farm walled garden and the American Garden (Illus 2, 3).
