**MILTON OF GARLOGIE, GARLOGIE, ABERDEENSHIRE,  
AB32 6SD  
LEVEL 2 STANDING BUILDING SURVEY REPORT**

**Alison Cameron  
Cameron Archaeology  
12 June 2014**

The Level 2 Standing Building Survey was carried out on 10 June 2014. A full series of photographs were taken and architects plans and illustrations used to chart several phases of development.

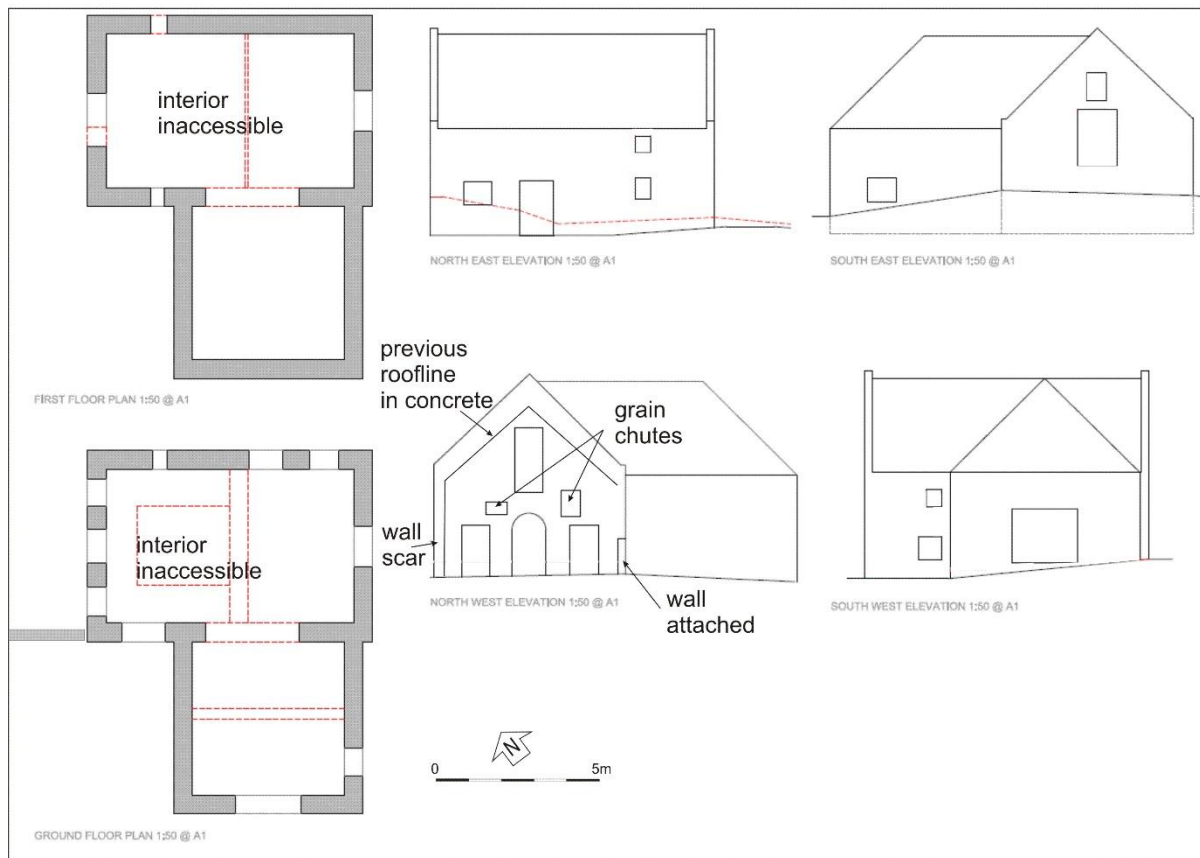
Illus 8 Building 3 (copyright Archial Norr)

The old mill building is in very poor condition with collapsing roof and therefore no access to the interior. The older section of the building on the NE is 6.2m wide and 10.3m long (Illus 8) and constructed in a similar style to Building 2 with roughly faced granite blocks and cherry cocking. When it was originally constructed it was twice the length and originally ended adjacent to the lade (now infilled) where there was presumably a mill wheel. The NW end of the surviving building (Illus 10-11) shows a scar in concrete of a lower roofline where the NW end of the building has been removed. This wall has a central arched doorway (mostly obscured by boards), two low doors on either side, a large upper doorway and two grain chutes from the first floor to the ground floor. The northern example is wood and the southern example is concrete (Illus 11). There is a post-1900 extension on the south side of the building. A mill wheel is lying at the east end of the building (Illus 12).

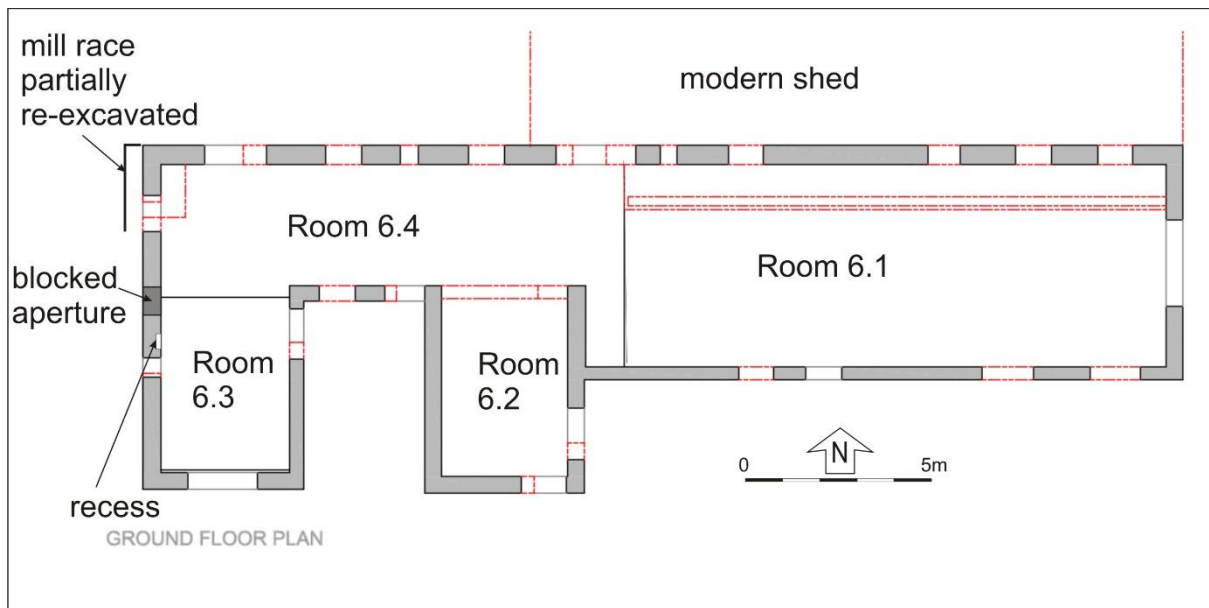
The steading is constructed of large granite roughly dressed blocks with cherry cocking. It is 33.8m long and 8.5m wide the east end (Illus 17, 18). There is a double gable extension on the south side with a small courtyard between Rooms 6.2 and 6.3. At the second Edition OS (1900; Illus 25) there is a building constructed in that courtyard and the roofline scars can be seen on the adjacent walls. The west end of the building was constructed onto the eastern arm of the lade and there was presumably a mill wheel on the exterior of the west wall but there is now no trace. There is a blocked aperture in the centre of the west wall (Illus 22) which probably housed the wheel. There has been some excavation work at the west end and stones removed from the mill lade revealing the remaining structure of the mill race (Illus 24). After use as a mill this building was converted for general agricultural use.

Illus 17 Building 6 plan showing blocked aperture and mill race on west wall (*copyright Archial Norr*)

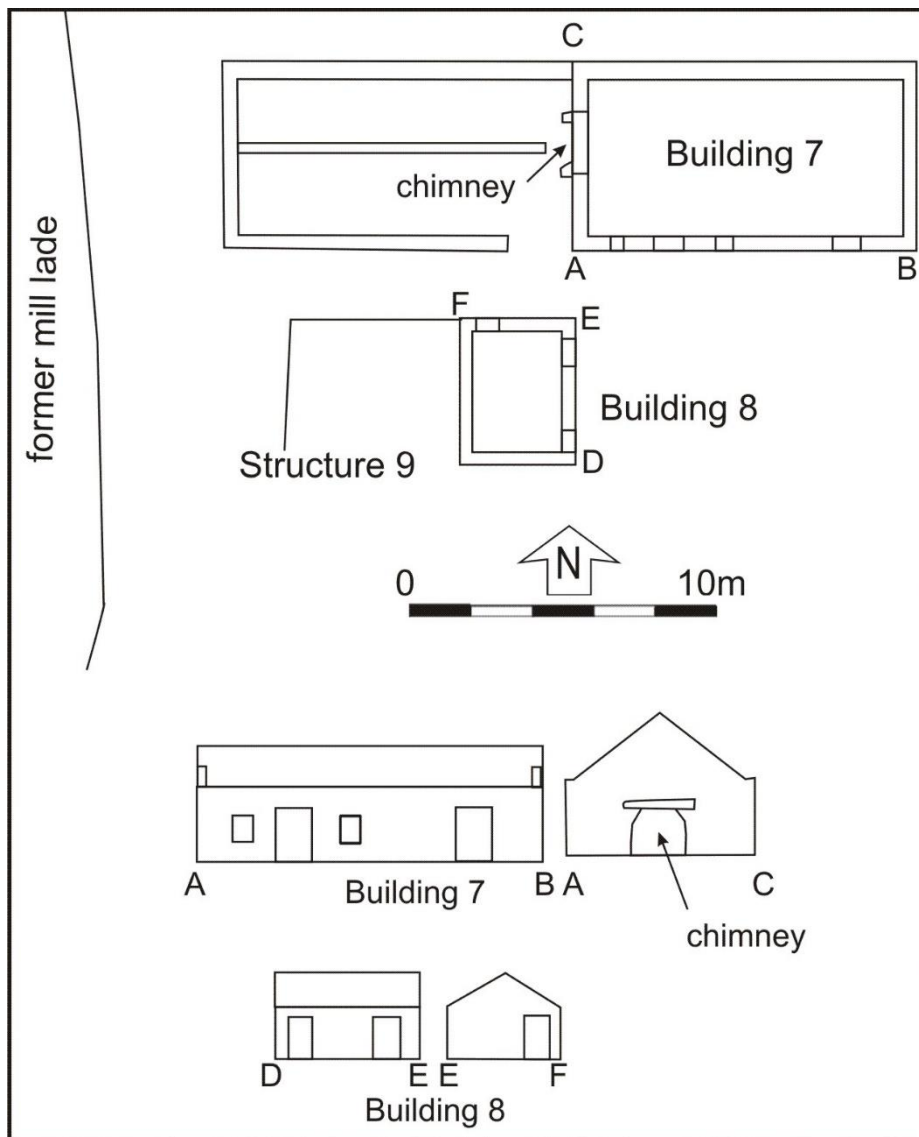
Illus 25 Buildings 7 and 8 plan and elevations

Building 7 is in a very poor condition, very overgrown and with no access to the interior. It was originally at least 24m long and 6.7m wide and constructed of granite roughly dressed blocks and cheery cocking. The walls of the east half of the building survive but there has been partial demolition of the west half and rebuilding in wood. There is an exposed chimney on the central wall (Illus 25, 28). This building is on the First and Second Edition OS maps between the east and west branches of the mill lade (Illus 34, 35).

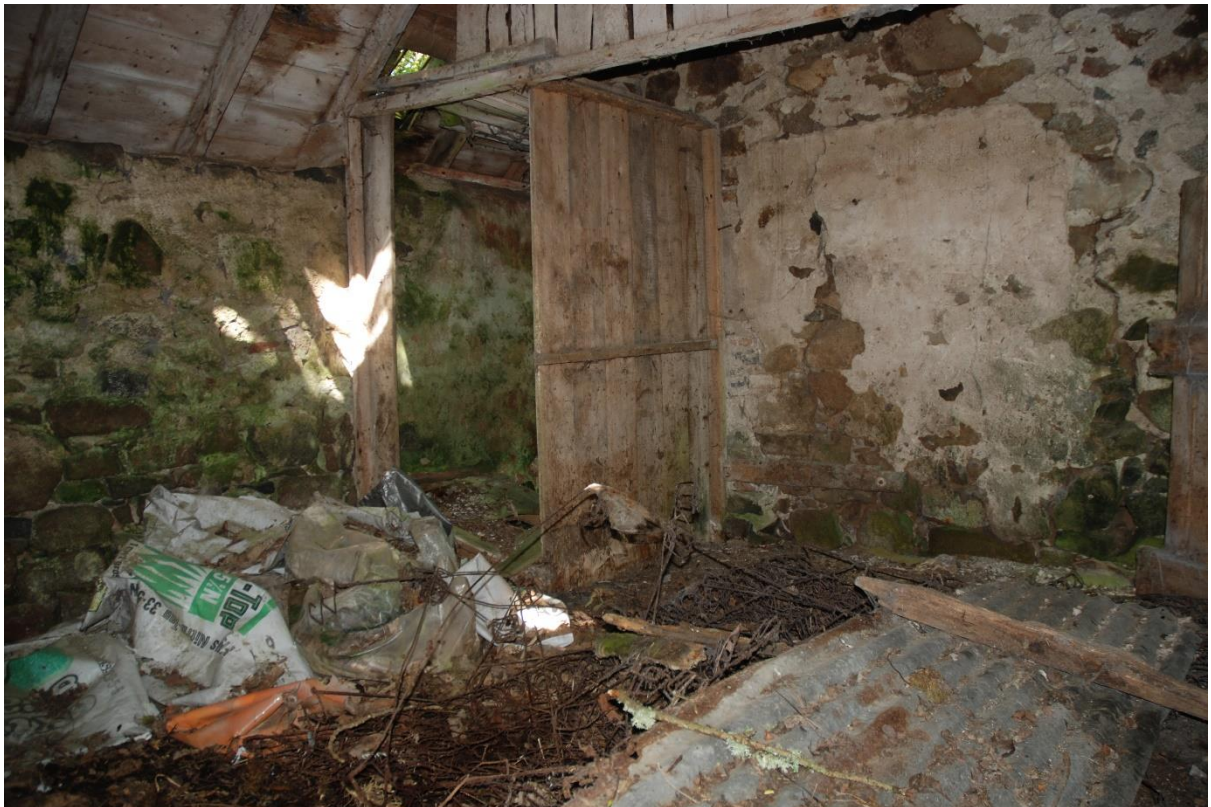
Building 8 is in a very poor condition, very overgrown and with no access to the interior. It is 5m long N-S and 4m E-W and constructed of granite blocks and cherry cocking (Illus 29). It was constructed after the First Edition OS map and prior to the Second Edition.

Illus 30 Bothy Building 8 interior; facing NW
