**Ley Farm, Crathes, Banchory, AB31 5QD
Report on Level 1 Standing Building Survey**

**Alison Cameron
Cameron Archaeology
14 November 2014**

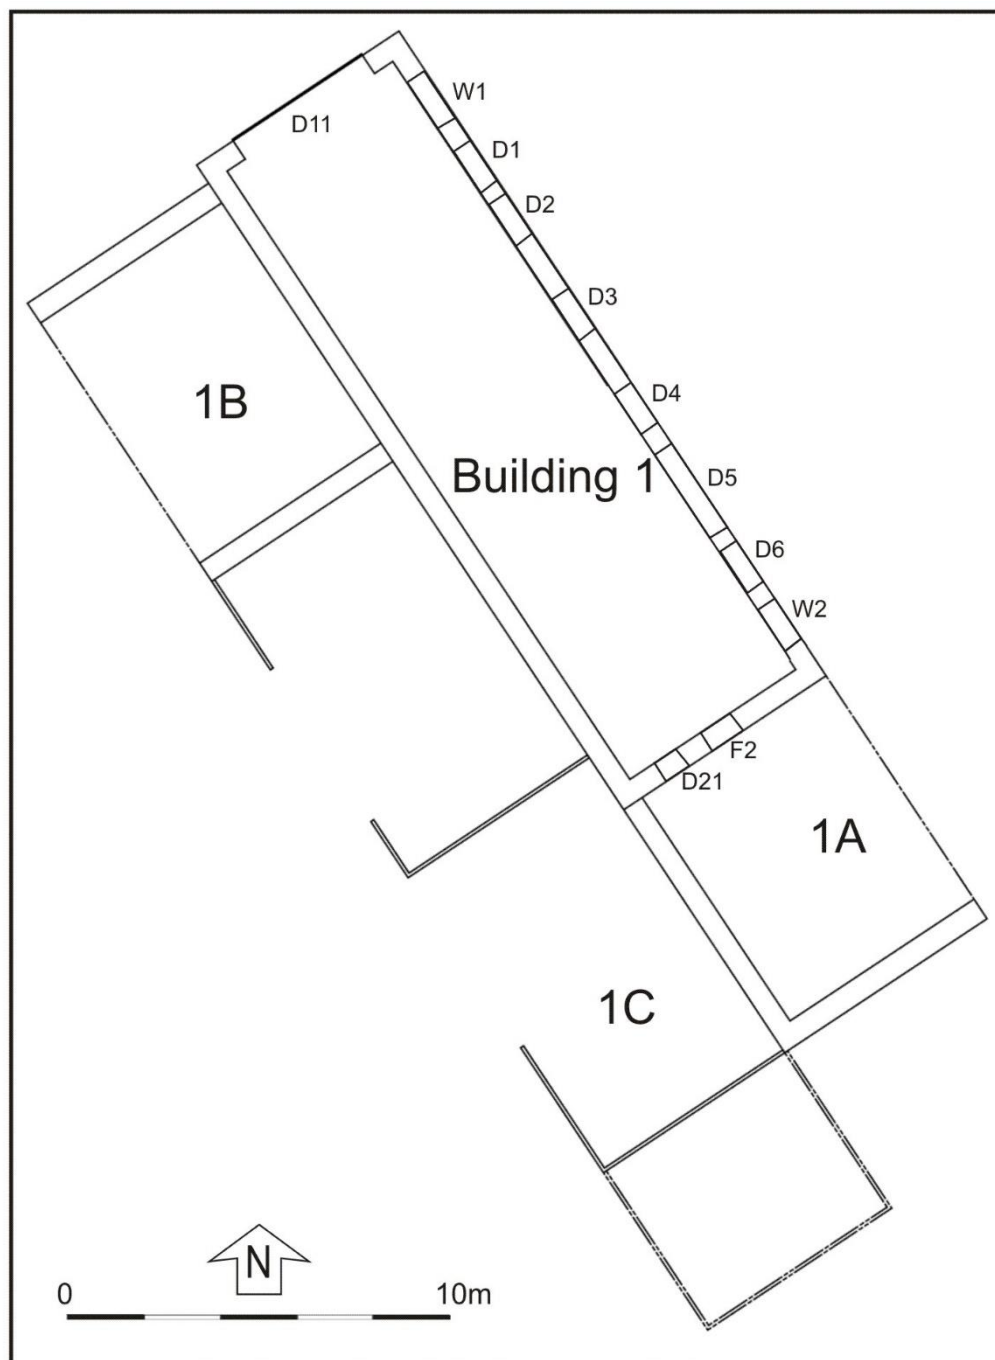
Illus 3 Plan showing Building 1 with rooms and main features (based on copyright Ian Duncan Architects)

Building 1 is 27.6m long and 9.85m wide and is constructed of large blocks of quarried granite with concrete floor. Room 1 is the main steading building and has two windows and six doors on the NE wall (Illus 3, 4) and one blocked on the SE wall (D21). All but W2 have been blocked with concrete brick or breezeblock. W1 and Doors 1-5 and 21 are all blocked with concrete blocks inscribed with 7-43 (Illus 7, 8) possibly representing the date of infill.

Door 11 is a modern aperture but there is a chimney above the gable indicating that the NW end of the building also housed a fireplace when the building was originally constructed. A blocked aperture in the centre of the SE wall (F2) is a blocked fireplace and this together with the small door and window (D6 and W2) suggest that the SE end of this building may originally have been a bothy for housing farm staff. There is the remains of a chimney on top of the SE gable above the fireplace.

It was not present on the First Edition OS map and was therefore constructed in the late 19th century. On the Second Edition it consists of one room with small outbuildings unattached but by the 3rd Edition Rooms 1B have been constructed and are roofed; the roof had been removed by the time of this survey. Room 1A appears as an unroofed enclosure on both later OS maps.

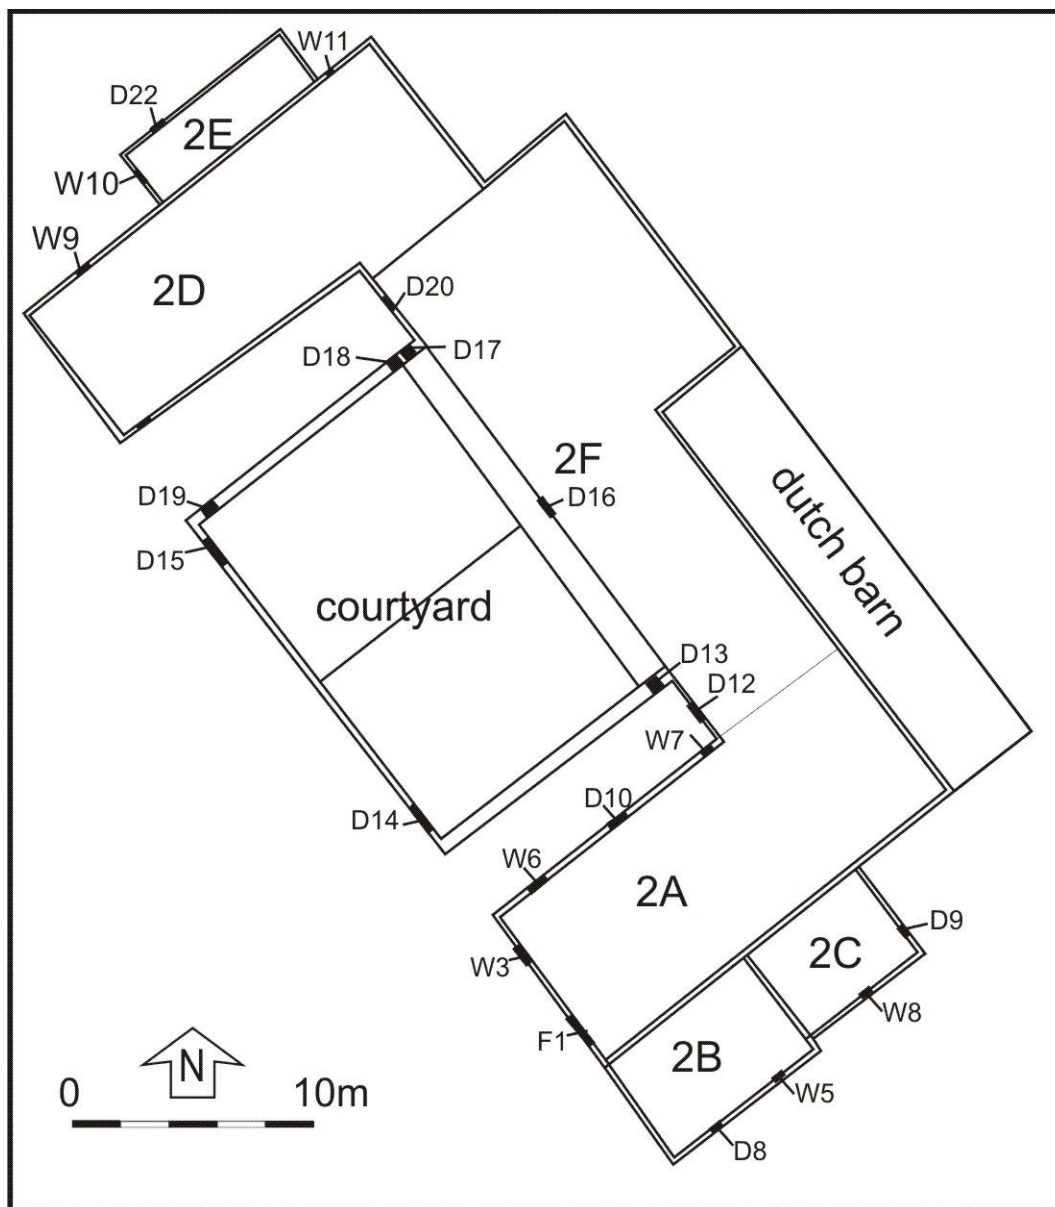
Illus 12 Building 2 plan showing main features recorded

Building 2 consists of a C-shaped steading (formed by rooms 2A, 2F and 2D; Illus 12) around a central open courtyard with several small additions on the NW, NE and SE sides. A modern Dutch barn is attached the NE side of the building next to the fence line. The earliest phase 2A and 2D area harled gabled wings constructed of granite fieldstones. Each has an upper doorway in the SW gables and the SW gable of 2A has a scar which may have been the attachment for a forestair (Illus 13, 14). The Phase 2 additions (2B, 2C and 2E; Illus 15, 16) are constructed of quarried granite blocks with pink granite lintels and quoins. The Phase 3 walls forming the SW, NW and SE walls of the courtyard are constructed of large quarried pink granite blocks (Illus 17).

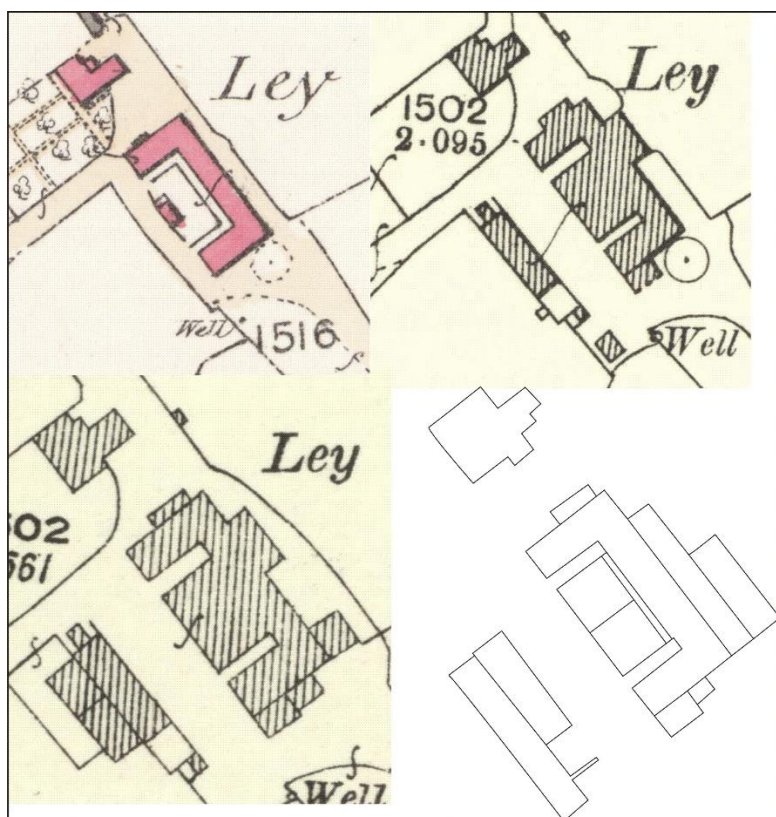
Illus 18 Phase plan showing Ordnance Survey 1st Edition (top left) 2nd Edition (top right) 3rd Edition (bottom left) modern plan (bottom right)

The First Edition OS map shows Building 2 as a C-shaped steading with a small building at the entrance to the courtyard. A horse mill has been constructed on the SE corner of the building. By the 2nd Edition the courtyard walls have been constructed and the courtyard roofed with Buildings 2B, 2C and 2E constructed and the horse mill is still in use. By the 3rd Edition all the buildings are still, in use but the horse mill is no longer present. The wall adjacent to the horse mill is harled and there is no evidence for this structure in the current buildings.
