**East Town Farm, Drumlithie
Aberdeenshire, AB39 3YR
Report on Level 1 Standing Building Survey**

**Alison Cameron
Cameron Archaeology
16 June 2015**

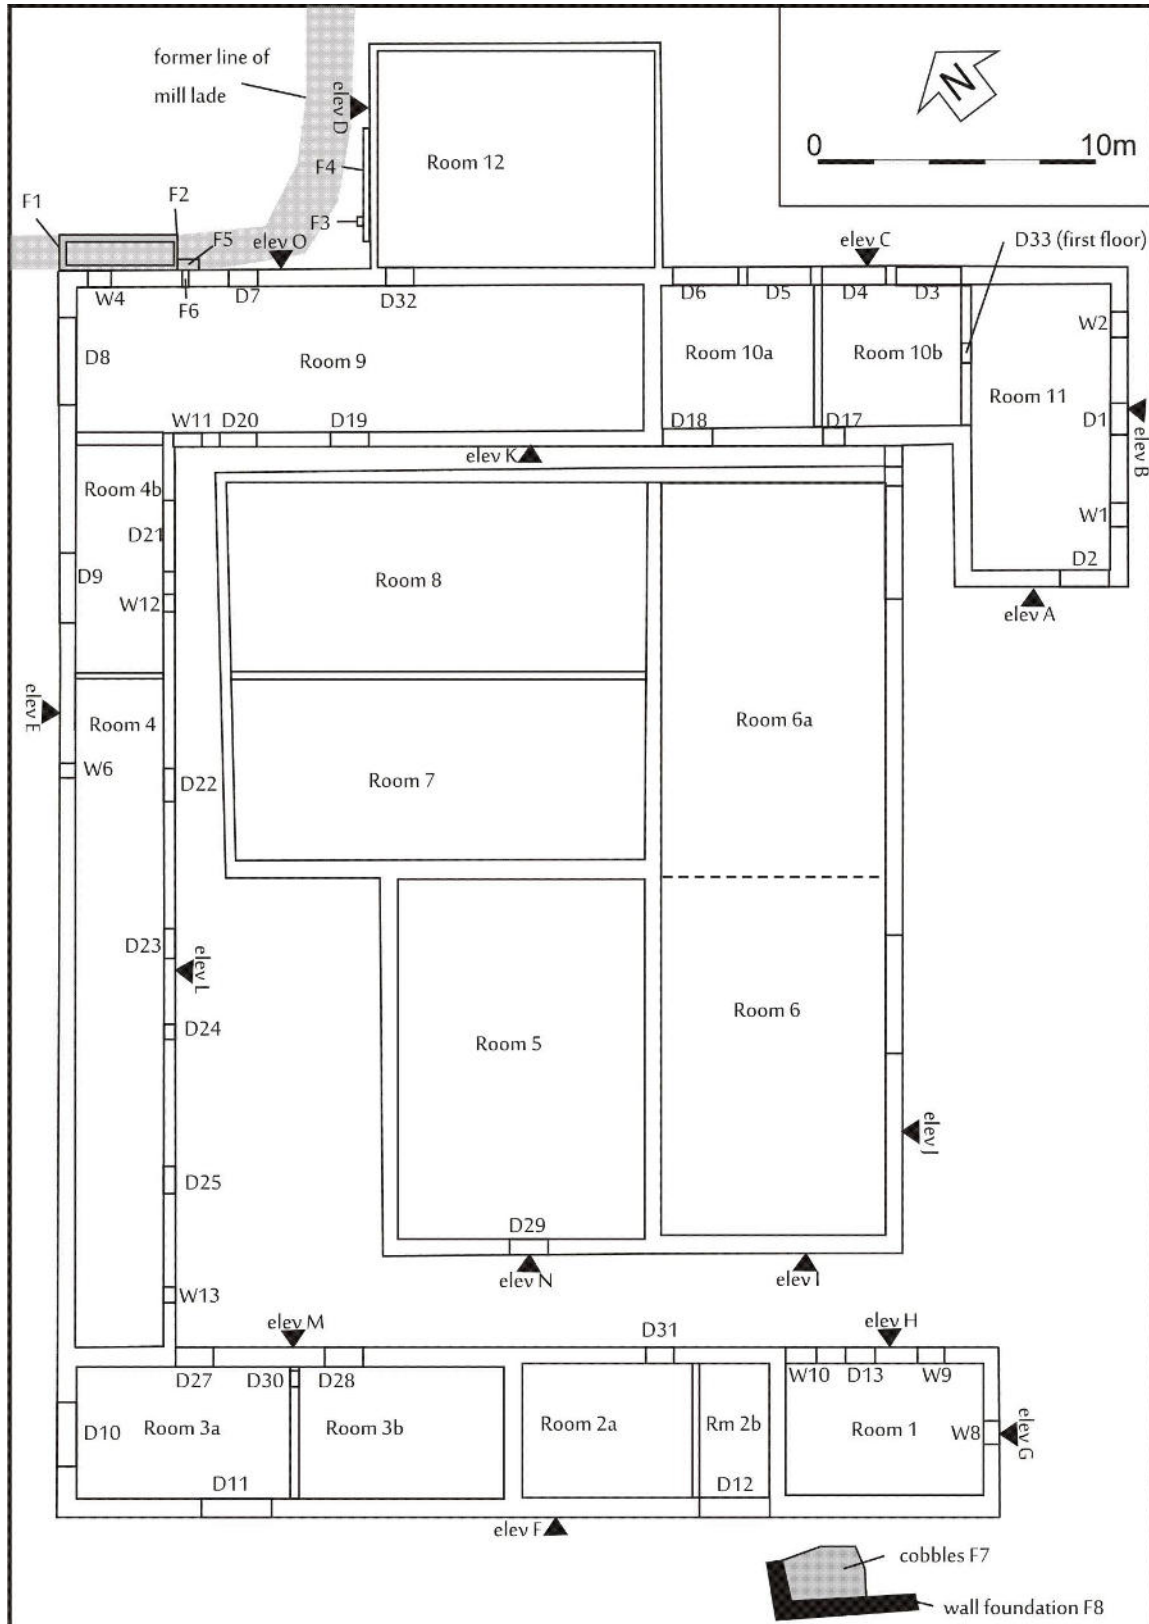
Illus 2 Plan of steadings annotated with numbers used in this survey (from copyright Project Management Scotland Ltd)

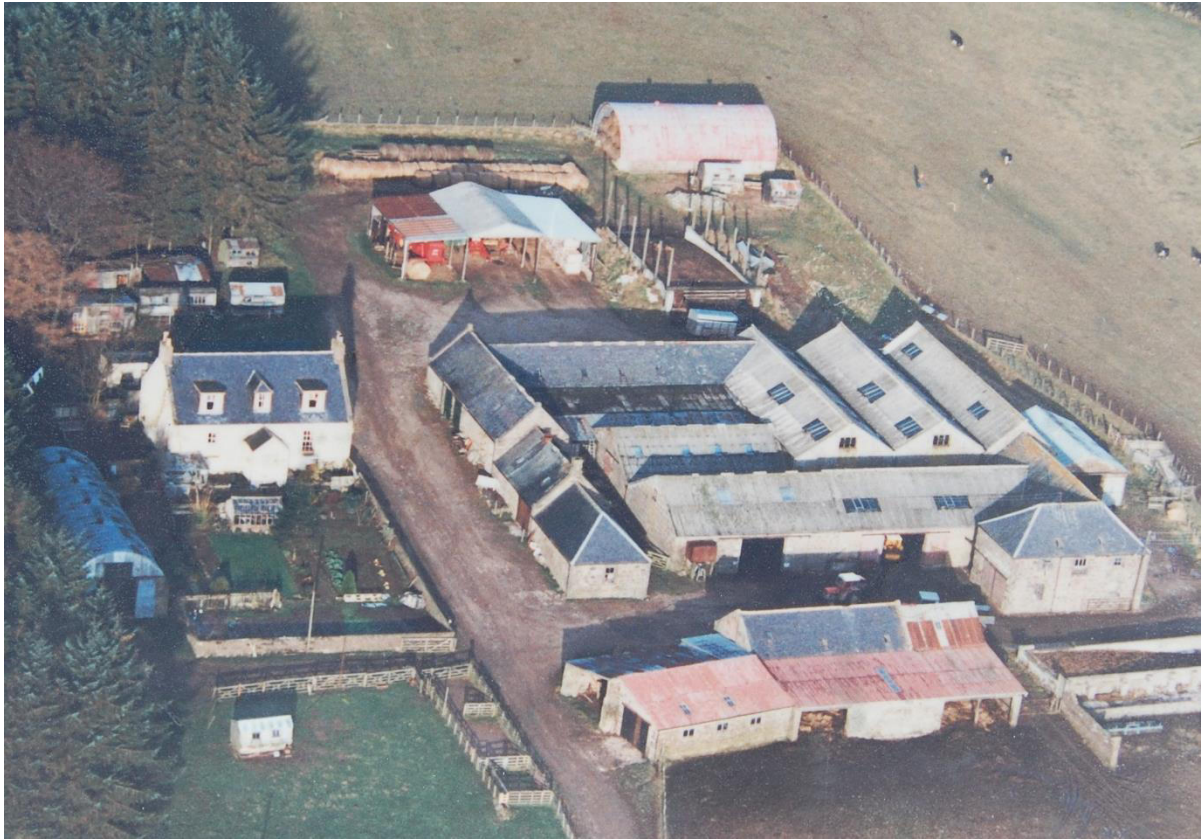
Illus 3 Copy of photograph of farm in 1980 showing buildings prior to collapse of roofs and dereliction of Rooms 4-8; facing N

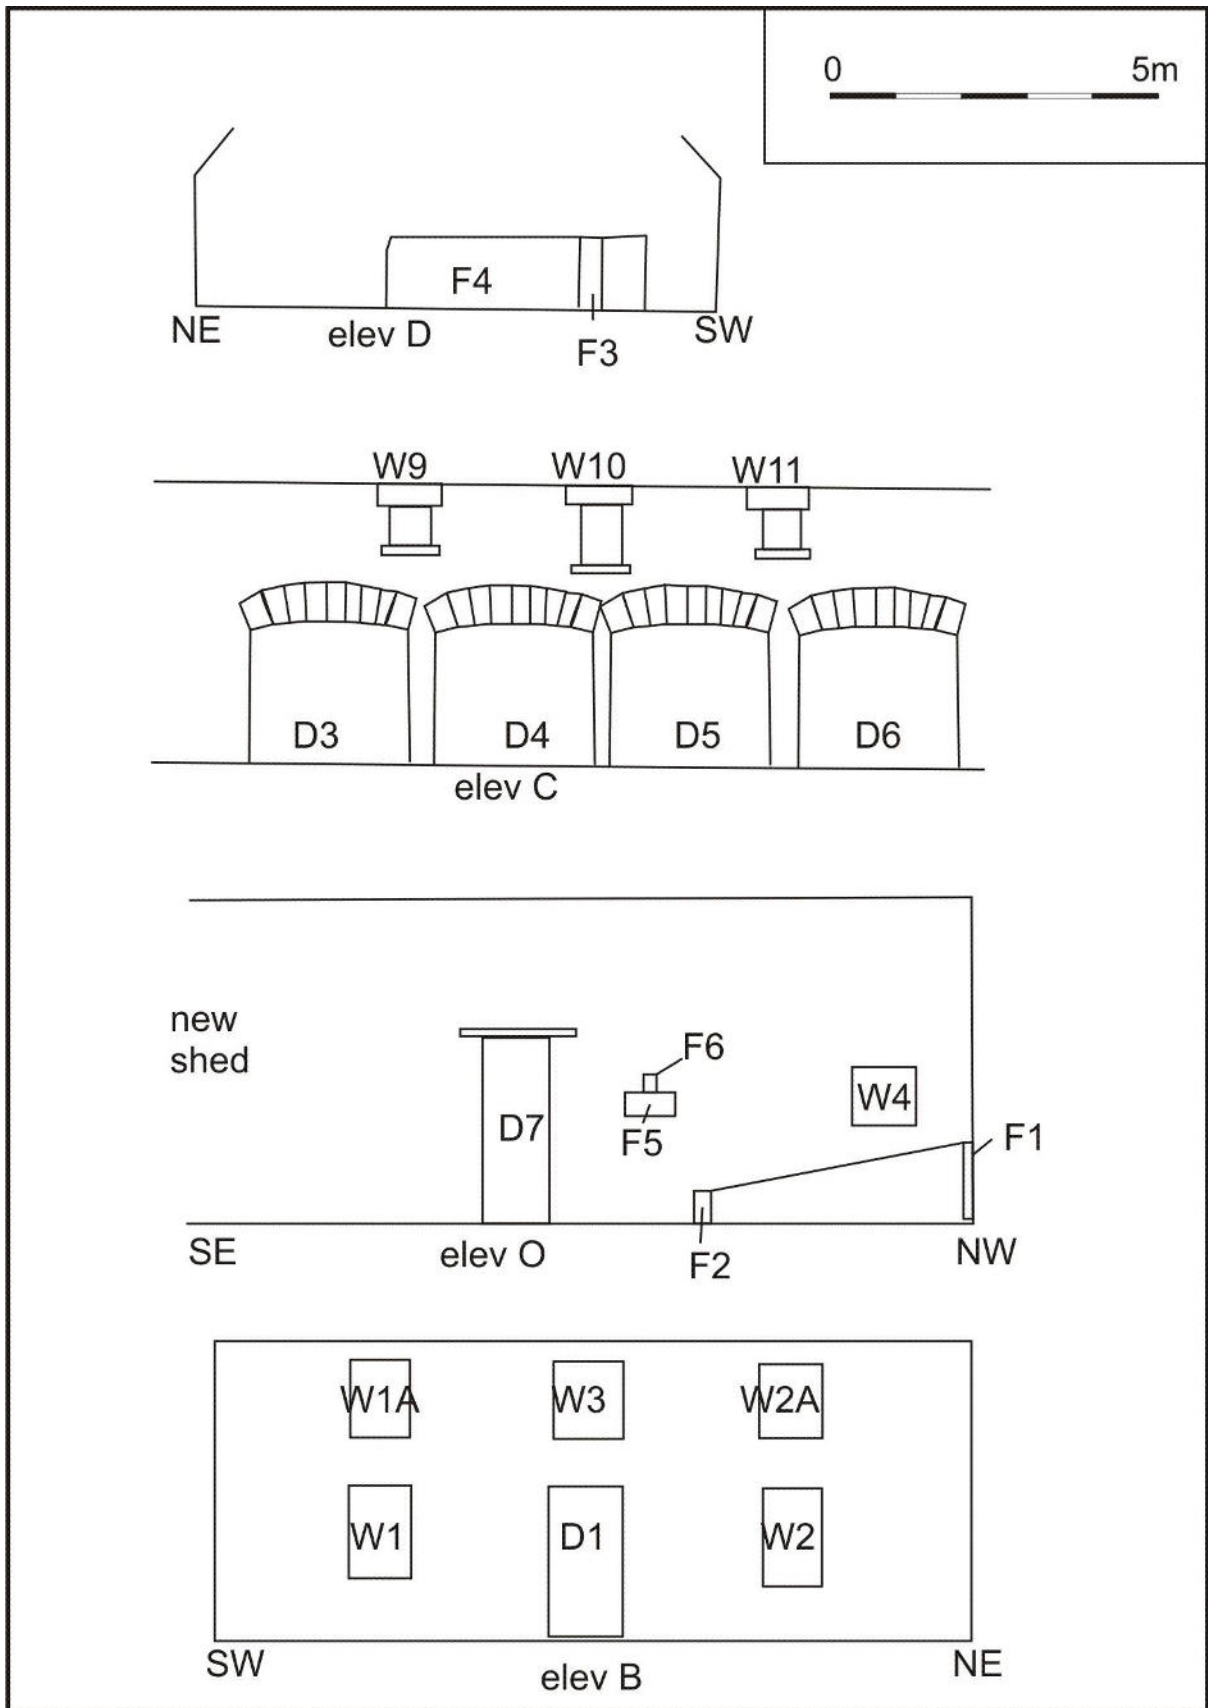
Illus 17 Elevations B, C, D and O

The NE façade has four granite cart doors (Illus 11, 17) and some of these have been blocked with breeze blocks in a later period.

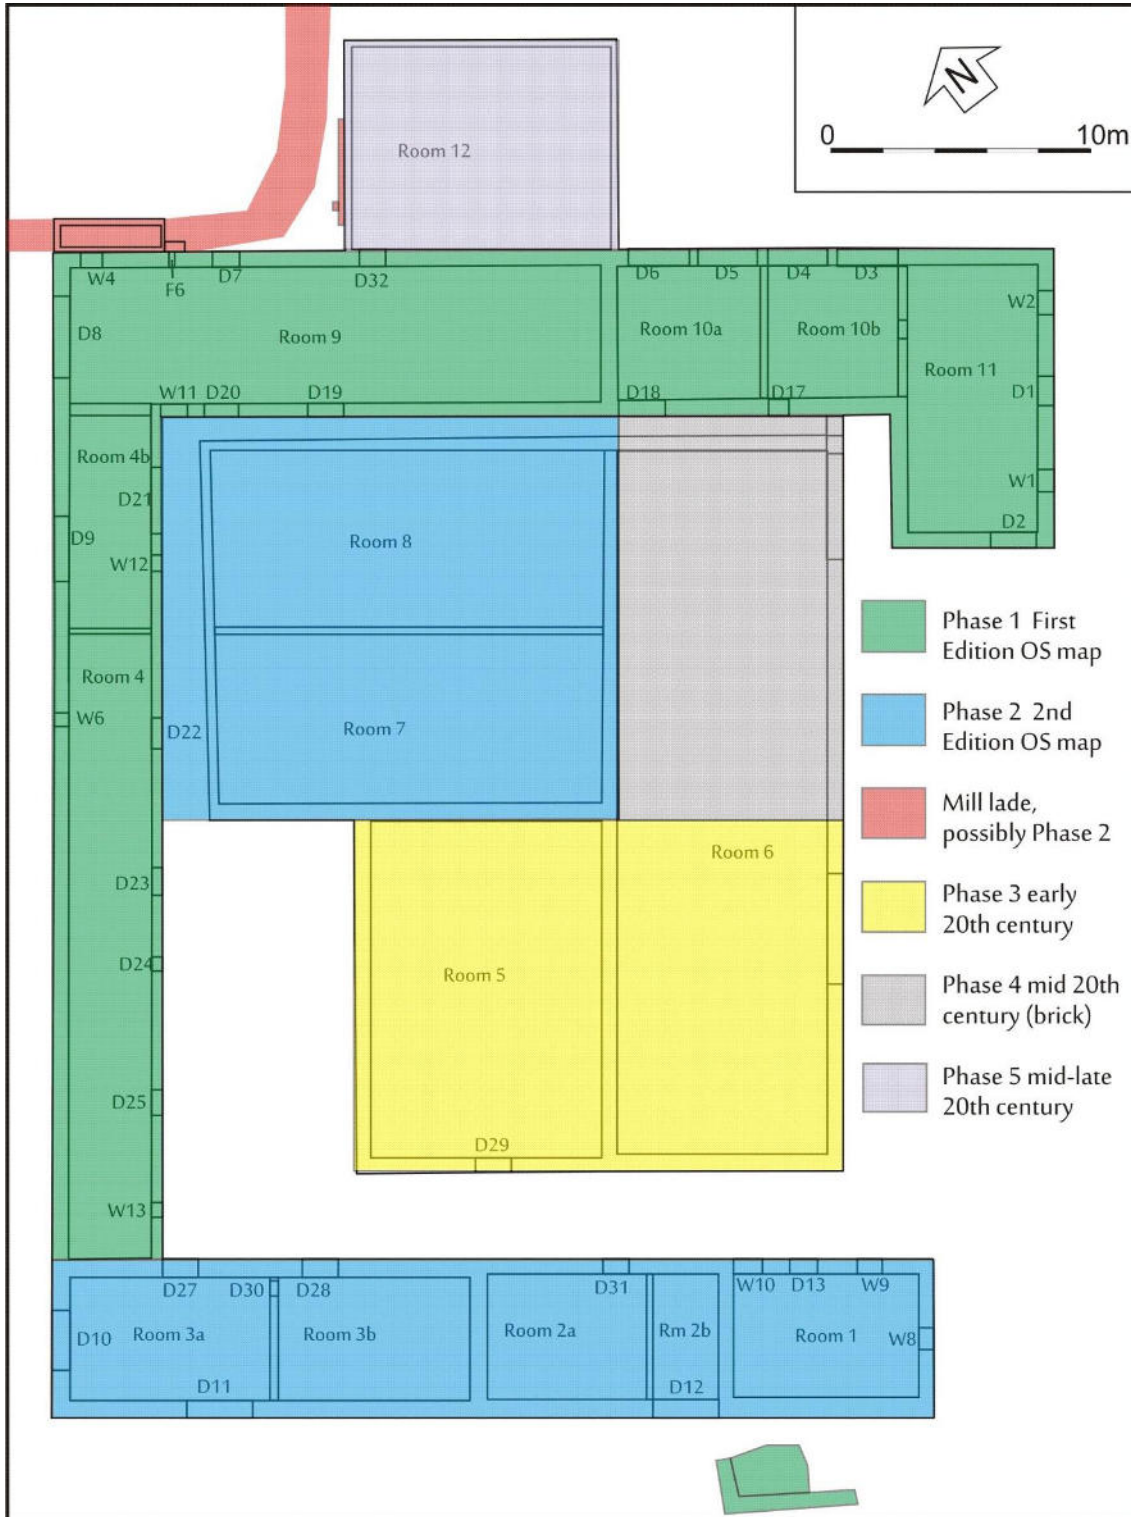
Illus 23 Phase plan showing development of the buildings (from copyright Project Management Scotland Ltd)

A Level 1 standing building survey was carried out on 10 June 2015; the weather was clear and bright. All exterior and interior walls were recorded photographically and architects plans were annotated. All main elevations and architectural details were drawn. At least five phases of construction were recorded (Illus 23). It is recommended that no further work is required during the proposed development.

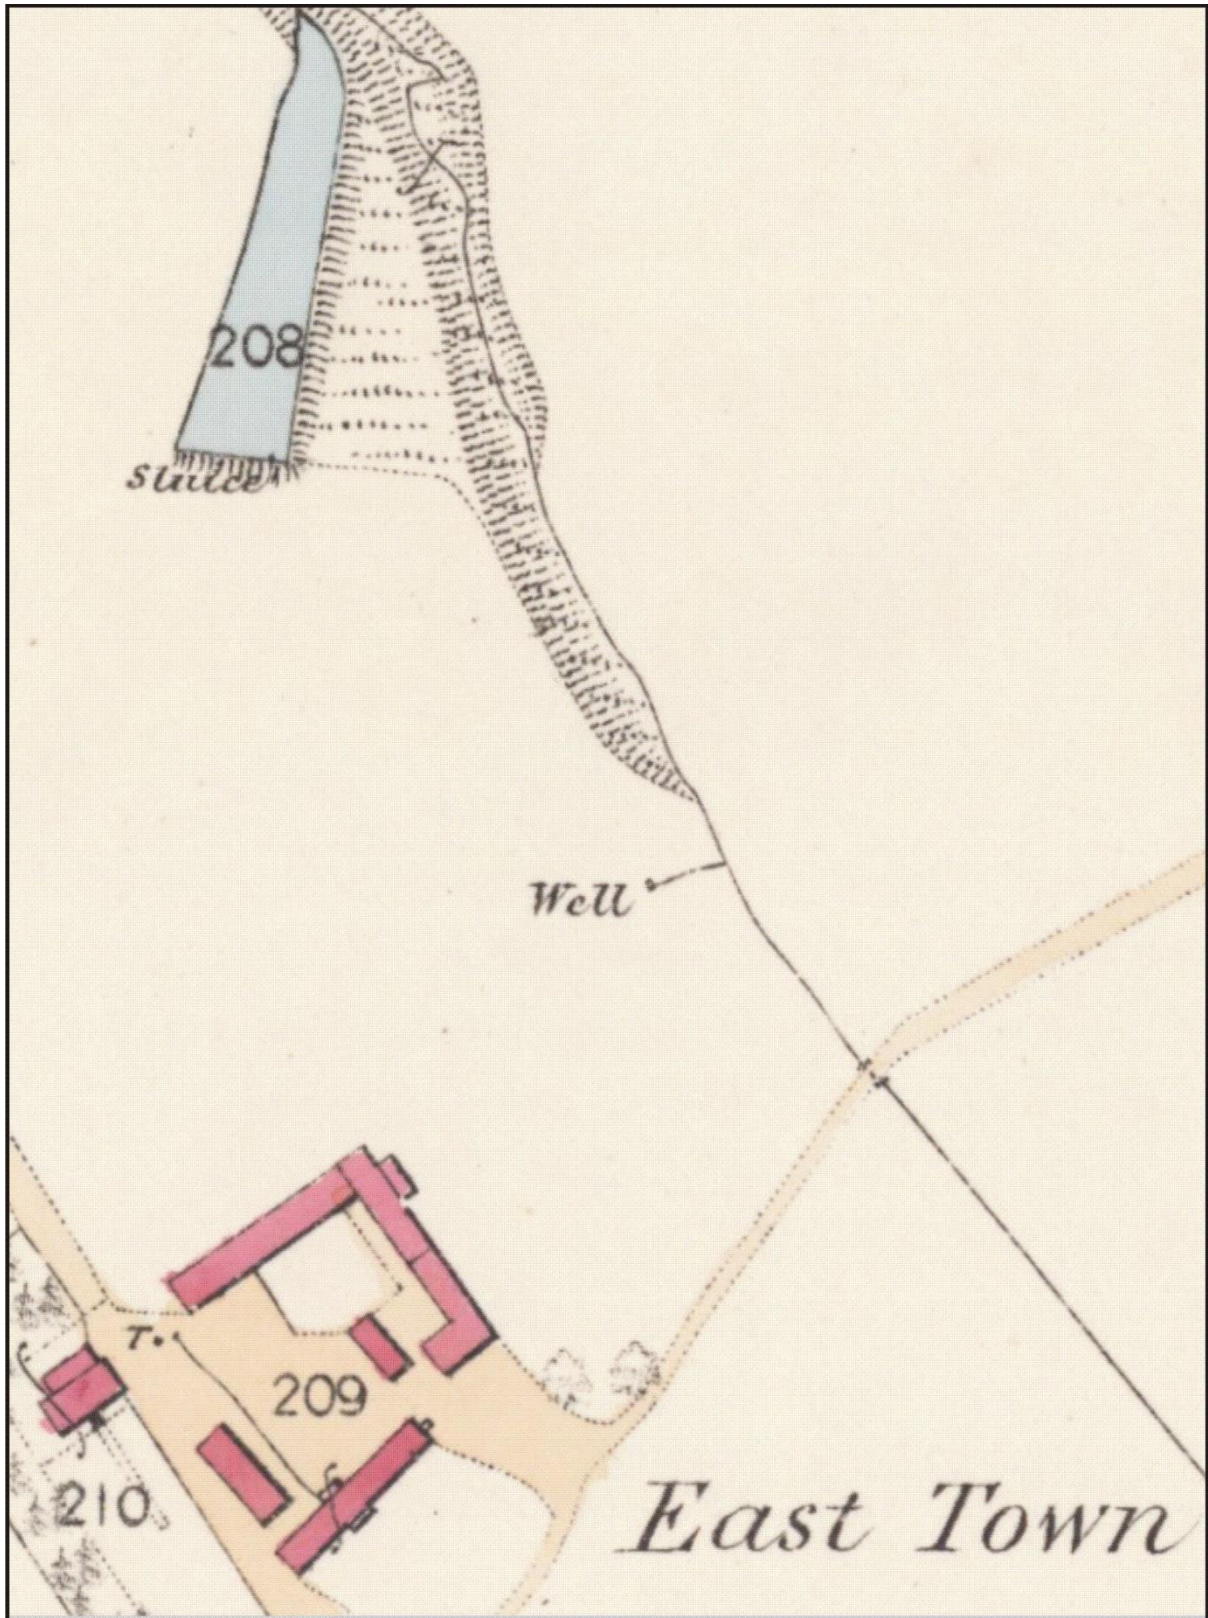
Illus 24 First edition OS map showing mill lade (top) Kincardine Sheet XVI.7 (Glenbervie) Survey date: 1864 Publication date: 1868 (copyright National Library of Scotland)

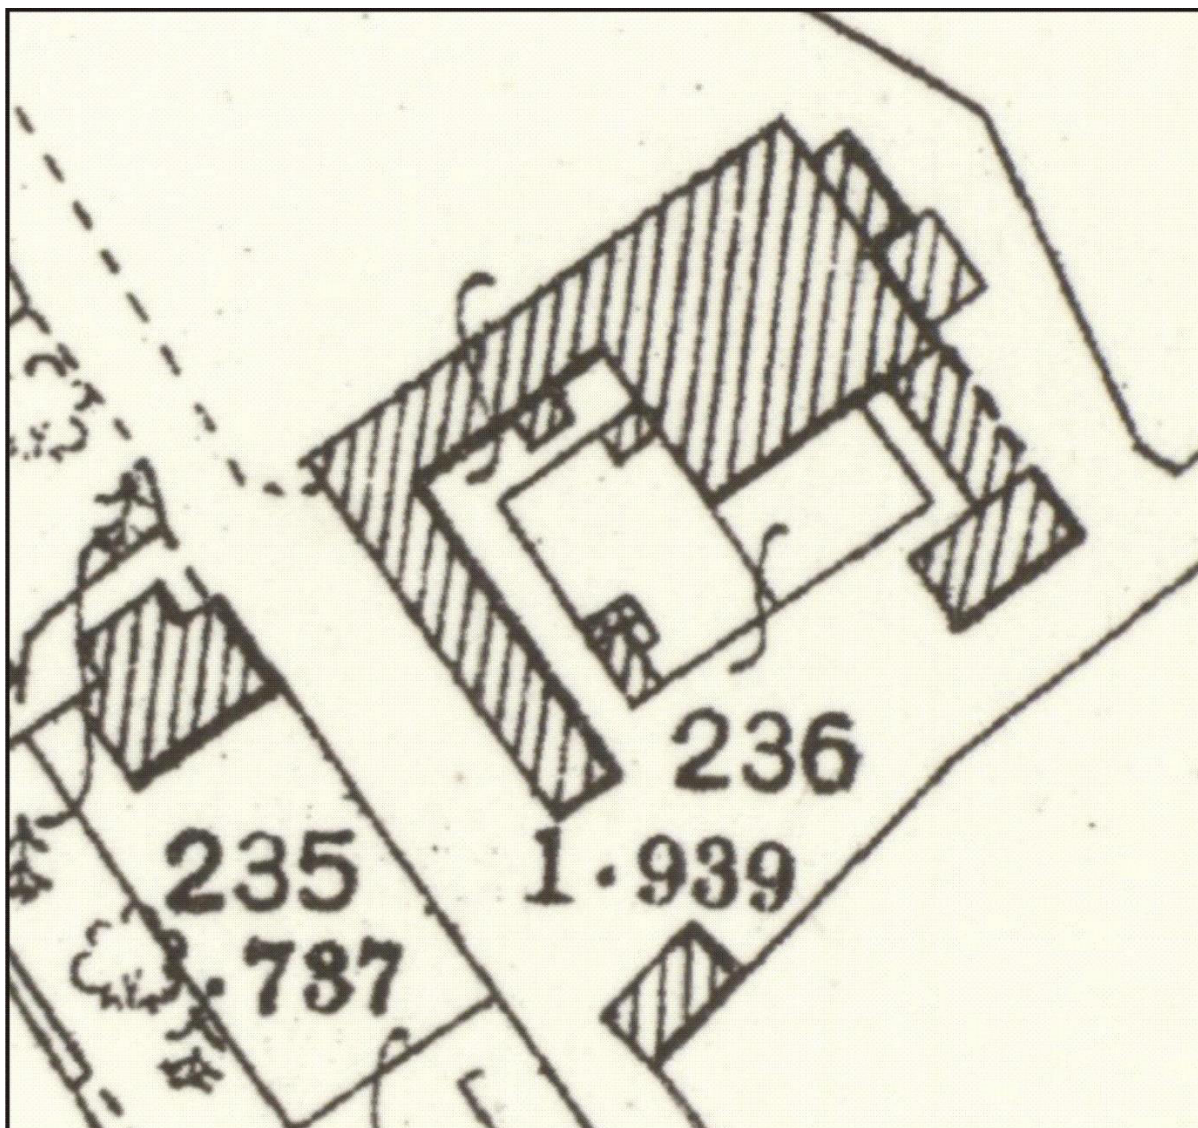
By the date of the 2nd Edition OS map (Illus 25) the detached SW wing has been demolished (F7, F8) and a SW wing attached to the SW end of Room 4 (Illus 21). This includes further steadings and a bothy at the south corner (Room 1; Illus 22). The waterwheel may have been added in Phase 1 or Phase 2. A fragment of wall (F3 and F4; Illus 12, 17) was built into a Phase 5 room (Room 12); it is the remains of a small building adjacent to the waterwheel on the 2nd Edition OS map.

Illus 25 2nd Edition OS map. Kincardineshire 019.04 (includes: Glenbervie)
Publication date: 1903 Revised: ca. 1901 (copyright National Library of Scotland)
