**Thainstone House Home Farm, Thainstone,
Inverurie, AB51 5NT**

Report on Level 1 Standing Building Survey

**Alison Cameron
Cameron Archaeology
26 June 2015**

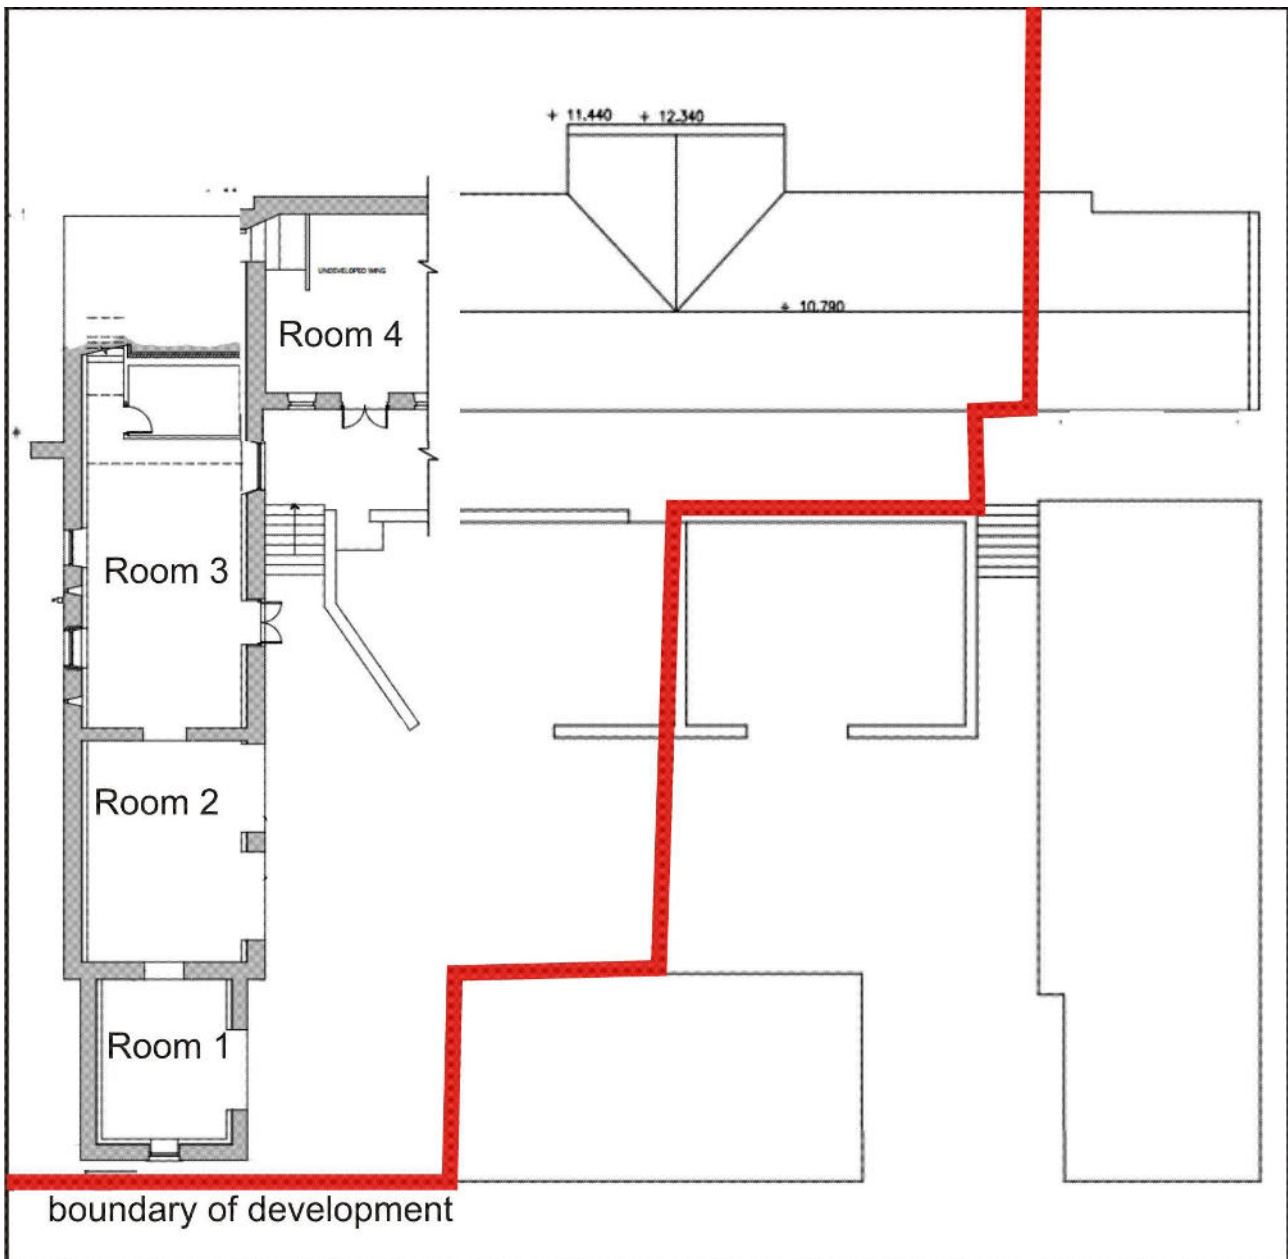
The steading was constructed in one phase in the early 19th century. There is a SW, NW and NE ranges around a central courtyard and a bothy on the SE side (Illus 2). This application concerns the SW and part of the NW ranges only as the other buildings have been converted previously.

Illus 2 Plan of development showing layout of steadings and rooms (copyright Ian Duncan Architects)

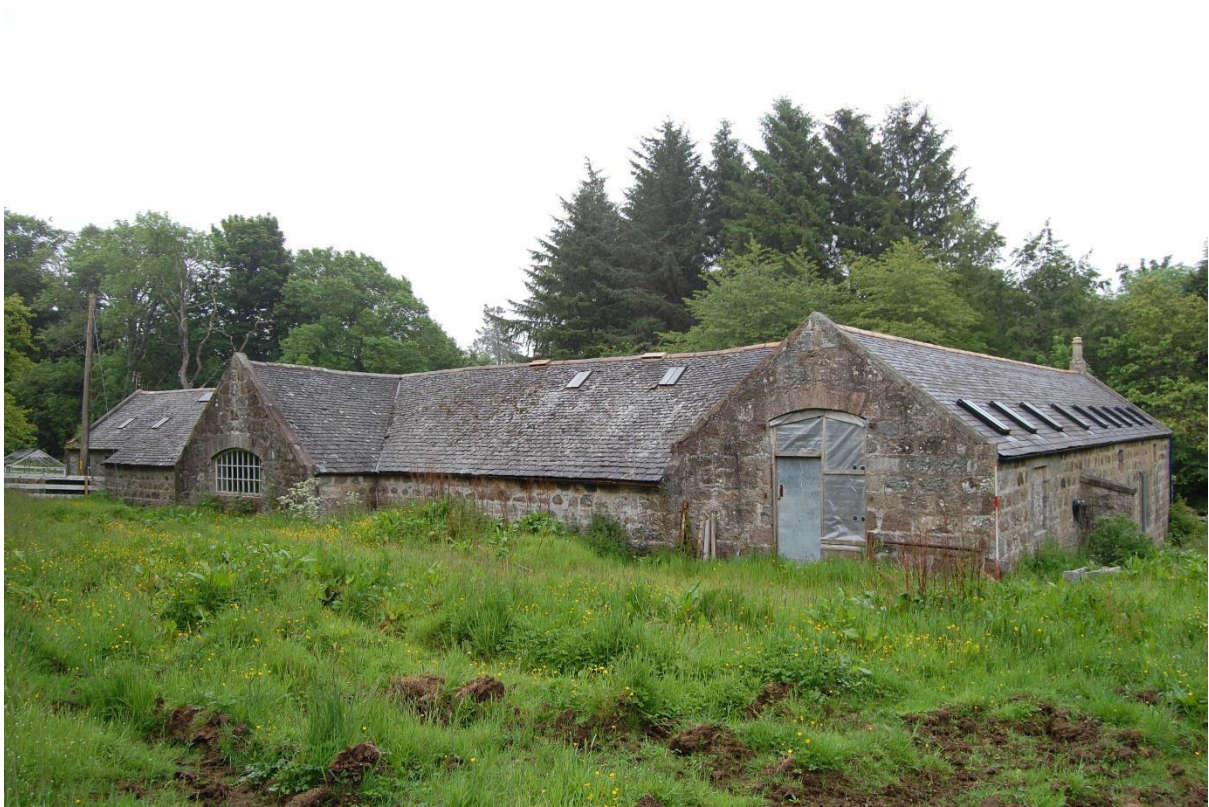
Illus 9 Steading from W; facing E
