**Plot G, Walled Garden House, Wardhouse Estate,  
Kennethmont, Huntly, AB52 6YL  
Report on Level 1 Standing Building Survey**

**Alison Cameron  
Cameron Archaeology  
30 June 2015**

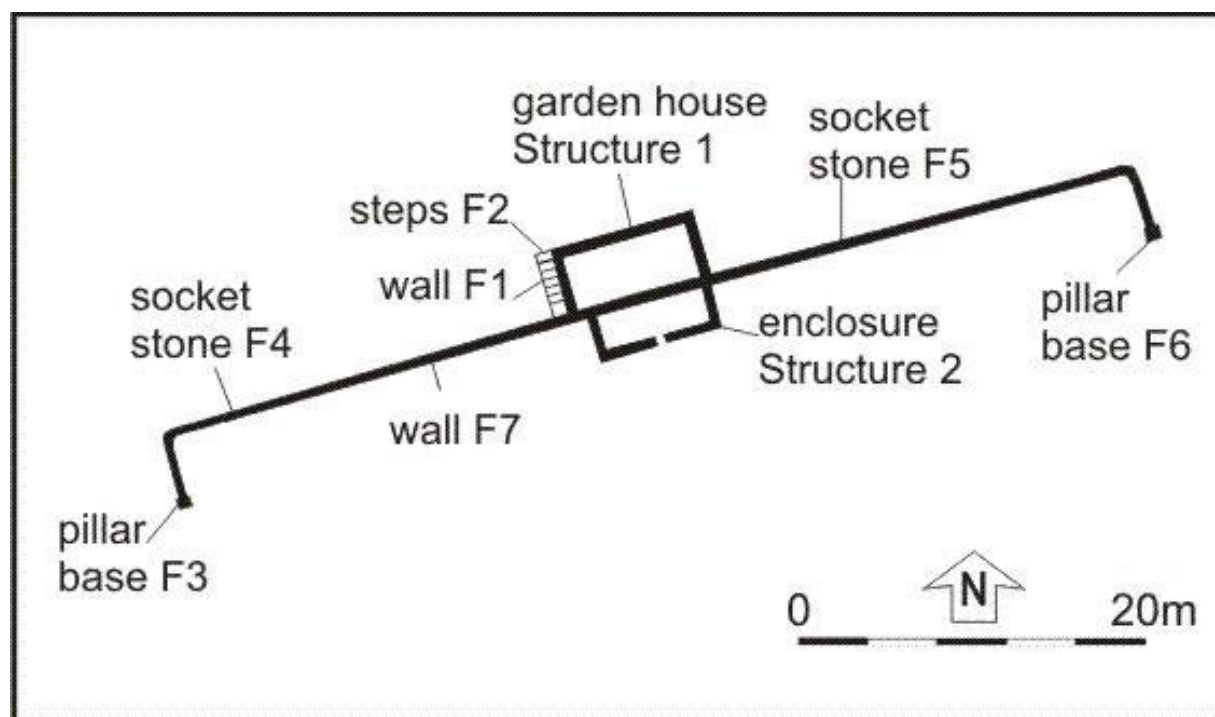
Illus 3 Plan of features recorded

The NNW wall of the former walled garden of Wardhouse survives and has been carefully and sensitively cleared of undergrowth by the current owners revealing a well-preserved wall (F7; Illus 3). The wall is constructed of sandstone blocks with an ashlar base course and red sandstone foundation (Illus 4) and stands to a maximum of 3m high. The wall has curved corners at the WSW and ENE ends and is the inner garden wall; there was an outer wall as well as the rest of this walled garden and no trace of these walls now survives (see OS maps Illus 21-23). There is a socket stone towards the WSW and a stone with a drilled hole (F5). The outer skin of stone wall around F5 has collapsed (Illus 5) and it is possible that this is the former location of a niche or other feature but there are no internal features such as niches or bee boles. At the terminal of each end of the wall are the bases for gateposts or pillars (F3, F6 Illus 3, 6) and the ashlar sandstone pillar stones were found by the current owners in the undergrowth (Illus 7). There are sparse iron sittings on the N face of the wall but numerous on the S face (Illus 8) for espalier of fruit trees. The undergrowth cleared by the current owners included a number of fruit trees and bushes.

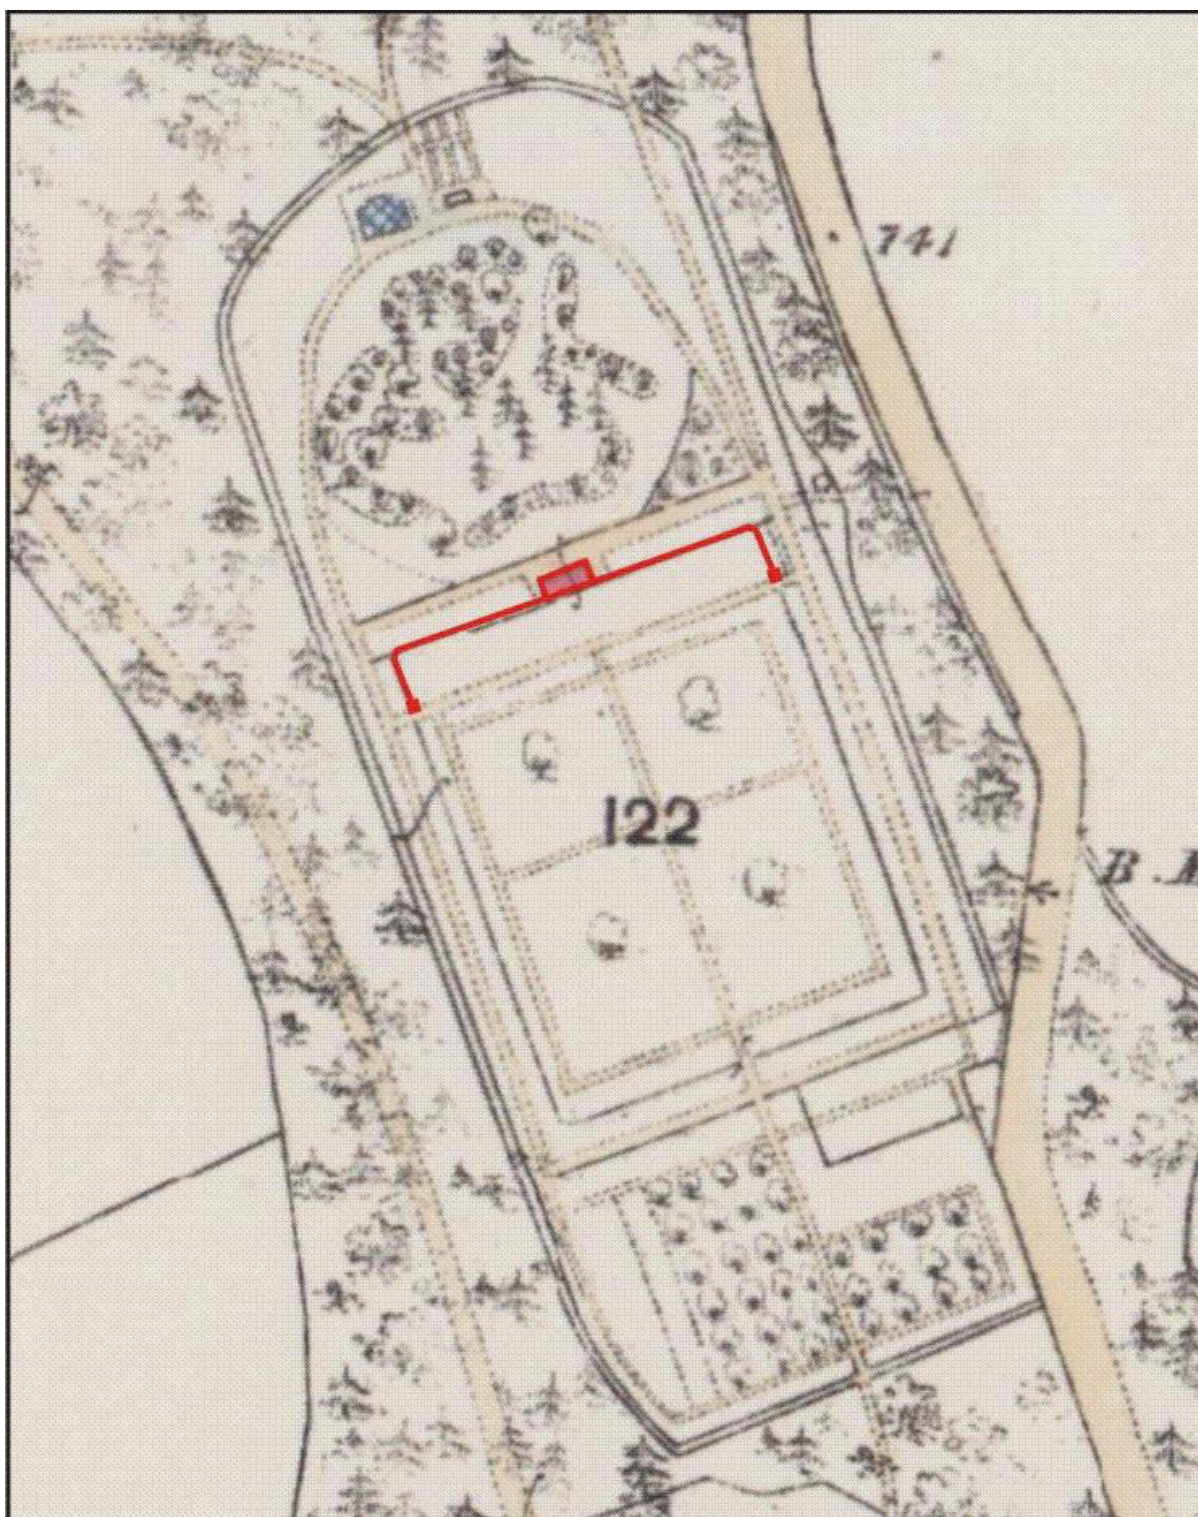
Illus 21 First Edition OS map showing Wardhouse walled garden. Structure 1 and wall F7 are marked in red showing how they fitted into the larger walled garden. Aberdeen Sheet XXXIV.15 (Kennethmont) Survey date: 1868 Publication date: 1874 (copyright National Library of Scotland)
