**Corgarff Parish Church, Corgarff, Strathdon,
Aberdeenshire, AB36 8YL**

Report on Level 1 Standing Building Survey

**Alison Cameron
Cameron Archaeology
5 August 2015**

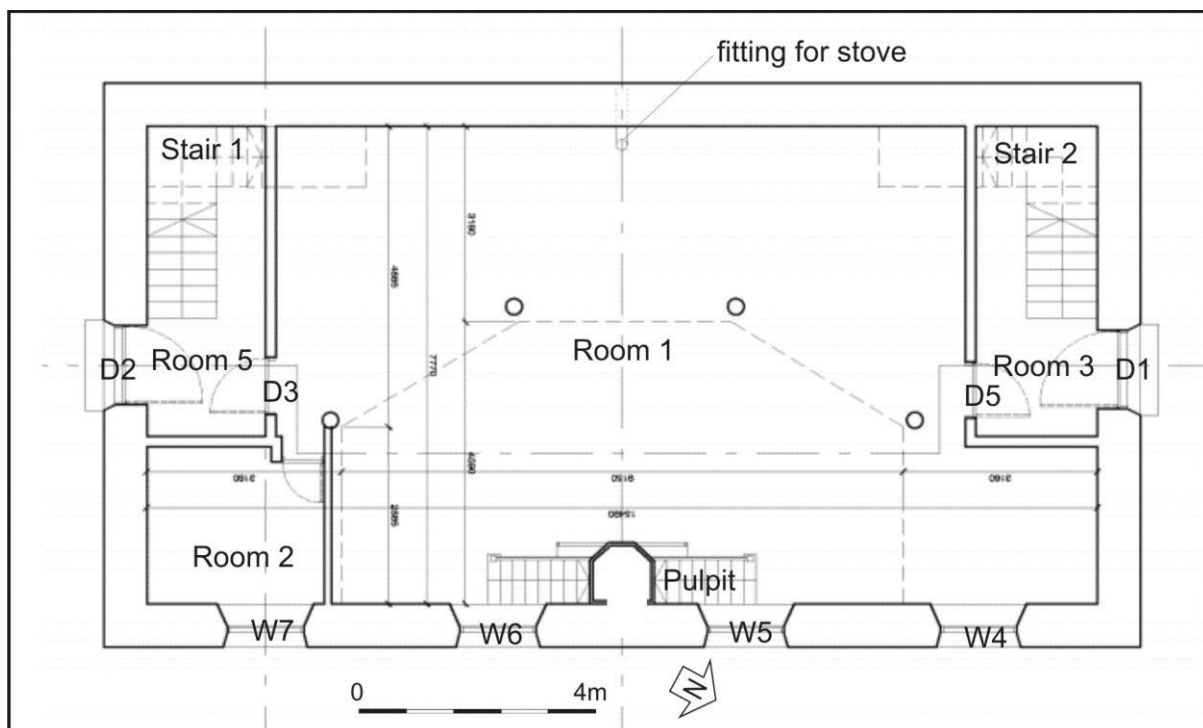
Illus 2 Ground floor plan annotated with survey numbers (based on Moxon Architects Ltd)

The church is oriented NNW-SSE and is 9m wide and 17.15m long with a granite base course 0.05m wide on all sides. The walls are 0.7m thick. There are no apertures on the WSW wall and 4 long pointed windows on the ENE wall (W4-W7). The gables have central pointed arched doors with smaller arched windows above (W2 and W9) and on either side of the door is a long narrow window 2.15 x 0.4m in size all of which are now blocked (W1/3, W8/10). There is a bell-cote above the NNW gable.

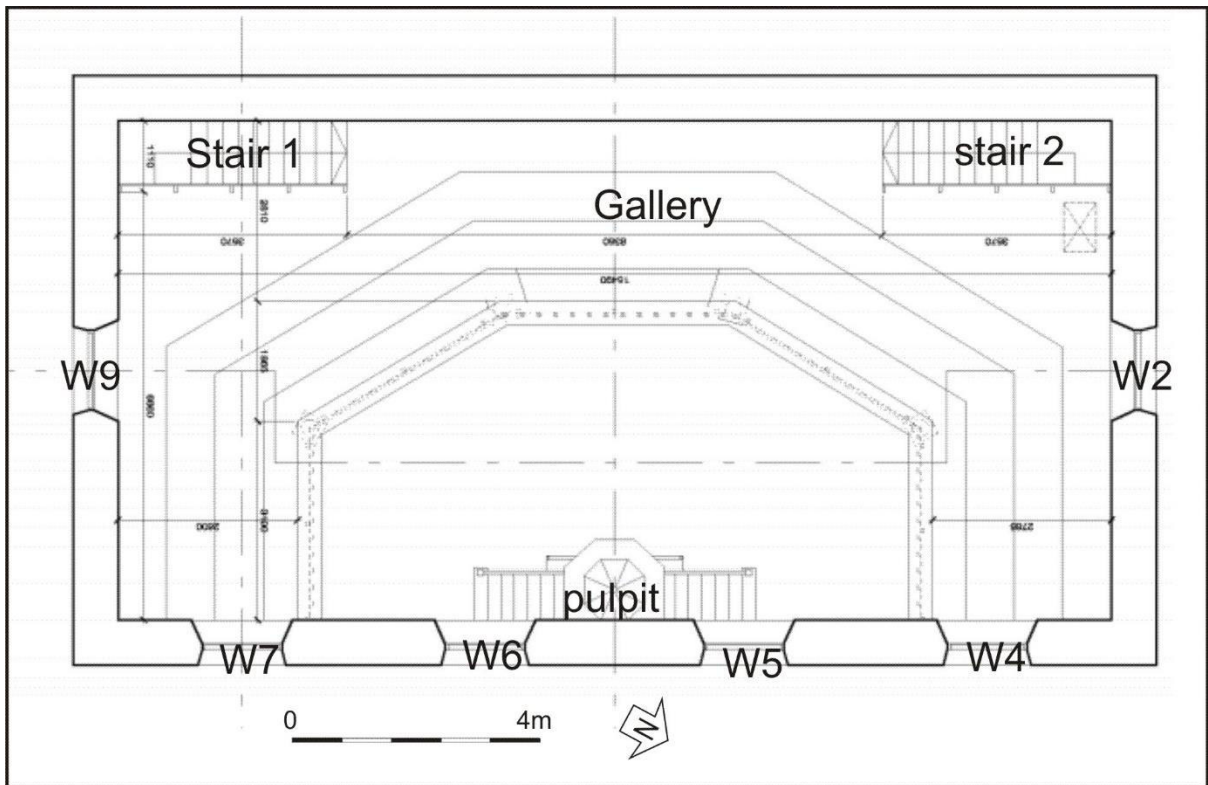
Illus 3 First floor plan annotated with survey numbers (based on Moxon Architects Ltd)

In Phase 2 the horseshoe shaped gallery was added in its current location bisecting window W7 (Illus 12, 13). Presumably long, narrow windows in the gables (W1, 3, 8, 10) were blocked at this time as these are now covered by the gallery. Room 2 was probably created at this time and stairs (Stairs 1 and 2) added to access the gallery.
