Former Mill At Glencally, Glen Prosen, DD8 4RQ

Report on Level 1 Standing Building Survey

**Alison Cameron
Cameron Archaeology
4 August 2015**

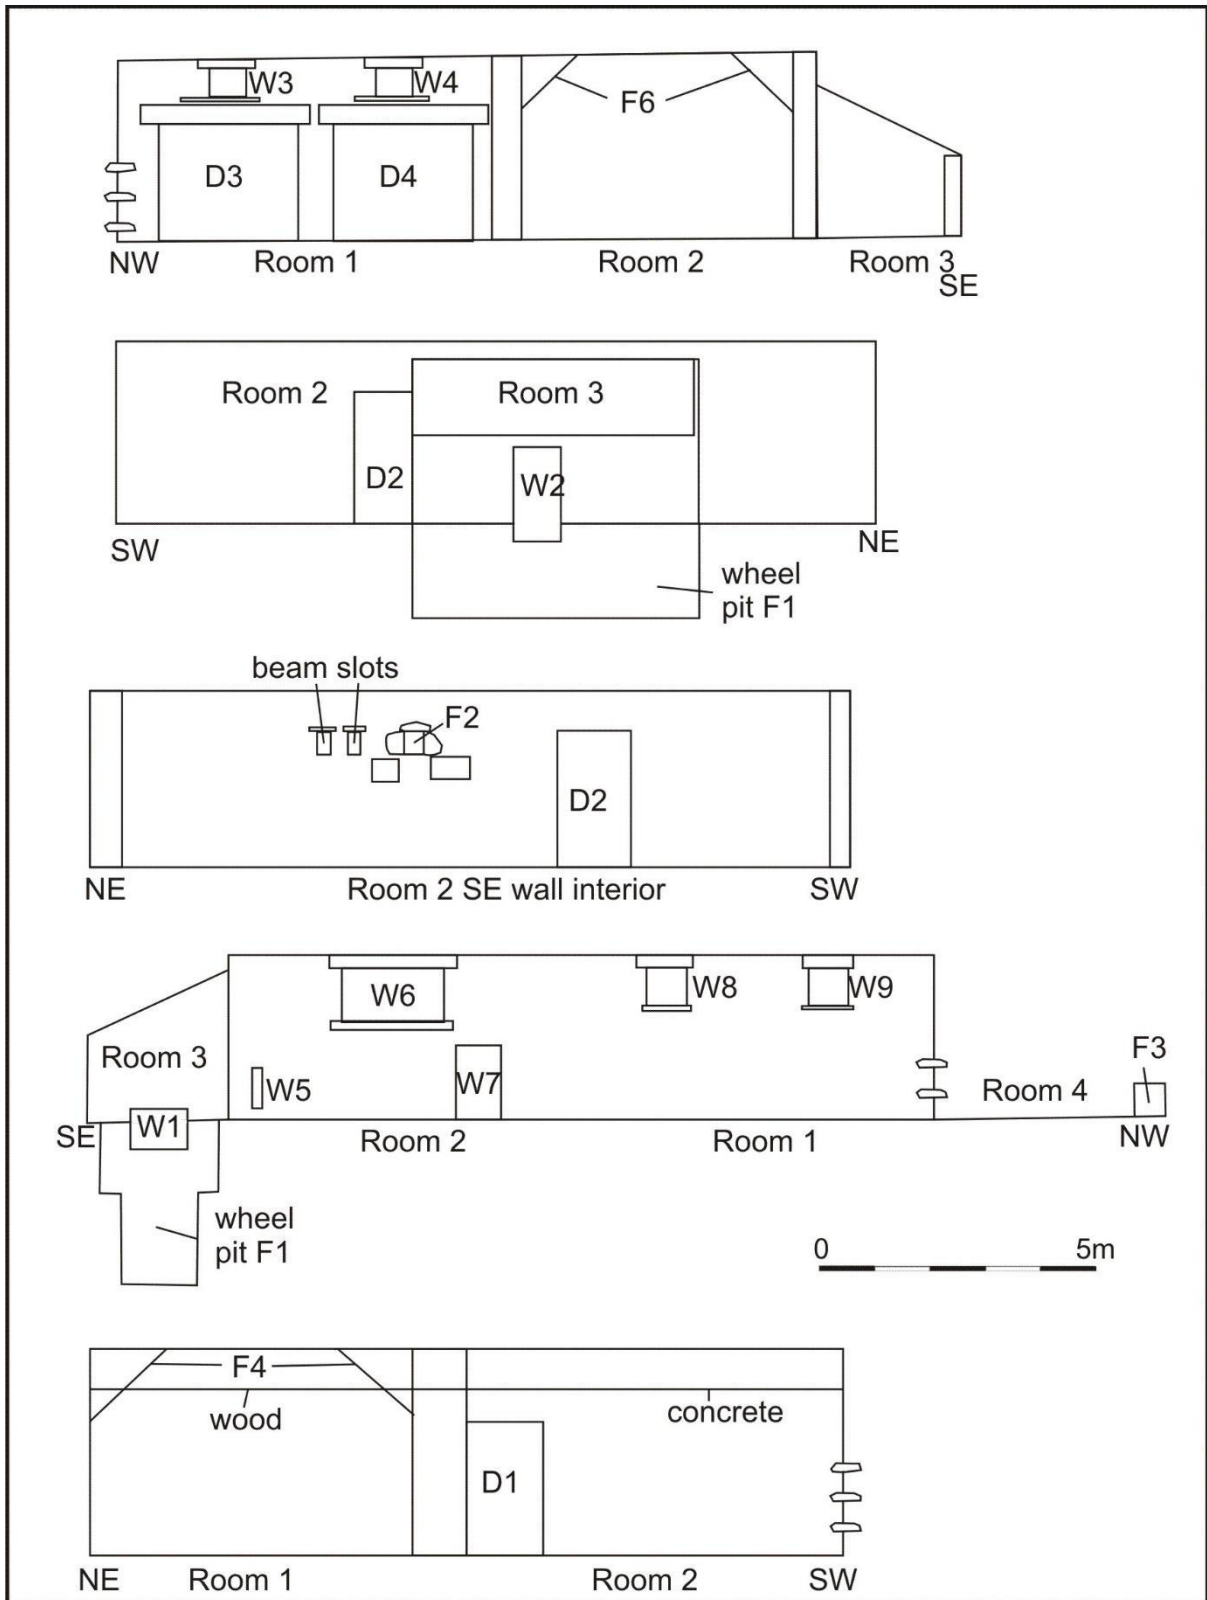
Illus 3 Building elevations

The Phase 1 mill is 13m NW-SE and 13.9m NE-SW and consisted of three rooms. The buildings are constructed of granite and sandstone rubble with granite lintels, quoins and jambs except Room 1 cart doors D3 and D4 which has red sandstone lintels (both cracked; Illus 9) on the SW façade. Room 2 is the main mill and Room 3 the wheelhouse (Illus 4, 5). Room 2 has doors in the NW and SE walls and the driveshaft mechanism for the wheel

survives in the SE wall (F2; Illus 7). The walls of the main building are 0.6m thick and Room 3 the wheelhouse has walls 0.55m thick. Roofs survive only on the wheelhouse which is in a poor condition.

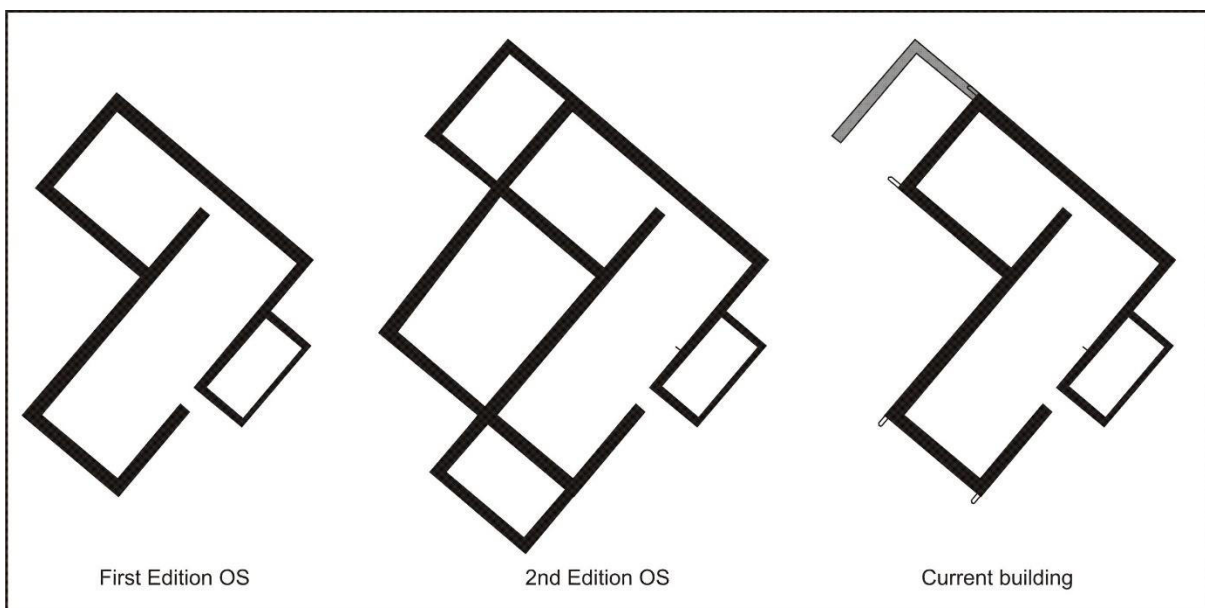
Illus 11 Phase plan

A Level 1 standing building survey was carried out on 28 July 2015. The original early 19th century L-shaped mill was extended prior to the 2nd Edition OS map (Illus 11) with an extension to the NW which was later demolished leaving a low walled enclosure (Room 4). An extension was also added to the SW and again this was demolished leaving tying in stones on the SW gable. A room added to the centre of the mill in the L between Rooms 1 and 2 was demolished prior to this survey. It is recommended that no further archaeological work is required during the current planning application.
