**Steading at Caldhome Farmhouse, Luthermuir,
Laurencekirk, AB30 1PS
Report on Level 1 Standing Building Survey**

**Alison Cameron
Cameron Archaeology
19 August 2015**

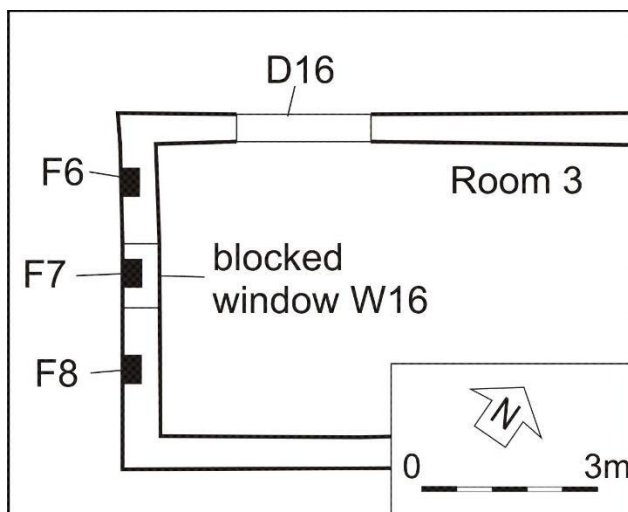
Illus 11 Plan of SW end of Room 3 first floor showing location of armorial panels F6, F7, F8

The SW gable of Room 3 has a central door with blocked window above and one ground floor window, also blocked. Three grey sandstone armorial panels have been inserted into the first floor of this exterior gable. The left hand (NW) stone (F6) bears a coat-of-arms and the initials AS and IB diametrically opposed. The centre stone (F7), built into the blocked window, bears the Barclay arms; the initials IB; at the bottom right hand corner the figures 7 1 and is pointed at the bottom left hand corner covering the numbers 1 6 (Jervise 1875-9, 138). The right hand (SE) stone (F8) is badly weathered but there is 'E O' visible. All the stones are delaminated to varying degrees.

The panels are being retained *in situ* (David Carnegie pers comm); if this changes their rehousing should be discussed with Aberdeenshire Council Archaeology Service (Claire Herbert).

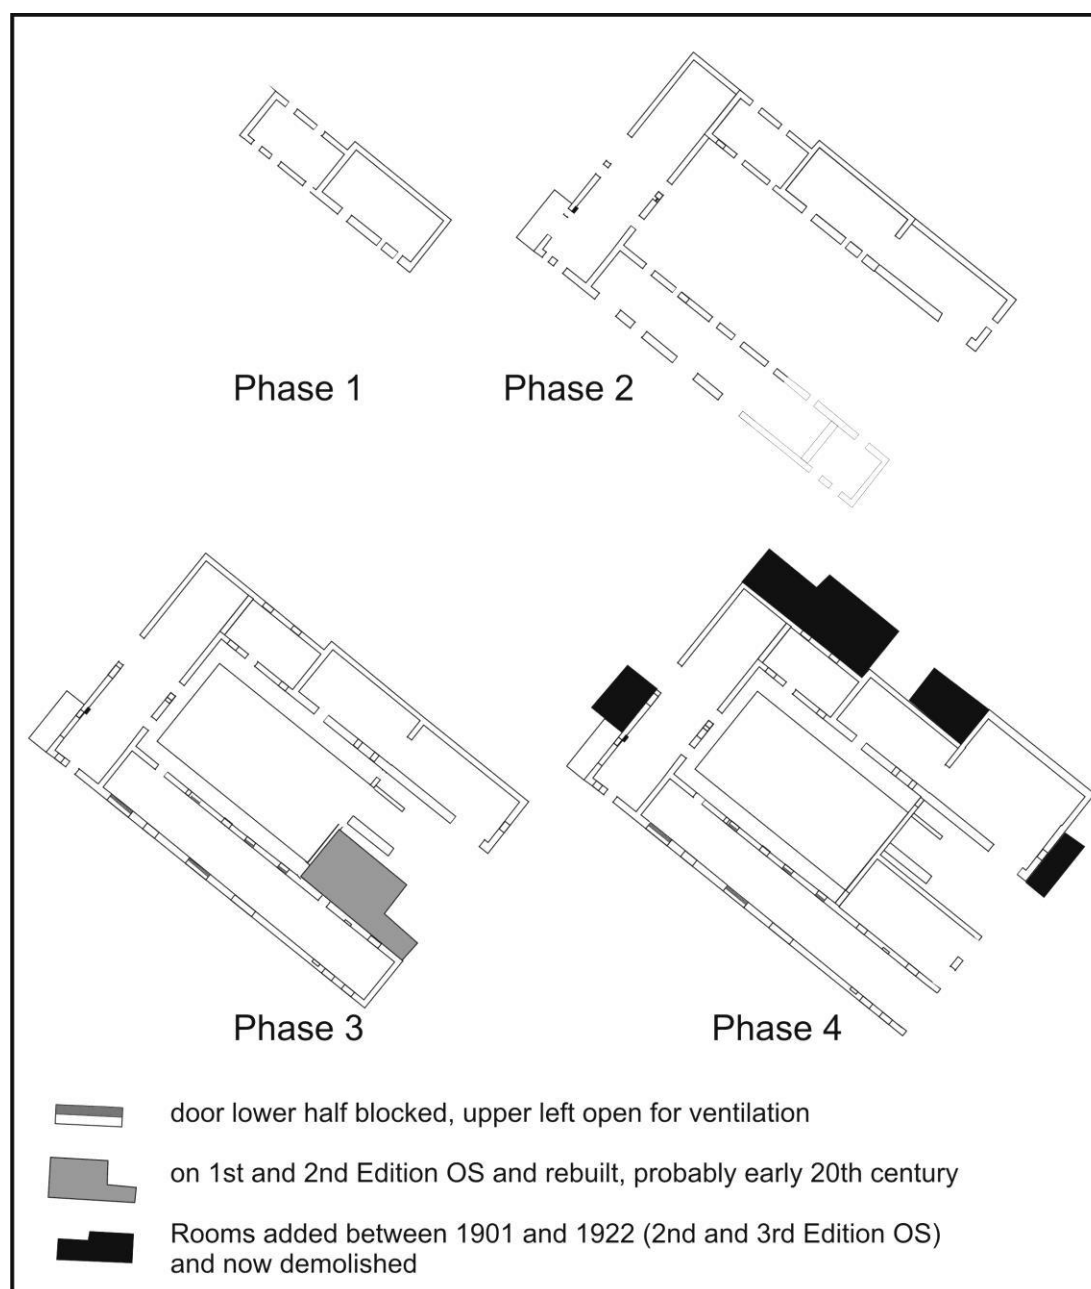
Illus 18 Phase plan based on standing building survey and incorporating some mapping evidence

A Level 1 standing building survey was carried out on 7 August 2015. At least 4 main phases of building were recorded. In Phase 1 Rooms 4 and 5 were constructed in red sandstone and there may have been other buildings which had since been demolished; red sandstone blocks appear in several walls and these may have been reused from the earliest phase. In Phase 2 Room 3 was added on to the NW end of Room 4 and a C-shaped steading created with a mill wheel at the NW corner and then further buildings added around the central courtyard.

It is recommended that no further archaeological work is required during this proposed development.
