West Mains of Barras, Barras, Stonehaven AB39 2UE

Report on Level 1 Standing Building Survey

**Alison Cameron
Cameron Archaeology
11 September 2015**

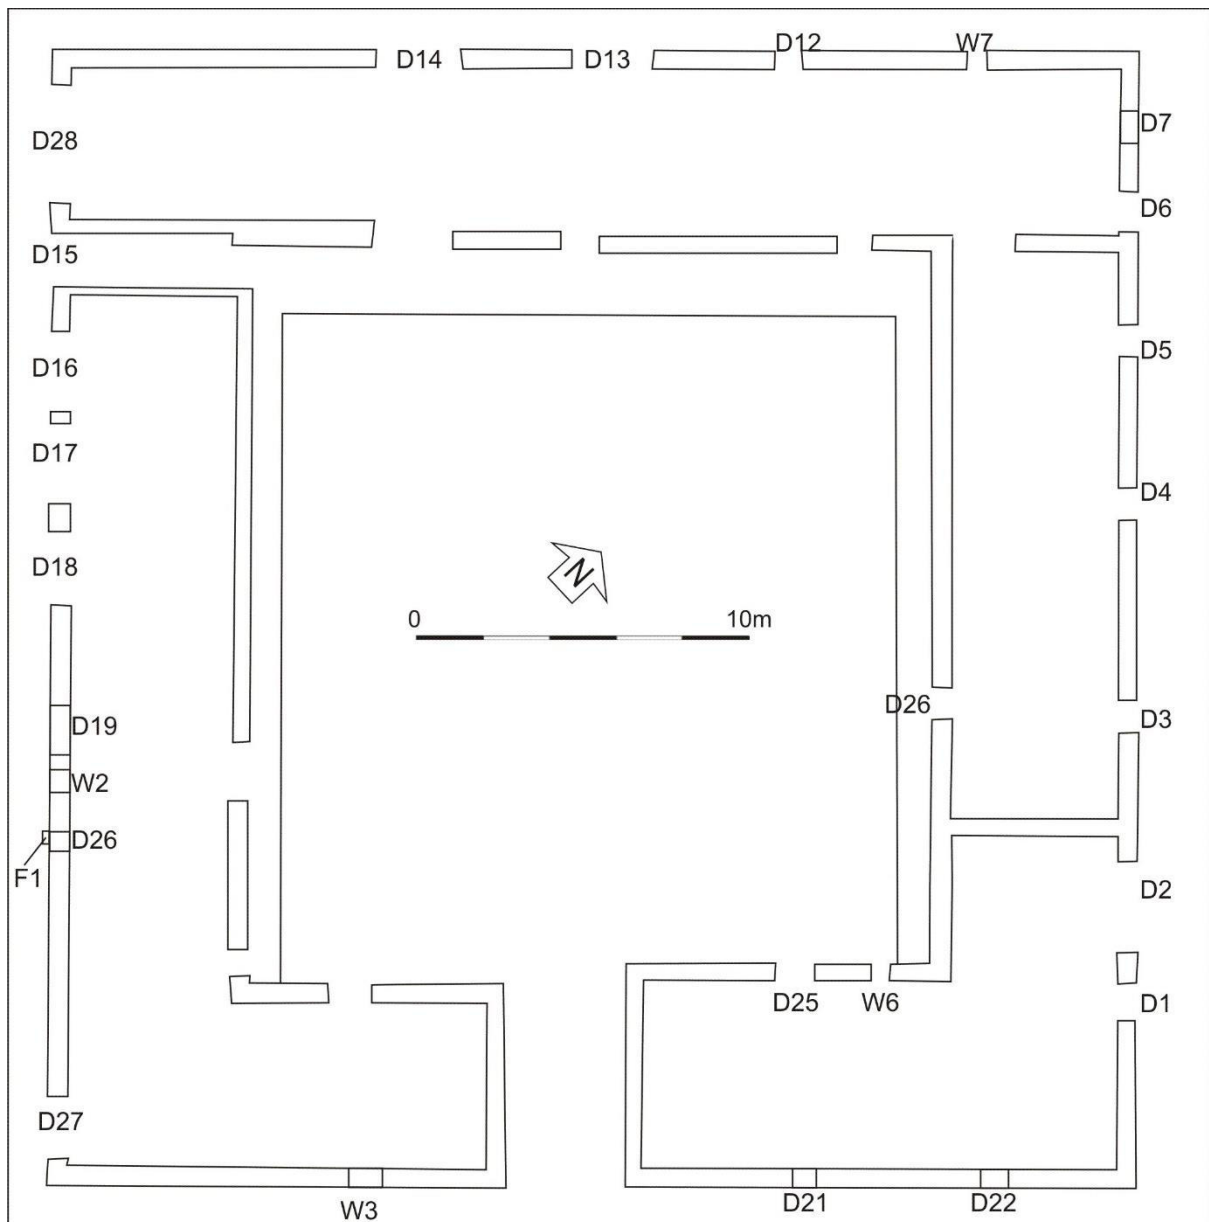
Illus 3 Building 1 plan (from copyright cumming and co)

Most of the apertures apart from the main gable doors (eg D28, D27) have been blocked with stone or breeze blocks when the buildings were converted for animal and farm use in the 20th century. The courtyard has been roofed and converted for animal use.

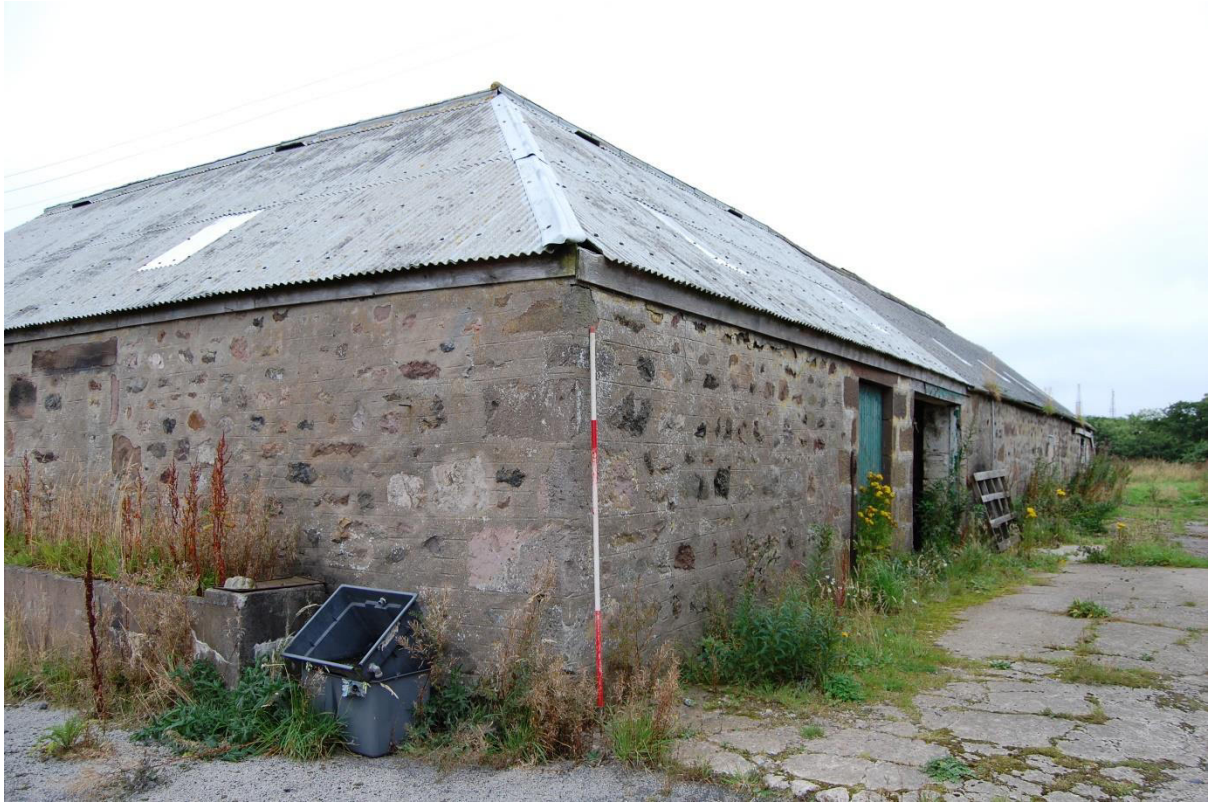
Illus 5 Building 1 E corner; facing W

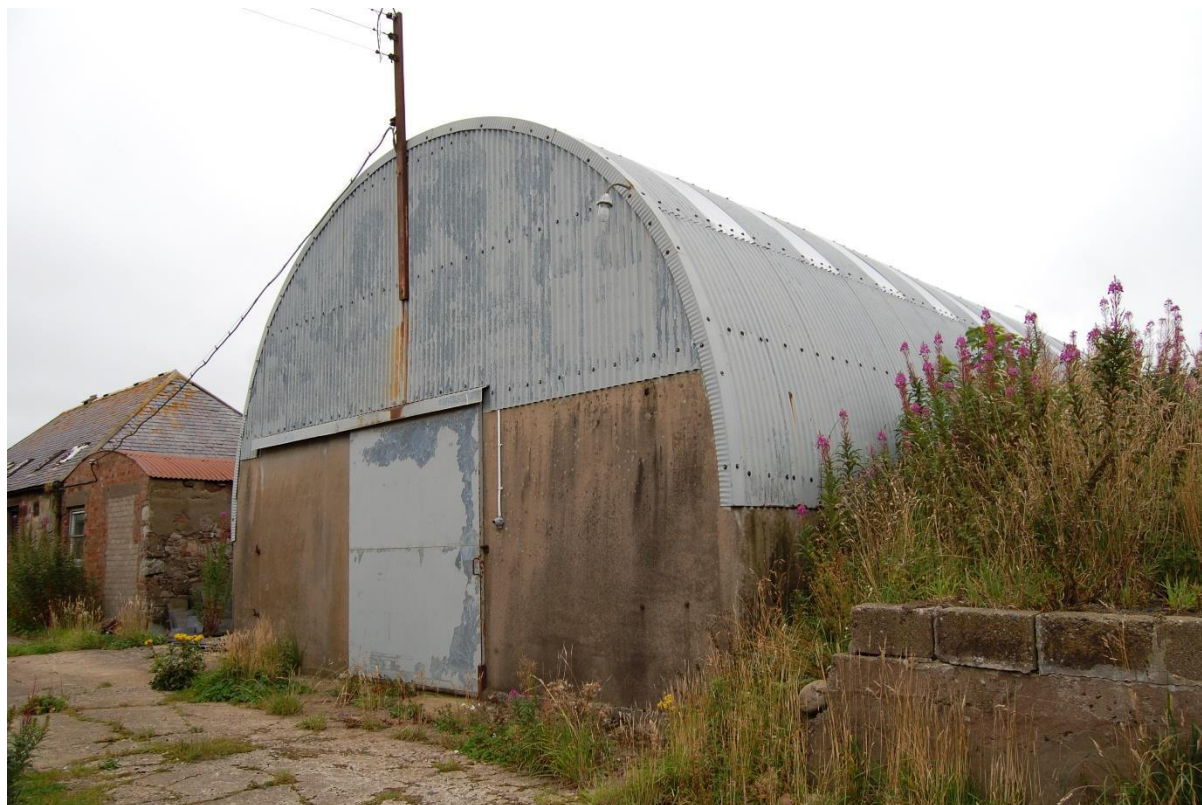
Building 2 is a modern barn, possibly originally incorporating a Nissen-type building (Illus 9).

Illus 9 Building 2; facing N

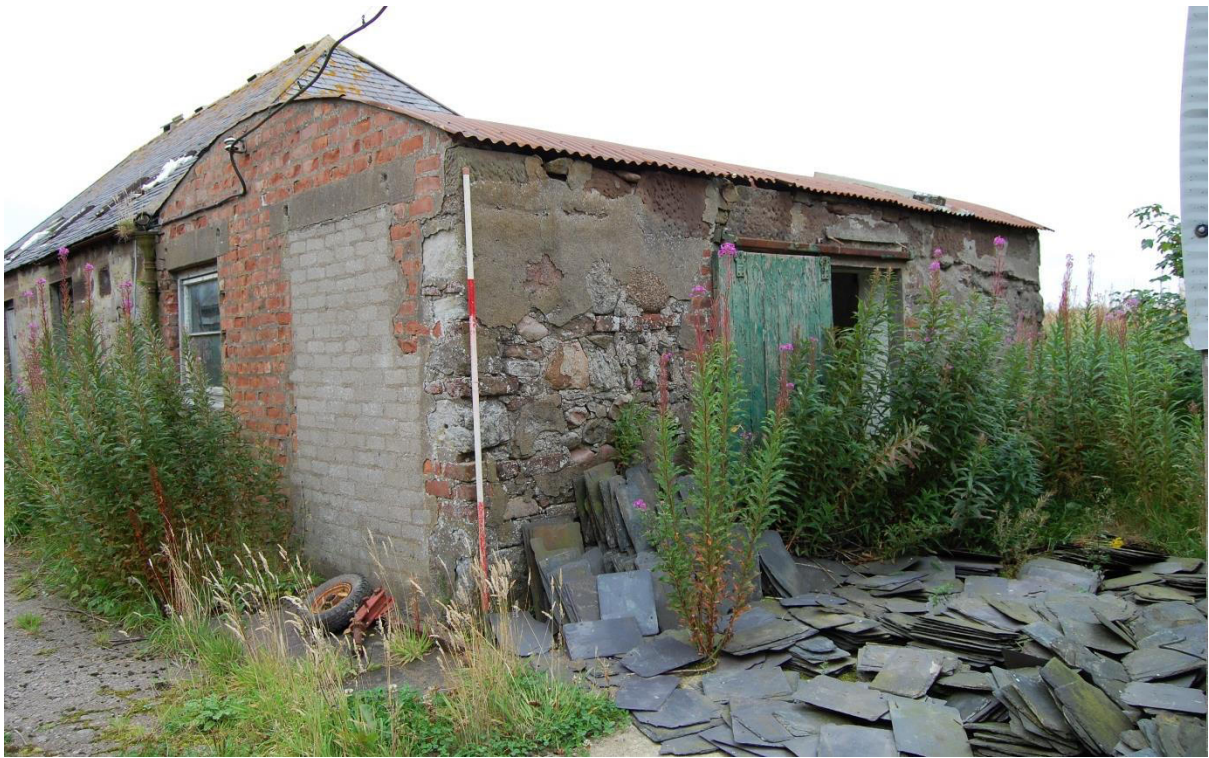
Building 3 is a small Nissen-type structure, built into an existing unroofed enclosure (retained in the SE wall; Illus 10) and infilled with brick on the SW front façade. It has infilled an unroofed enclosure on the 1st and 2nd OS maps. It is constructed of tin roof and red brick front SW wall (Illus 11). There is a window (W4) and door (D23) both with poured concrete lintels in the SW façade and these have subsequently been blocked and the interior lined with concrete for animal use.

Illus 10 Building 3; facing NW

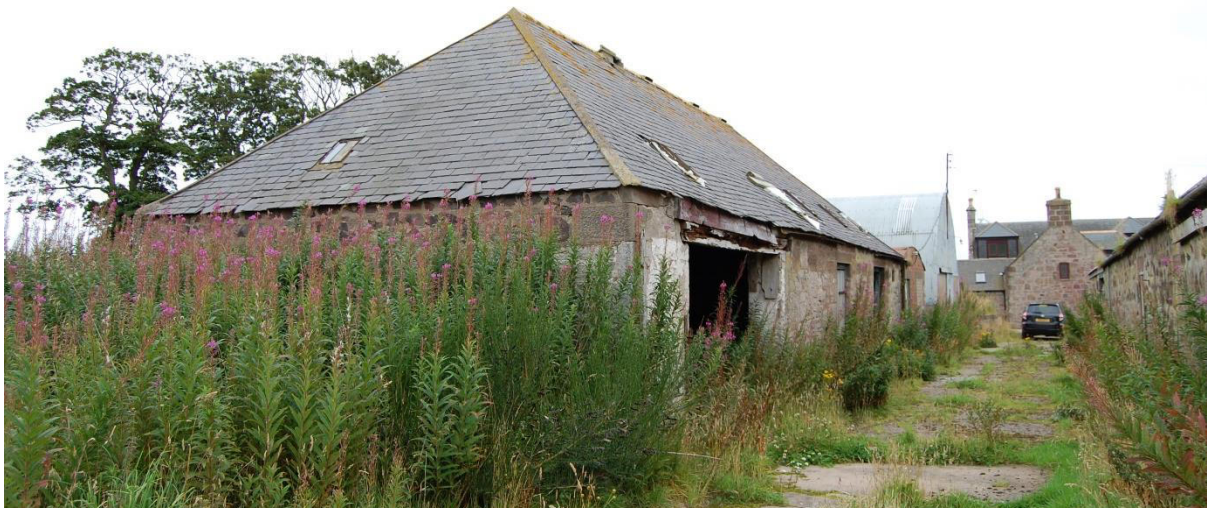
Building 4 is the 'stable' building. It is constructed of granite and sandstone rubble with red sandstone door and window mouldings (Illus 12). It is attached to the NW wall of Building 3 and has doors D8, D9 and D10 on the SW wall.

Illus 13 Building 4; facing SE

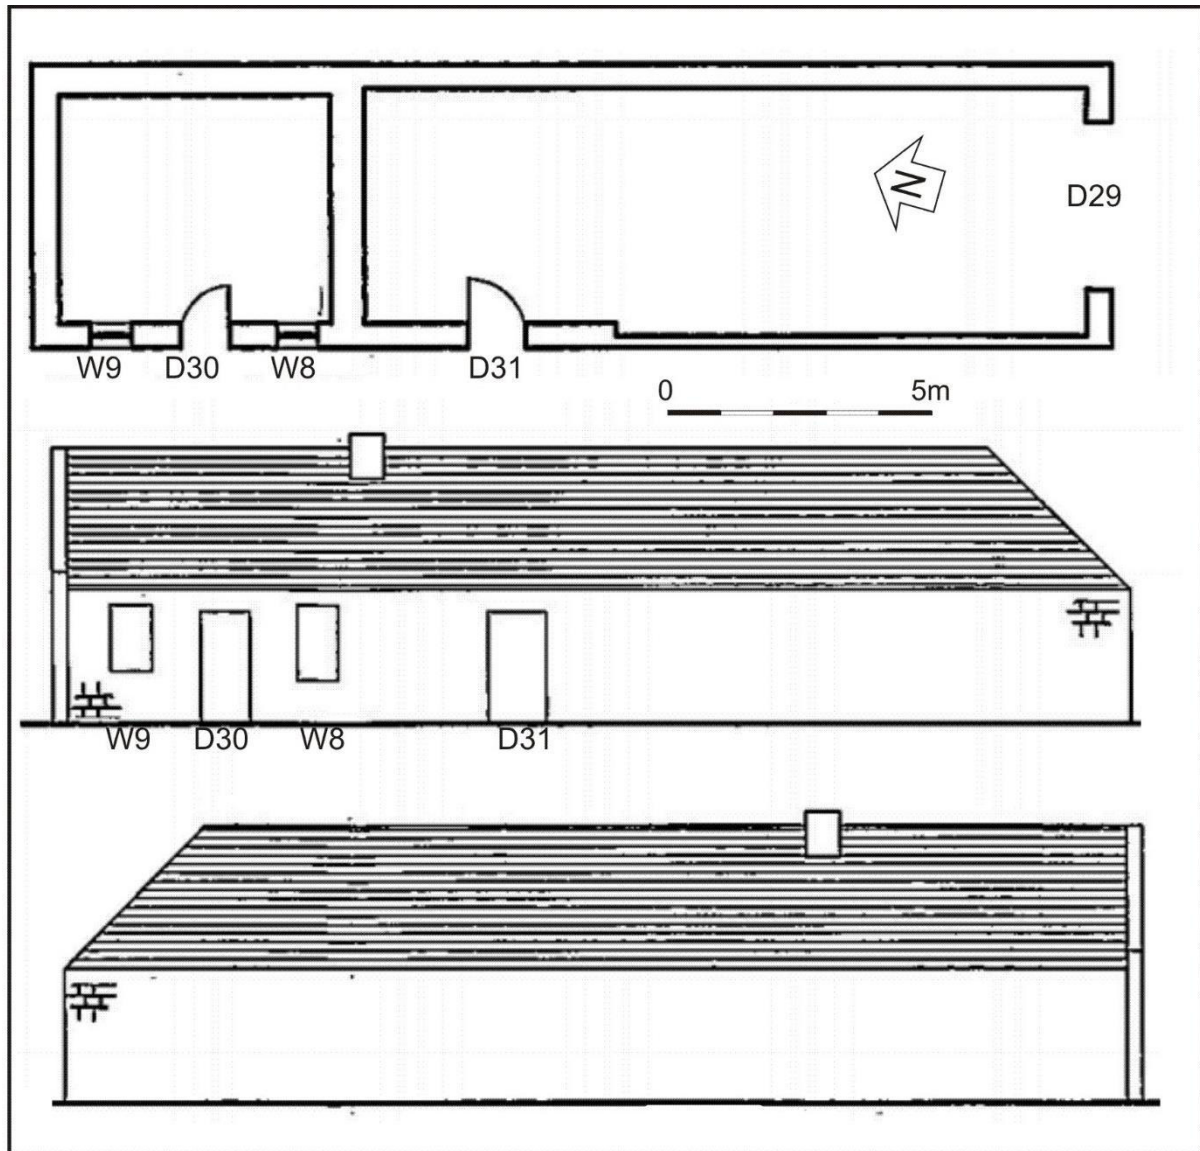
Illus 14 Building 5 bothy plan (top) and elevations (below) (from copyright cumming and co)

Building 5 is the 'bothy' building (Illus 14). It has been heavily rebuilt at the SE end (Illus 15), is heavily overgrown (Illus 16) and the roof is not safe for access to the interior. It is divided into two rooms (Illus 14) with windows W8 and W9 and doors D30 and D31 on the SW façade. The NW room has been for domestic use (bothy) with the SE room for agricultural use.

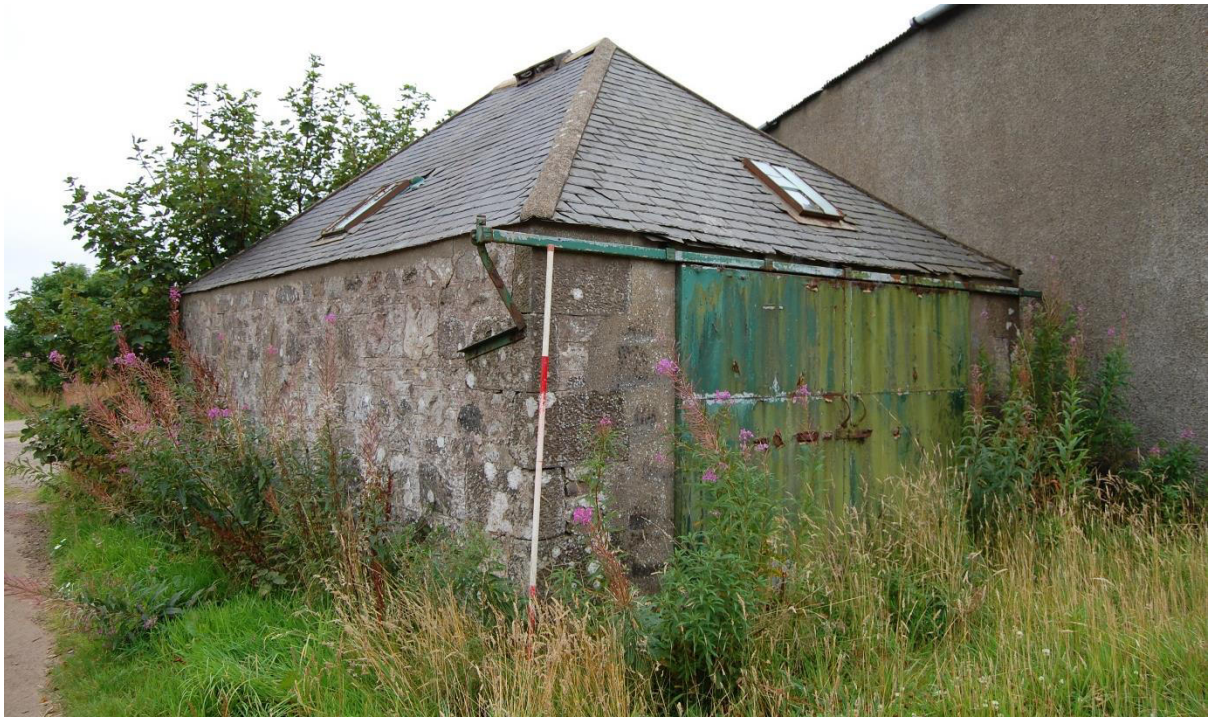
Building 6 is a small bothy or garage on the main road SW of the main buildings. It is overgrown with no access to the interior. It is constructed of grey sandstone rubble and has a main door in the NE façade. It is a later addition to the farm complex, probably constructed in the late 19th or early 20th century.

Illus 17 Building 6; facing W
