**A WALKOVER SURVEY OF THE FORESTED AREAS AT  
CRATHES CASTLE, BANCHORY, ABERDEENSHIRE**

Dr Robert Lenfert  
Cameron Archaeology  
February 2015

# **A Walkover Survey of the Forested Areas at Crathes Castle, Banchory, Aberdeenshire**

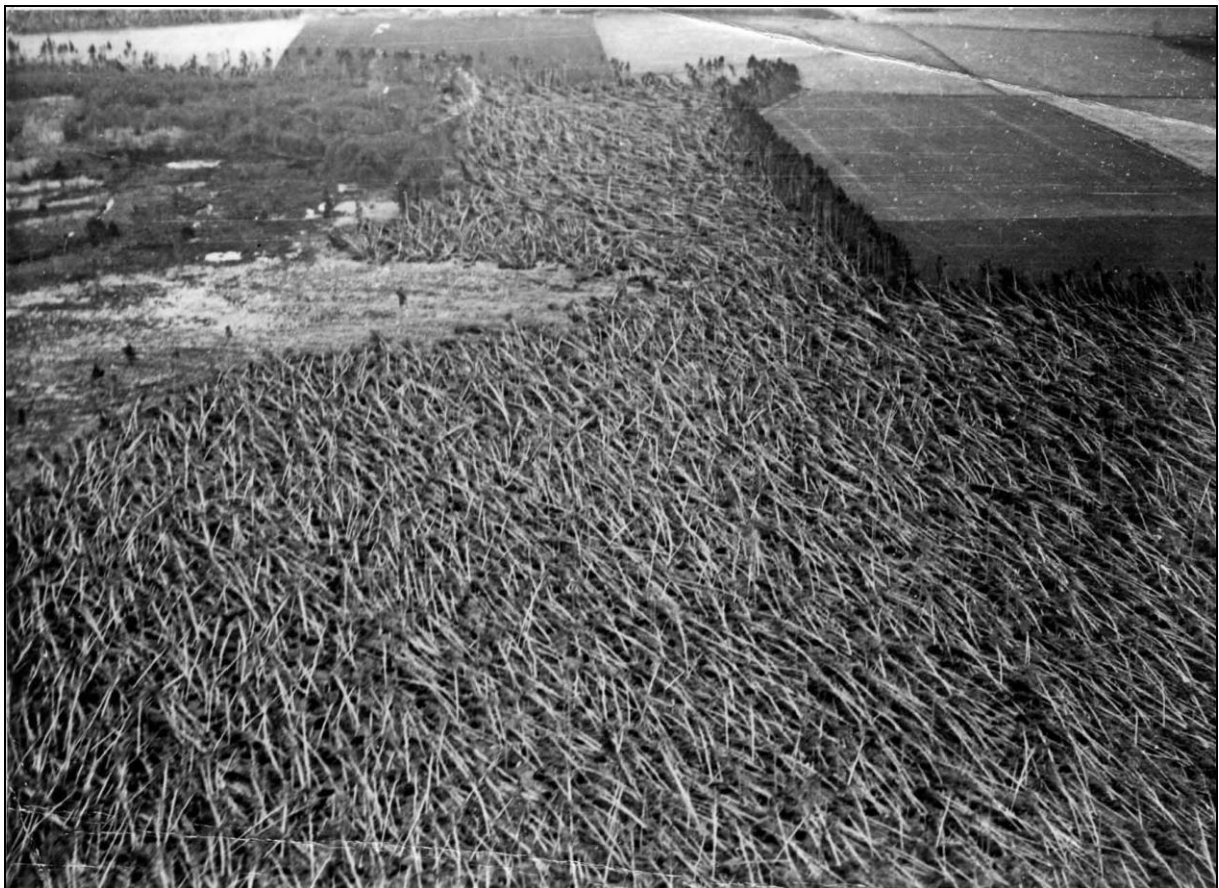
**Illustration 3: Aerial photo of Crathes Castle Estate in the aftermath of the 1953 storm. Note thin boundary of surviving, upstanding trees (c. Scottish Forestry Commission).**

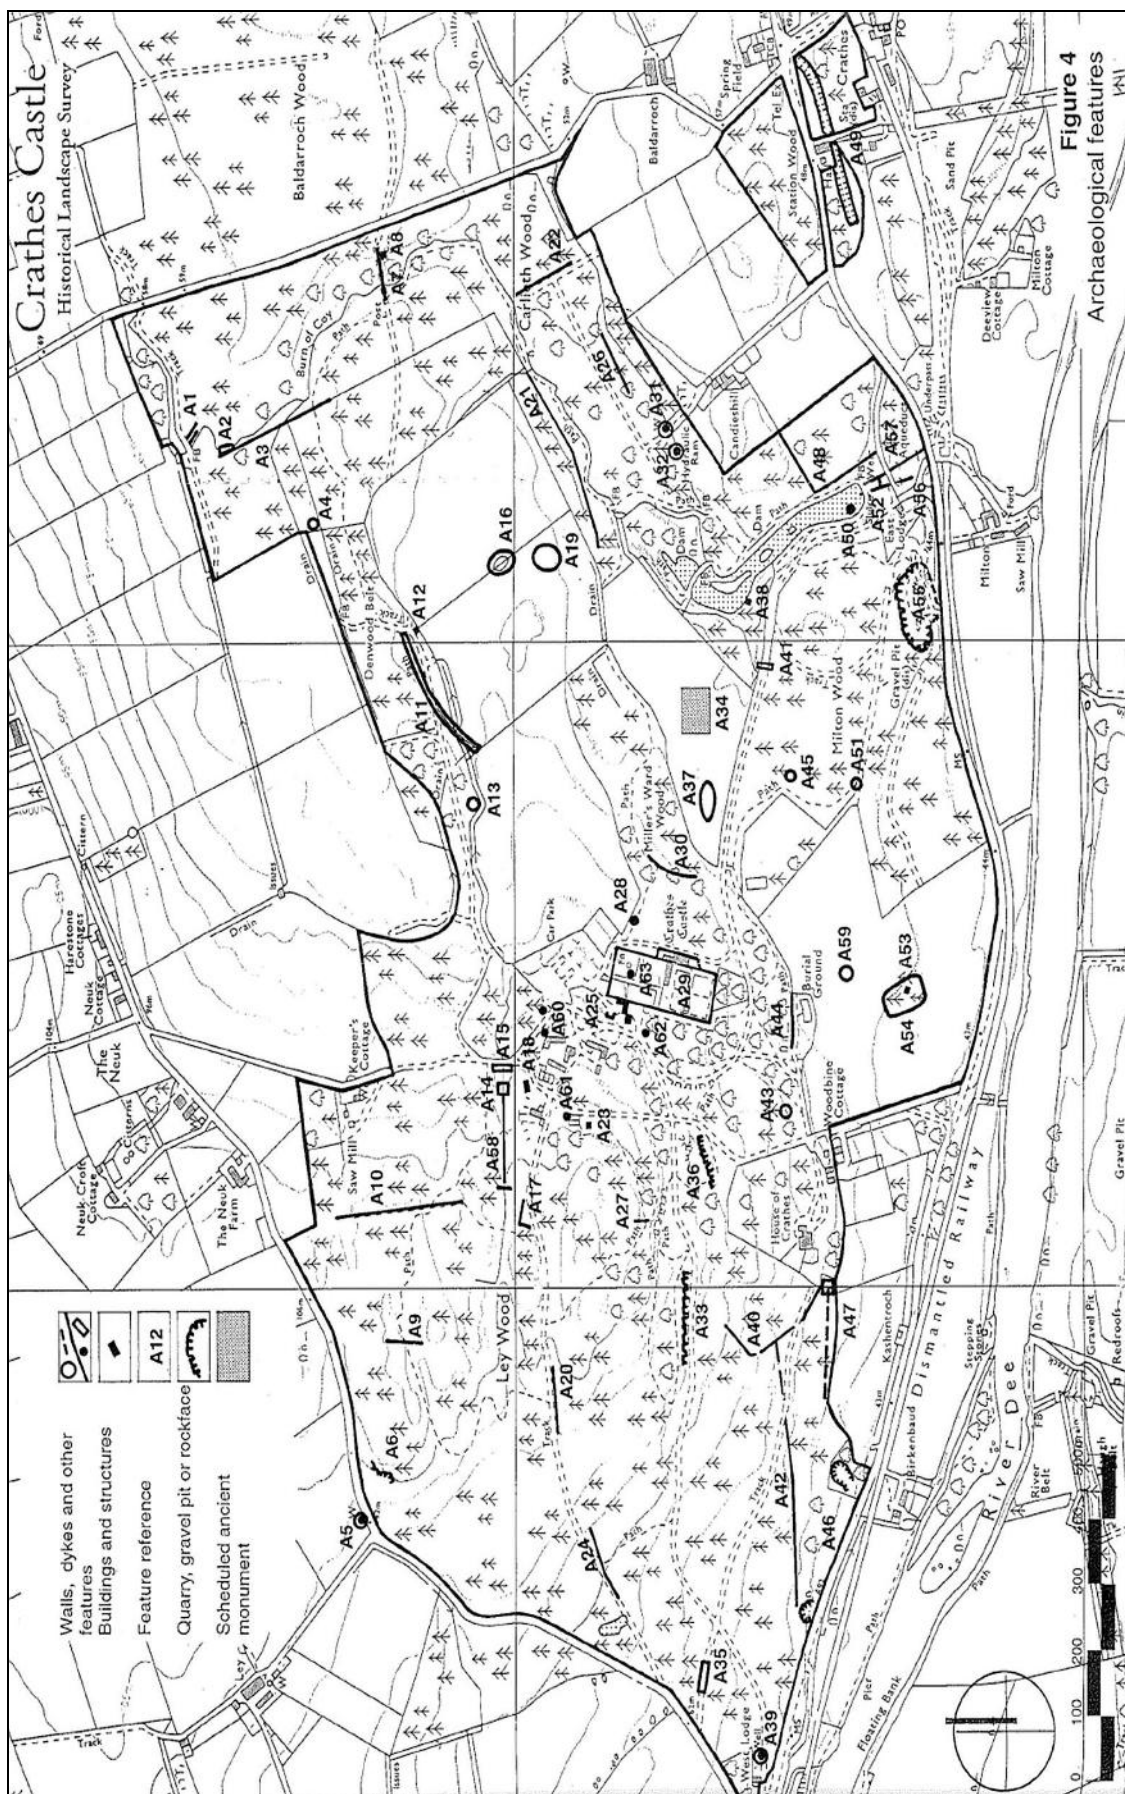
Illustration 5: Location of features from previous AOC survey (c. NTS 1997).

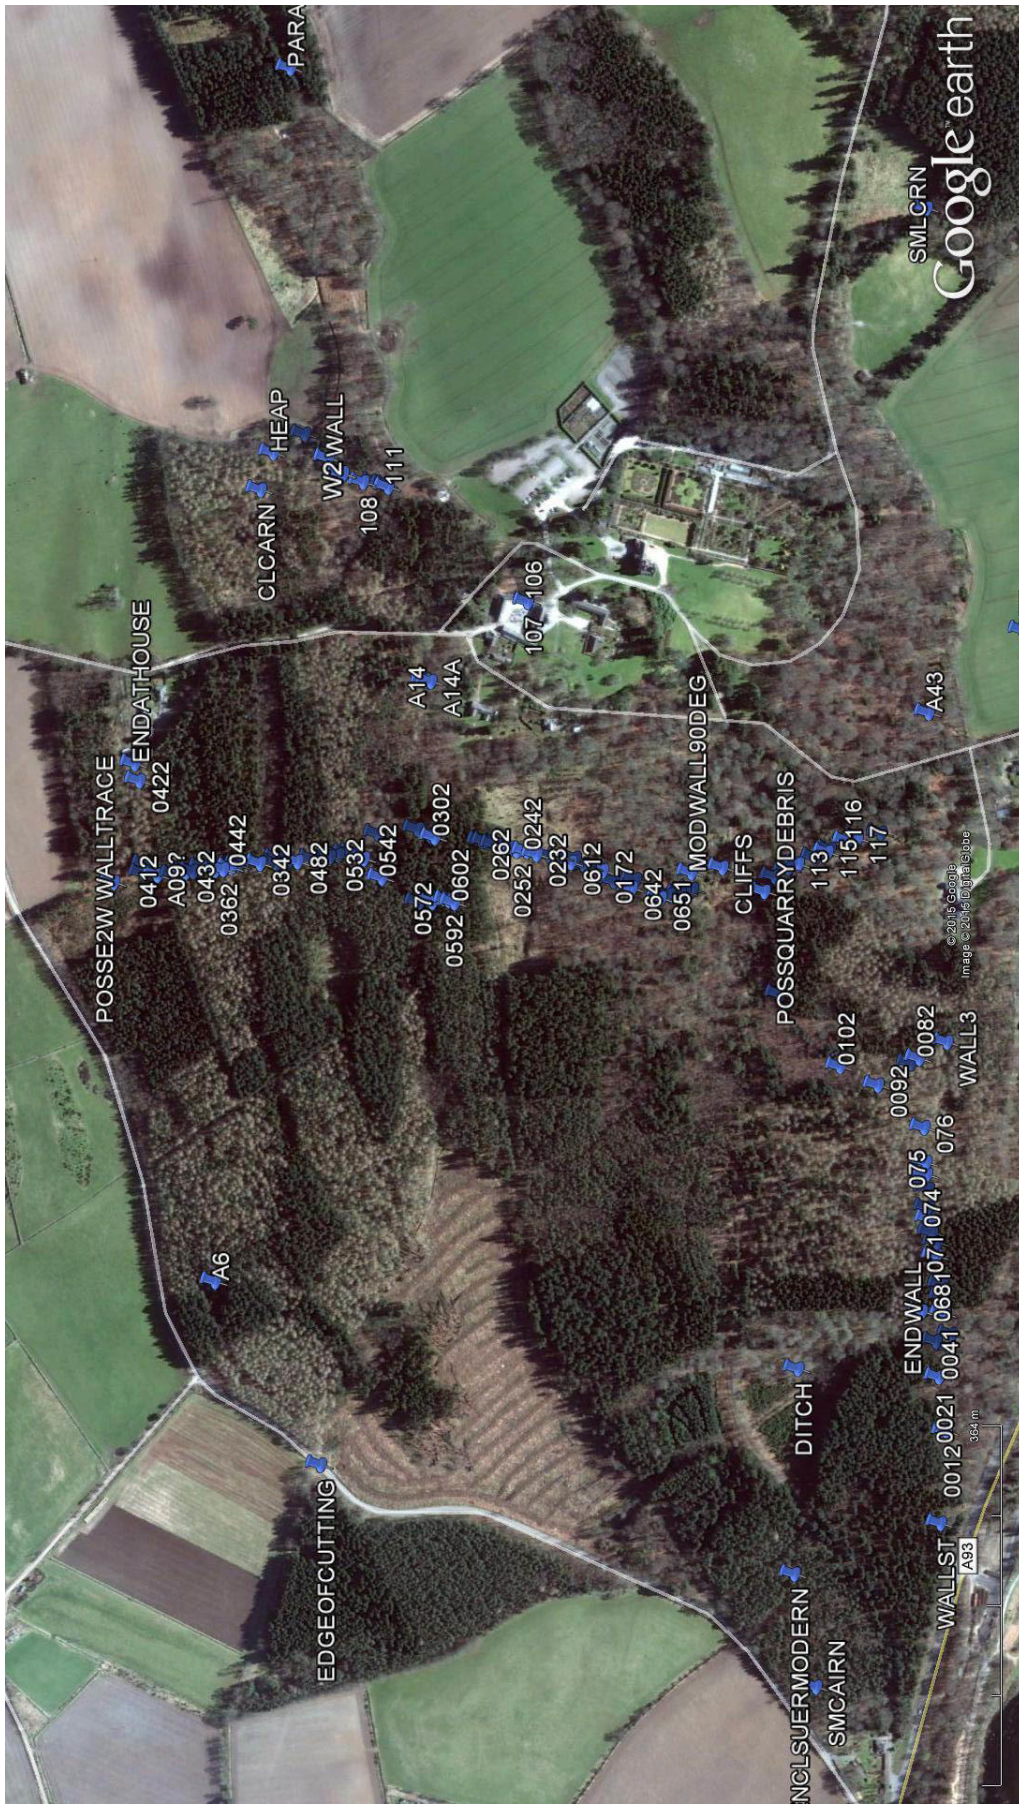
Illustration 7a: GPS waypoints along walling and discrete features taken in western half of estate (image c. GoogleEarth 2015).

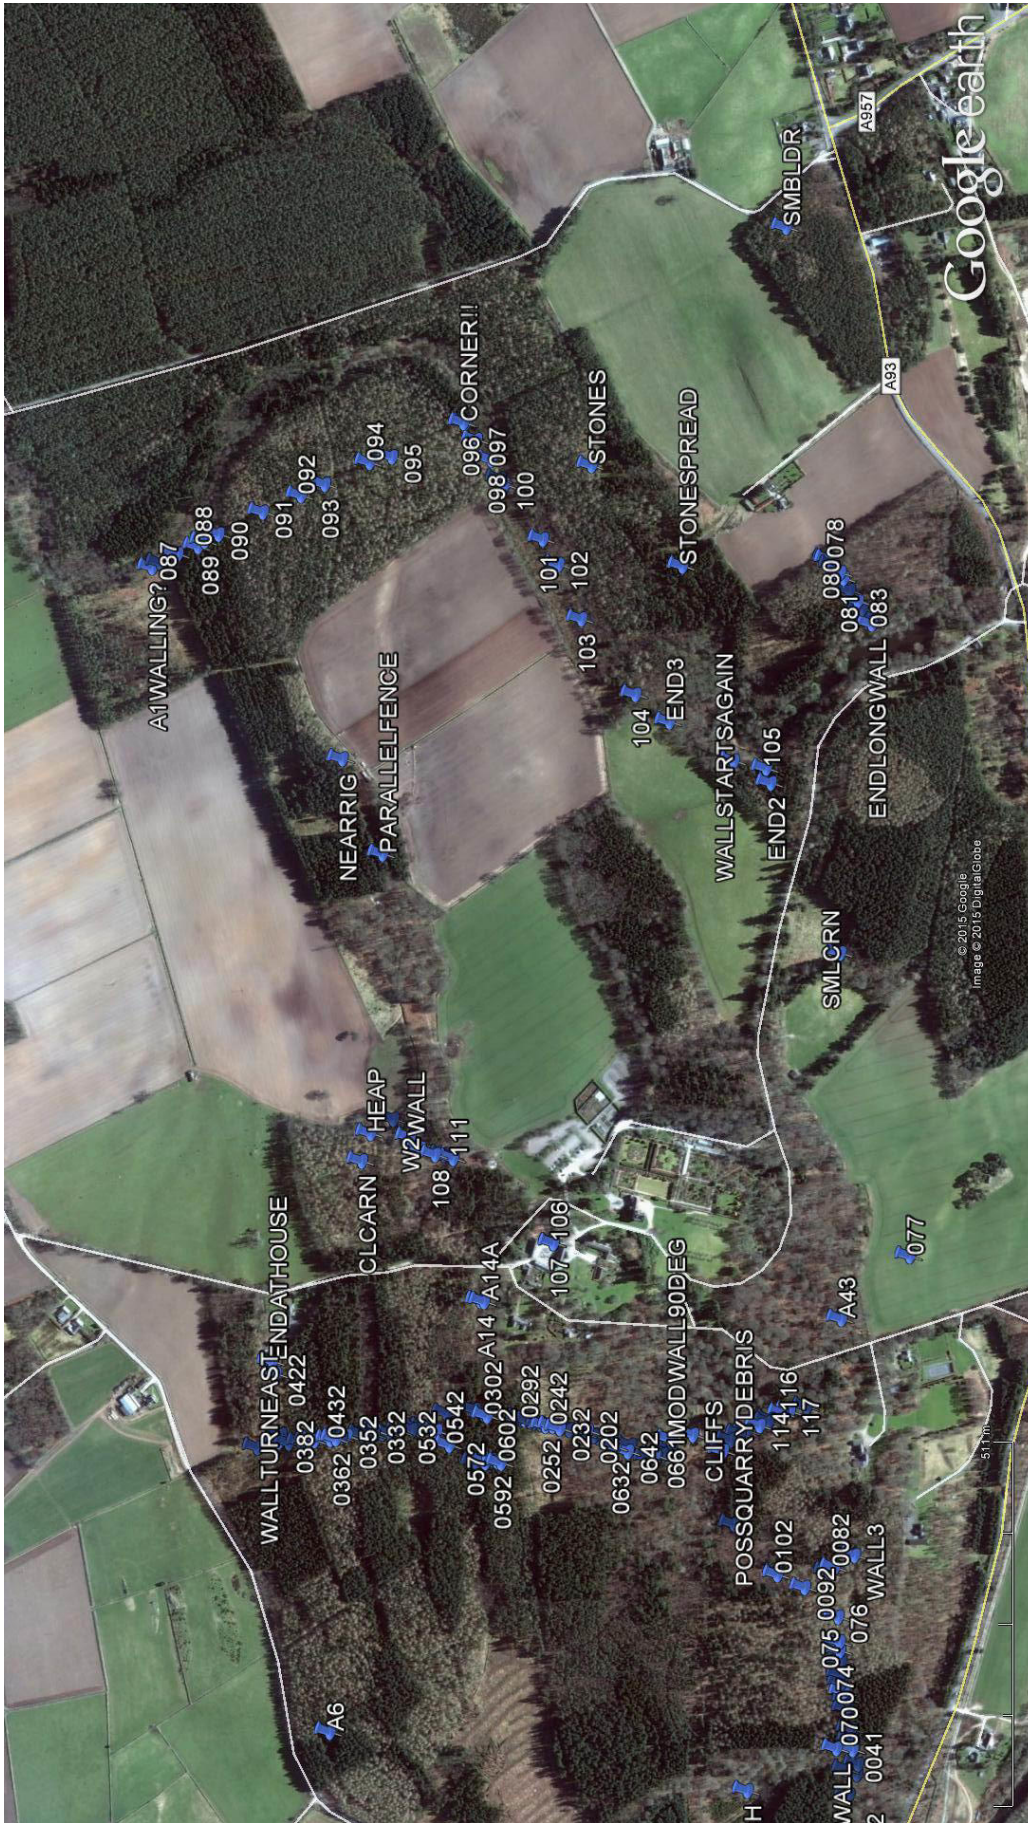
Illustration 7b: GPS waypoints along walling and discrete features taken within the estate (image c. Google Earth 2015).
