**Steading At Mains of Duncanstone, Lazyfold Road,
Duncanstone, Inch, Aberdeenshire, AB52 6YX
Report on Level 1 Standing Building Survey**

**Alison Cameron
Cameron Archaeology
24 November 2015**

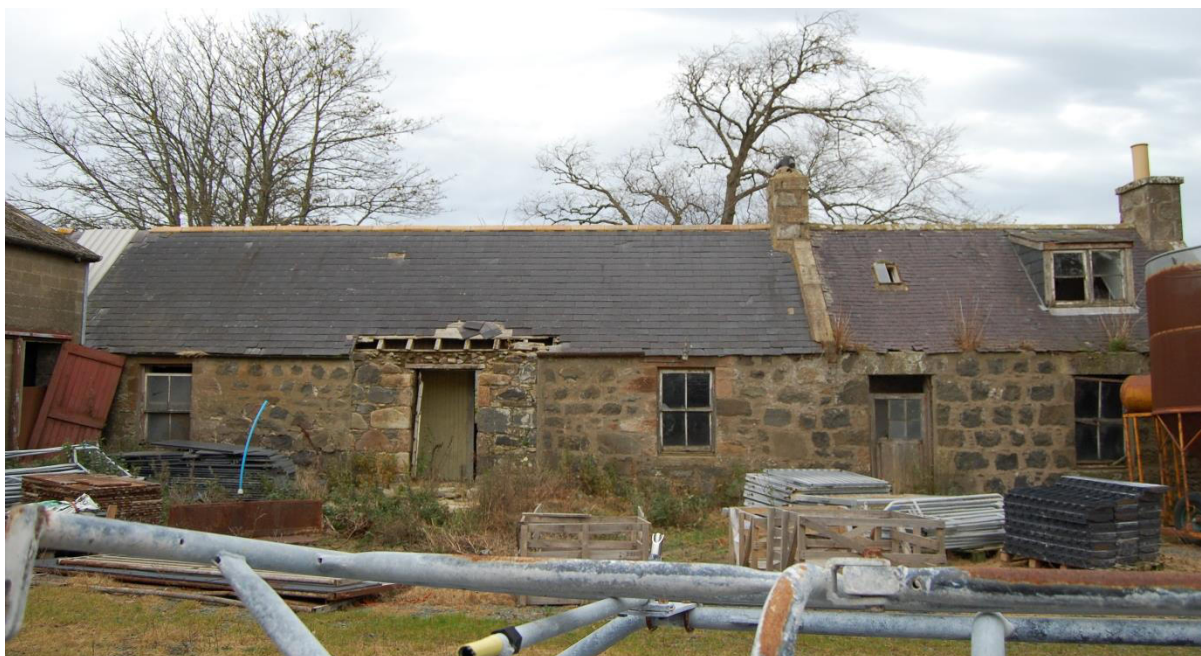
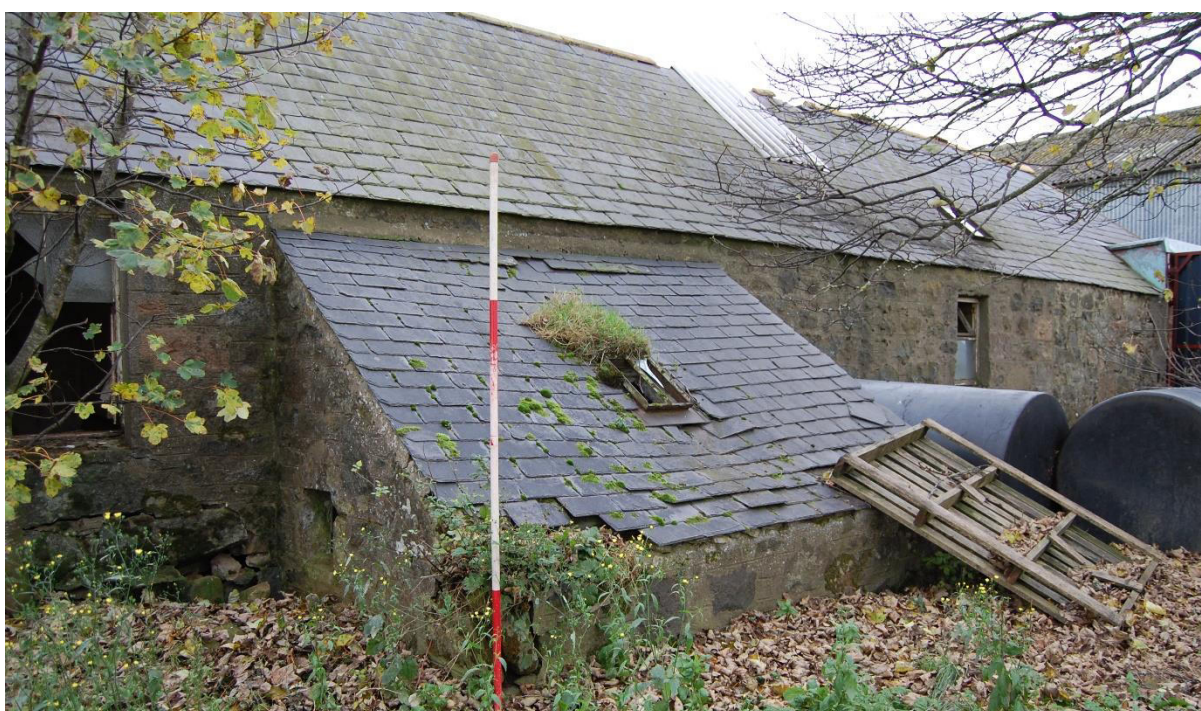
Cover: top Rooms 2-5 S wall showing Phase 1 structure (left) Phase 2 (right), facing NNW. Bottom Phase 1 cold store Room 1, facing SSW

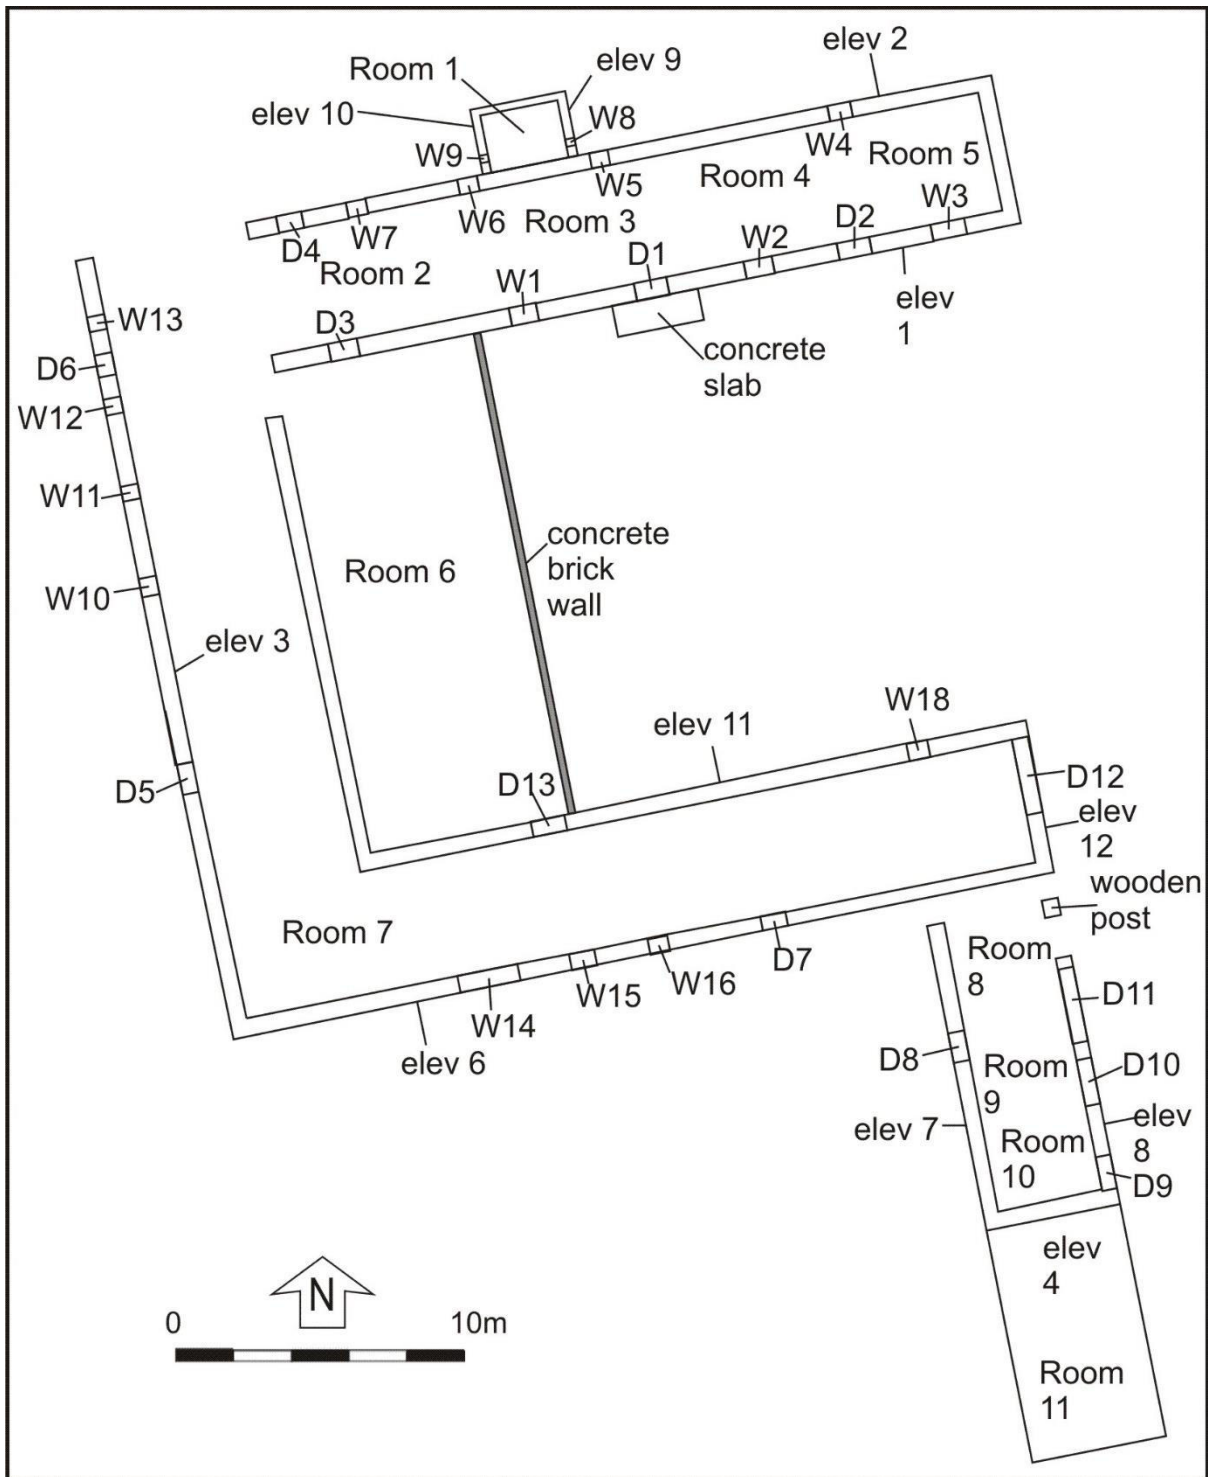
Illus 2 Plan showing buildings with room, aperture and elevation numbers

To the SE is a small separate building consisting of Rooms 8, 9, and 10 and partially demolished structure Room 11 which does not appear on the OS maps and may have been an unroofed enclosure.

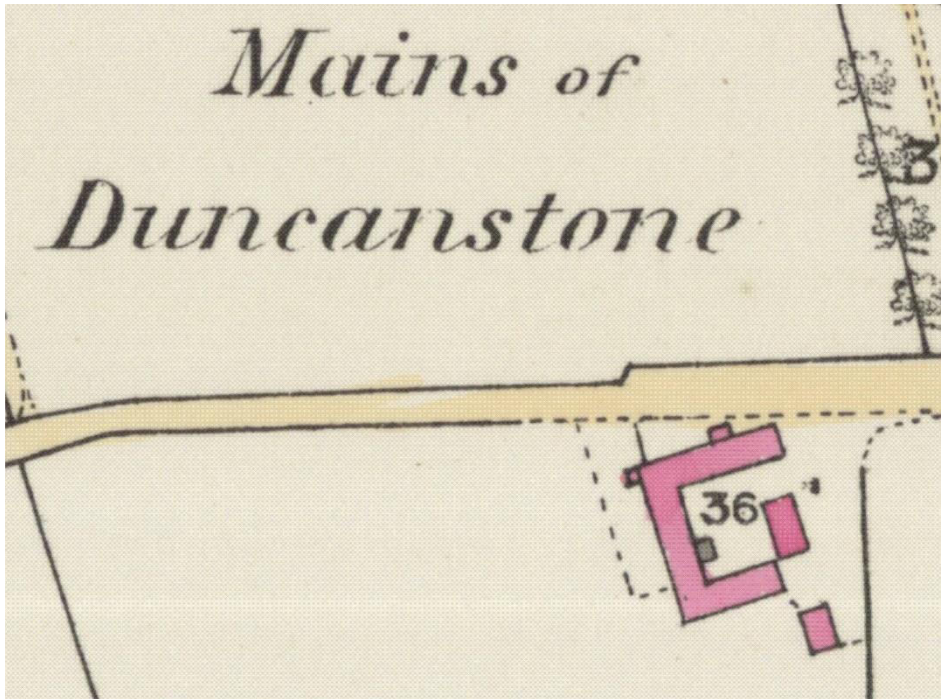
Mains of Duncanstone farmstead (Canmore NJ52NE 149) appears on the First Edition OS map (Illus 17) as a C-shaped steading on a WSW-ENE orientation with a small separate building partially closing the open side of the central courtyard and a small bothy to the SE. There are small extensions off the N and W exterior walls and a small outbuilding within the courtyard. By the Second Edition OS map (Illus 18) the steading has been extended to the E and Room 8 added to the n end of the bothy building. A horse mill has been added to the W end of the S wall of the main steading building.

Illus 17 1st Edition Ordnance map. Aberdeen Sheet XLIII.12 (Leslie) Survey date: 1866 Publication date: 1870 (copyright National Library of Scotland)

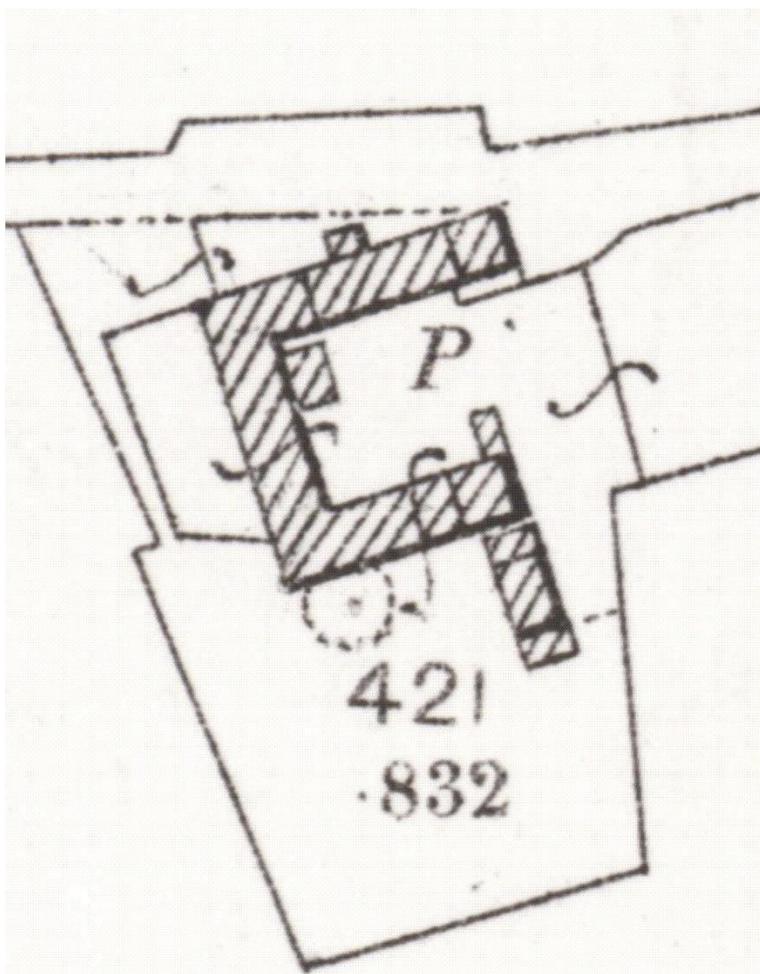
A horse mill was added to the S side of this wall on the 2nd Edition OS map and the apertures W14 and W15 may be associated with this structure. The ground level has been raised in the area of the horse mill and these apertures are partially obscured.

Illus 18 Second Edition OS map. Aberdeenshire 043.12 (includes: Kennethmont; Leslie) Publication date: 1900 Revised: 1899 (copyright National Library of Scotland)
