**Balnabreich Farm Steading, Careston, Brechin, Angus,
DD9 6RT
Report on Level 1 Standing Building Survey**

**Alison Cameron
Cameron Archaeology
18 March 2016**

SUMMARY

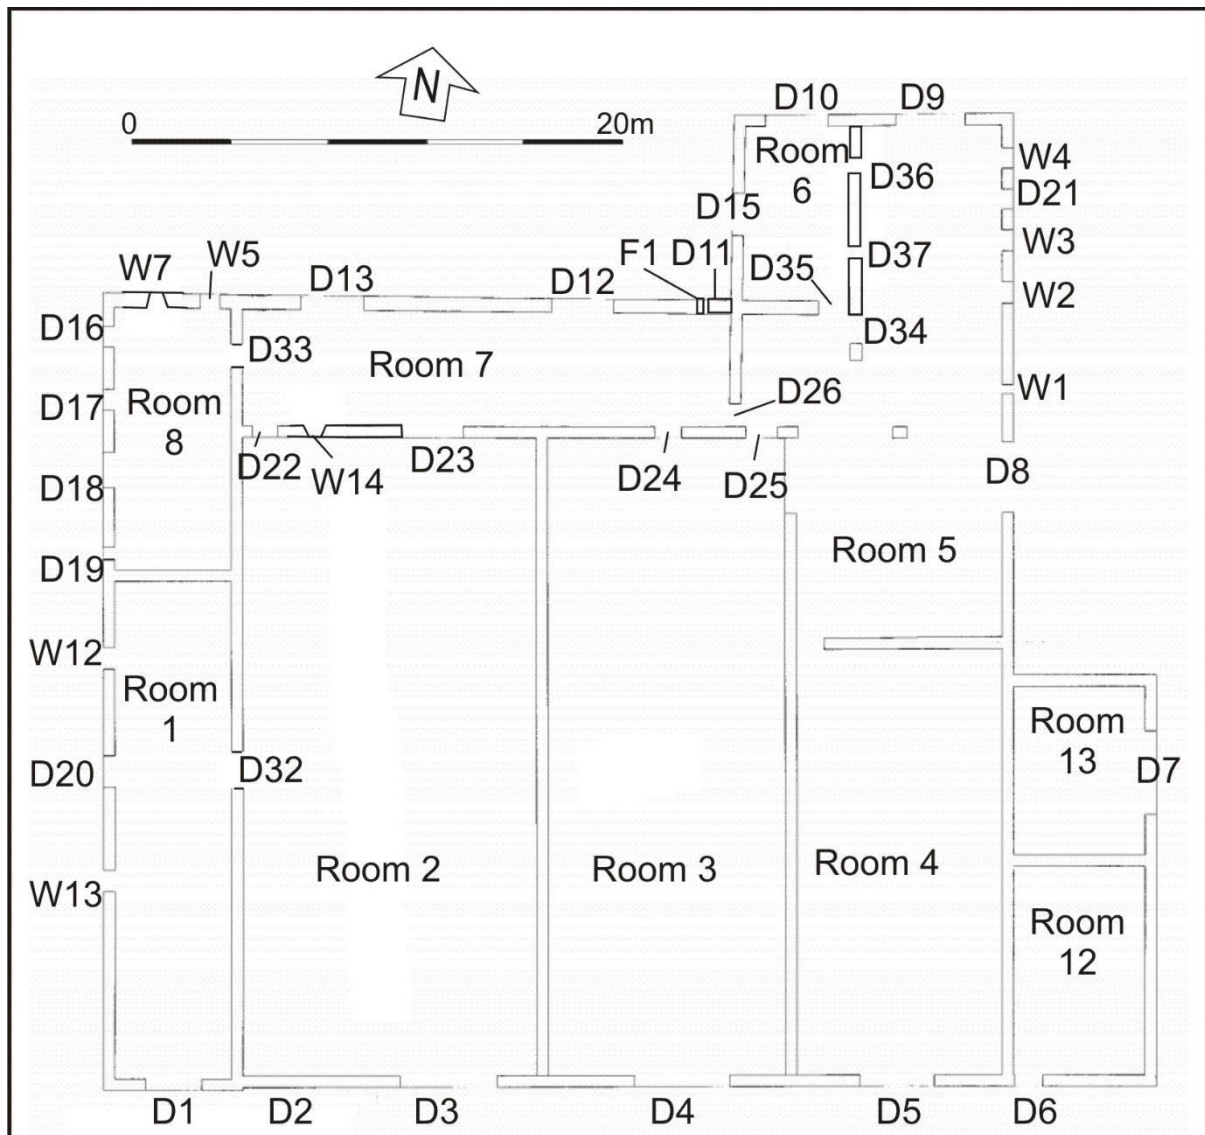
Illus 4 Building 1 ground floor plan (from copyright A.B Roger & Young)

Rooms 1, 5, 7 and 8 were originally constructed in Phase 1. They are constructed of sandstone blocks and rubble with sandstone and wood lintels and sandstone sills. Room 1 is 6.1m wide and has two windows (W12 and W13) and a door (D20 later converted to a window) in the W wall and one door D32 into the former small open courtyard. Room 8 at the NW corner is a two storey structure which has been heavily altered with concrete internal fittings and partitions. It originally had four large cart doors D16-D19 2.6m wide and 2.3m high (Illus 6) on the W wall. They have large wooden lintels and sandstone block jambs and have been blocked with red brick and smaller apertures opened with concrete lintels and sills. There are four small windows in the first floor which is not accessible as the wood stair and floors are in poor condition.

A blocked window W7 can be seen on the interior N wall but is obscured on the exterior. There is a small Phase 1 first floor window on the N wall (W6) and a later window (W5).

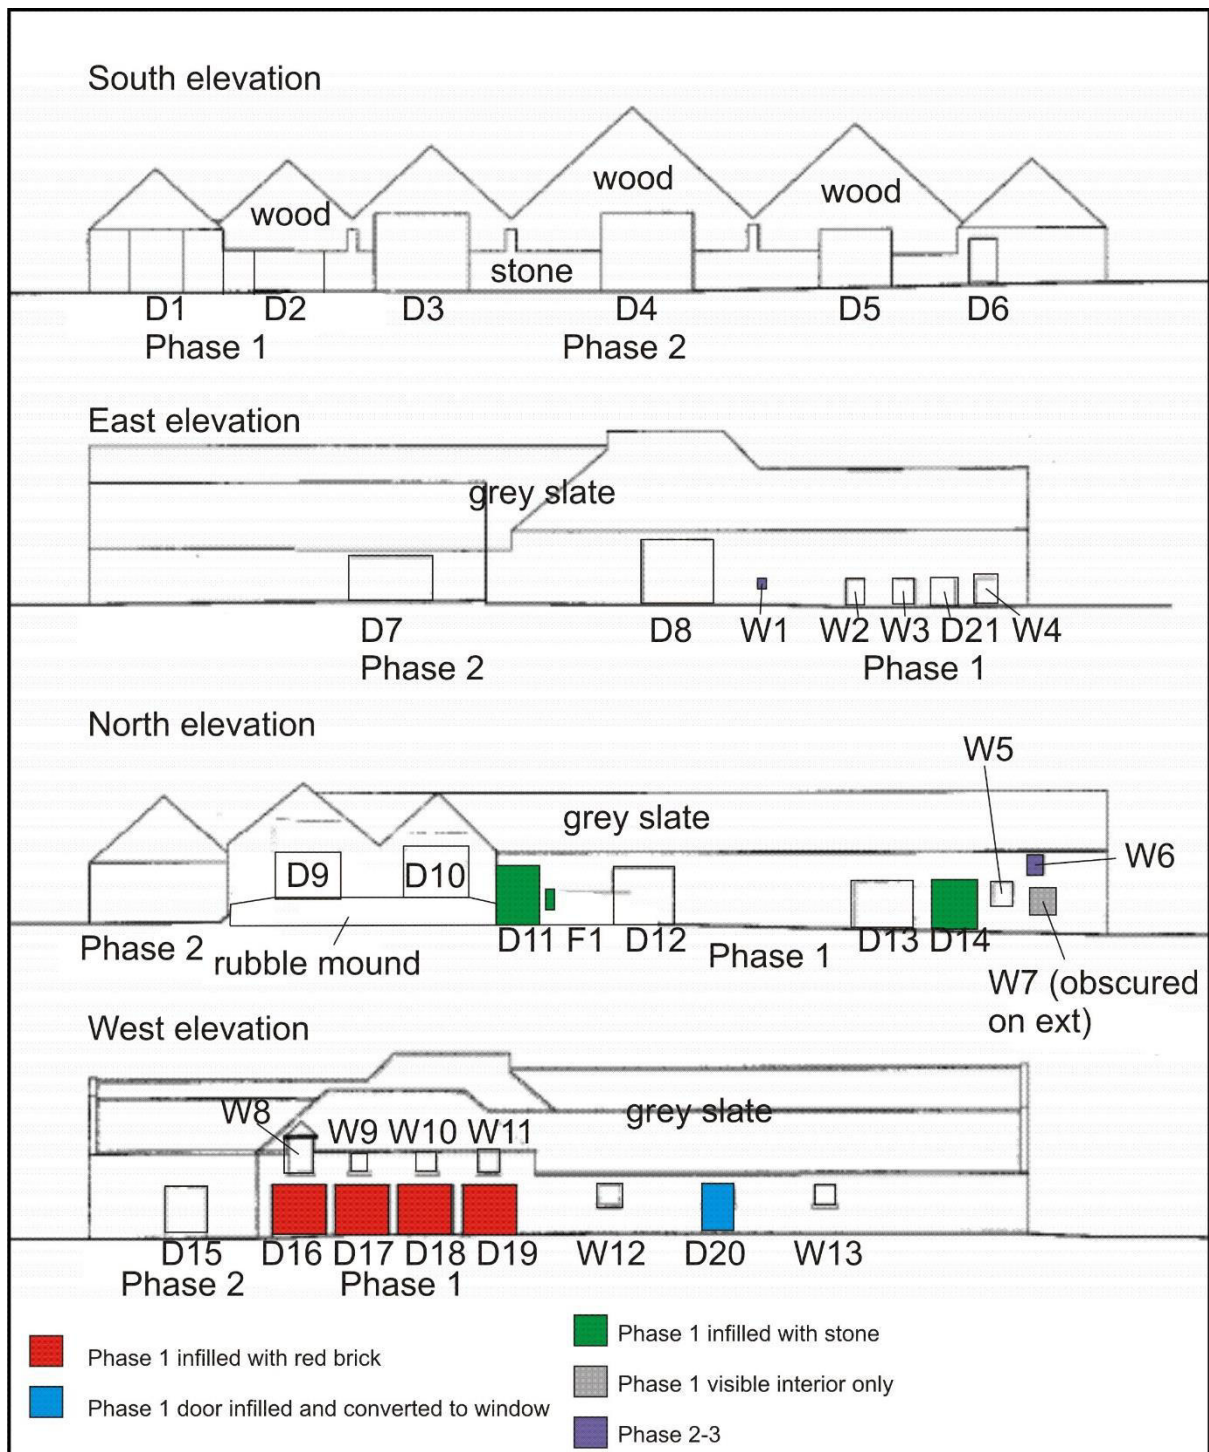
Illus 5 Building 1 elevations (from copyright A.B Roger & Young)

Room 7 has two large doors in the N wall (D12, D13) and two blocked doors D14 at the W end and D11 at the E end (Illus 7). There is a small stone aperture adjacent to D11 (F1). The S wall has a large door D23 which has been widened and three smaller doors D22, D24 and D25. There are a series of stone corbels on the N and S walls (Illus 8) for Phase 1 wooden beams and a series that have been utilized to support the current roof beams. The interior and much of the exterior of these rooms have been whitewashed.

Room 5 has been heavily altered and combined but the N section was constructed in Phase 1. There is a door in the N gable (D9) at first floor level which is now accessed up a ramp. This is likely to be a later door and this building was probably accessed at ground floor level when it was originally constructed. There is a series of windows (W2, W3, W4) and a door

D21 which are in the E wall at ground level. There has been much historical dumping of building rubble and soil in this area partially blocking these apertures after they went out of use. The room now has a large milling machine in this area and these apertures are now virtually inaccessible.

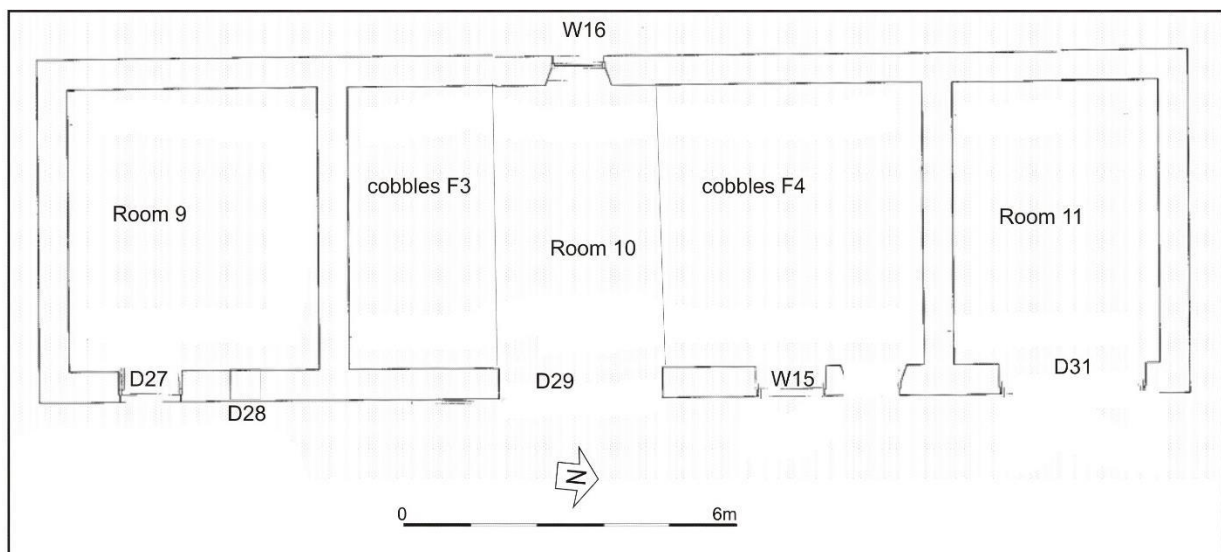
Illus 10 Building 2 plan (from copyright A.B Roger & Young)

Building 2 is a rectangular outbuilding 20.05m long and 6.1m wide. It is one storey high, constructed of sandstone rubble with sandstone block lintel, sills and jambs, whitewashed on the exterior with grey slate roof. There are three rooms; Room 10 was constructed in Phase 1 (prior to the 1st edition OS map; Illus 2) and is now one central larger room which has the remains of cobbled stone floors (F3 and F4) and a window on the W wall (W16). This room may have originally been divided into two with large cart door D29 for one room and smaller D30 and W15 for the second room. There are two smaller rooms with Room 11 at the N built in Phase 2 (between 1st and 2nd OS maps) and Room 9 added in Phase 3 (between 2nd and 3rd Edition OS maps).

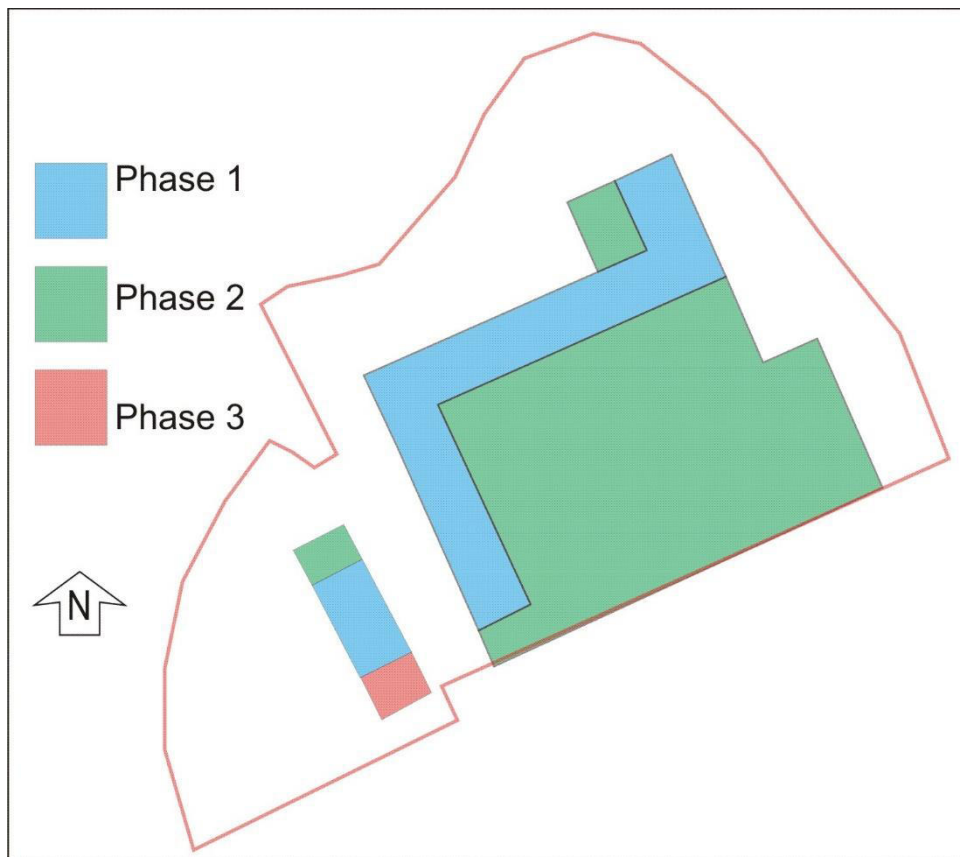
Illus 16 Phase plan (from copyright AB Roger & Young)

A Level 1 standing building survey was carried out on 14 March 2016. At least 3 phases of development (Illus 16) were recorded at this farm which was probably built in the early 19th century, possibly utilizing stone from the nearby demolished Fuirdstone Castle.
