**Kepplestone Mansion, Viewfield Road,  
Aberdeen, AB15 7AW  
Report on Level 1 Standing Building Survey**

**Alison Cameron  
Cameron Archaeology  
14 July 2016**

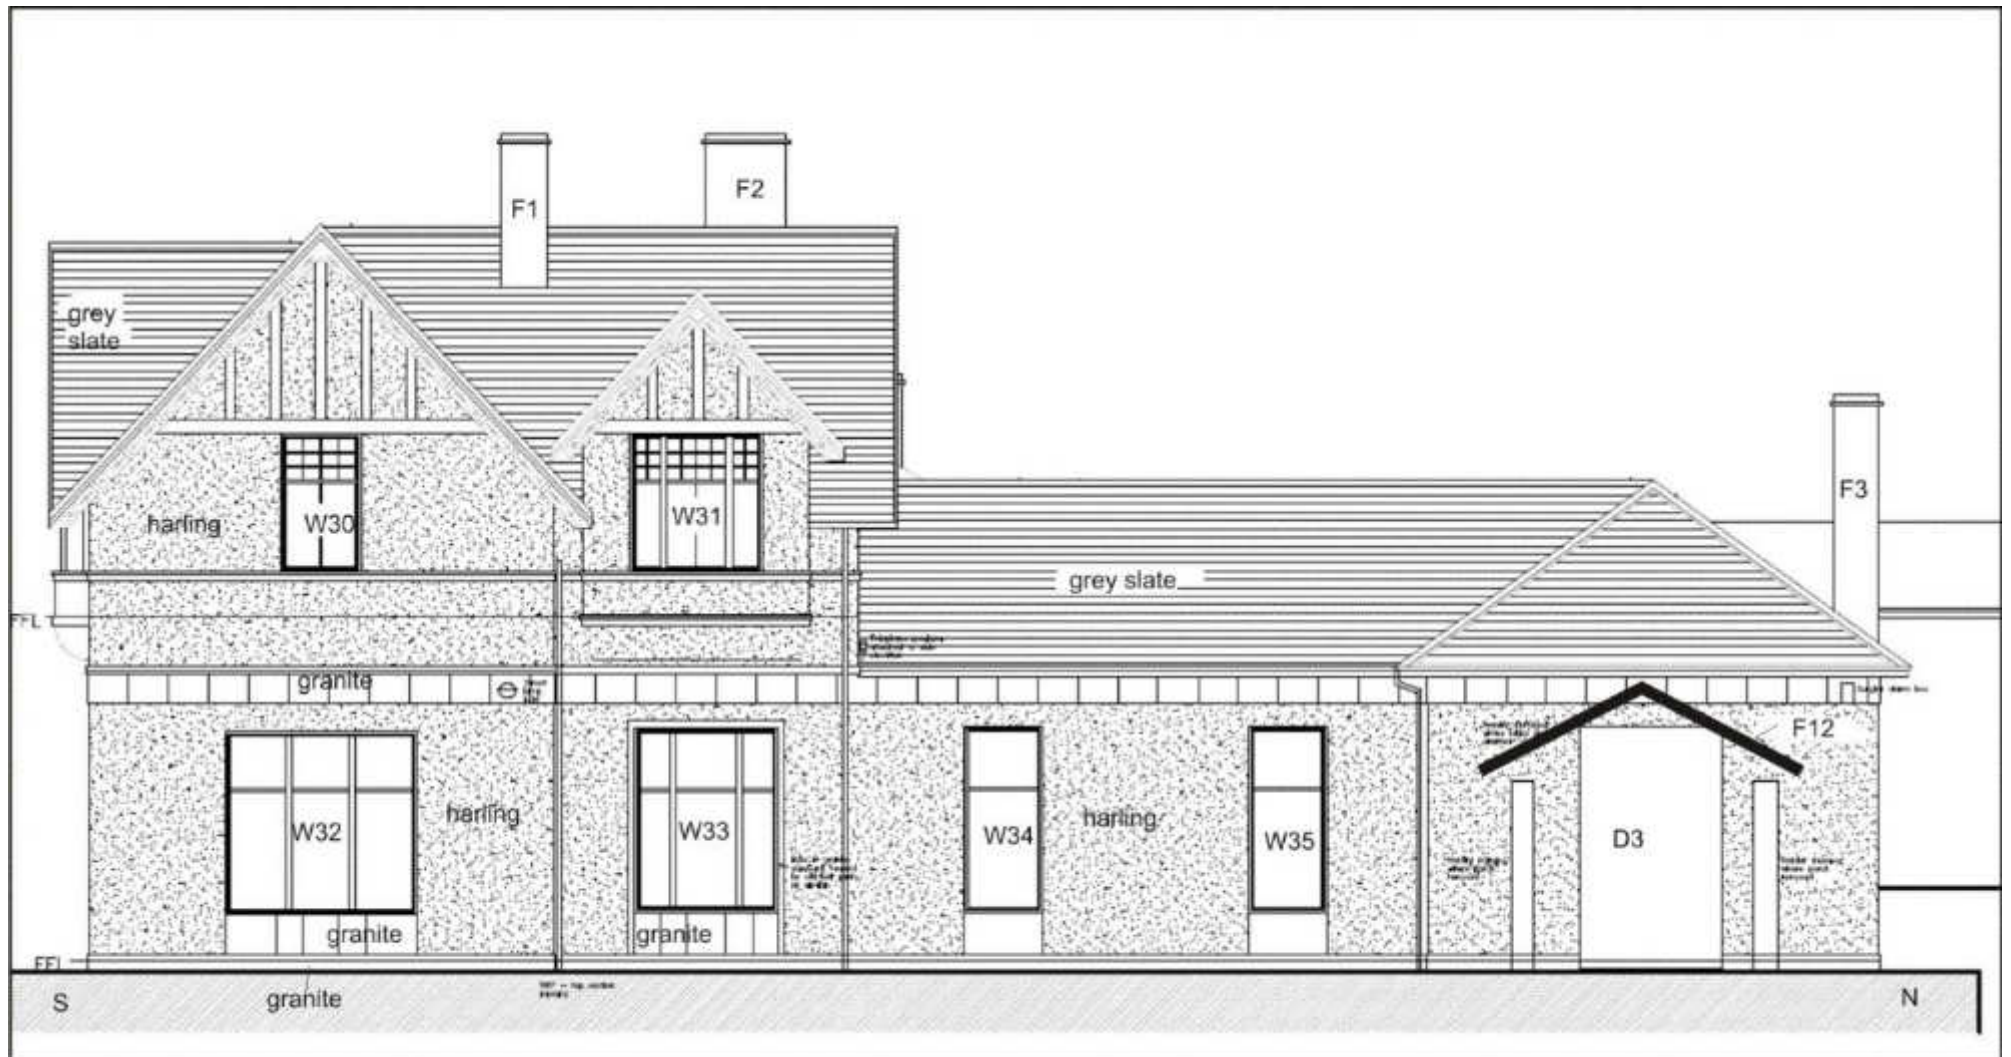
Illus 4 East elevation annotated with numbers used in this survey Building 1 (copyright Stewart Milne Homes).

The buildings started as a group of buildings along the E side of Viewfield Road with a small farmhouse set back from the street. This house was then enlarged with additions to the N and S (Illus 22, 23) and the buildings joined with large modern doorways added to the extension. Buildings were then added around the courtyard and to the E of the house, most of which have since been demolished. Scars where these have been removed include F12 on the E façade (Illus 4) and F14 on the N façade (Illus 5).

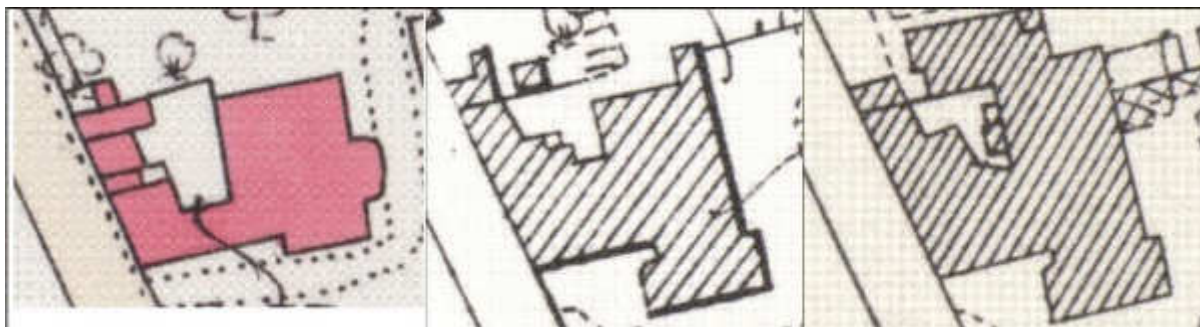
Illus 22 OS maps. Left: First Edition Ordnance Survey map Aberdeen Sheet LXXV.14 . Centre: Second Edition Ordnance Survey map Aberdeenshire 075.14. Right: Third Edition Ordnance Survey map Aberdeenshire 075.14 (copyright National Library of Scotland).

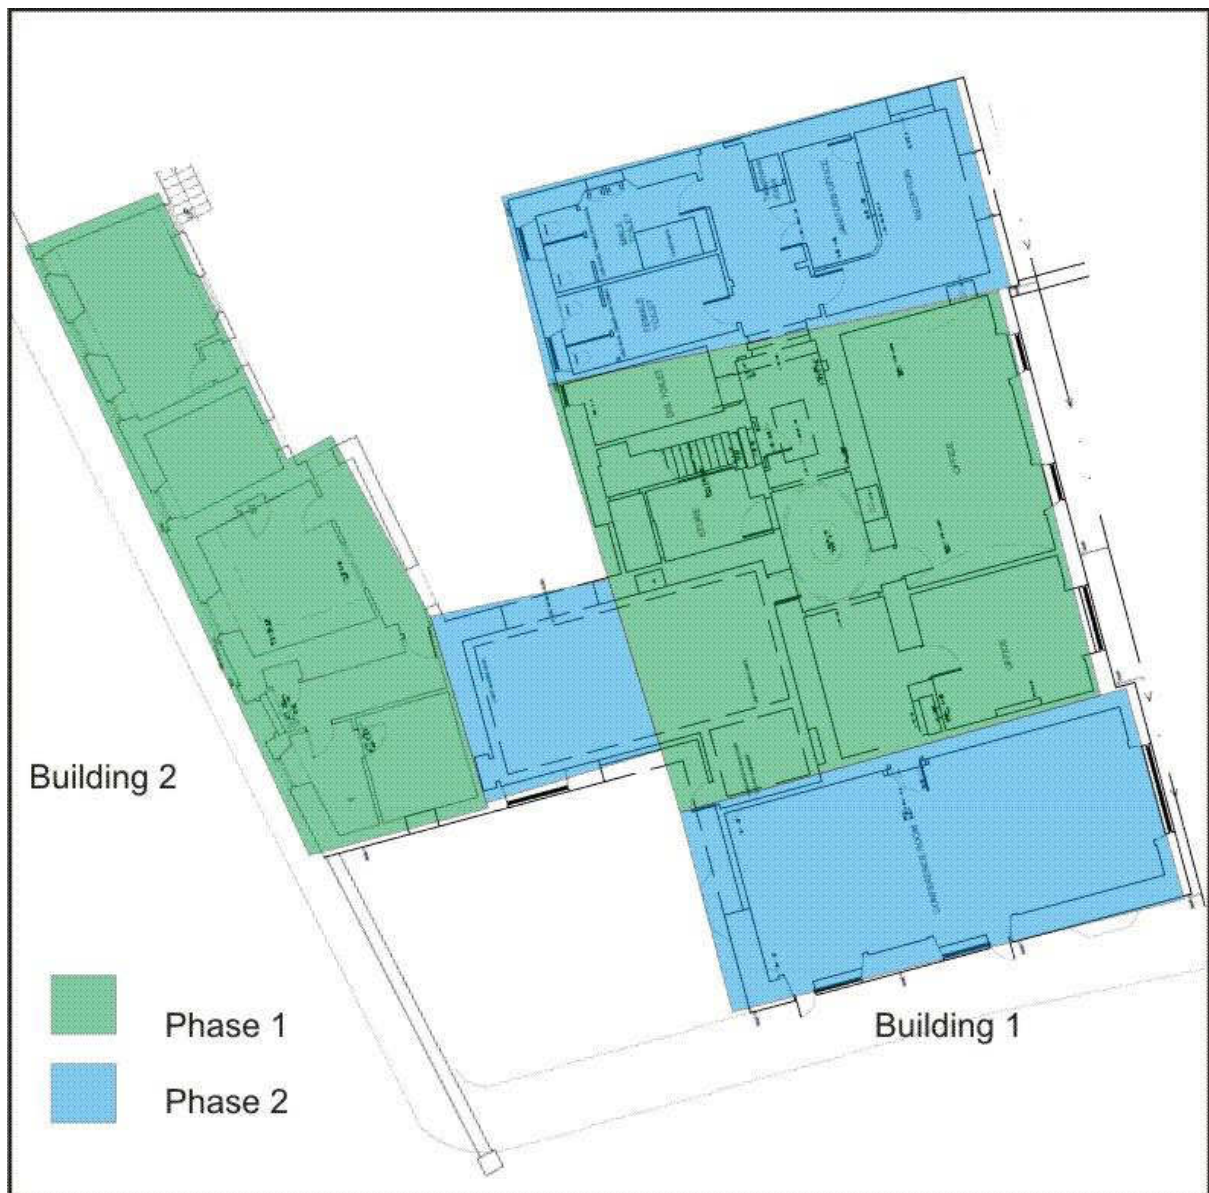
Illus 23 Possible phase plan based on survey and OS maps: the Phase 1 areas may have been linked around the small courtyard (copyright Stewart Milne Homes).
