**Mill of Kelly Sawmill, Tarves, Aberdeenshire, AB41 7EN
Report on Level 1 Standing Building Survey**

**Alison Cameron
Cameron Archaeology
9 October 2016**

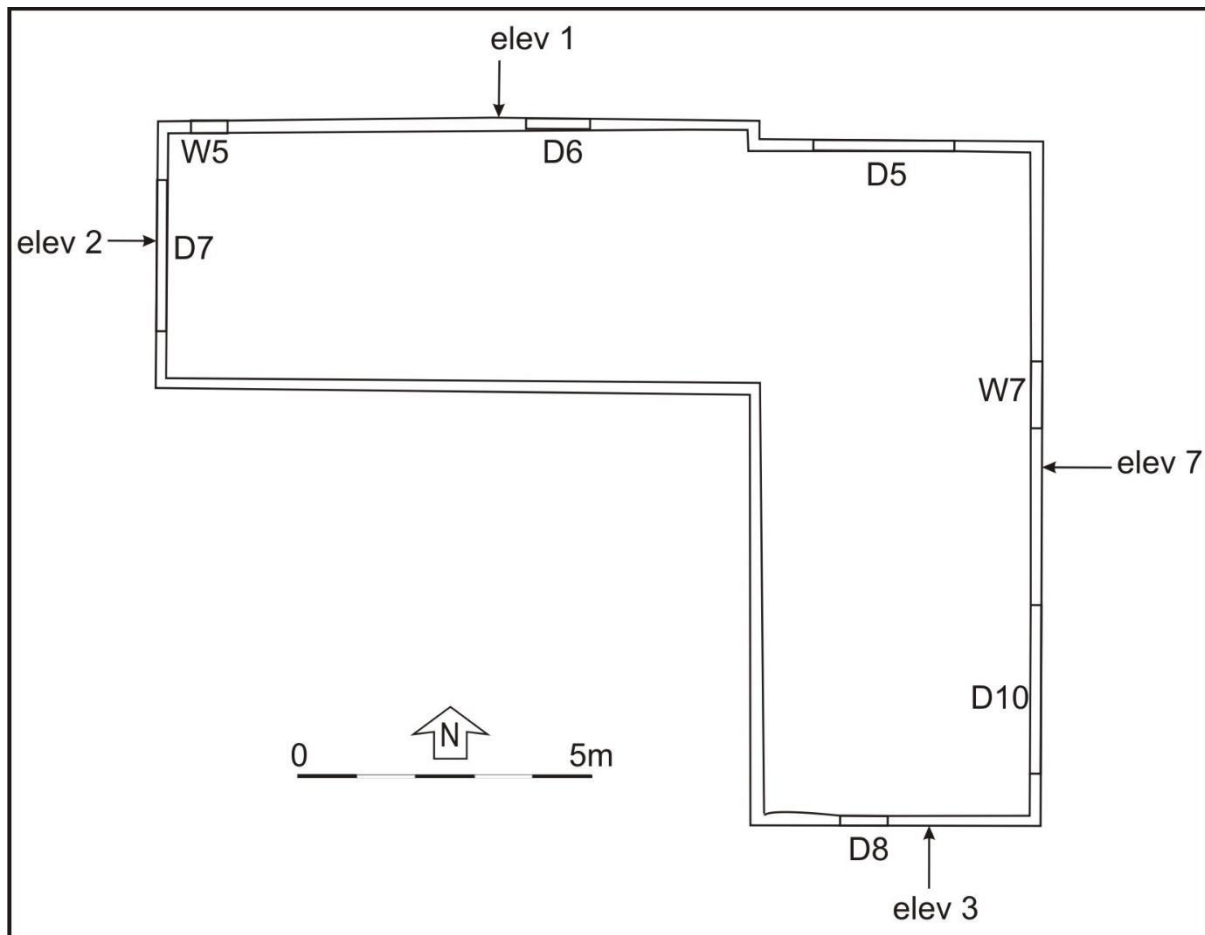
Illus 4 Building 1 plan

Building 1 is L-shaped, 15m W-E and 11.5m N-S (Illus 4-7). There are large doors in the W and N gables and the S end of the E wall and smaller doors and windows in other walls. The W end has been slightly extended since the Second Edition OS map. There is a concrete foundation (F1, Illus 8) 0.5m deep under the E wall which is not visible on the N wall; access to the W wall was not possible to determine whether there was a similar foundation on other walls. The walls are of wooden planks which have been repaired many times (Illus 9). The roof appears in moderate condition (Illus 10) suggesting this has been replaced since the original construction.

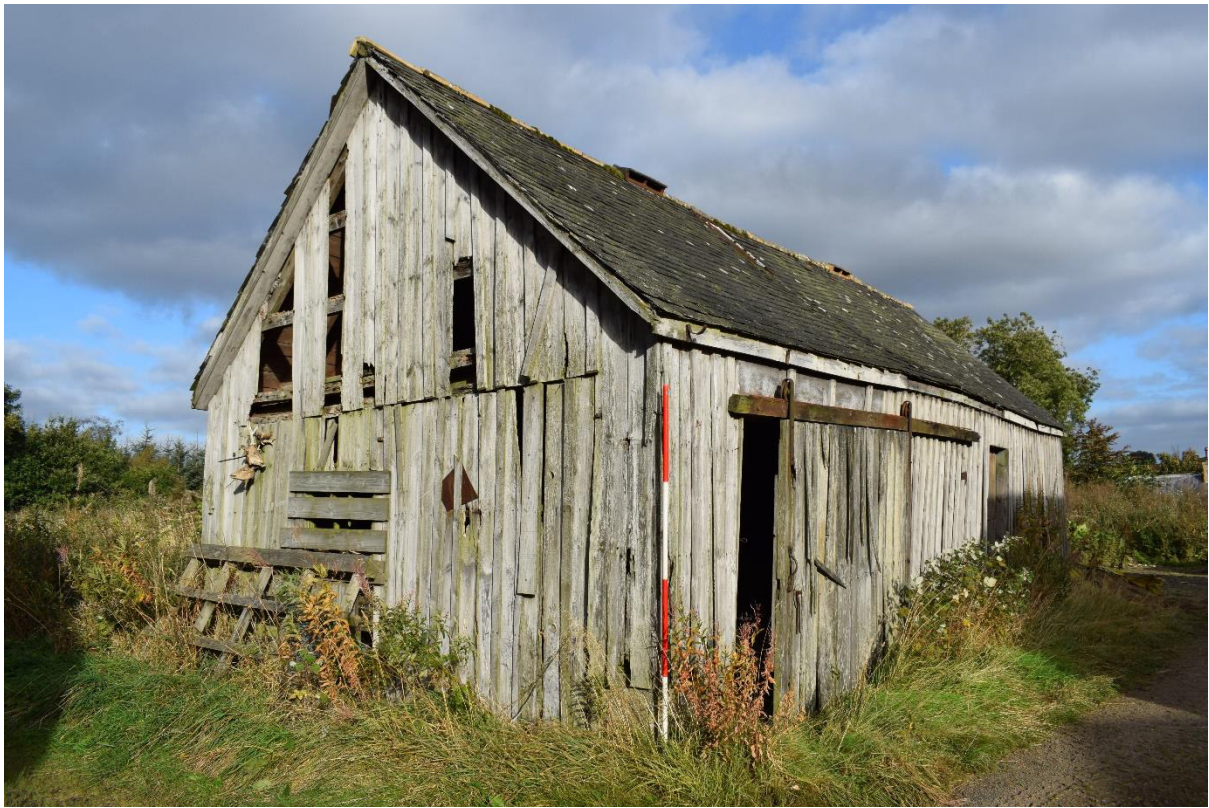
Illus 7 Building 1 from the SE; facing NW

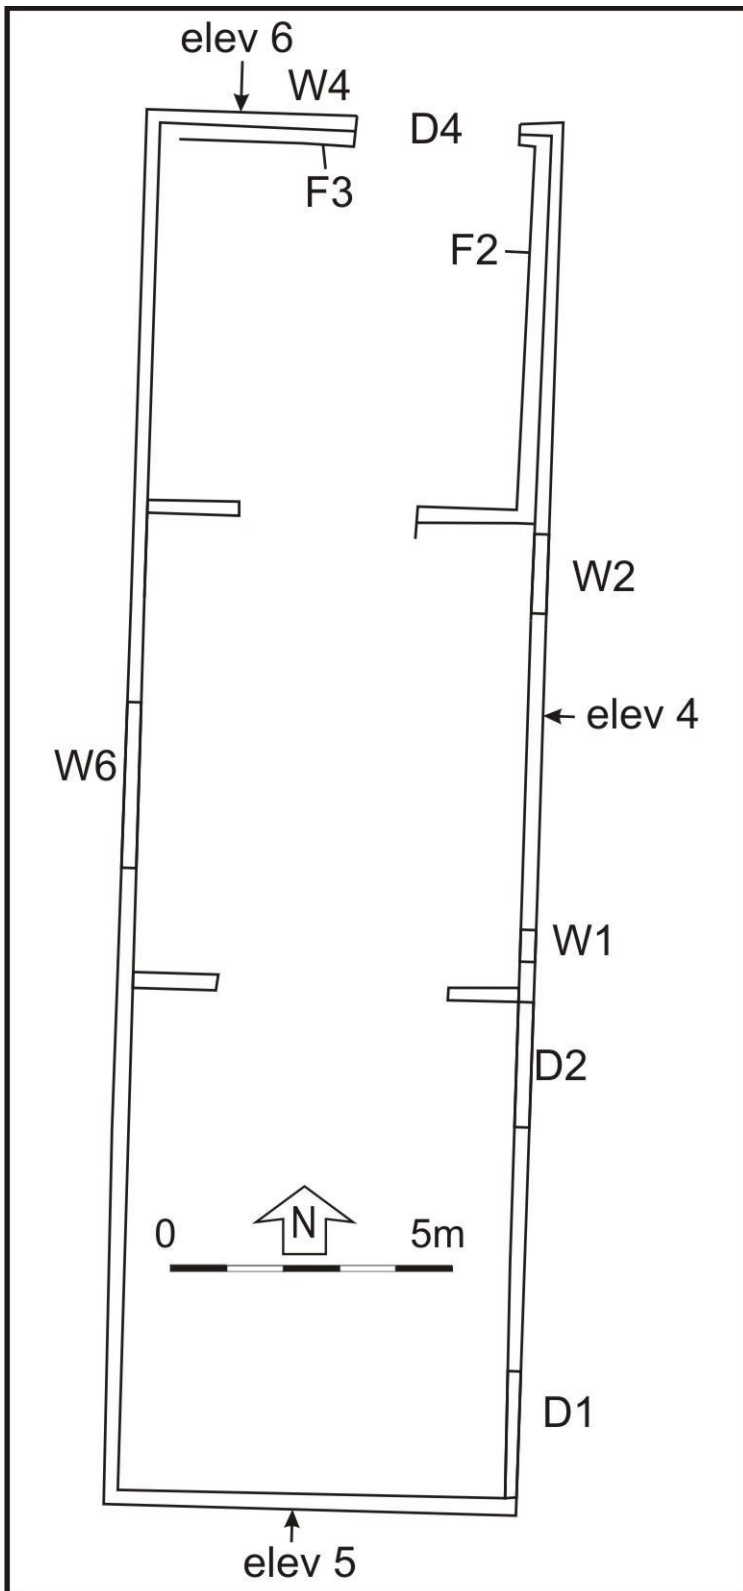
Illus 12 Building 2 plan

Building 2 is rectangular, 25m N-S and 7.5m W-E. There are 3 rooms (N, centre and S). The centre and S rooms are constructed from wood planking with grey slate roof (Illus 12-13) and wood planking floor (Illus 15). There are large doors in the E wall and windows in the W wall (not accessible). There is a first floor window in the S gable with the remains of a wooden platform (Illus 14).

The N room has been added later and the W and E walls and roof are constructed from asbestos cement roofing panels on a wooden frame (Illus 19), the N gable is constructed from short wooden panels secured with iron nails (Illus 16) and the floor is earthen (Illus 17-19). There are stone foundations under the E wall (F2; Illus 17) and the N wall (F3, Illus 18).
