**Mearns Coastal Church, Castle Street, Johnshaven,
Aberdeenshire, DD10 0JA**

Report on Level 1 Standing Building Survey

**Alison Cameron
Cameron Archaeology
24 October 2016**

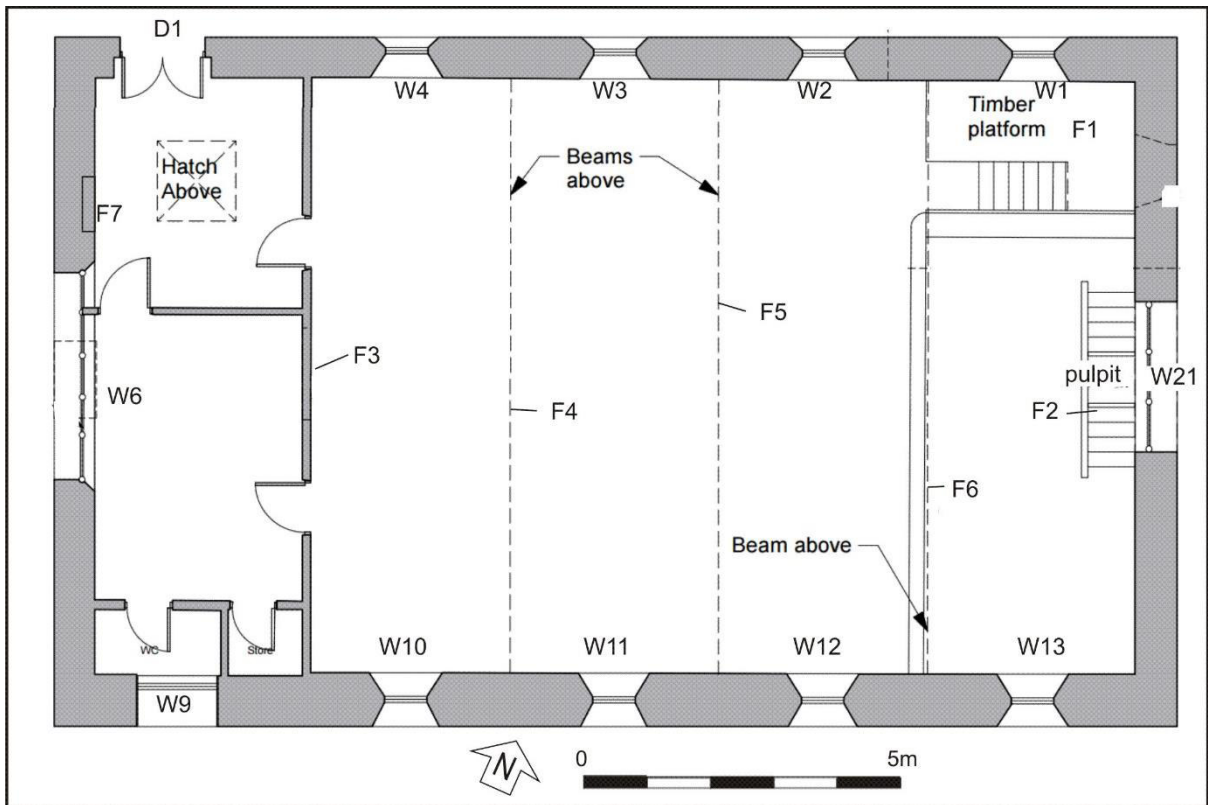
Illus 2 Ground floor plan annotated with numbers used in this survey (copyright kerry smith architects)

The 'ground;' floor level is the full length and width of the church. There is a large window at the ESE end (W21) which has been partially covered by the organ (F2) with small window above (W20). W6 on the WNW gable is also partially in this floor. There are large windows 90cm wide and 3m high with stained glass on the NNW and SSE facades (W1-W4 on NNW and W10-W13 on SSE). There is a door (D1; Illus 7) on the W end of the NNW façade at the ground level from the street and a quatrefoil window on the W end of the SSE façade (W9 (Illus 5, 12).

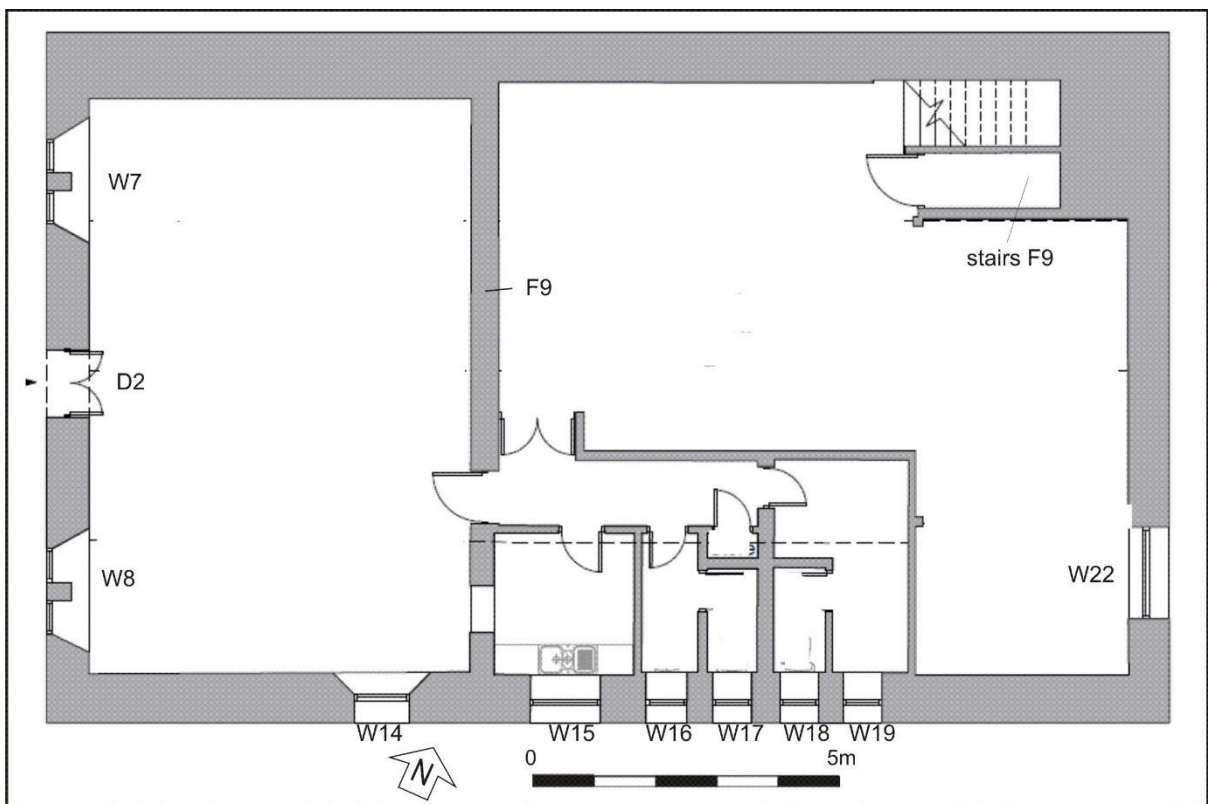
Illus 3 Basement plan annotated with numbers used in this survey (copyright kerry smith architects)

The basement (probably vestry and session house) was constructed in this phase but there is no evidence of whether this area was only accessible from the outside W end or whether there was an access from the church which has not survived following the re flooring and Phase 2 access created.

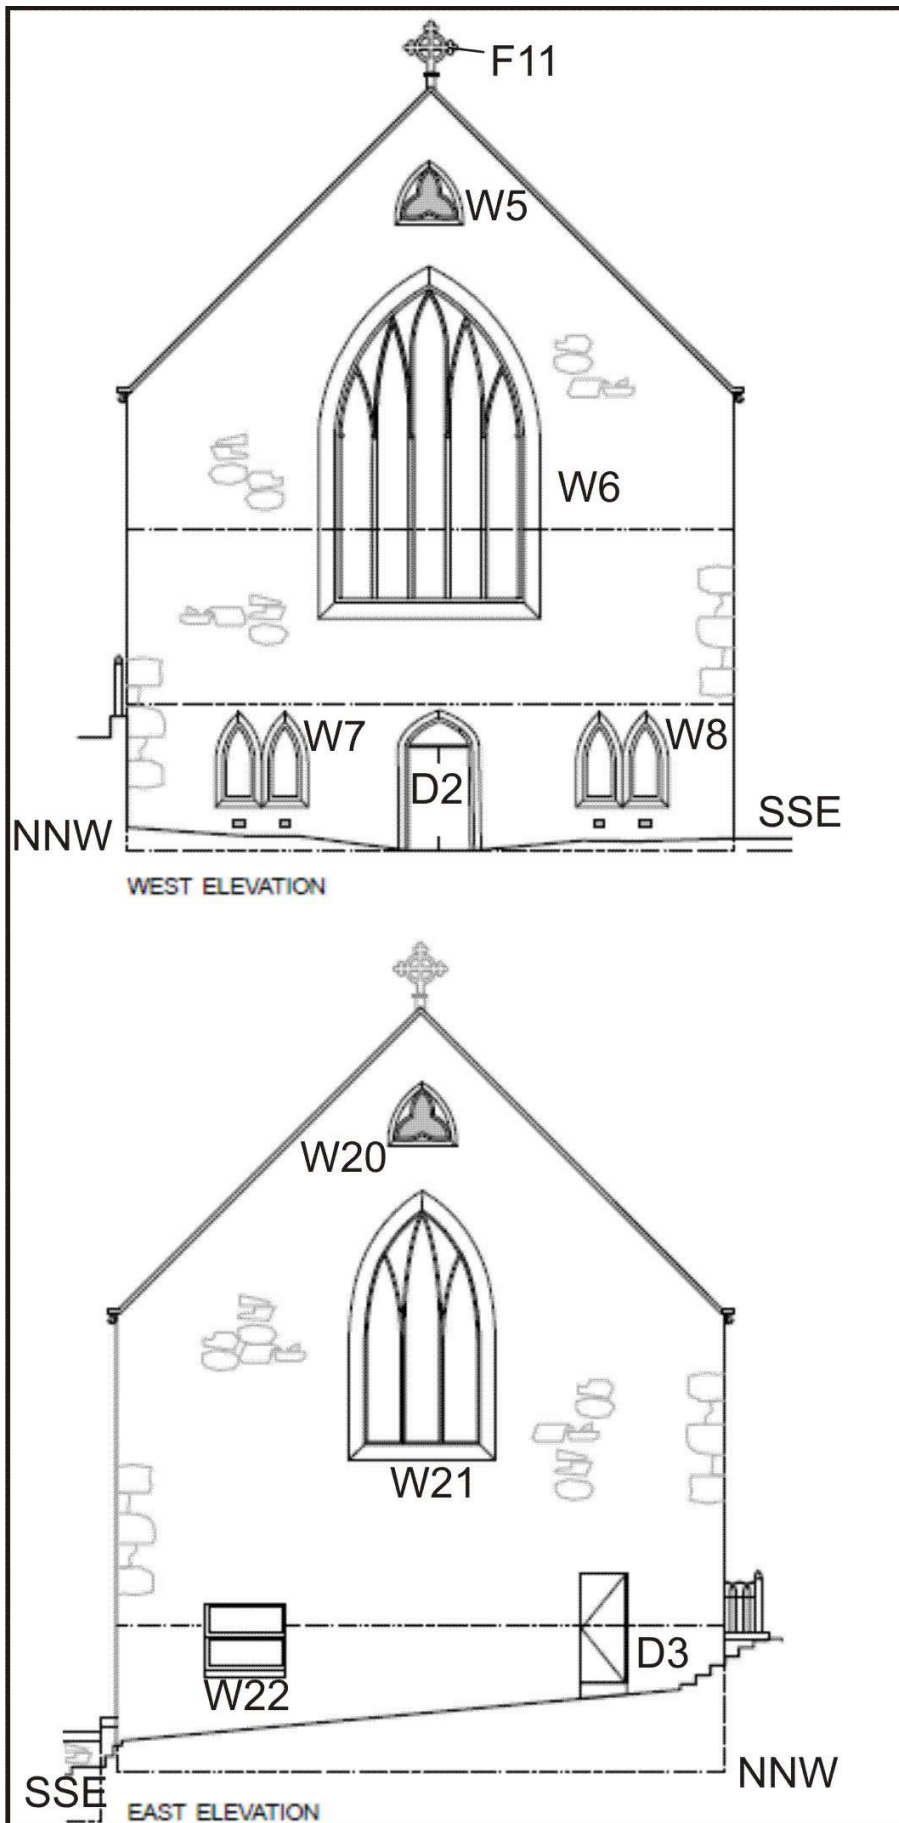
Illus 6 WNW and ESE elevations annotated with numbers used in this survey (copyright kerry smith architects)

The church is 11m wide and 18.5m long. There is a basement divided into two separate rooms (E and W rooms), the 'ground' floor and the attic which is accessible by ladder to the W end only. The walls are 50cm thick and constructed of pink and grey sandstone blocks with cherry cocking. The original window and door moulding are also of pink and grey sandstone as is the trefoil topped portico over D1 (F10; Illus 7) and the celtic cross finial over the WNW gable (Illus 8). The basement W room is 6m long and the E room is 10m long, both the full width of the church (10m internally) (Illus 3). The rooms are divided by a stone wall (F9). The basement is accessed from the ground floor on the W side of the church and via concrete steps from the NE corner of the 'ground' floor church (F9); there is a wood paneled structure built around the steps on the ground level (F1; Illus 2). There is a door, D2 and windows W7 and W8 on the WNW wall and a large upper window W6 and small upper window in the top of the gable (W5; Illus 6, 13).

The pointed arch door and windows in the WNW façade on the basement level were built in Phase 1 and reflect the slope into which the church was built. The principal door on the NNW facade (D1) would have been the main access for church services and D2 would have been the main access into the vestry and session house. These apertures have sandstone mouldings around the pointed arch door D2 and windows W7 and W8 (Illus 6, 9)
