**Land to North West of Seggieden Farm,
Kennethmont, Huntly, AB54 4NW
Report on Level 1 Standing Building Survey**

**Alison Cameron
Cameron Archaeology
30 January 2017**

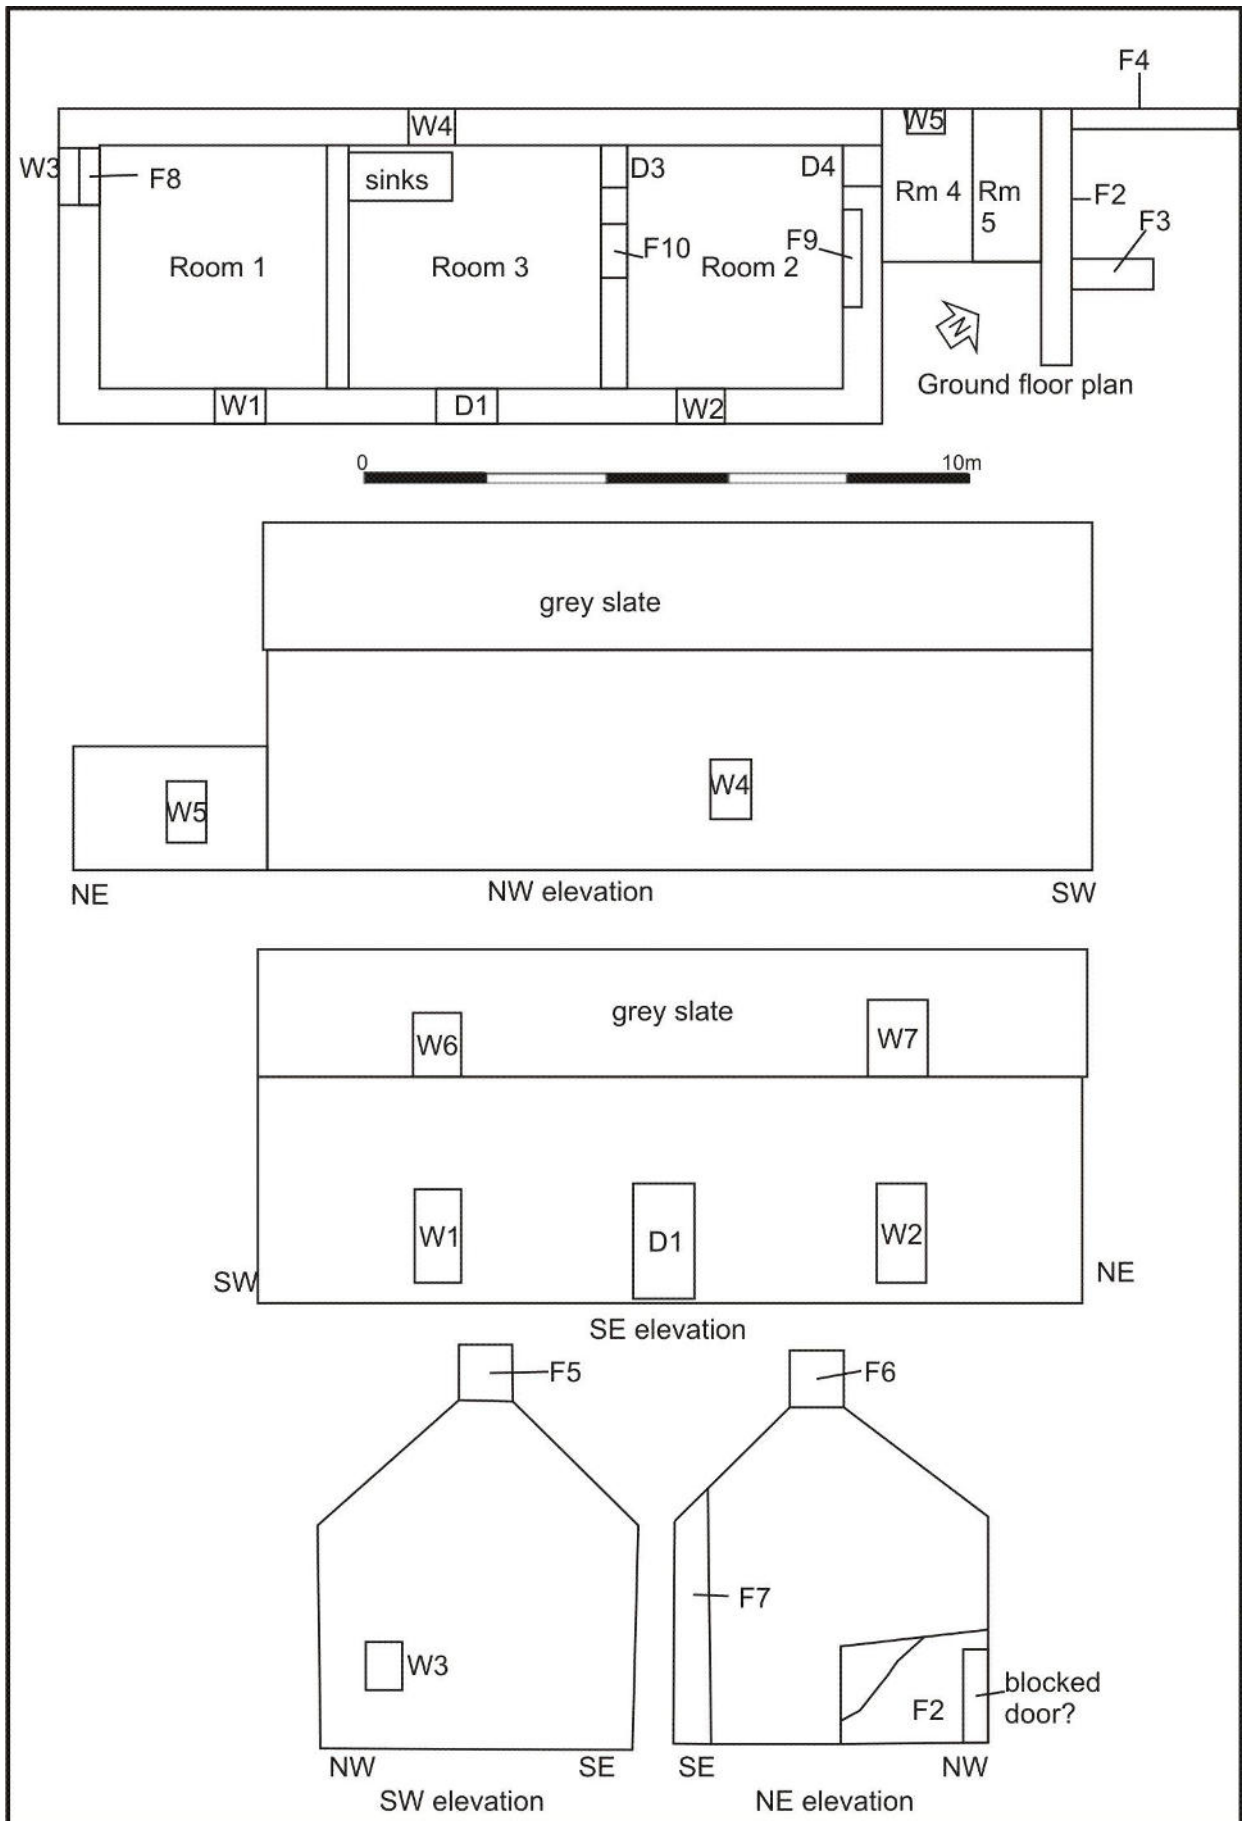
Illus 2 Plan and elevations of the cottage

The two-storey cottage is 13.5m long and 5.15m wide (see cover). It is constructed of quarried grey (and a few pink) granite blocks with cherry cocking, the roof is of grey slate and the lintels and sills are granite. The lintels of W1 and W2 have several quarry drill marks (Illus 3). The main 'front' façade faces SE and there is a central door (D1) with flanking ground and first floor windows. There is a blocked window (W3) in the SW gable (Illus 4, 5) and after this was blocked the interior was converted into an alcove cupboard (F8) in Room 1 (Illus 6).

The building has two main reception rooms the full width of the house, Room 1 in the SW and Room 2 in the NE. Room 2 has a large fireplace on the NE wall (Illus 7) and a central alcove shelving in the centre of the SW wall flanked by doors to the hall (D6) and to Room 3 (D3). There is a room under the stairs (Room 3) with large sinks and a window to the NW.

Door 4 leads to the extension, now mainly corrugated iron construction with corrugated roof (Illus 8) but this would have been a stone extension and there are remains of this stone structure (F2, F3 and F4; Illus 9).
