**24 Bogie Street/2 New Road, Huntly,
Aberdeenshire, AB54 8HE
Report on Level 1 Standing Building Survey**

**Alison Cameron
Cameron Archaeology
8 March 2017**

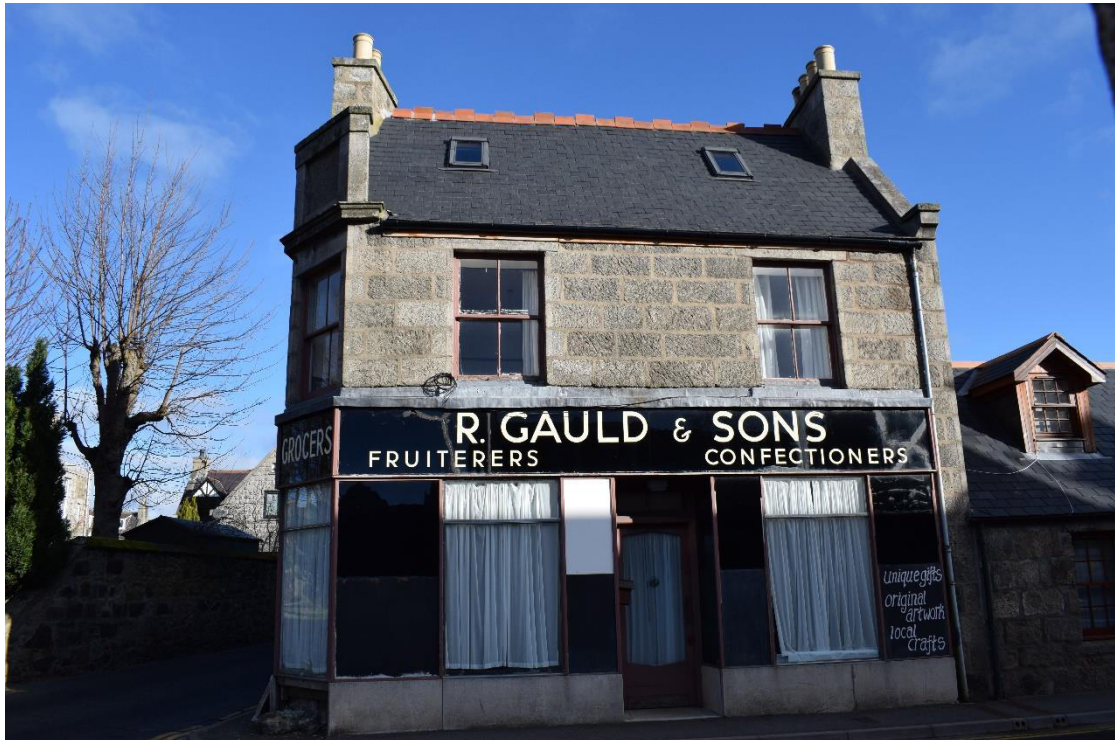
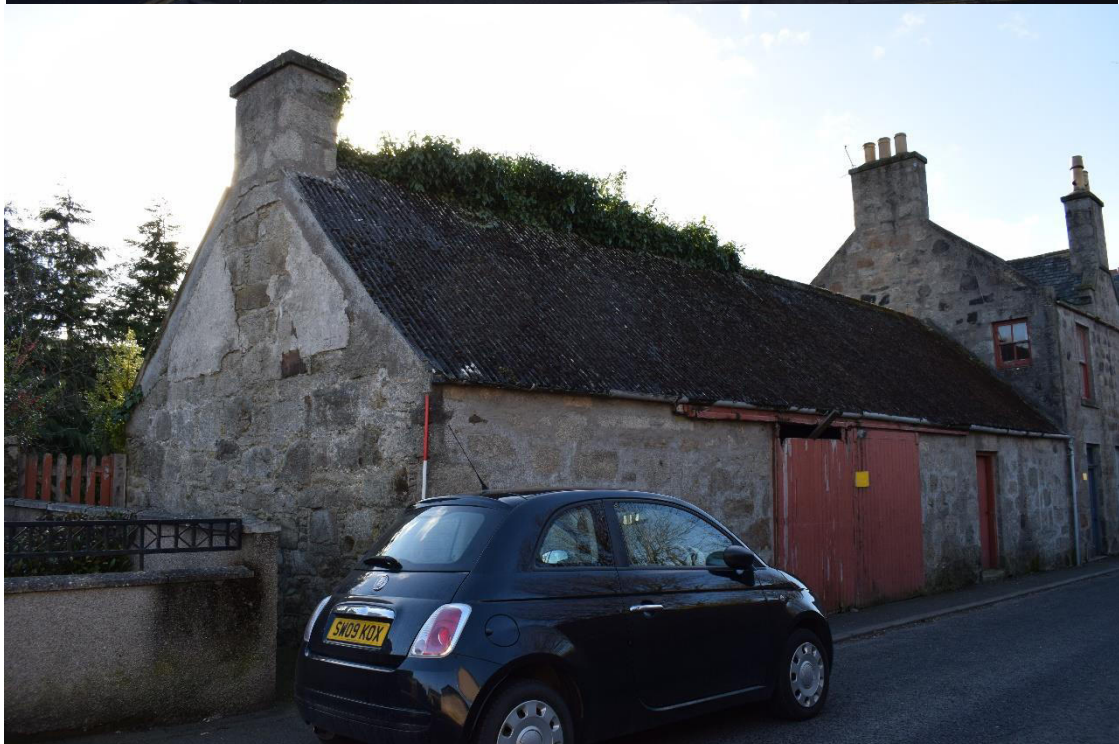
Cover: top Building 2 SSW shop frontage on to Bogie Street; facing NNE. Bottom Building 1 frontage on to New Road; facing S

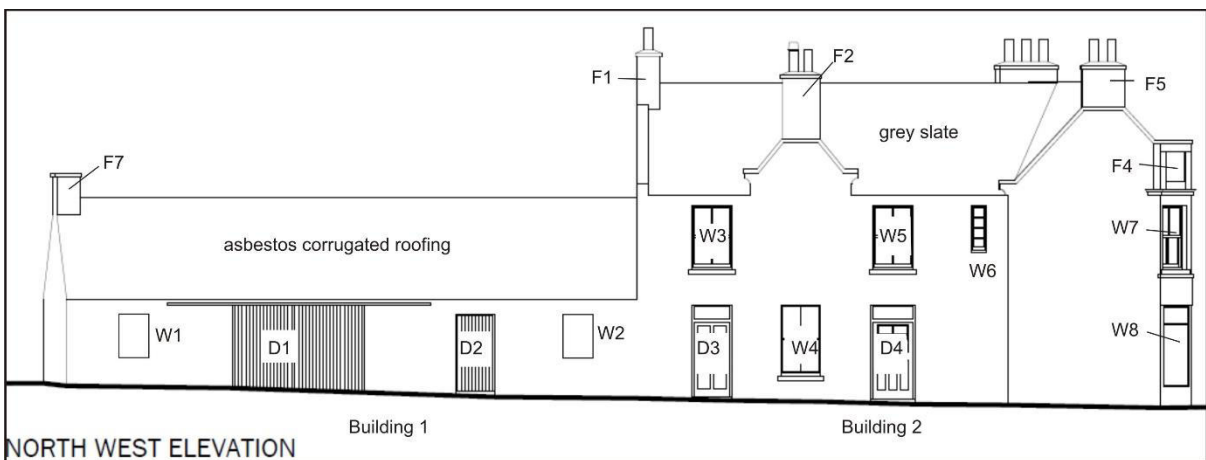
Illus 4 NW elevation annotated with numbers used in this survey (copyright Ian Duncan Architects)

The E wall of the building is very overgrown with ivy (Illus 7) but the remainder of the building was fully accessible. There are large stone fireplaces on the ground floor (Illus 8-10) and smaller fireplaces on the former first floor (Illus 8-10). A partition across Room 2 has been removed (Illus 11) and the floor joists can clearly be seen on all walls (Illus 12). Two windows on the W wall of this building have been infilled with rubble (Illus 4, 11).

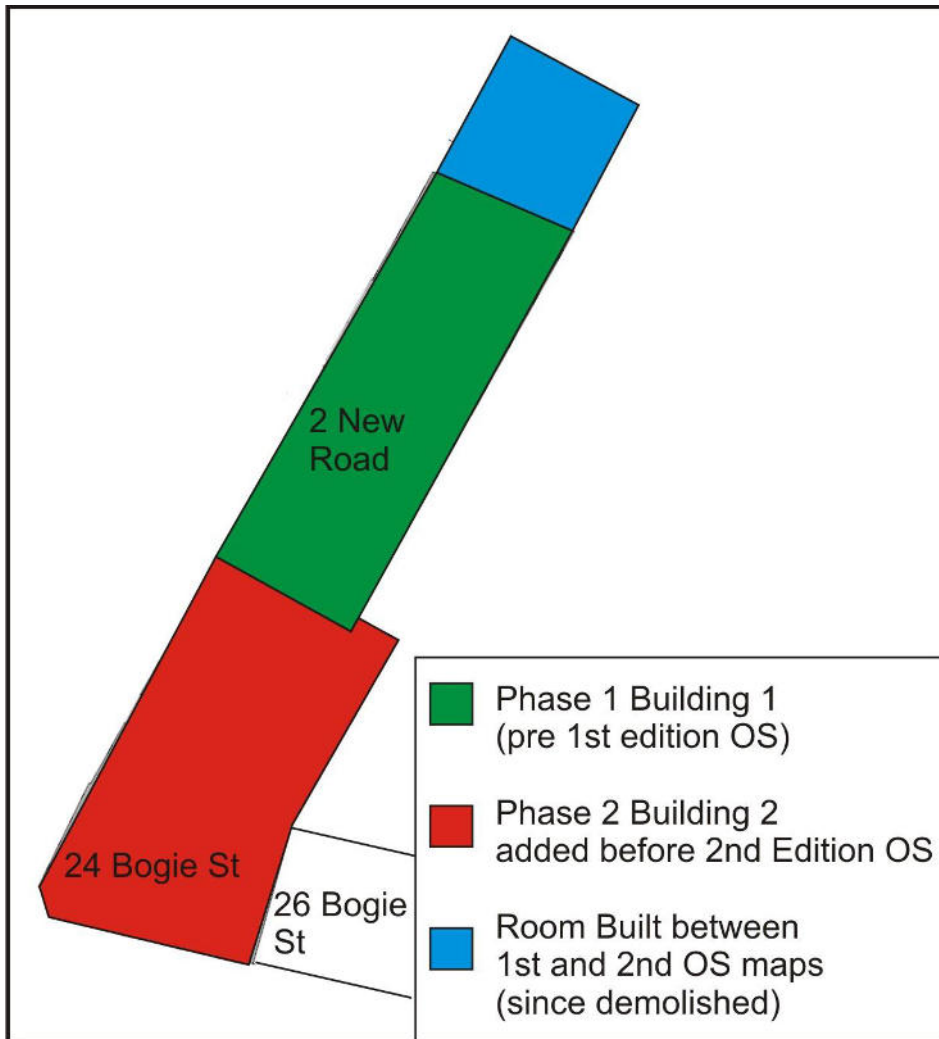
Illus 25 Phase plan (from copyright Ian Duncan Architects).

A Level 1 standing building survey was carried out on 28 February 2017. Two buildings were recorded photographically and architects plans and elevations checked and annotated. Building 1 probably dates to the early 19th century and was probably built as workshops with domestic accommodation on the first floor. Building 2 was constructed prior to 1900 and attached to the existing buildings on Bogie Street and New Road (Illus 25).

It is recommended that no further archaeological work is required during the current planning application.
