**Land At Upper Oldmill Farm, Turriff  
Aberdeenshire, AB53 8BU  
Report on Level 1 Standing Building Survey**

**Alison Cameron  
Cameron Archaeology  
19 April 2017**

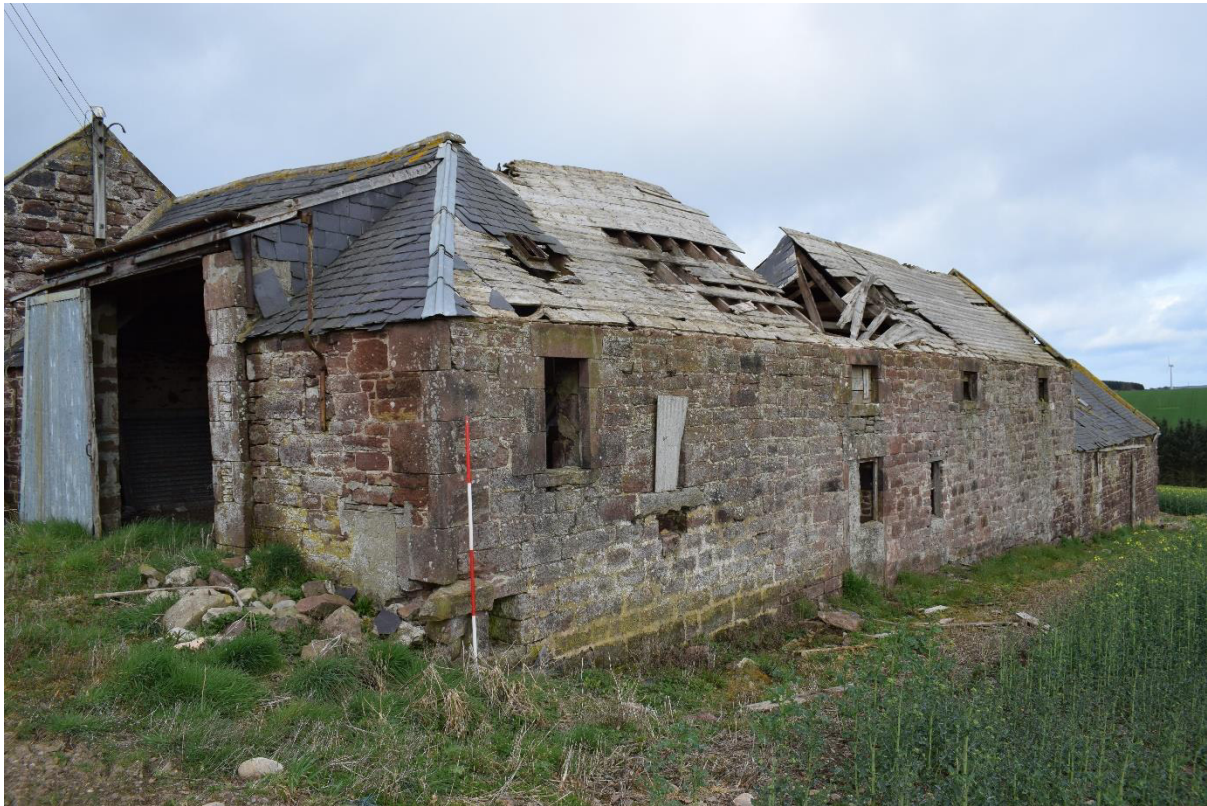
Cover: top: Mill building from SE; facing NW. Bottom; aperture for mill wheel driveshaft (F4, top F5 bottom); facing W

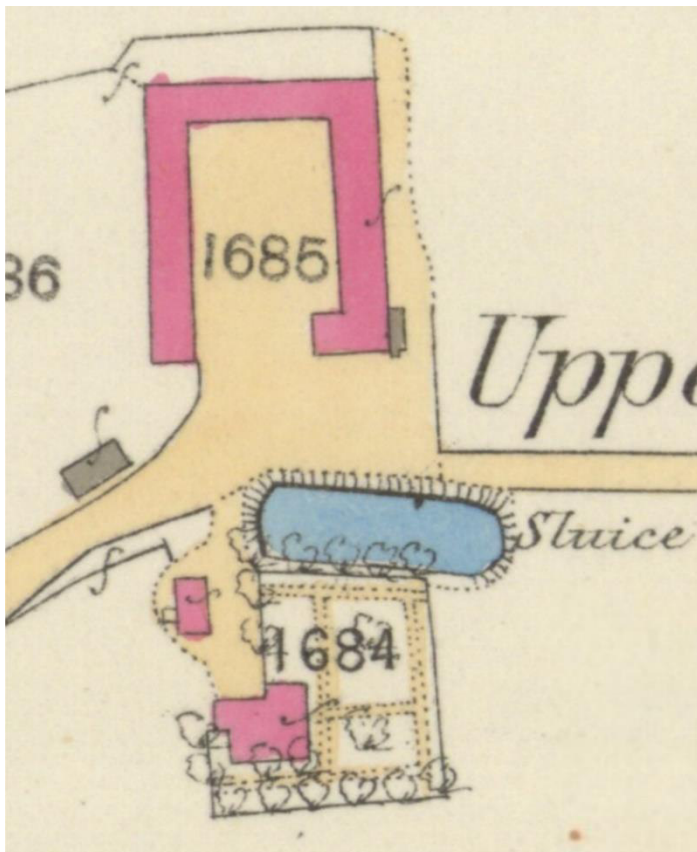
Illus 23 First Edition Ordnance Survey map. Aberdeen Sheet XIX.6 (Turriff)  
 Survey date: 1869 Publication date: 1873 (copyright National Library of Scotland)

Room 4 is the former mill (see cover photos; Illus 14). It is in the SE corner of the steading and there was a mill wheel attached to the E wall on the First edition OS map (Illus 24).

Room 4 on the SE corner of the complex had been a mill and a millwheel can be seen attached to the E wall on the First Edition OS map (Illus 23). In Phase 1 the complex was C-shaped with the access from the south opposite the mill pond and the farmhouse but by the Second Edition map the W and S wings had been rebuilt and the access changed to the west wing. Room 3 was a cart shed with three large cart doors accessed from the central courtyard and Room 6 a bothy with access into the inner courtyard. A later door was added in the W wall to allow access to the exterior. Large doors in the N and E facades were also reduced in size to create windows more suitable for general agricultural use and the door in the S façade was reduced in size to create a smaller door (Illus 20).
