**Greyfriars (John Knox) Church, Broad St/Queen St,  
Aberdeen, AB10 1AP  
Report on Level 2 Standing Building Survey  
and Watching Brief**

**Alison Cameron and Dr Robert Lenfert  
18 April 2017**

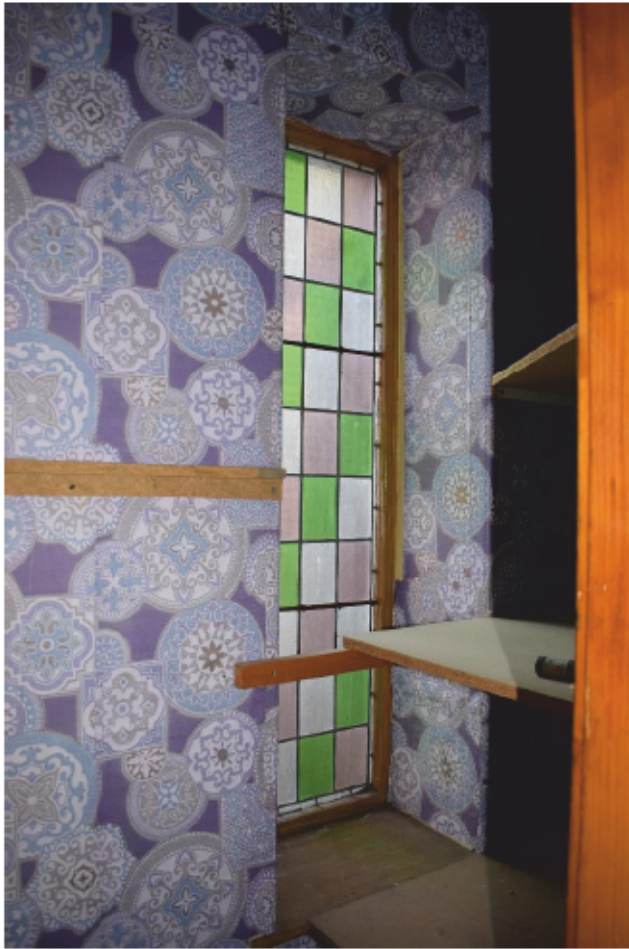
Illus 6 Stained glass in W29 in porch on SW side Room 1; facing WSW

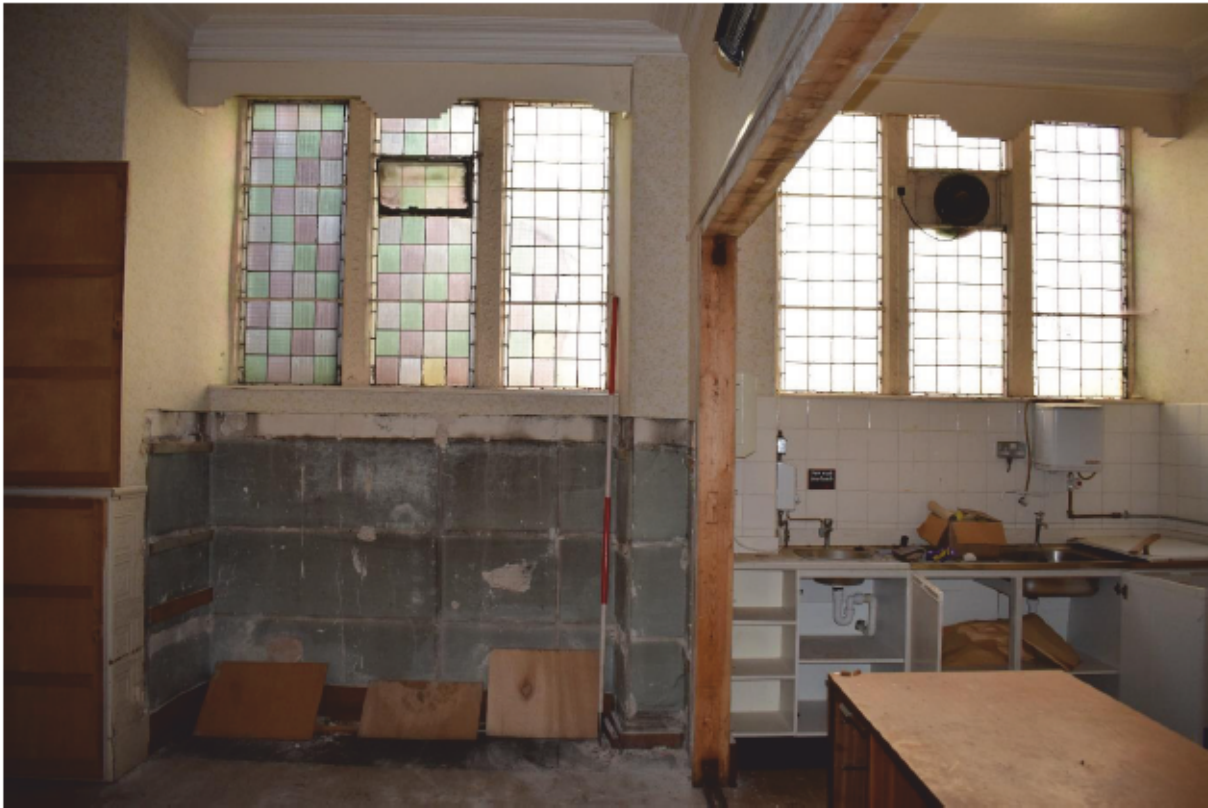
Rooms 3 and 5 are adjoining and have large windows on the SE wall (W32, W33; 1.9m wide and 1.55m high; Illus 7). The room has been the kitchen in the lower ground floor and there are fuse boxes built into a cupboard in the NE wall.

Illus 7 Room 3 (left) and 5 (right) windows W33 (left) W32 (right); facing SE

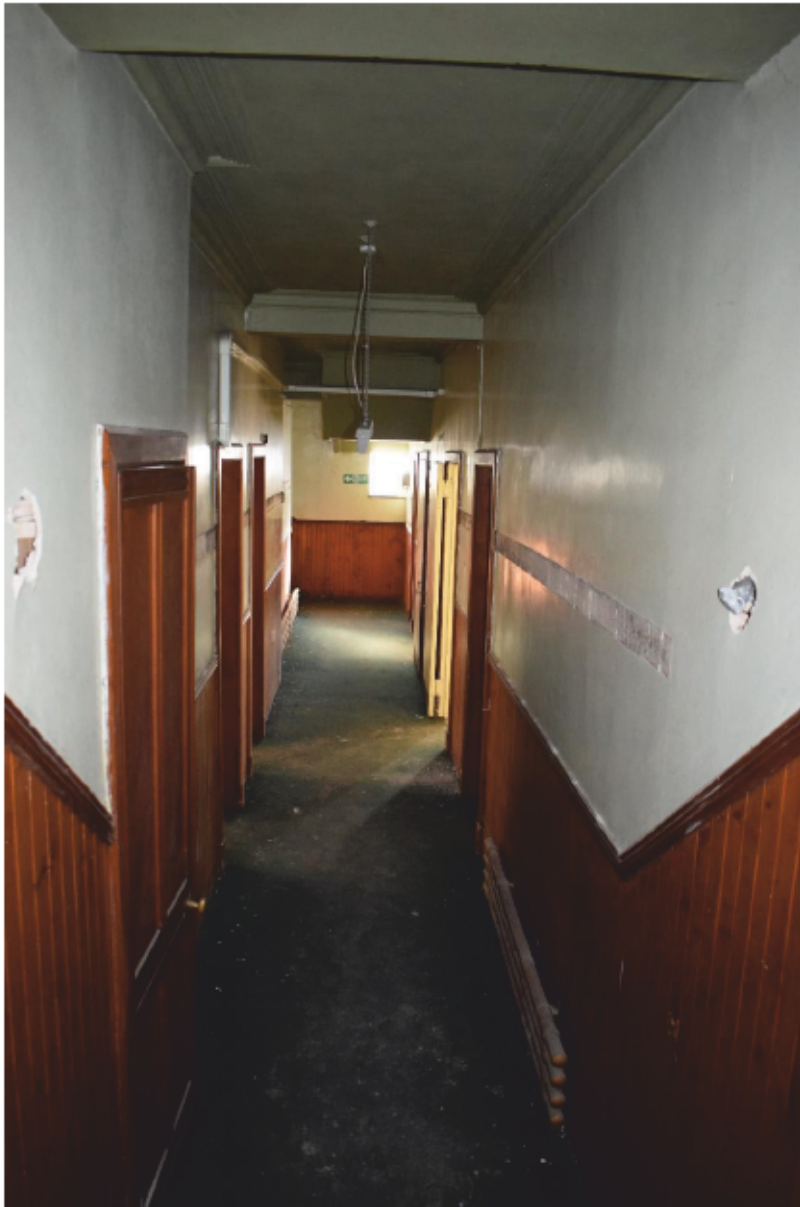
The lower ground floor corridor leads from the ground floor down steps at the NE of the building to the SW wall (Illus 8). The NW wall of the corridor bisects W15 on the SW wall suggesting this corridor has been inserted at a date after the construction of the church. On the NW wall there are doors to access the large hall (Room 8; D12, D13) and a door to the ladies toilet (D14). On the SE side there are doors to access Rooms 3 and 5 (D9, D10) and the corridor takes a dog leg at the SW end to access D2 and gent toilets through D16. The corridor is wood panelled and there are iron tubular radiators throughout.

Illus 8 Room 6 lower ground floor corridor; facing SW

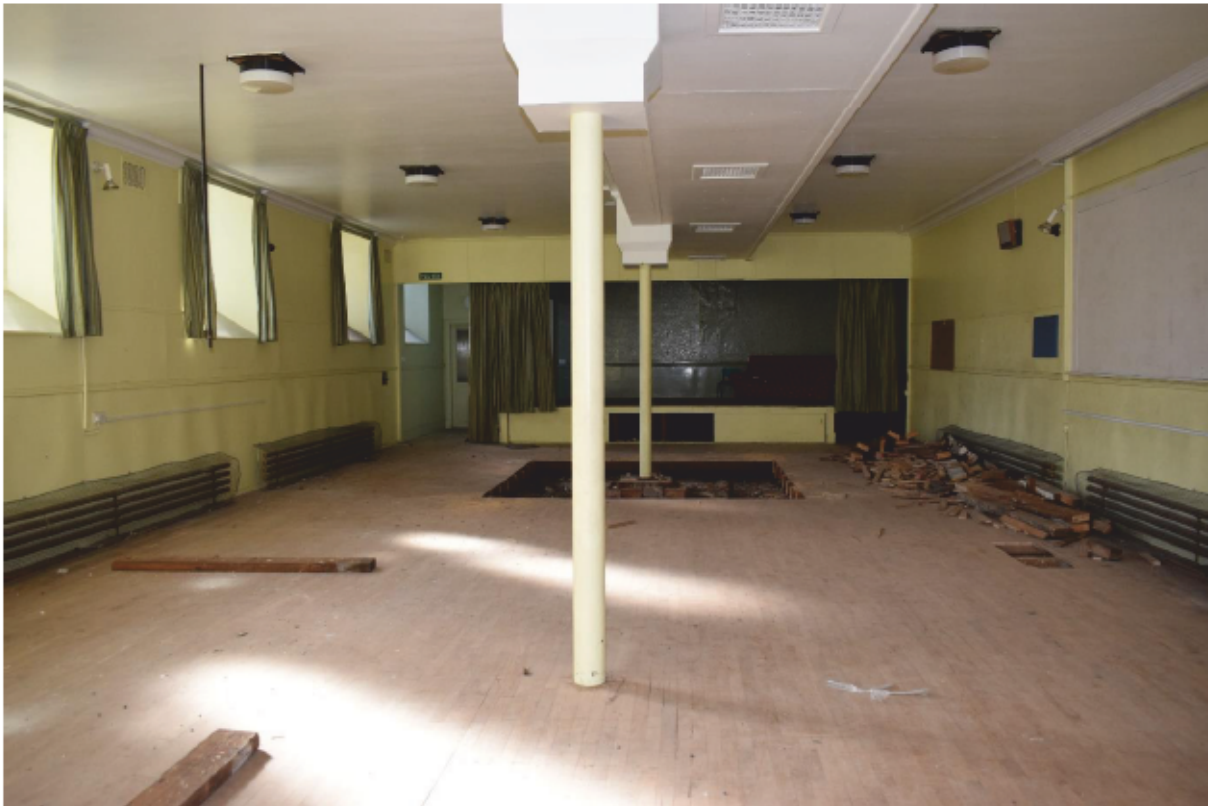
Room 8 is the large hall under the church (Illus 11). It has large windows on the SW wall (W10-W16; 1.65m high and 1.25m wide). There is a stage at the NW end of the room and doors to the corridor on the SE wall.

Illus 11 Lower ground floor hall Room 8 with cast iron pillars (F30 and F31 (centre), windows on SW wall W13, W12, W11, W10 (left) and stage (centre); facing NW

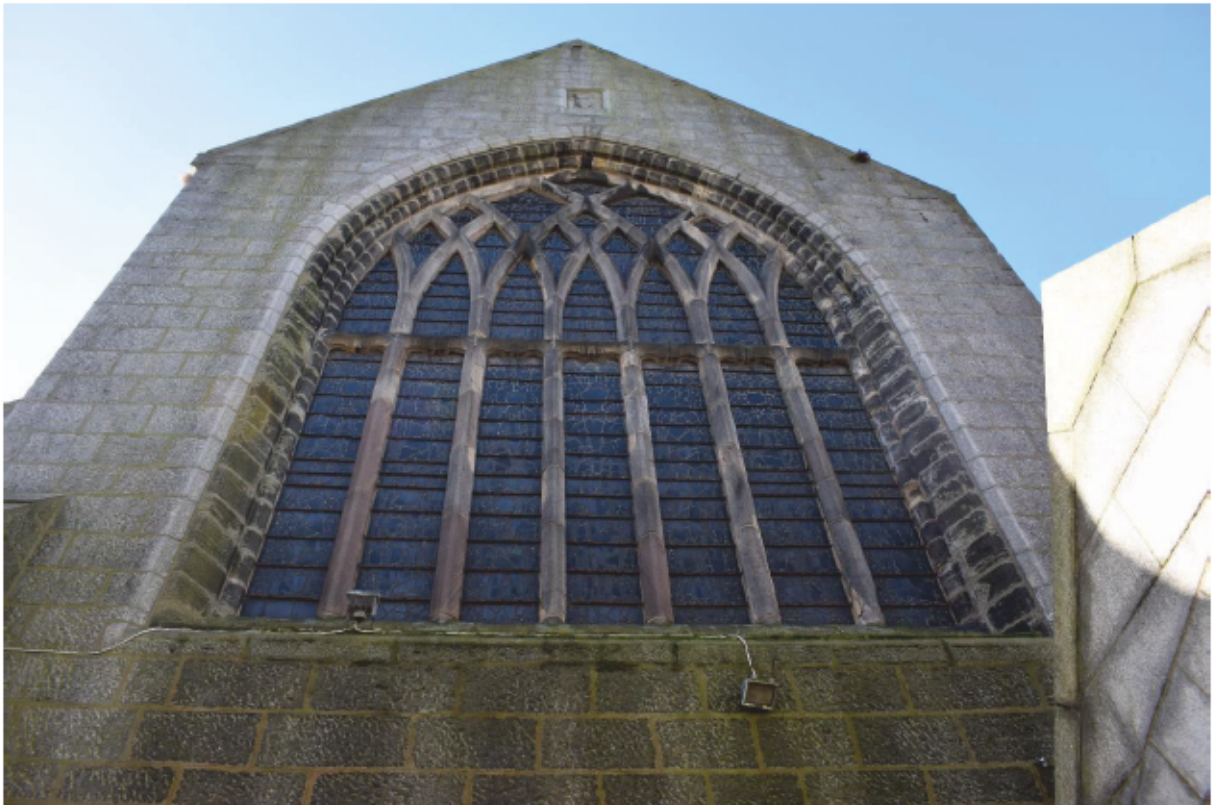
Illus 13 Exterior W34; facing NW

W34 sandstone tracery removed from SE window old greyfriars and rebuilt into SE window of this church with new glazing celebrating Greyfriars church and other religious scenes

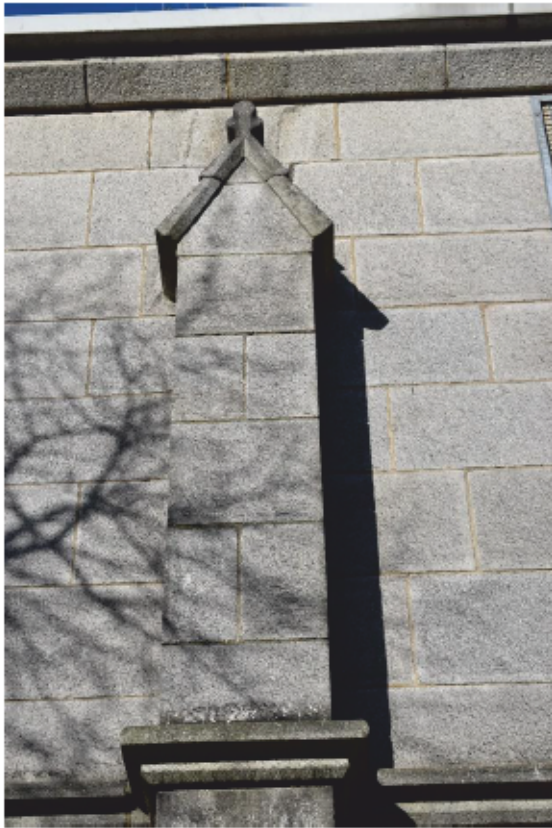
Illus 16 Detail of pointed top of decorative buttress F7 on SW façade of main church; facing NE

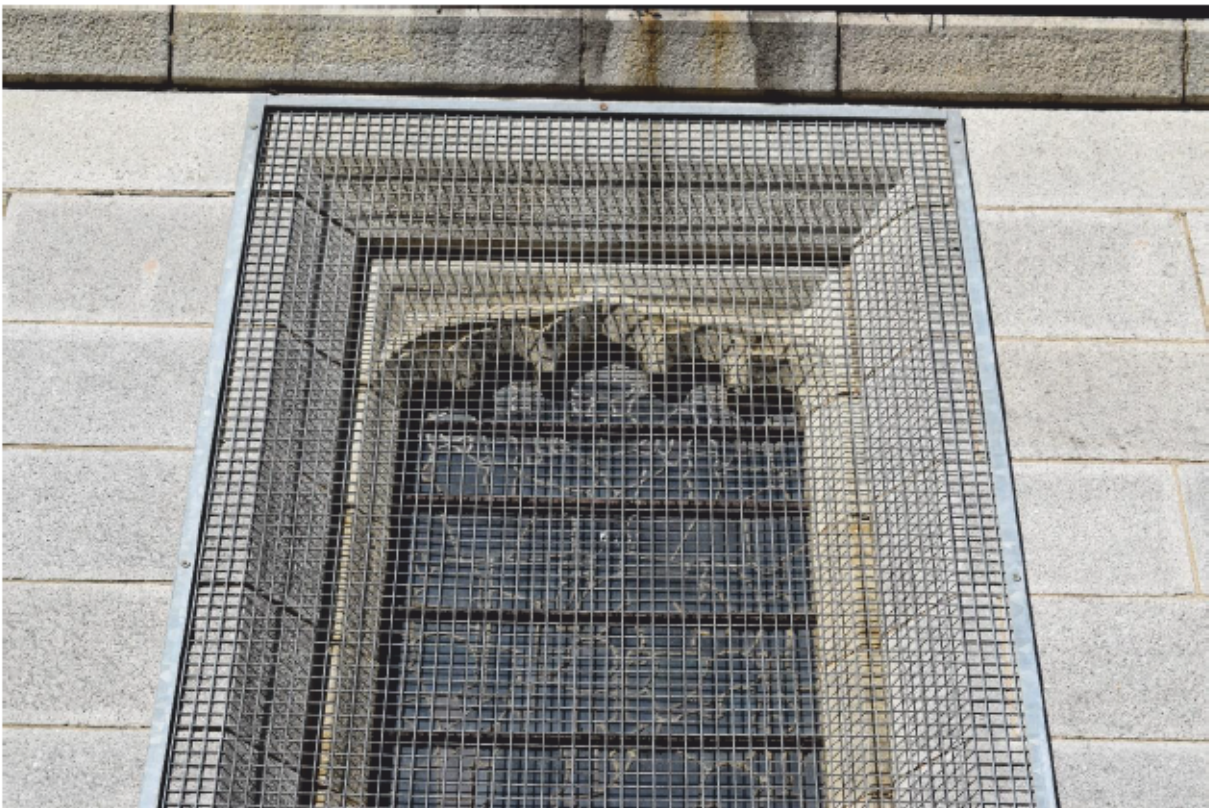
Illus 17 Detail of scalloped lintel of W22, SW façade of main church; facing NE

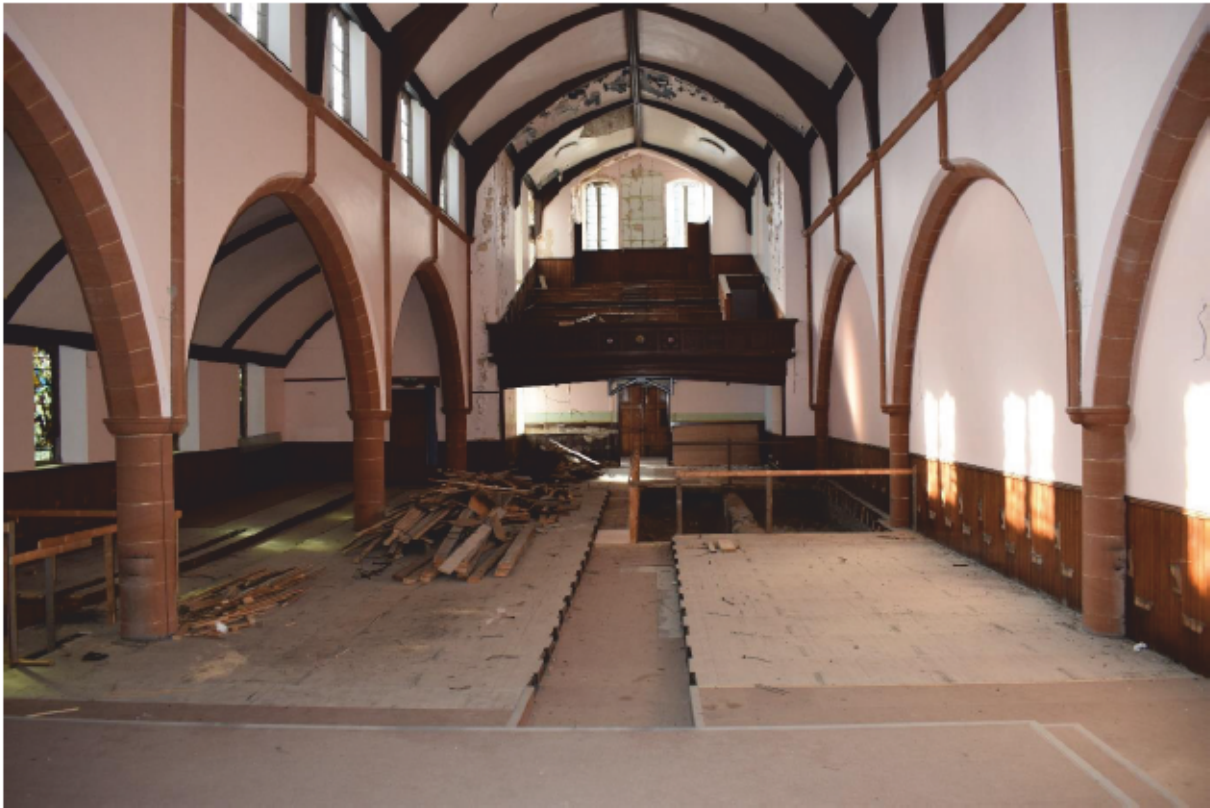
Illus 18 Room 10 interior showing sandstone pillars (F17 and F18 left; F15 and F16, right) with gallery F32 (centre); facing NW

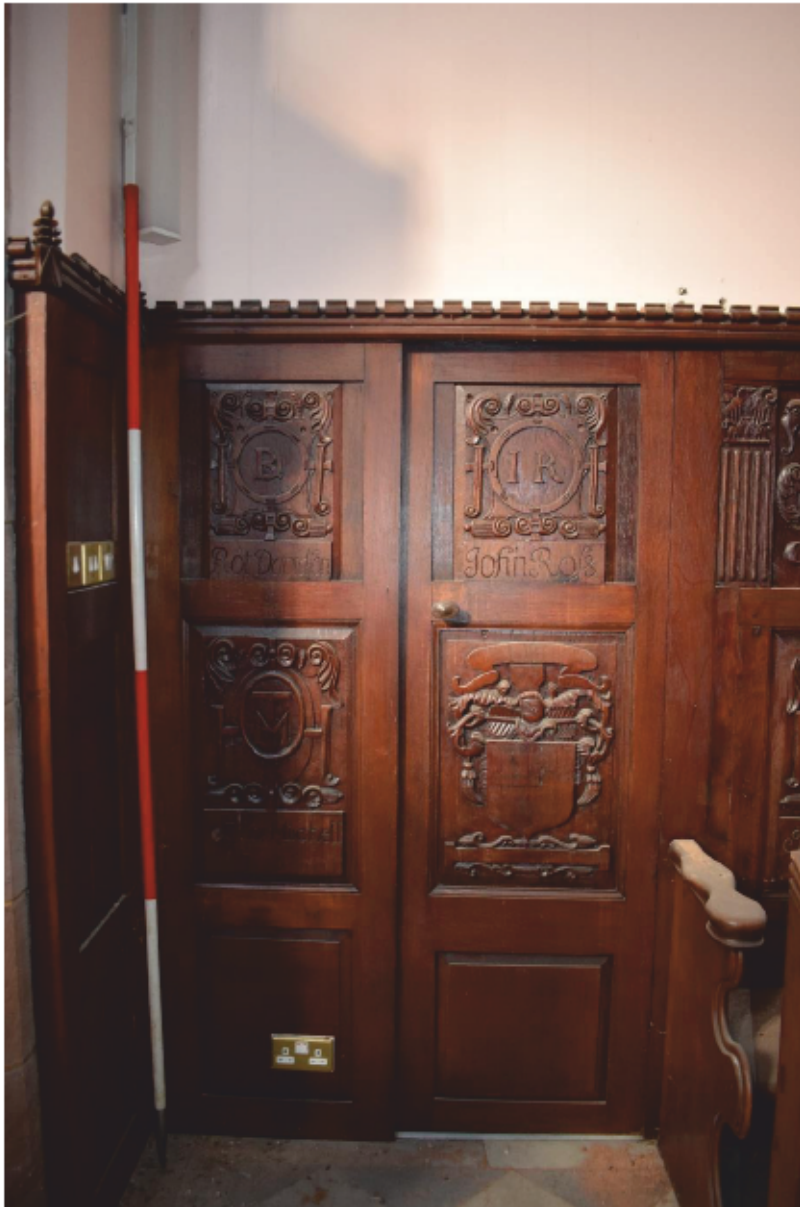
On the SE wall under window W34 are a series of wooden panels on the NE, SE and SW wall around the area of the altar (F12; Illus 19, 20). These are carved with names, initials and dates in the late 17<sup>th</sup> and early 18<sup>th</sup> centuries. The panels are typically 45cm high and 43cm wide and are incorporated in door D18 between the church and the ministers robing room (Illus 19) but also in the door (D3) and in the SE edge of the Gallery (see below). Some of the script is poorly executed and all are male names. It has been suggested that these are apprentice pieces (Jane Geddes pers comm) and may have been relocated from the old Greyfriars Church or St Nicholas (possibly after the fire of 1874). There is also a series of wood panels in St Nicholas Church.

Illus 19 Wooden panels F12 built into door D18 between Rooms 10, main church and Room 9 minister's robing room; facing NE

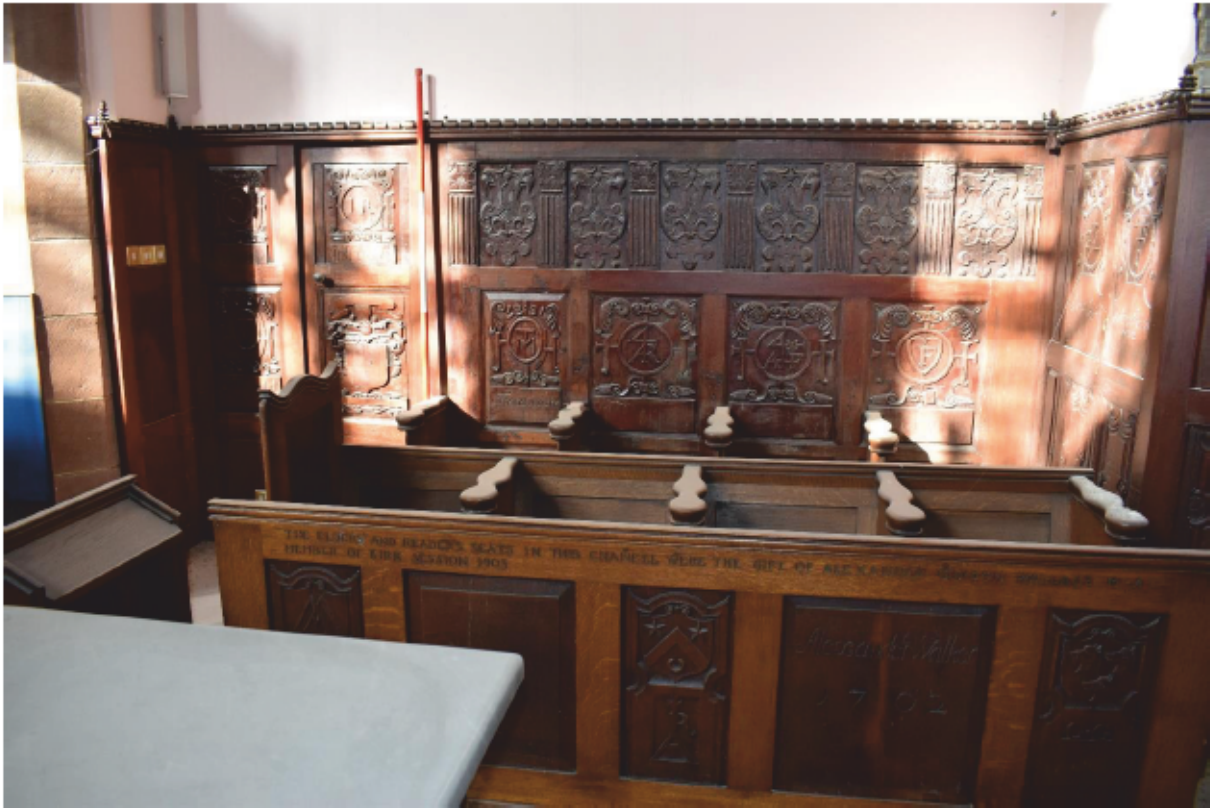
Illus 20 Wooden panels F12 on NE wall of choir

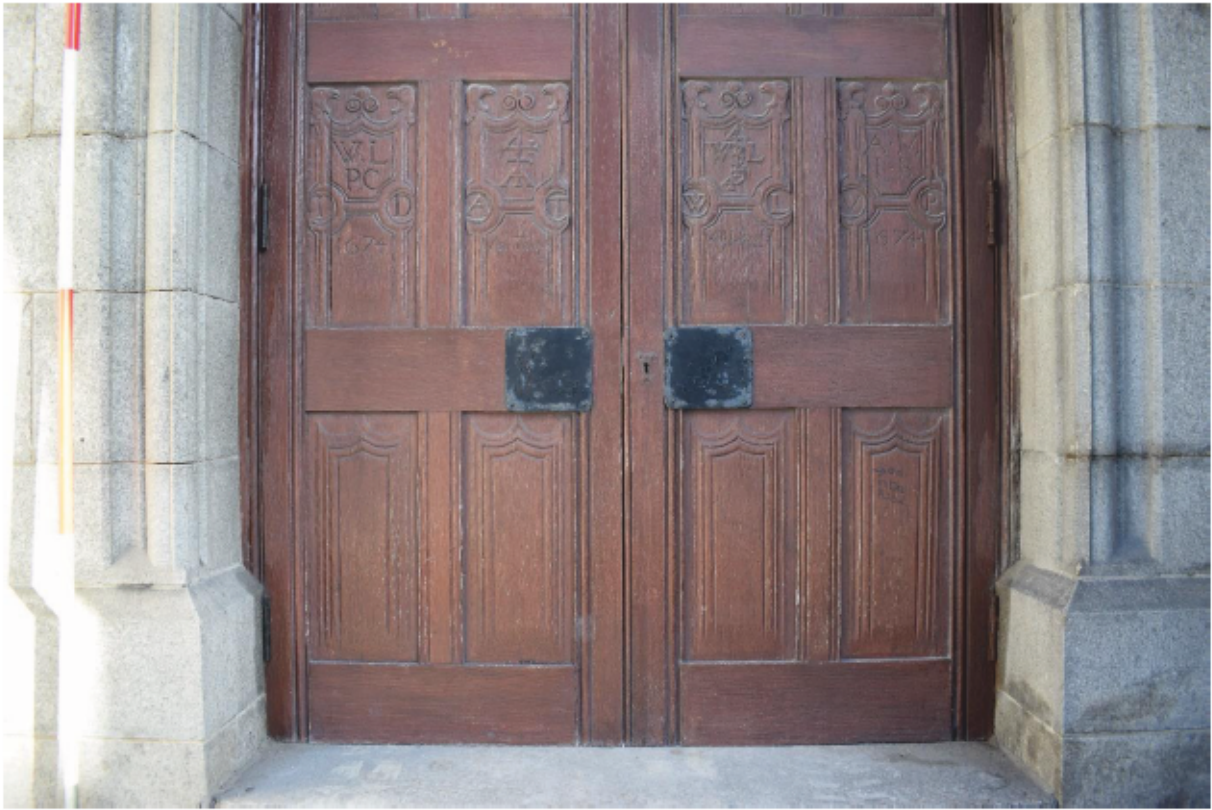
This entrance hall has a window (W1; 1.5m wide, 2.15m high) on the SW wall D3 on the NW wall, the main door leading down steps to Broad Street. The door is made from reused wooden panels (Illus 21, 22) and there is a dated keystone (1901; Illus 23) on the exterior (Illus 23). There are stairs in the N corner of the room to the first floor gallery F32. There is a small Room 14 on the NE of this room and there is an under stair cupboard and a window (W40) to the NE. There is a stone plaque in the W corner (Illus 24).

Illus 21 Door 3 reused wooden panels; facing SE

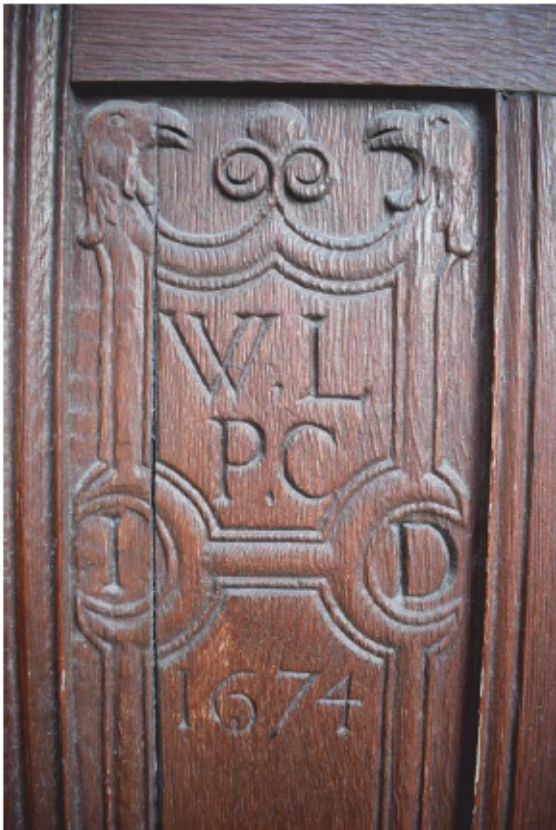
Illus 22 Detail of 1674 reused wooden panel; facing SE

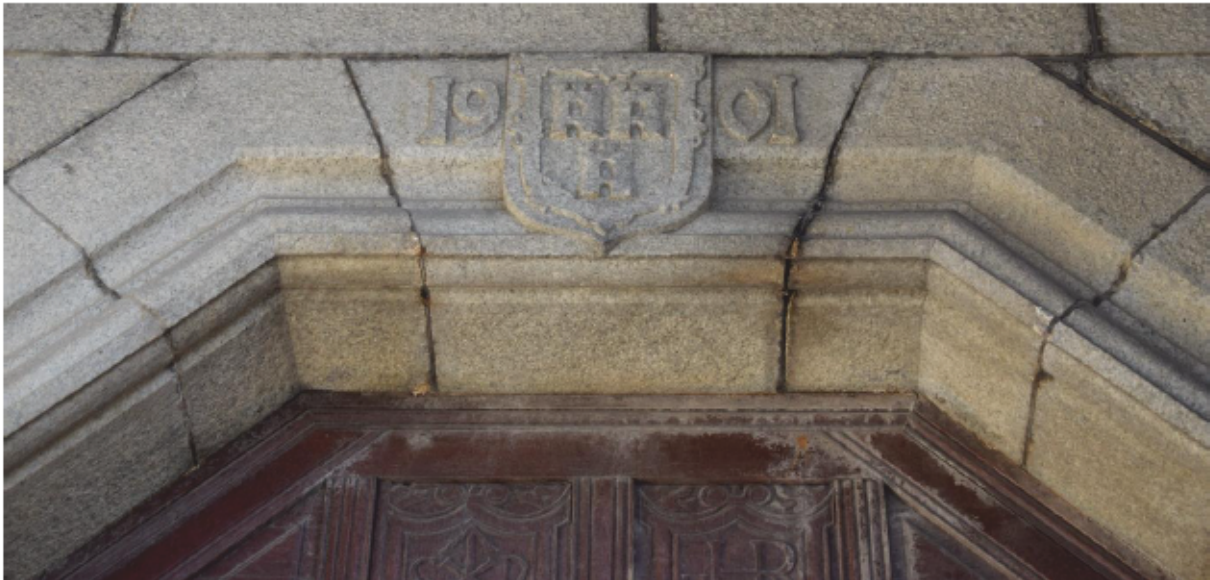
Illus 23 Detail of keystone in arched lintel above D3; facing SE

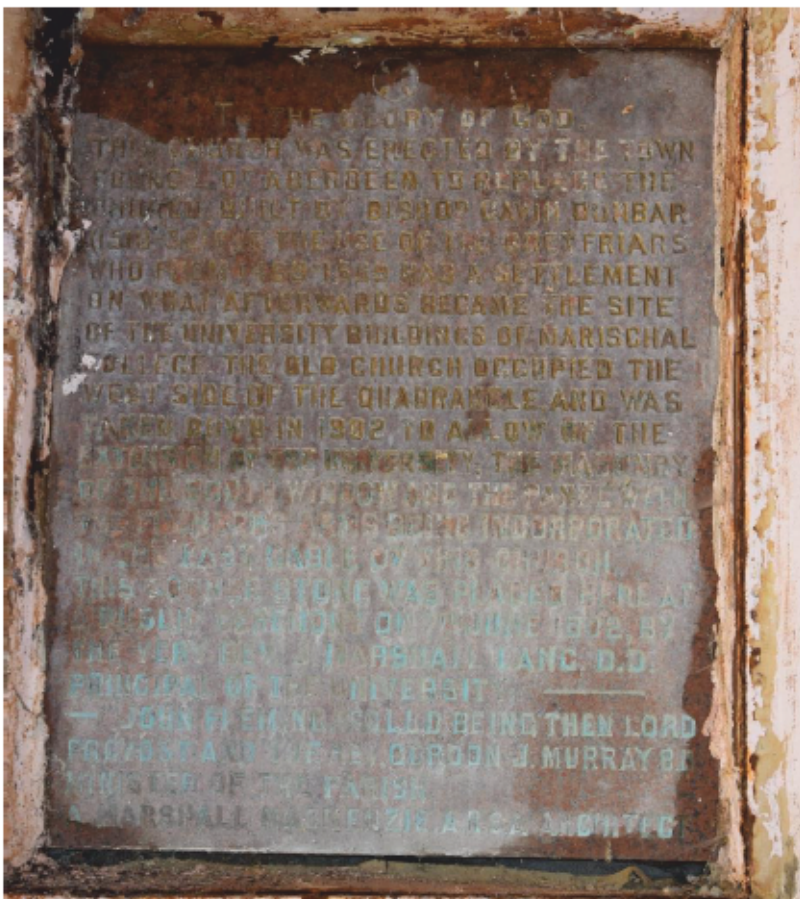
Illus 24 Stone plaque with history of the Greyfriars site; facing W

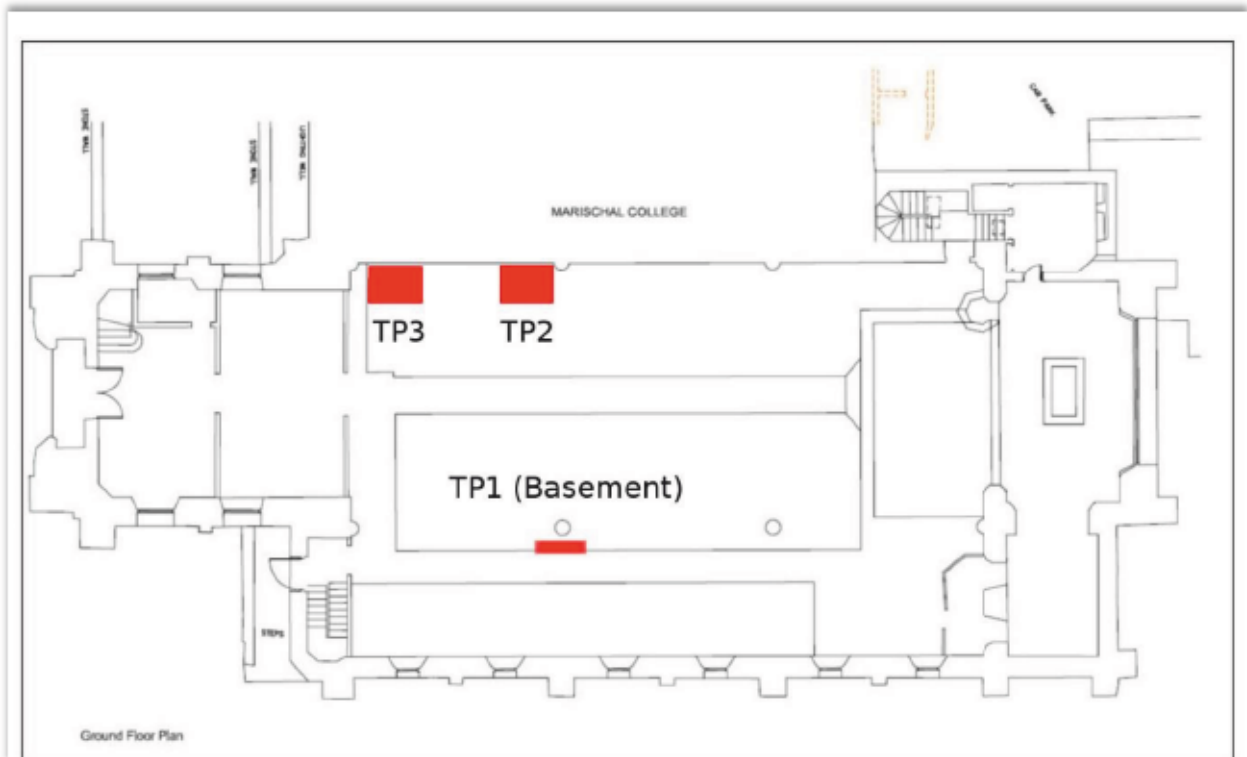
The first pit (TP1; Illus 25, 26) was hand-excavated and was located in the basement in an offset mid-point location towards Queen Street to the east. TP1 measured 1.2m in overall length by 0.55m in width, and reached a maximum depth c. 0.75m. Fill consisted of a mid-brown sandy-clay containing moderate amounts of small stones, gravel and drain tile, along with remnants of bitumen used to waterproof the sub-flooring.

Illus 25 Approximate locations of test pits within Greyfriars Church. TP1 was in a basement location. TP2 & TP3 were on the ground floor. The basement does not extend to Marischal College (copyright TCD Architects).

TP2 (Illus 27) and TP3 (Illus 28) were located below the sub-flooring on the ground level within the western half of the church itself, adjacent to the eastern wall of Marischal College (Illus 25). TP2 measured approximately 1.5m in width by 2.0m in length and reached a maximum depth of some 1.6m. It was bordered on the eastern side by a partial retaining wall, implying that this area had been previously partially excavated during construction. Fill consisted of a sandy-silt interspersed with stone and small cobbles. The fill, as to be expected in such an environment, was extremely dry and powdery after lying protected from the elements and moisture for over a century.
