**Cross St/Frithside St/Mid St/Manse St,
Fraserburgh, AB43 9JB
Report on Level 2 Standing Building Survey**

**Alison Cameron
Cameron Archaeology
16 June 2017**

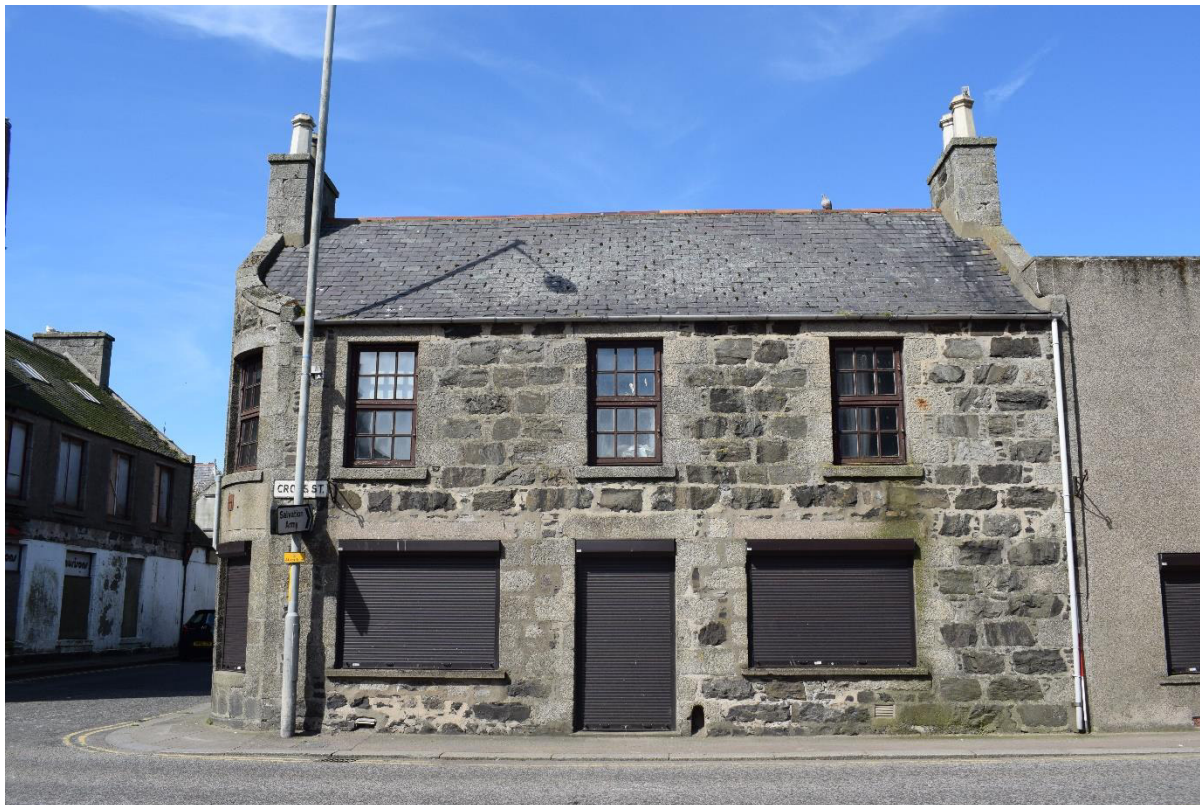
Illus 7 Building 1 E Cross Street façade; facing W

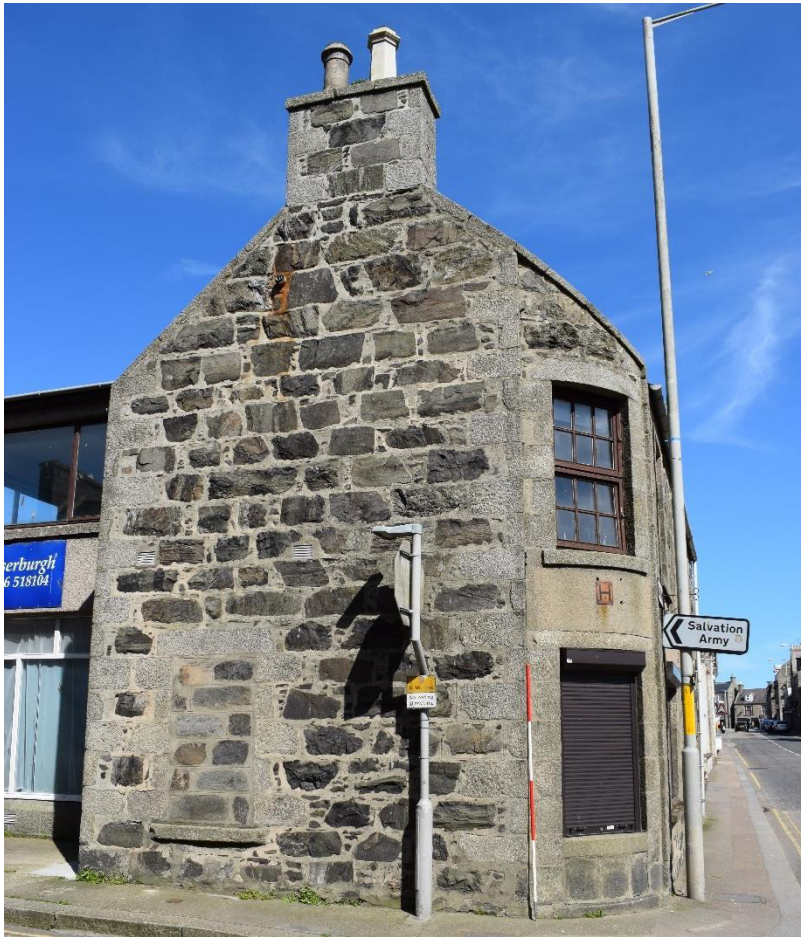
Illus 8 Building 1 south (Frithside Street) façade; facing N

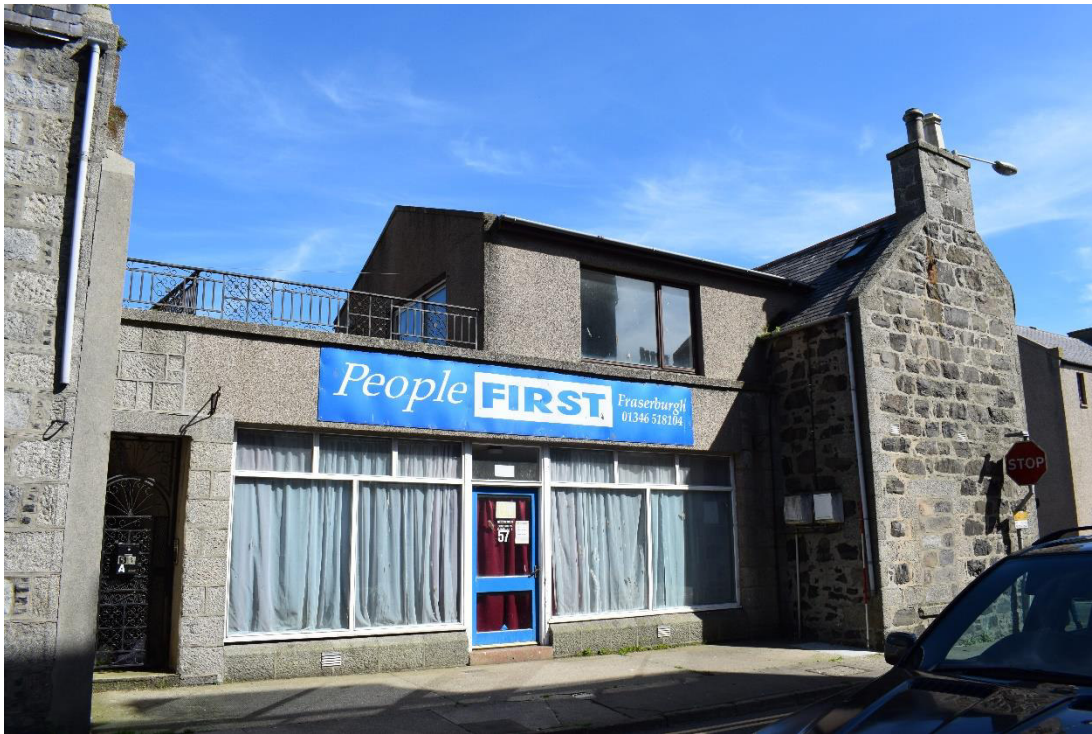
Extensions (1A, B, C, E) to Building 1 probably date to the mid to late 20th century (Illus 10-12).

Illus 10 Building 1A south Frithside street façade; facing NNE

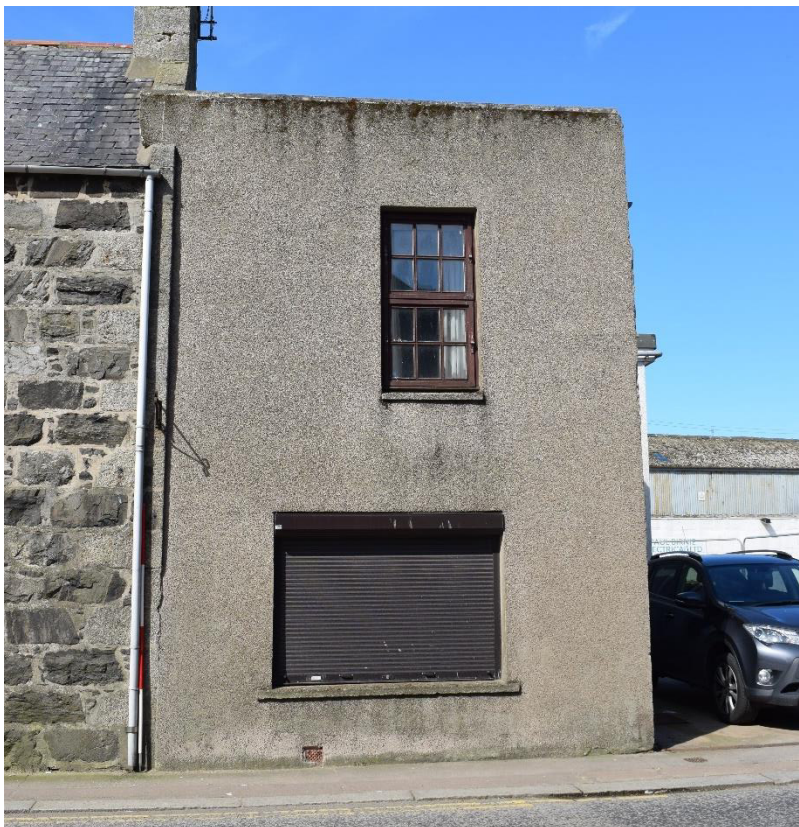
Building 1 is on the First Edition OS map where Building 1C also appears (Illus 9); this building has either been demolished and rebuilt or the roof has been removed and the walls harled giving it the appearance of a flat-roofed more recent extension.

Illus 11 Building 1C east Cross Street façade; facing W

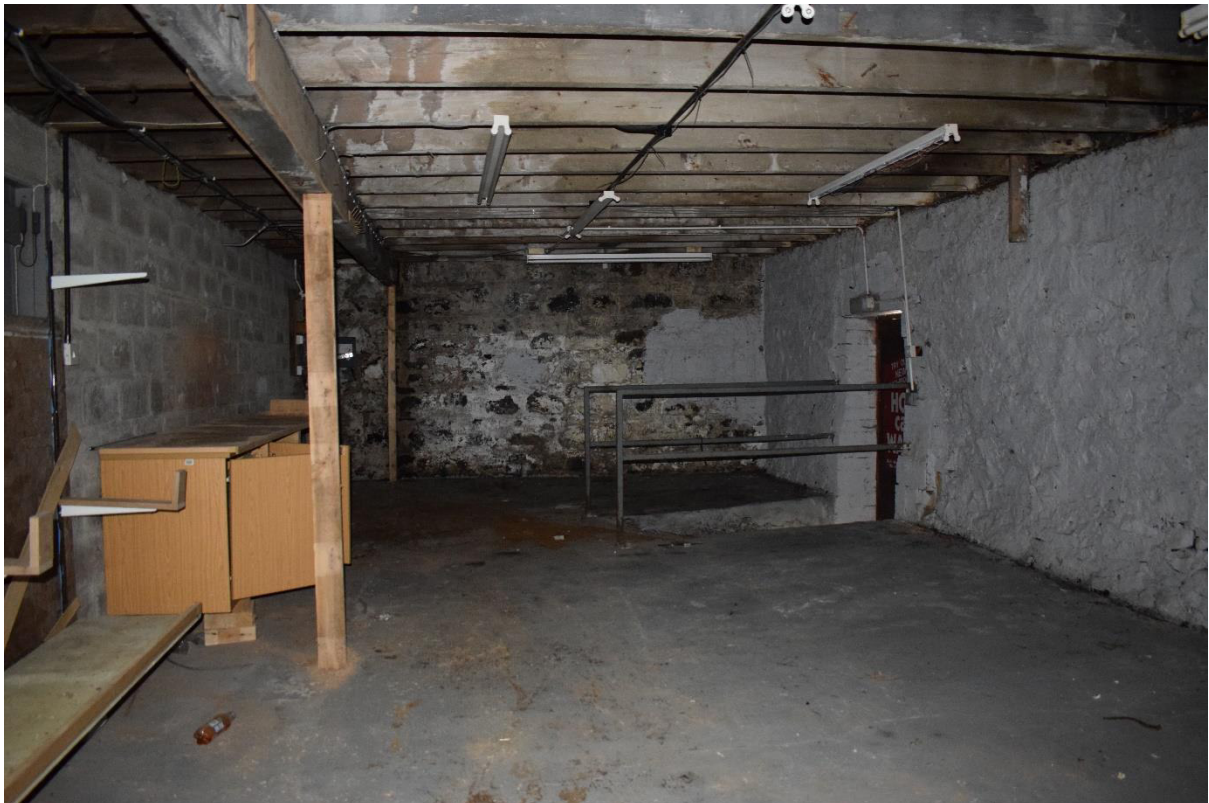
Building 2 is oriented NNW-SSE in the centre of the site (Illus 13-16); it is 23m long and 5m wide. It is on the Second Edition OS map but has been partially rebuilt. It is a stone rubble building but has been altered using concrete blocks in the E wall (Illus 11). The stone wall of Building 6 can be seen on the interior where Building 2 has been added on after the construction of Building 6 (Illus 12). The original building may have been single storey but the building has been extended in height with metal paneling and asbestos concrete roofing (Illus 11).

Illus 16 Building 2 interior with stone wall S wall Building 6 (centre); facing N

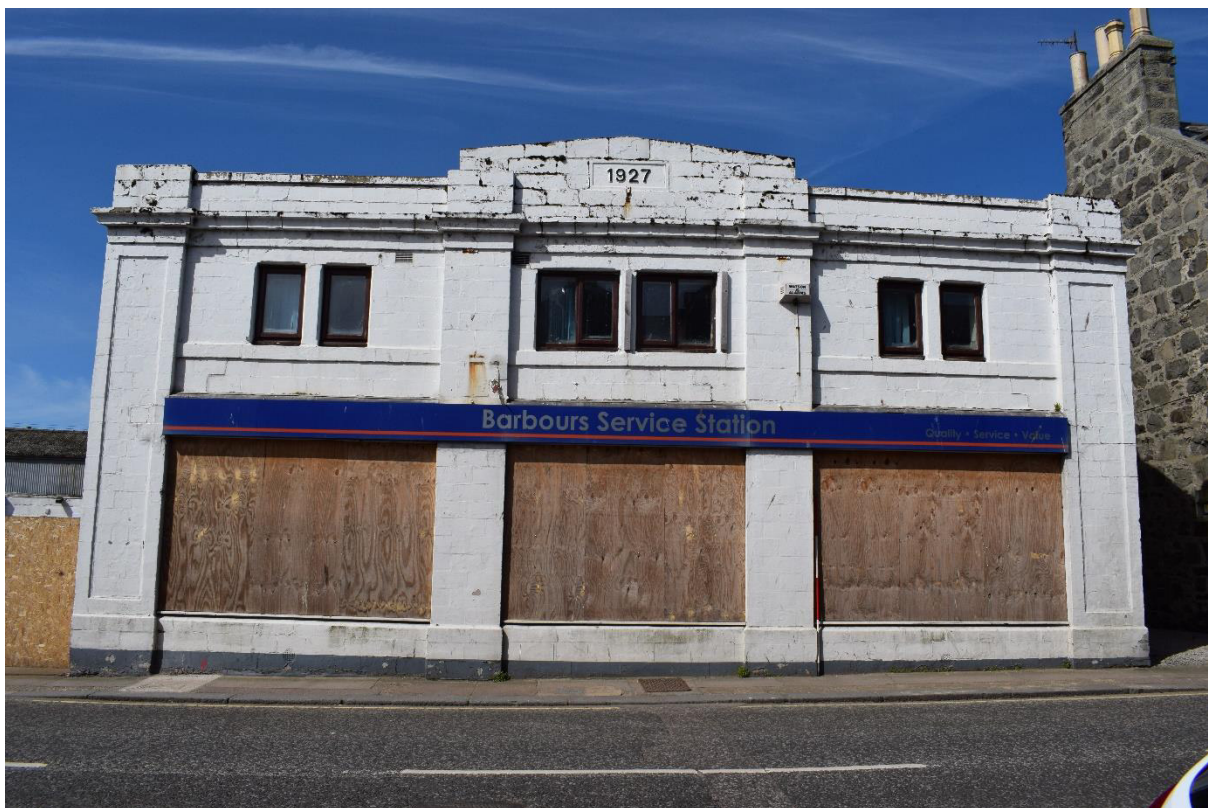
Building 3 is a former garage 12m wide and 15m deep constructed of concrete blocks (Illus 17-24). It is two storey with large windows (now covered) on the ground floor Cross Street

façade (W30, W31, W32) and smaller windows above (W27, W28, W30). There is a small blocked door on the N wall (Illus 16). The building has been extensively modernized and the ground floor was used as a shop and the upper floor as a flat. There is a 1927 date stone in the gablet on the E facade (Illus 20, 21). There has been a large door on the S wall which would have allowed access to the forecourt (Illus 23). The garage forecourt structures and petrol tanks have been recently removed.

Illus 20 Building 3 east Cross Street façade; facing W

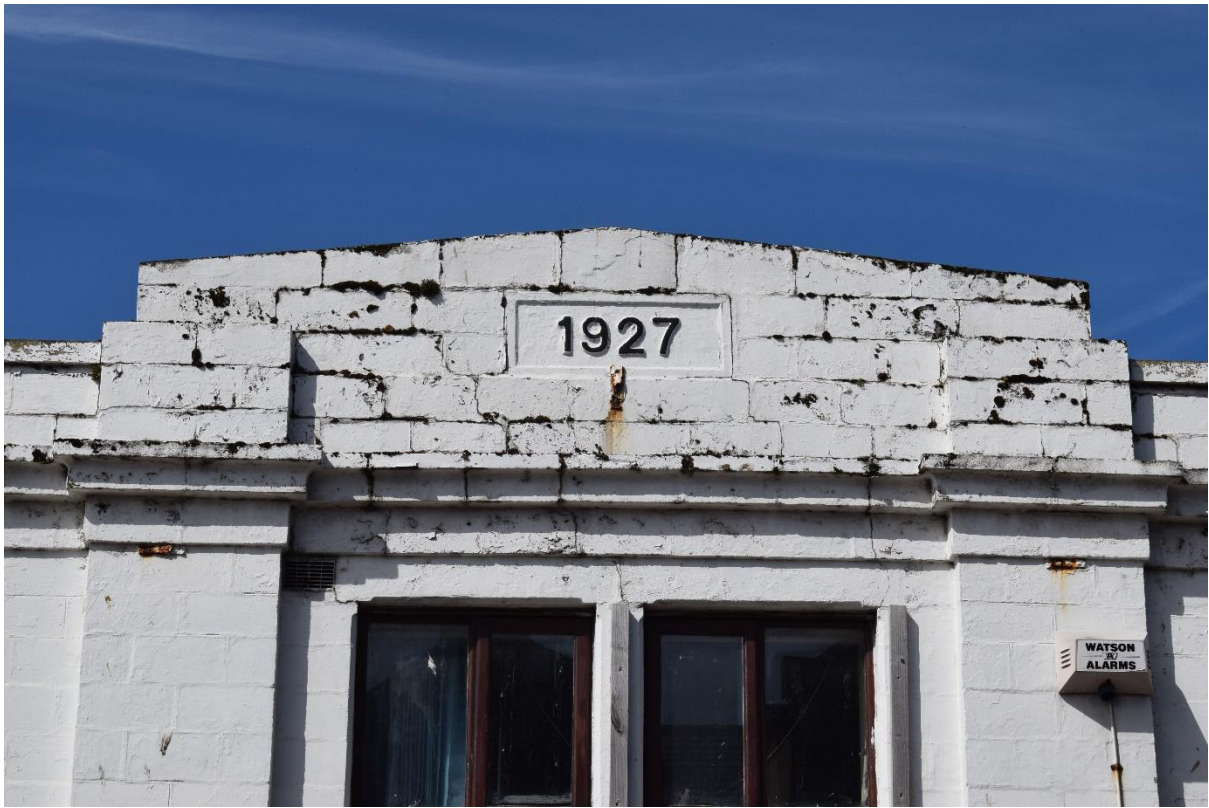
Building 3 is an Art Deco 1927 garage constructed of concrete blocks; there is date stone on the gablet above the front east façade on Cross Street. It has a flat above and has been completely modernized. The previous owner of the garage has asked to keep the date stone when the building is demolished (Clarke Dalziel pers comm).

Illus 21 Detail of 1927 date stone (F3); facing W

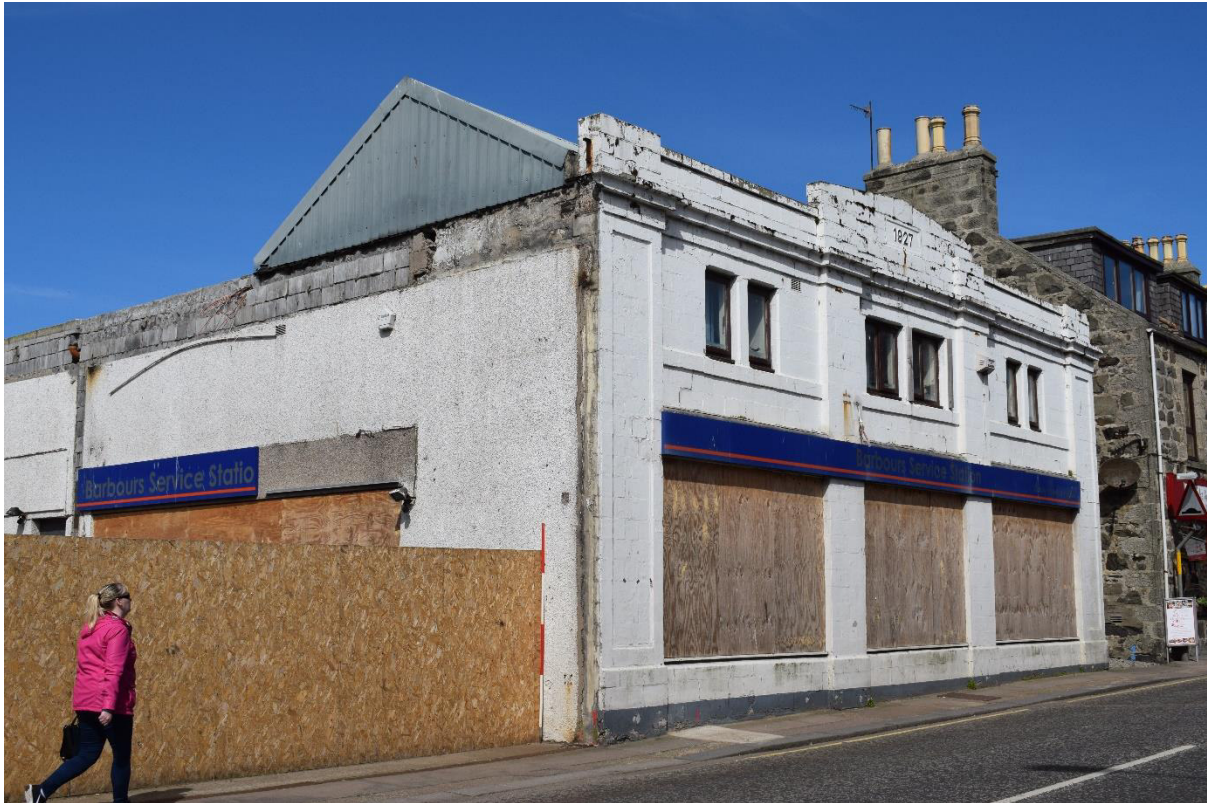
Illus 23 Building 3 S wall; facing NW

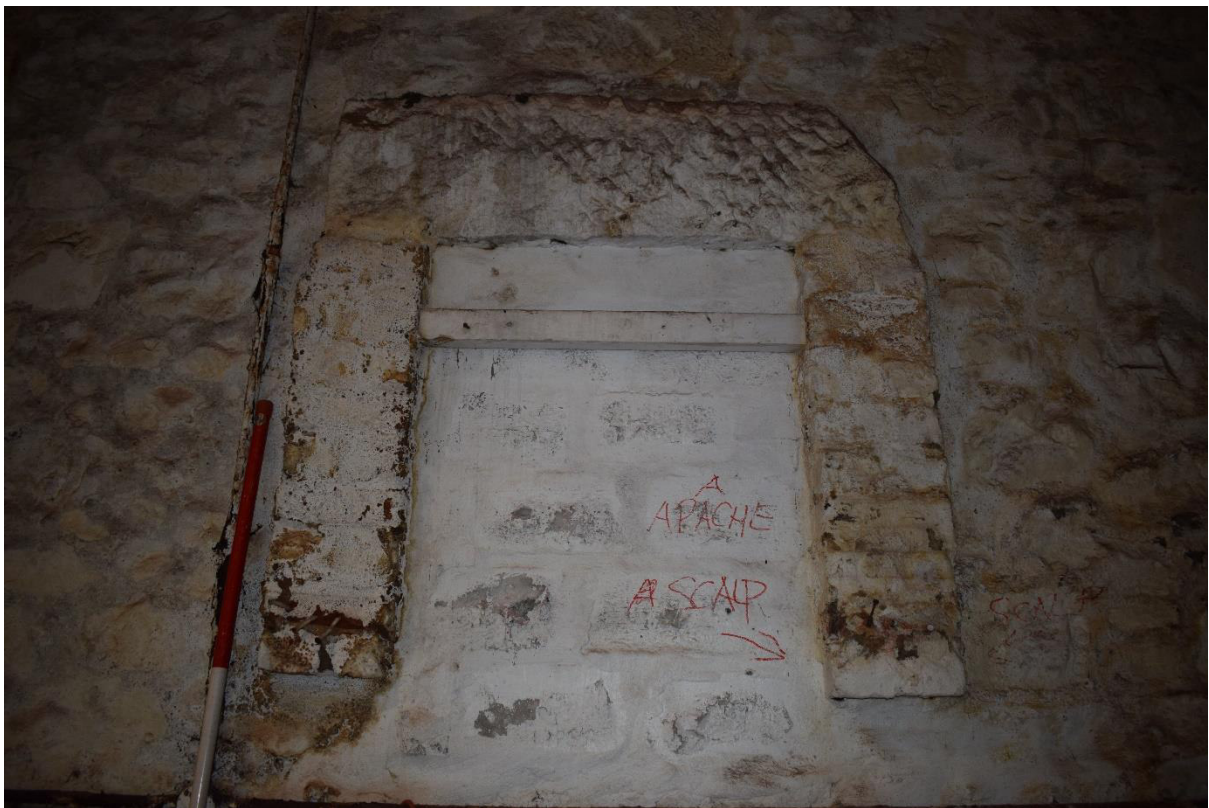
The interior of the S wall has four fireplaces (Illus 29-31) built into the upper level of the wall (F12-16). The fireplaces are constructed of red brick and stone lintel and are 1.3m wide and 1.8m high. It was originally two storeys and these fireplaces are on the first floor level. They have probably been within small upper rooms, possibly living accommodation and the walls of these rooms have been removed and the interior walls whitewashed removing all evidence of them.

Illus 30 Detail of F12; facing S

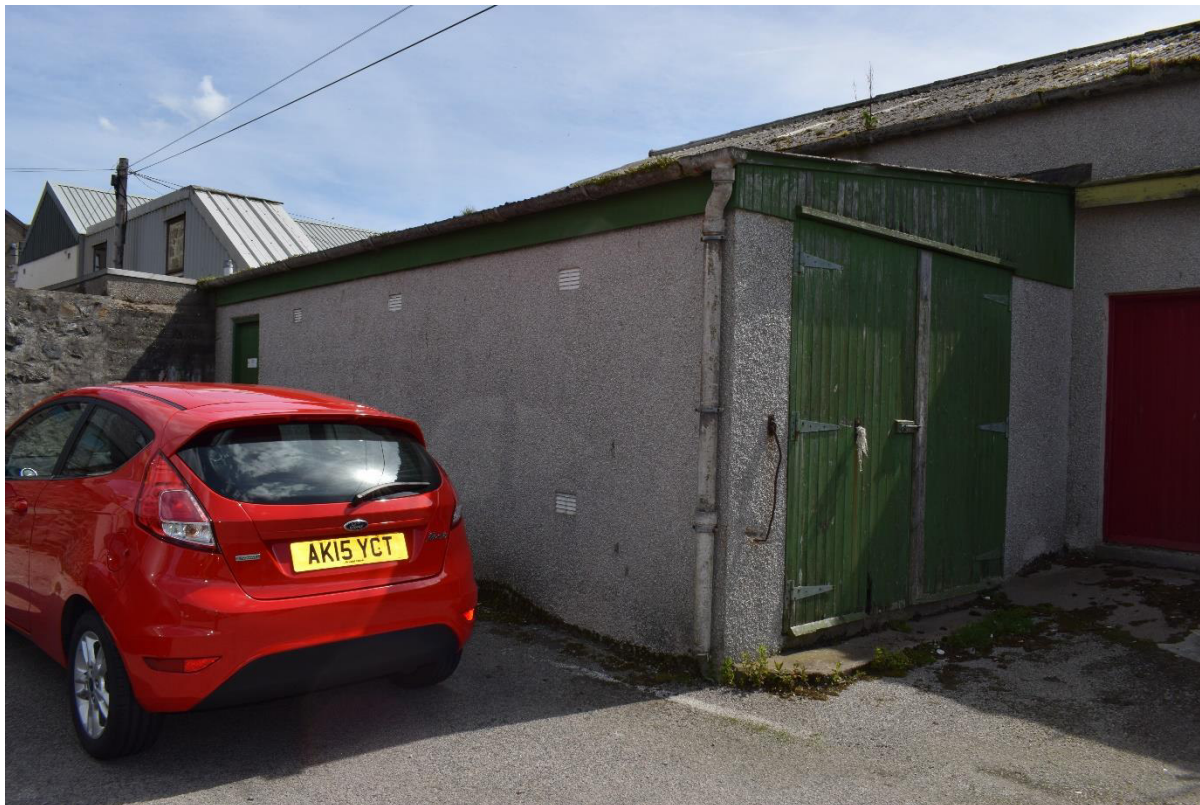
Building 5 is a small harled shed added on to the N wall of Building 4 (Illus 233). It has a garage door on the W wall and a small access door on the N wall.

Illus 33 Building 5; facing SE

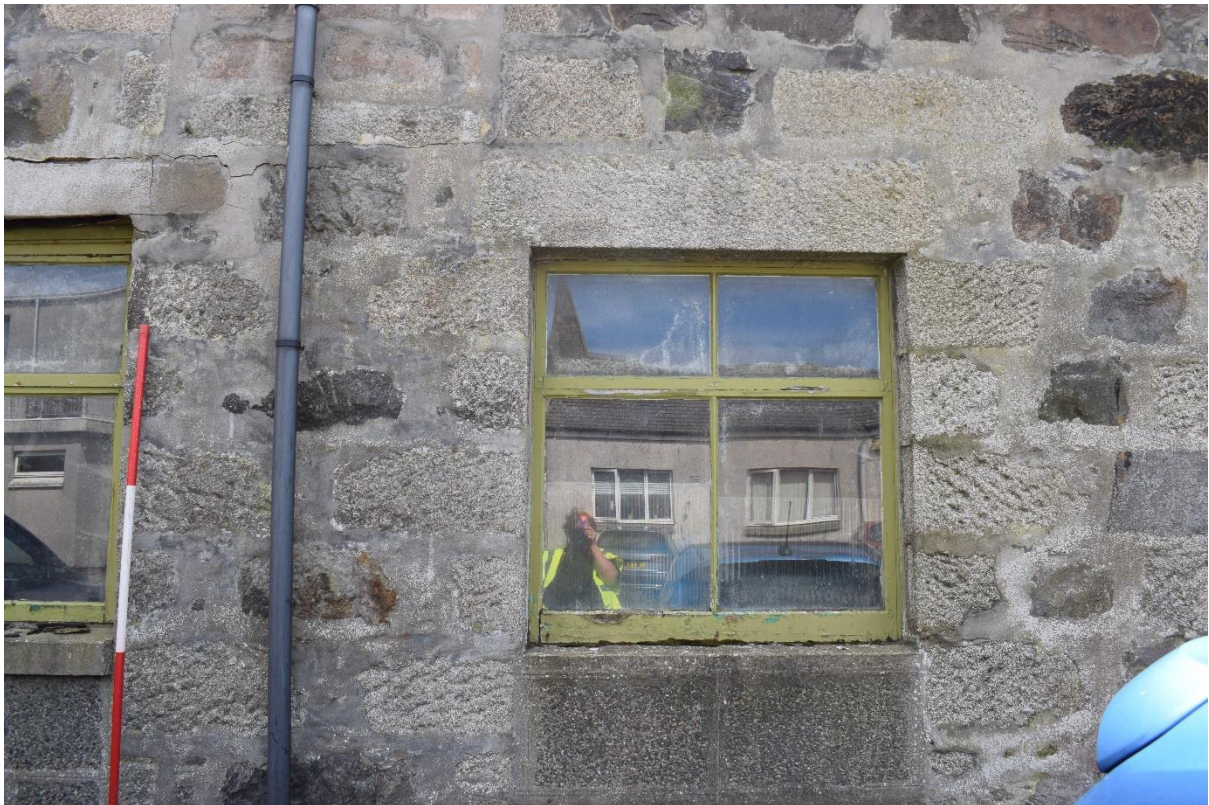
Illus 37 Building 6 N wall W33; facing S

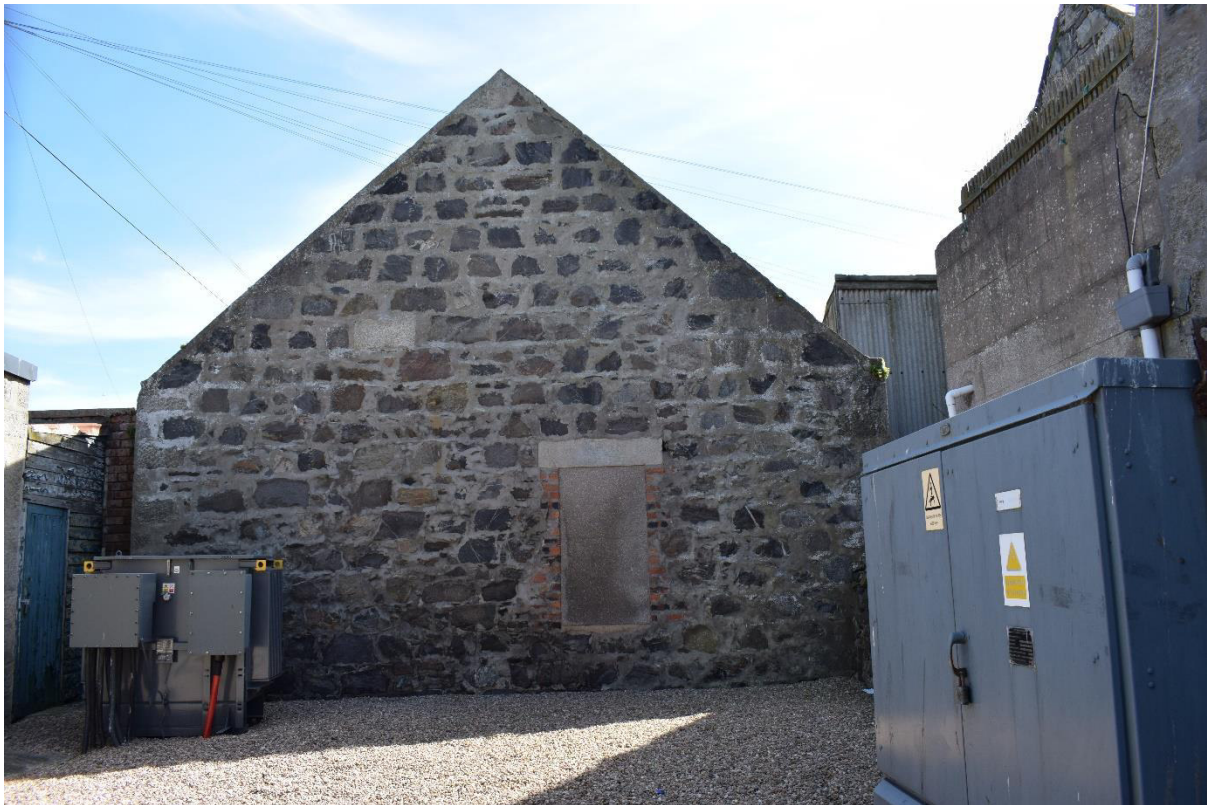
Illus 40 West wall seen through gates of electricity sub-station; no access; facing E

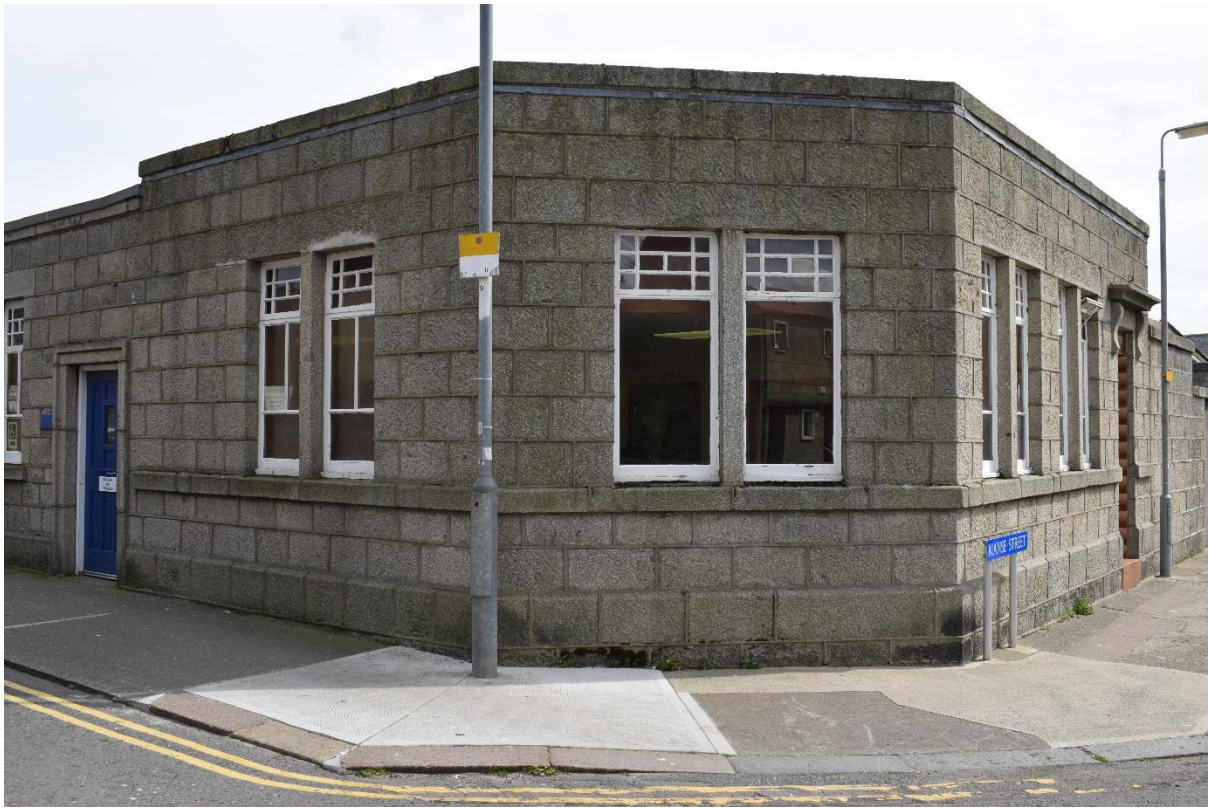
Illus 47 Building 7 rear south façade; facing NNW
